SEMI-ANNUAL ENVIRONMENTAL MONITORING REPORT

#11 Semiannual Report

(Reporting Period: July-December 2022)

**GEORGIA: URBAN SERVICES IMPROVEMENT INVESTMENT PROGRAM
(TRANCHE 6)**

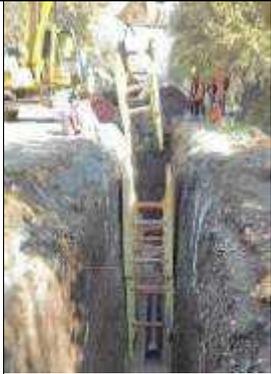
| Date of Visit | Name of Company Name of Contract | Auditors Name | Purpose of audit | Summary of any Significant Findings | Implemented Actions | ² Implementation Status |
|---|---|---|---|---|---|--|
| | | | | <p>deeper than 1.5 m.</p> <p>Provide all safety signage and lights in the night and follow traffic management plan</p> <p>Provide ladders in the trench for workers to come out in case of emergency</p> <p>Provide bridges for crossing trenches if access of any household is prevented by trench</p> | | <p>Completed in 12 November 2022</p> <p>Completed in 12 November 2022</p> <p>Completed in 12 November 2022</p> |

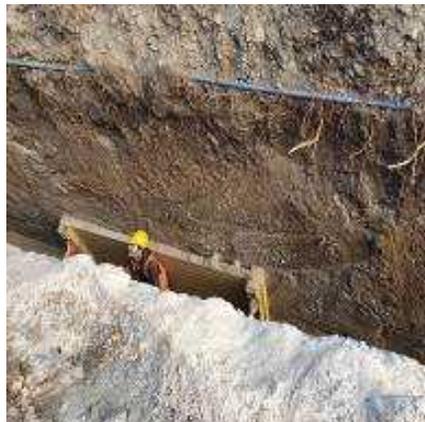
Photo N1, MAR-01 (9 November 2022)

- Walls of the deep trenches (>1.5m) should be strengthened by boards to avoid landfall of the soil and accidents (workers damage), please see Photo N2 below

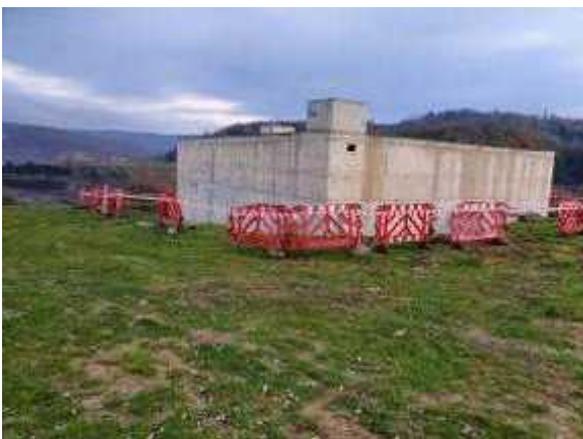
PHOTO N1 – AVARIONI RESERVOIR

50. There is a one open issues under CHI-01 sub-project: the temporary fencing is existing at Avarioni reservoir site, which this is grossly inadequate, does not serve the purpose and as such hard fencing of steel on strong column supports should be provided.

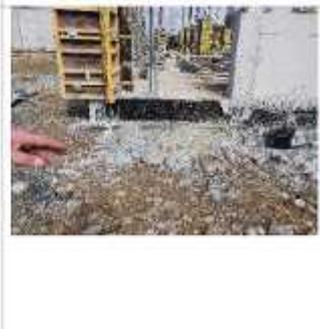
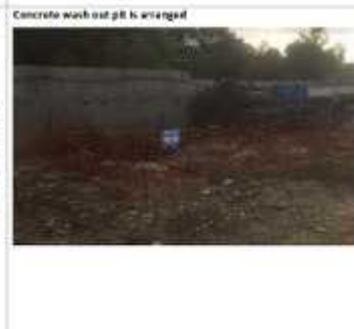
| Non-compliance point | Non-compliance photo | Corrective action photo |
|---|---|---|
| <p>5. Concrete wash out pit should be arranged at construction site. 'Concrete Rivers' should be immediately removed from the soil (Photo #10).</p> | | <p>Concrete wash out pit is arranged</p> |

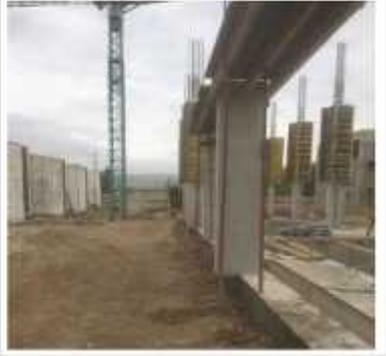
| Non-compliance point | Non-compliance photo | Corrective action photo |
|---|---|--|
| | | <p data-bbox="842 181 1005 208">Concrete spalls are removed</p> |

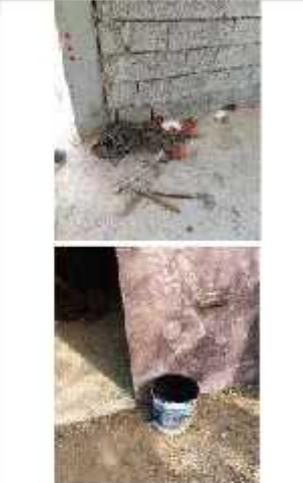
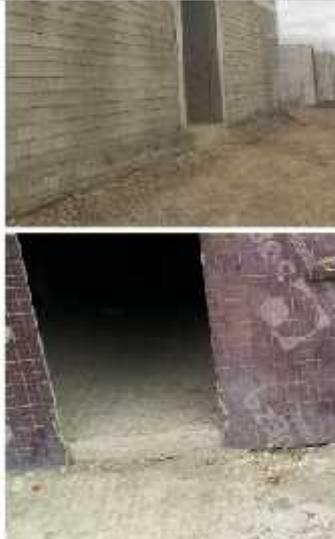
| Non-compliance point: | Non-compliance photo | Corrective action photo |
|--|--|---|
| <p data-bbox="323 766 467 1048">A. Hazardous waste are disposed all over the territory and are stored without proper regulations and pose a threat to the environment and the health of the workforce employed on site. Hazardous waste storage area shall be properly arranged and workers shall be trained by CC on safe handling of hazardous waste and materials (79mm x14, 215, 415)</p> | | |
