SEMI-ANNUAL ENVIRONMENTAL MONITORING REPORT

#14 Semi-annual Report

(Reporting Period: July-December 2024)

**GEORGIA: URBAN SERVICES IMPROVEMENT INVESTMENT PROGRAM
(TRANCHE 6)**

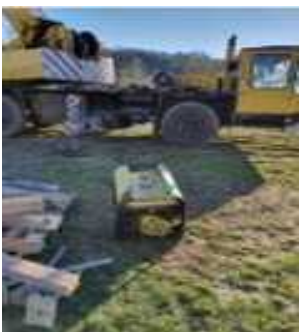
2	Avrioni Reservoir Oil spill Fuels and lubricants spills to be eliminated	Containers with fuel/lubricant should be managed properly (stored at the proper organized place with concrete floor and roofing) to	Photo N2

UWSCG End of June 2024	Completed June 2024 No traces of leakage were identified in the project area

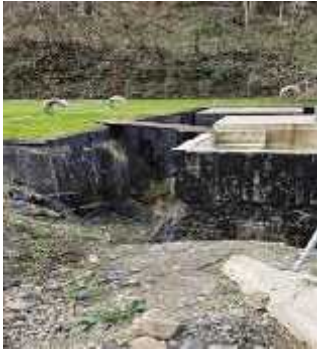
BISI Reservoir and Pumping Station					
6	Open trenches of the BISI Pumping Station are observed	Trenches on the BISI reservoir should be filled or fenced off their borders.	<p style="text-align: center;">Photo N6</p>

UWSCG	<p>Not yet completed</p> <p>A new tender will be issued to complete these remaining tasks, with funding provided through the central government budget. UWSCG is responsible for ensuring the completion of the CHI-01 sub-project.</p>
7	Uncontrolled disposal of construction waste were outside the BISI reservoir was fixed.	Construction Waste must be collected and disposed from the project area.	<p style="text-align: center;">Photo N7</p>

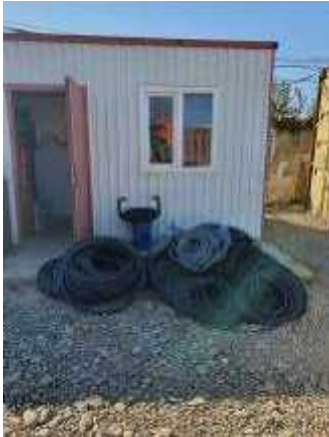
7 November 2024		ADB's Environmental Safeguard Mission, led by Mrs. Ninette R. Pajarillaga, Country Environmental Focal and Ms. Nino Nadashvili, Associate Safeguards Officer Georgia Resident Mission Asian Development Bank Environmental	ADB's Environmental Safeguard Mission	<p>Waste Management Site internally should be arranged properly and cleaned regularly, waste should be removed regularly, Photo N1</p>

<p>Verbal instruction was given to contractor to immediately improve the situation.</p> <p>Non-Compliance Notice was issued and is presented in Annex B of this report.</p> <p>(Photo-documentations are presented in Annex B, non-compliance note)</p> <p>Corrective Action Plan</p>	<p>Completed, Mid-November 2024, Photo N1</p>

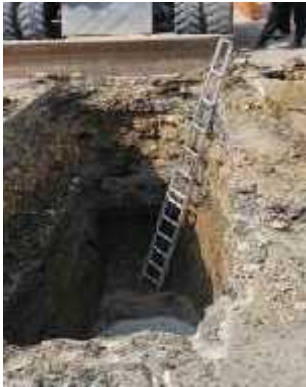
Date of Visit	Name of Company Name of Contract	Auditors Name	Purpose of audit	Summary of any Significant Findings	Implemented Actions	Implementation Status
Continuously during reporting period (July-December 2024)	China Geo-engineering Corporation (CGC) (Peoples Republic of China)	Environmental, H&S Specialist of Contractor Mr. Levan Inashvili	Regular Environmental monitoring of sites	Day to day monitoring of sites Compliance with Environmental and HES requirements	Prepare Monthly Environmental Monitoring Reports and send to SC	Performed monthly during the reporting period
8 August 2024	MAR-01 LOT-01, LOT-02, LOT-03 and LOT-06	Environmental Specialist of Supervision Consultant HILL Mr.Nikoloz Neparidze	Regular Environmental monitoring of sites	<p>The deep trench is not reinforced with protective shields, Photo N1</p>

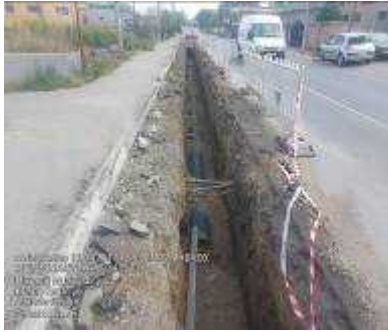
Date of Visit	Name of Company Name of Contract	Auditors Name	Purpose of audit	Summary of any Significant Findings	Implemented Actions	³ Implementation Status
		Neparidze		<p>other flaws, shoring is not being used, there is a lack of adequate protection of the trench and the traffic signals are insufficient, this way putting at risk not only workers but the population that needs to use that road, Photo N1</p>

<p>The quality of the performed works is not in accordance with the requirements of the Contract, as the backfilling of the trenches is not being done in layers, nor is it properly compacted, Photo N2</p>	<p>Non-Compliance Notice was issued and is presented in Annex B of this report.</p> <p>(Photo-documentations are presented in Annex B, non-compliance note)</p> <p>Corrective Action Plan has been developed by contractor and sent to SC and UWSCG</p>	<p>Completed, end of September 2024, Photo N1</p>

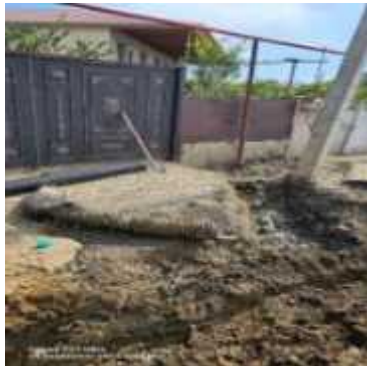
10 October 2024		Environmental Specialist of Supervision Consultant HILL Mr.Nikoloz Neparidze	Permanent monitoring of Sites	<p>The deep trench is not reinforced with protective shields, Photo N1</p>

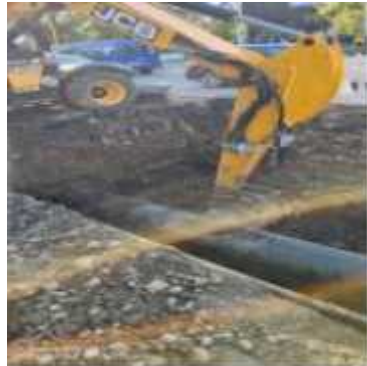
<p>The workers are not using the PPE, Photo N2</p>	<p>Verbal instruction was given to contractor to immediately improve the situation.</p> <p>Non-Compliance Notice was issued and is presented in Annex B of this report.</p> <p>(Photo-documentations are presented in Annex B, non-compliance note)</p>	<p>Completed, Mid. October 2024</p> <p>Completed, Mid. October 2024</p>

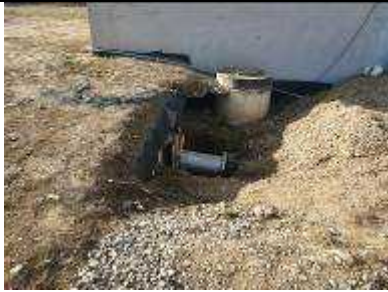
<p>The construction internal area should be regularly cleaned and organized, construction materials should be placed separately and stored properly, Photo N4</p>

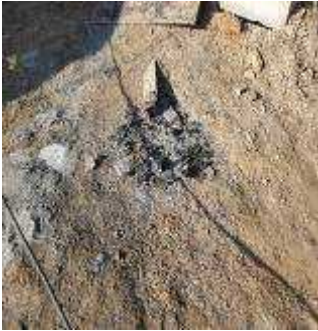
<p>Concrete must be removed from the area and the soil must be reclaimed, Photo N7</p>		<p>Completed, immediately, Photo N4</p>

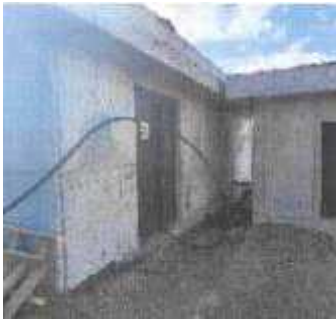
<p>Safety ladder should be installed on construction site to avoid workers damage</p>

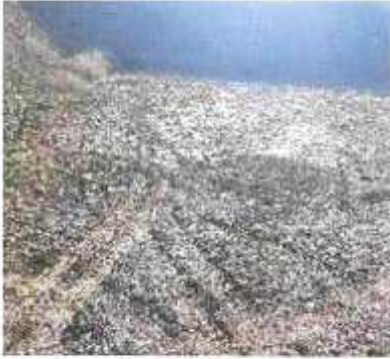
2. The construction site is completely covered with gravel (Photo No. 1);

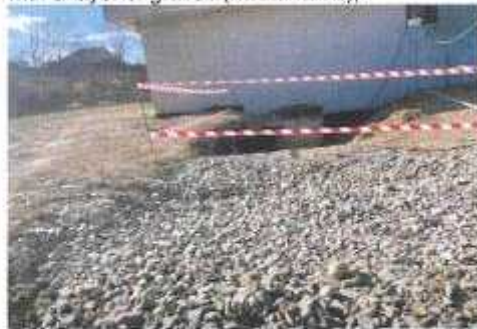
4. The construction internal area should be regularly cleaned and organized, construction materials should be placed separately and stored properly (Photo No. 4);

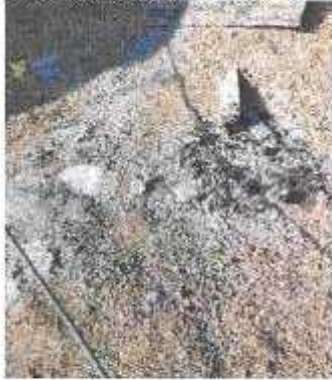
6. Burning of waste on the construction site is prohibited (Photo No. 6);

6. Burned waste was removed from the construction site (Photo No. 4);

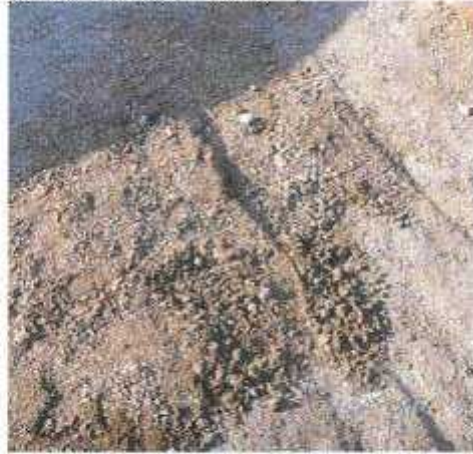
7. Concrete must be removed from the area and the soil must be reclaimed (Photo No. 7);

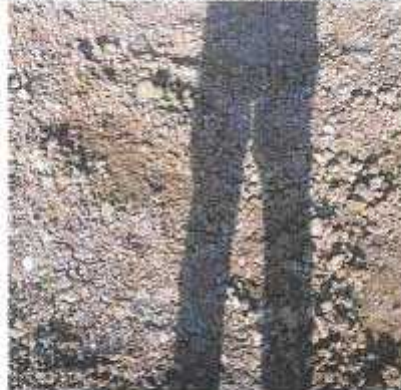
8. Safety electric cables should be arranged at construction site not to create danger for workers (Photo No. 8);

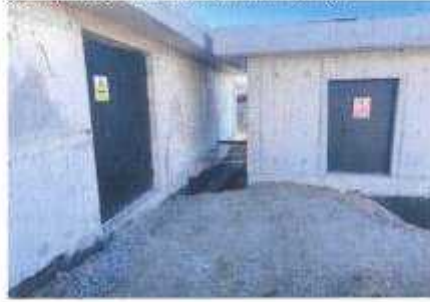
9. Safety ladder should be installed on construction site to avoid workers damage (PhotoNo. 9).
