Bi-annual Environmental Monitoring Report

Project Number: 43405-023

July-December 2017

GEORGIA: URBAN SERVICES IMPROVEMENT INVESTMENT PROGRAM (TRANCHE 2) (FINANCED BY THE ASIAN DEVELOPMENT BANK)

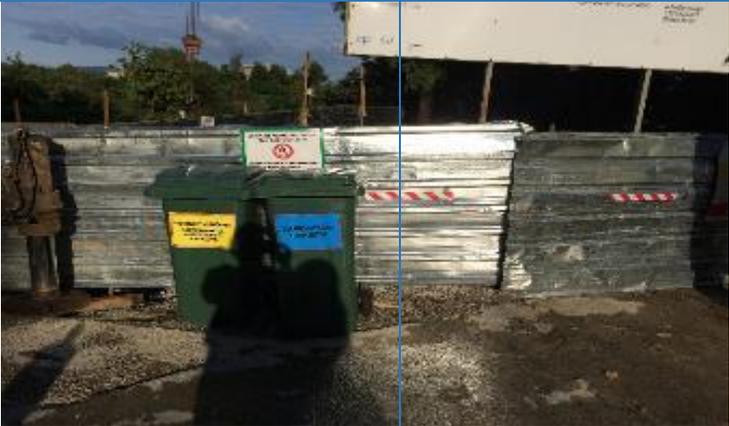
Project	Specific Issues	Deadline for submission/Implementation	Implementation Status
Status of findings of ADB mission carried out on 28 September – 2 October 2017			
Ure-01 Construction of Reservoir #1 in Ureki			
	<u>Waste Management:</u> There were separate waste containers for municipal and hazardous waste at the site with signatures, but they were not placed at special designated area with roofing and concrete base/secondary drip tray	September 2017	Completed (Please see the improved site photo below)

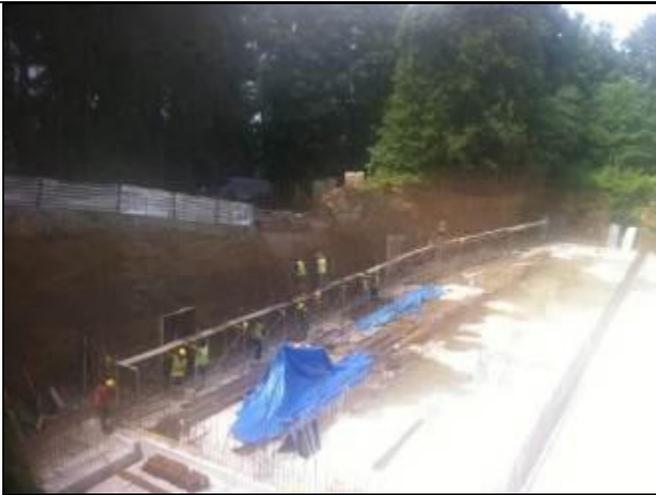
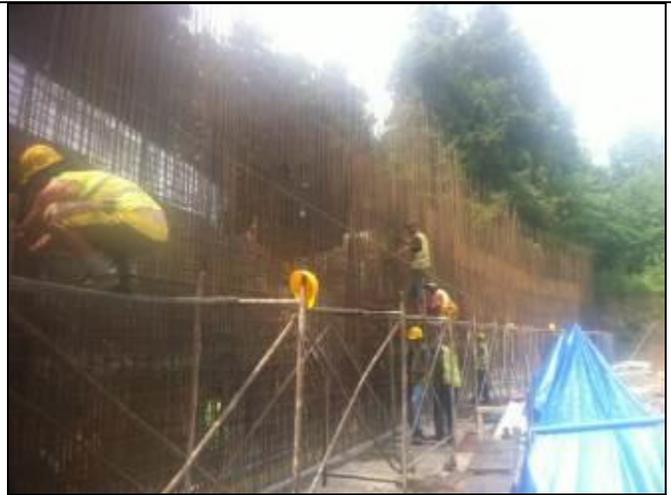
Project: USIIP	Non-compliance Notice UREKI
Contract No: URE-01	
Contractor: PERI	
Reference: UREKI – RESERVOIR	
This notice is to advice you, the prime Contractor, on the referenced Contract, of the following notice on environmental measures to be implemented urgently .	
<u>NON-COMPLIANCE IN UREKI</u>	
RESERVOIR	
<ul style="list-style-type: none">- Safety rules during high-altitude works should be respected to avoid workers damage- During high-altitude works special protection equipment should be used- Implementing works without special protection equipment is strictly prohibited- Workers always should use complete PPE

All these conditions have to be remedied within three days (by the 7 August 2017) by the prime Contractor (Peri).

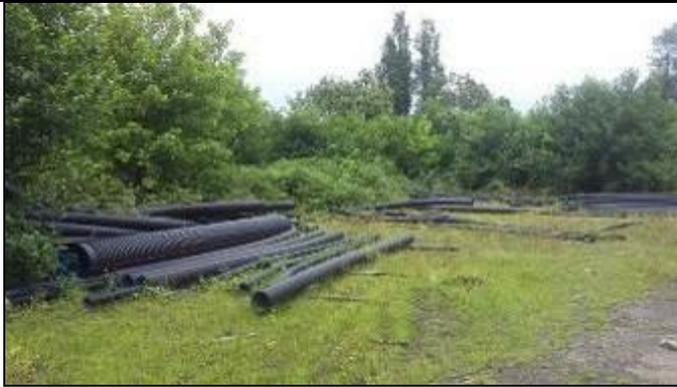
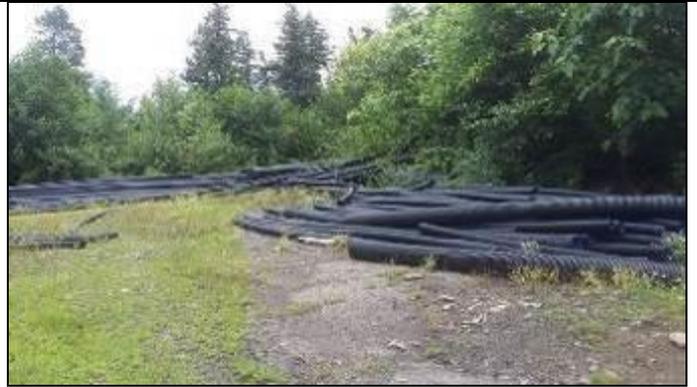
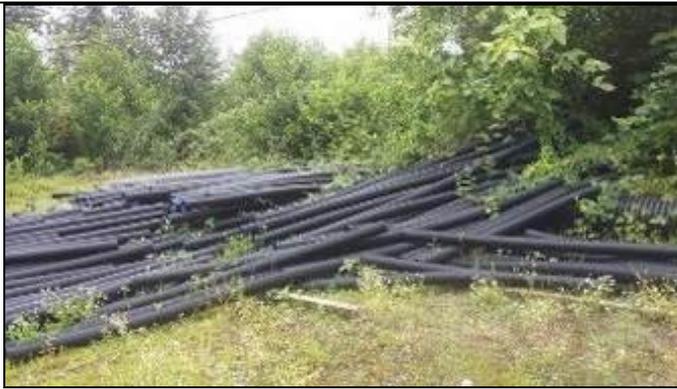
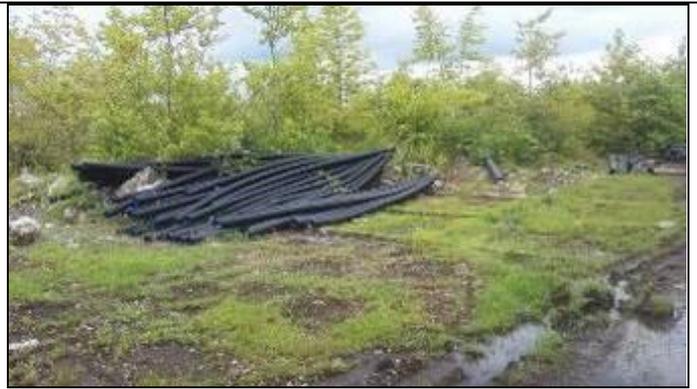
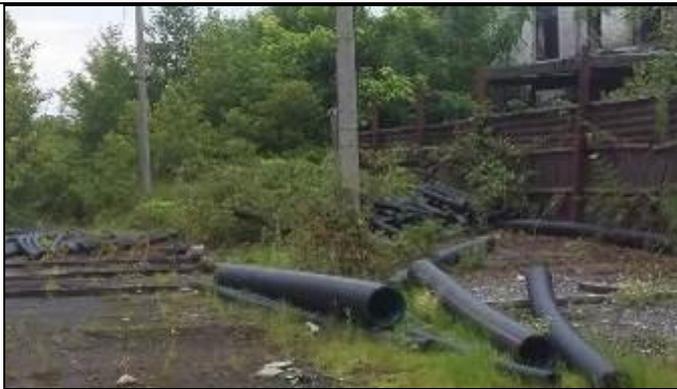
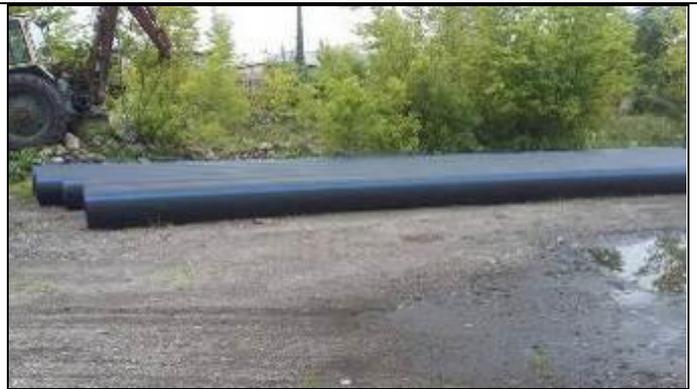
Trees (nearby territory) should be freed from pipes to avoid its damage

Piles dedicated warehouse should be fenced, protected and organized as suggested for warehouse arrangement

All these conditions have to be remedied within four days (by the 16 July 2017) by the prime Contractor (Peri).

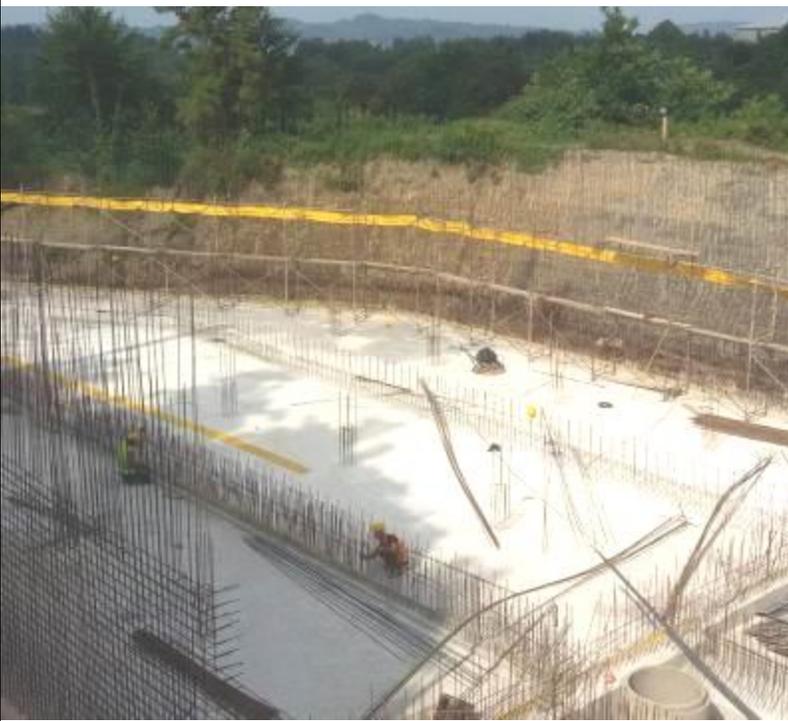
Photo 1

Scaffold are installed for working at heights;

Minor						
No	Requirement reference	Details of non-conformity	Corrective Action Taken	Evidence provided	Date reviewed	Reviewed by
1.	Non-compliance Notice UREKI; Project: USIIP Contract No: URE-01 Contractor: PERI Reference: UREKI – RESERVOIR	Safety rules during high-altitude works should be respected to avoid workers damage	Appropriate Scaffolds has been installed, with hardened platforms and mid rails. Working at Height is performed under permanent supervision of Site HSE Officer.	Please find photo below	07.08.2017	G. Tkemaladze

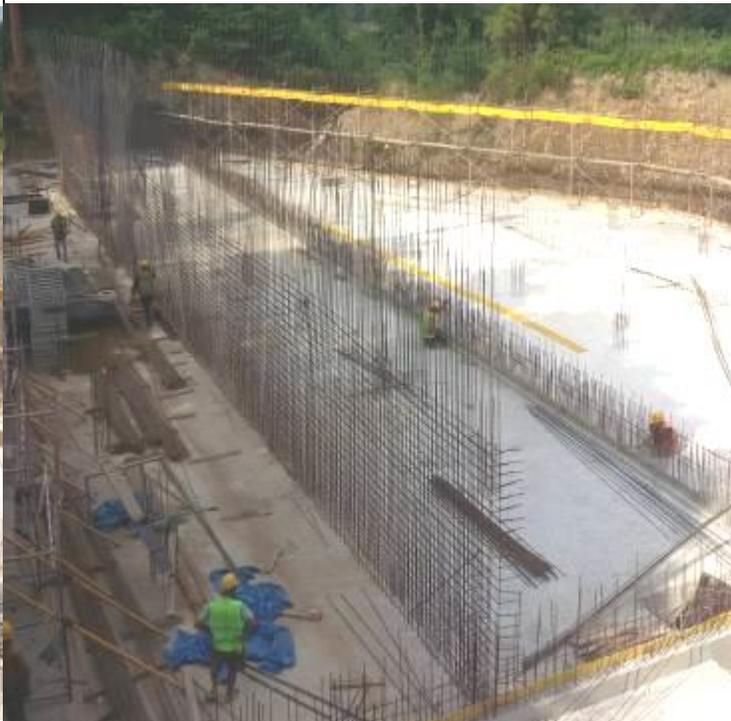
Photo 2

Site staff are equipped with required PPE;
