## Semi-annual Environmental Monitoring Report

*Project Number: 43405-025*

*Reporting Period: January-June 2019*

### **GEORGIA: URBAN SERVICES IMPROVEMENT INVESTMENT PROGRAM (TRANCHE 3) (FINANCED BY THE ASIAN DEVELOPMENT BANK)**

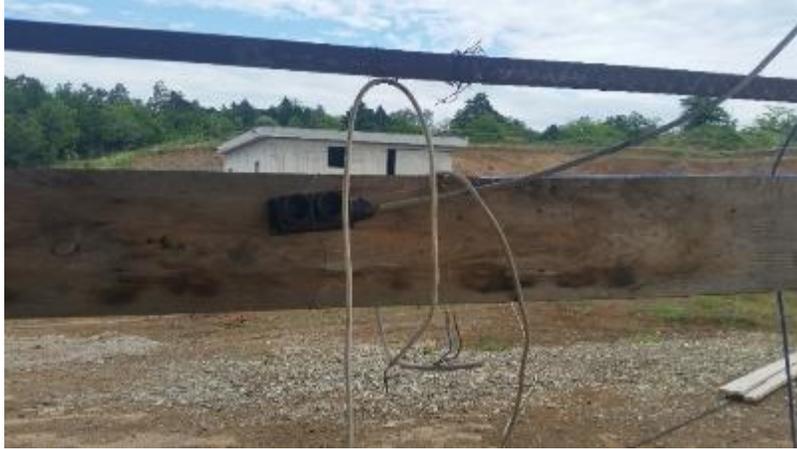
Photo: Near Miss Under KUT-01 project, Godogani Reservoir

**110.** Near Miss Example No3 under KUT-01 sub-project included not properly used electrical cables. Electrical plug was missing, no insulation on place.

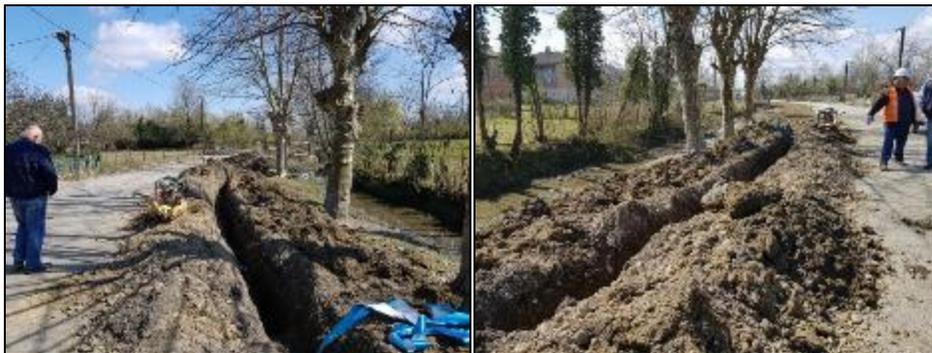
Photo: Near Miss Under ABA-01 project, Abasha Network

**114.**The following Near Misses were reported under ABA-01 projects during the reporting period, January-June 2019. Walls of the deep trenches (>1.5m) were not strengthened by boards to avoid landfall of the soil and accidents/workers damage (Please see the photo below). Strong instructions were given to contractor by SC and UWSCG/USIIP to improve the situation and keep the improved standard.

<p>Walls of the deep trenches (&gt;1.5m) should be strengthened by boards to avoid landfall of the soil and accidents (workers damage)</p>	<p>Contractor is given strong instruction to improve the situation, develop CAP (if requested) and send improved photos of Site to SC and UWSCG by the mid of July 2019.</p>
<p>Construction activities information signs should be installed at each construction segment</p>	
<p>Construction materials should be brought when needed to avoid its long time disposal in the streets and disturbance of residents and businesses</p>	
<p>All transmission line construction segments should be cleaned/well organized on regular bases</p>	
<p>Workers always should use complete PPE</p>	
<p>Refilling/compaction and reinstatement process should bring site at the same or better condition as it was before construction</p>	
<p>Walls of the deep trenches (&gt;1.5m) should be strengthened by boards to avoid landfall of the soil and accidents (workers damage)</p>

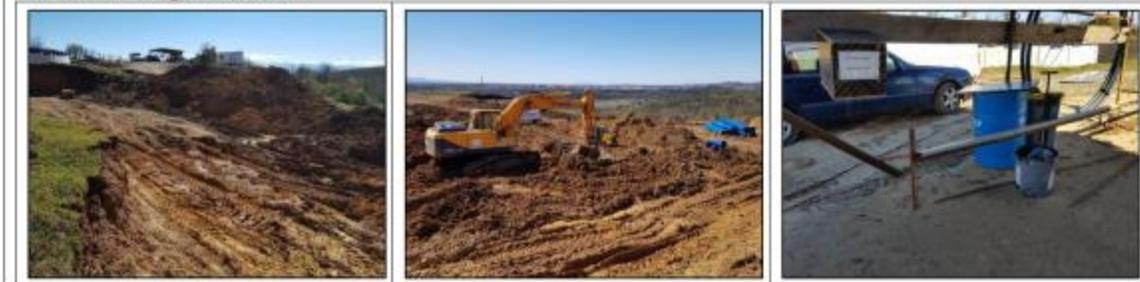
**Photos of Godogani Reservoir**

- Trees at the construction site and nearby deep excavation zone should be protect to avoid its damage
- Construction waste should be timely removed from the construction site and disposed properly

- Safety norms during working at height should be provided
- Containers with fuel/lubricant should be managed properly (stored at the proper organised place with concrete floor and roofing) to avoid leakage and ground contamination

- Workers always should use complete PPE
- Site internally should be arranged properly and cleaned regularly

All these conditions have to be remedied within four days (by the 5 April 2019) by the prime Contractor (SMK).

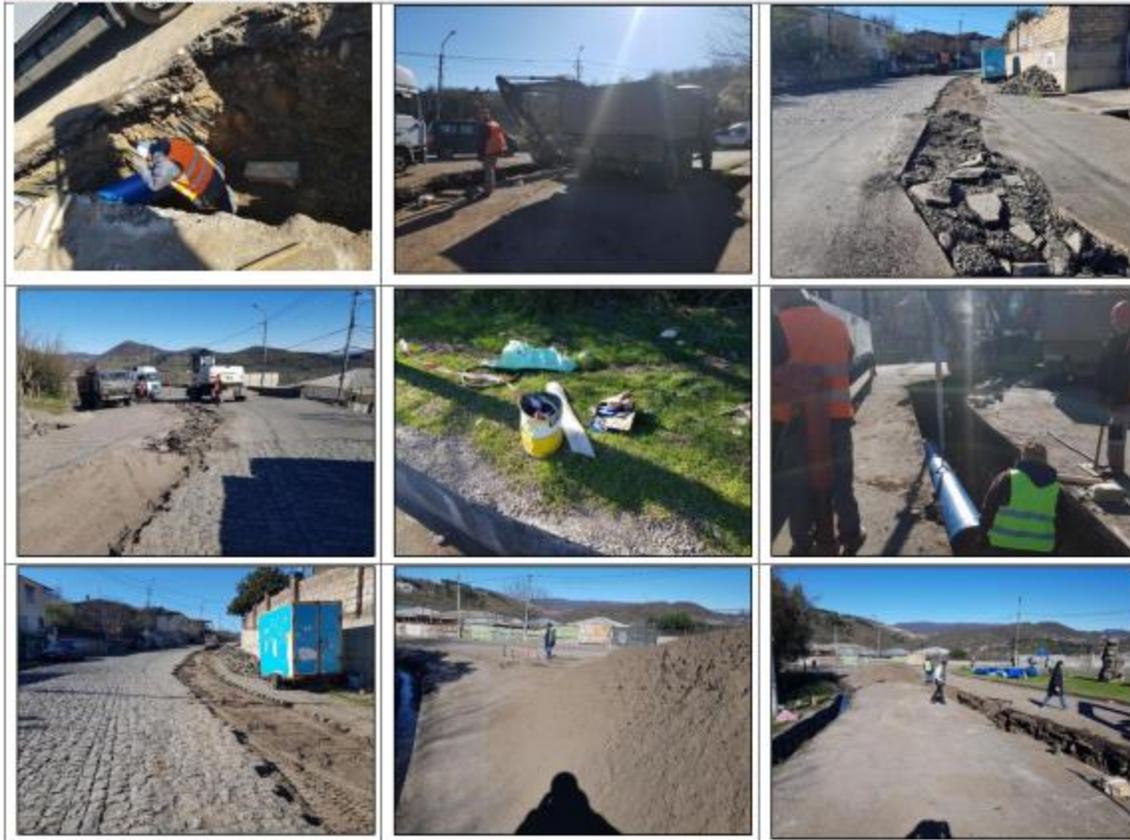
**Photos of Kutaisi Network**

- Safety signs/tapes around of all open trenches should be installed to avoid accident of population
- Walls of the deep trenches (>1.5m) should be strengthened by boards to avoid landfall of the soil and accidents (workers damage)
- Construction activities information signs should be installed at each construction segment
- Construction materials should be brought when needed to avoid its long time disposal in the streets and disturbance of residents and businesses
- All transmission line construction segments should be cleaned/well organized on regular bases
- Workers always should use complete PPE

- Refilling/compaction and reinstatement process should bring site at the same or better condition as it was before construction

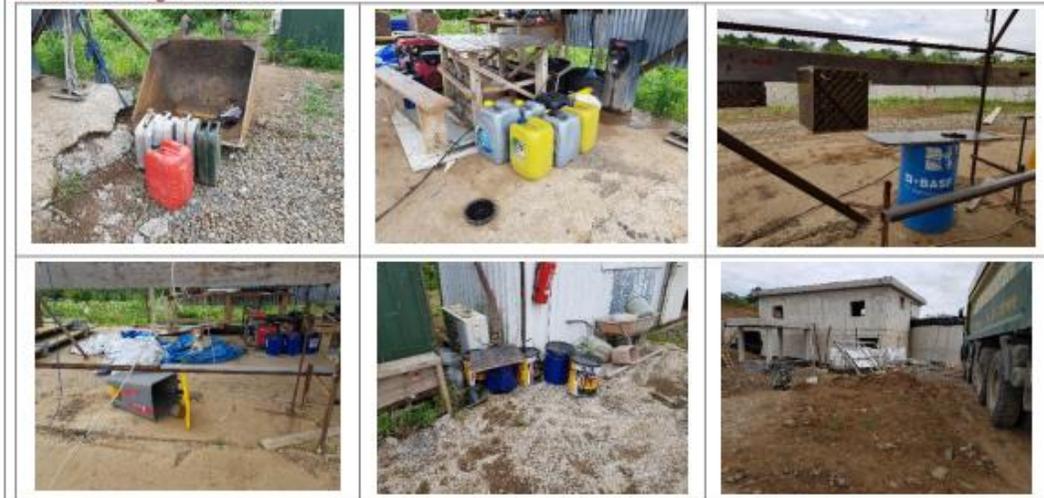
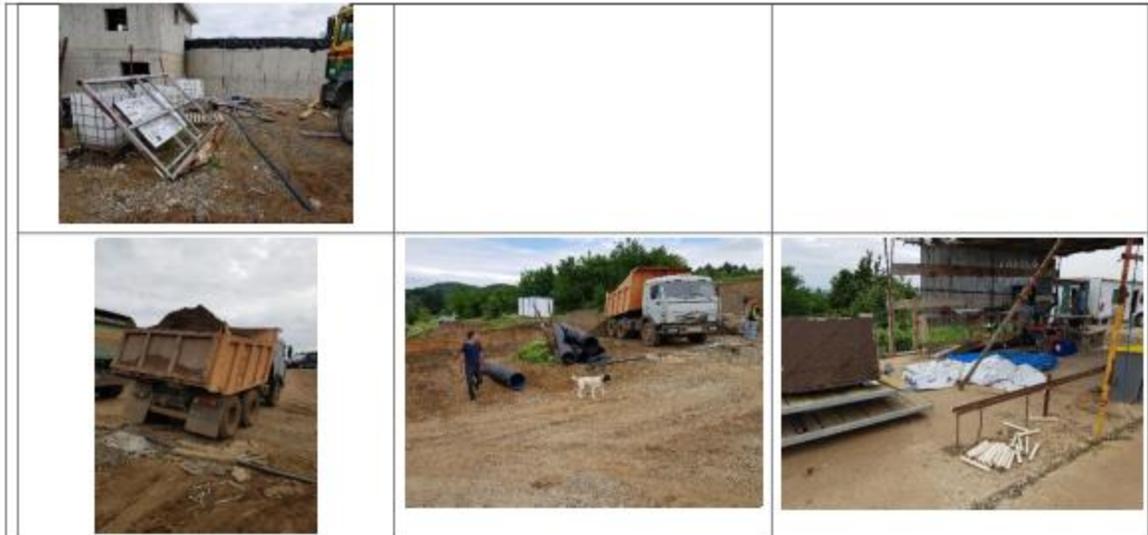
**Photos of Godogani Reservoir**

- Electricity cables should be well protected and handled properly to avoid damage of workers
- Containers with fuel/lubricant should be managed properly (stored at the proper organised place with concrete floor and roofing) to avoid leakage and ground contamination

- Site internally should be arranged properly and cleaned regularly

All these conditions have to be remedied within four days (by the 5 June 2019) by the prime Contractor (SMK).

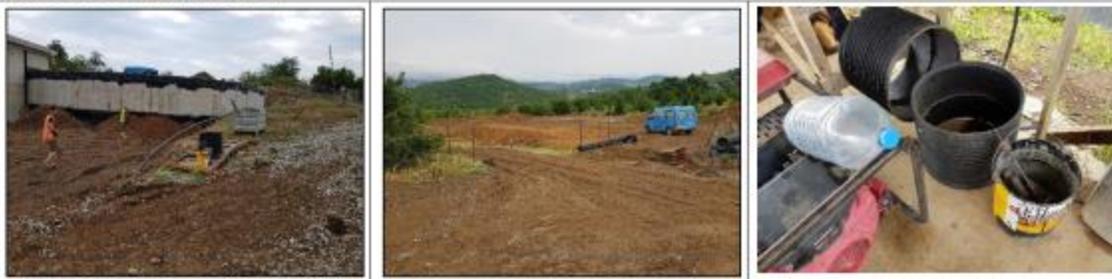
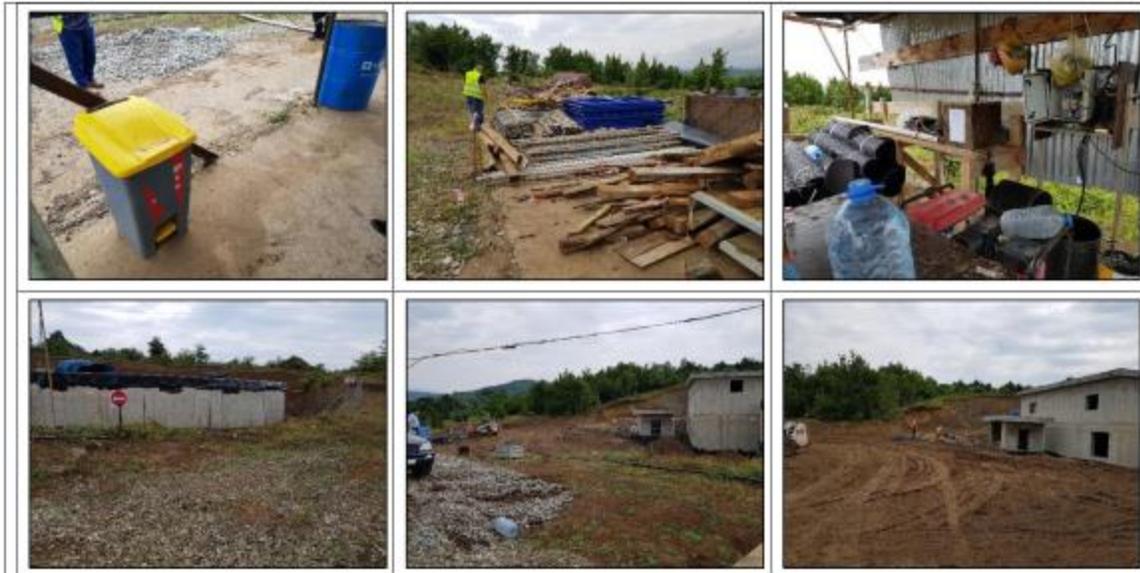
**Photos of Godogani Reservoir**

- Soil (surplus/accumulated soil) for backfilling purposes should be managed/stored properly
- Trees at the construction site and nearby excavation zone should be protect to avoid its damage

- Complain box should be placed at proper place
- Site internally should be arranged properly and cleaned regularly

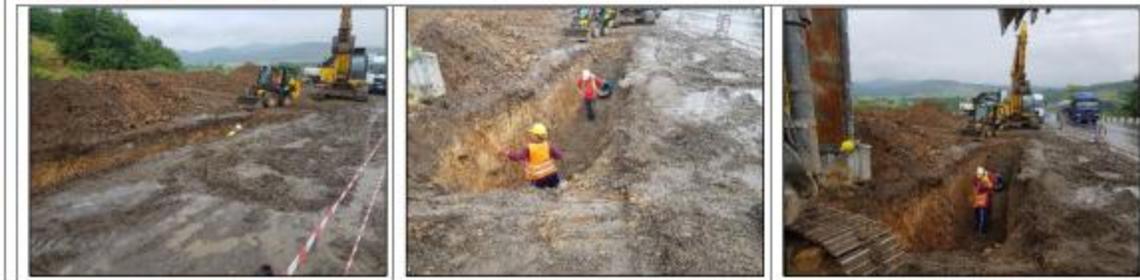
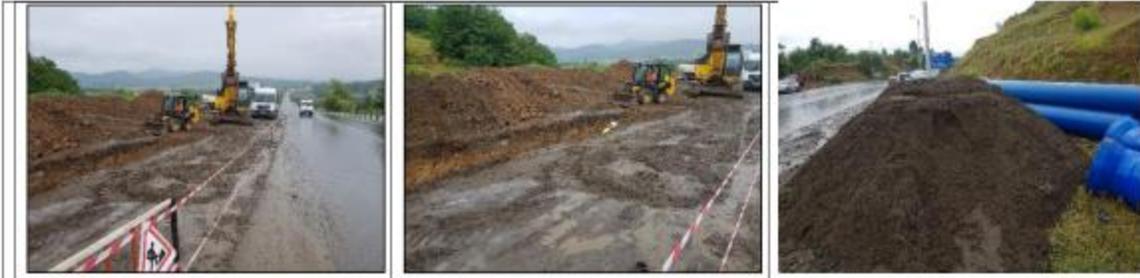
**Photos of Kutaisi Network**

- Walls of the deep trenches (>1.5m) are not strengthened by boards to avoid landfall of the soil and accidents
- Construction activities information signs should be installed at each construction segment
- Special signs and blinking signs should be installed near to main road
- During materials transportation tarpaulins cover should be used always
- Construction materials should be brought when needed to avoid its long time disposal in the streets and disturbance of residents and businesses
- All transmission line construction segments should be cleaned/well organized on regular bases
- Workers always should use complete PPE
- Refilling/compaction and reinstatement process should bring site at the same or better condition as it was before construction

All these conditions have to be remedied within three days (by the 6 July 2019) by the prime Contractor (SMK).

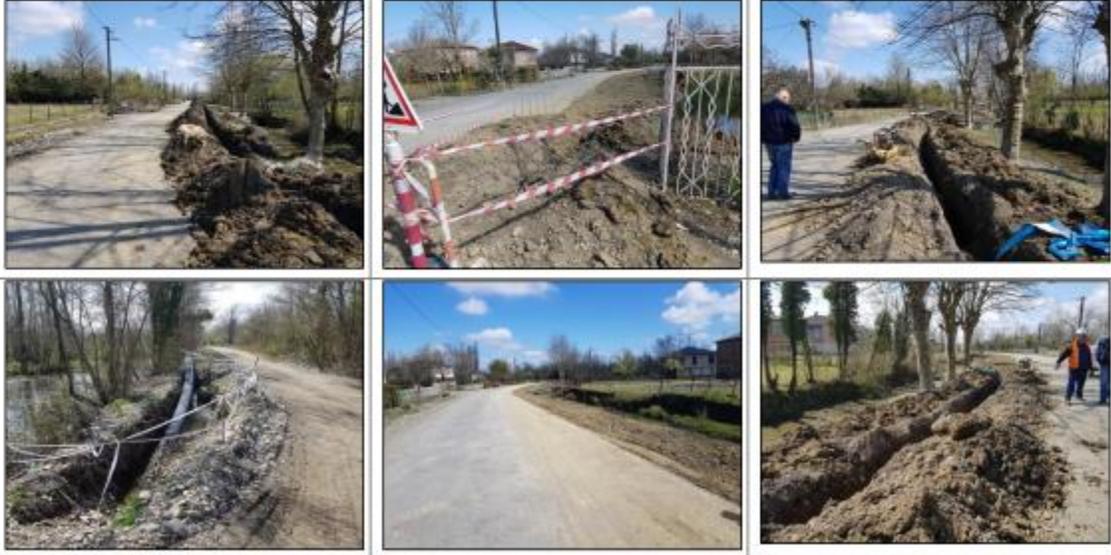
<b>Photos of Abasha Network</b>

Project: USIIP	<b>Non-compliance Notice ABASHA</b>
Contract No: ABA-01	
Contractor: As Inshaan-N	
Reference: ABASHA – Network	
This notice is to advise you, the prime Contractor, on the referenced Contract, of the following notice on environmental measures to be implemented <b>urgently</b> .	
<b>NON-COMPLIANCE IN ABASHA</b>	
<b>NETWORK</b>	
<ul style="list-style-type: none"> <li>- Trees of nearby construction zone should be protected to avoid its damage</li> <li>- Safety signs/tapes around of all open trenches should be installed</li> <li>- Surplus/accumulated soil for backfilling purposes should be managed/stored properly</li> <li>- Construction activities information signs should be installed at each construction segment</li> <li>- Safety/warning signs/tapes and trench side barriers around of deep open trenches should be installed to avoid accident of population</li> <li>- Workers always should use complete PPE</li> <li>- Refilling/compaction and reinstatement process should bring site at the same or better condition as it was before construction</li> </ul>

All these conditions have to be remedied within three days (by the 4 April 2019) by the prime Contractor ( <b>As Inshaan-N</b> ).	
Date of site visits: 27.03-28.03.2019	
Irakli Legashvili EPTISA - Environment

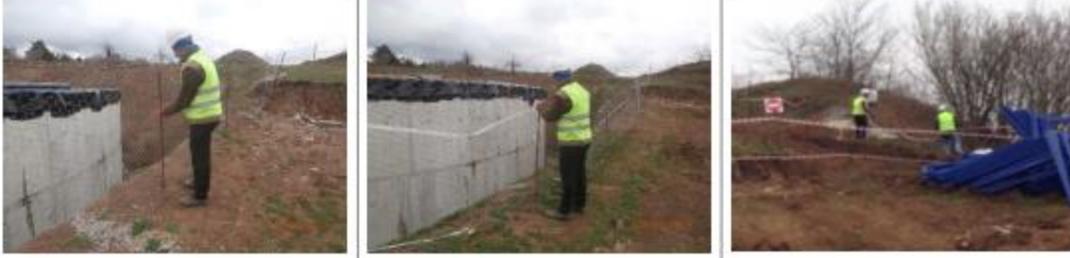
Photos of Godogani Reservoir

- Due to construction activities specification the location of gate was changed and it will be arranged as soon as possible in appropriate place.
- Proper warning and information signs are installed at the entrance and perimeter of the site.
- SMK took action and trees nearby deep excavation zone are protected(covered with soil to avoid its damage).
- High visible safety signs/tapes and trench side around of deep open excavation is installed from all sides to avoid accidents.
- Containers with fuel/lubricant is managed properly to avoid leakage and ground contamination.
- SMK took action and waste containers will be renewed with the relevant indication signs as soon as possible
- SMK took action and all construction materials are properly segregated and stored adequately.
- All workwrs are using complete PPE.
- Site is cleaned regularly.

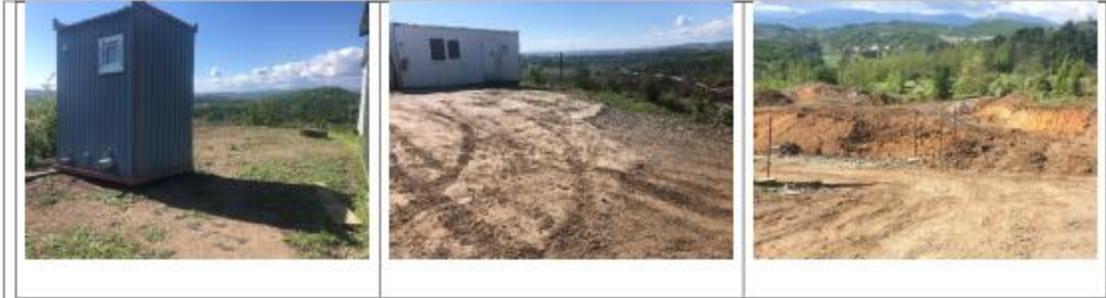
**Photos of Godogani Reservoir**

- Soil surplus for backfilling purposes are managed properly.
- trees nearby deep axcavation zone are protected,(it was covered with soil to avoid its damage).

- Containers with fuel/lubricant is managed properly to avoid leakage and ground contamination.
- SMK took action and all construction materials are properly segregated and stored adequately.

- Proper waste containers will be renewed and labled as soon as possible.
- All workwrs are using complete PPE.
- Site is cleaned regulary.

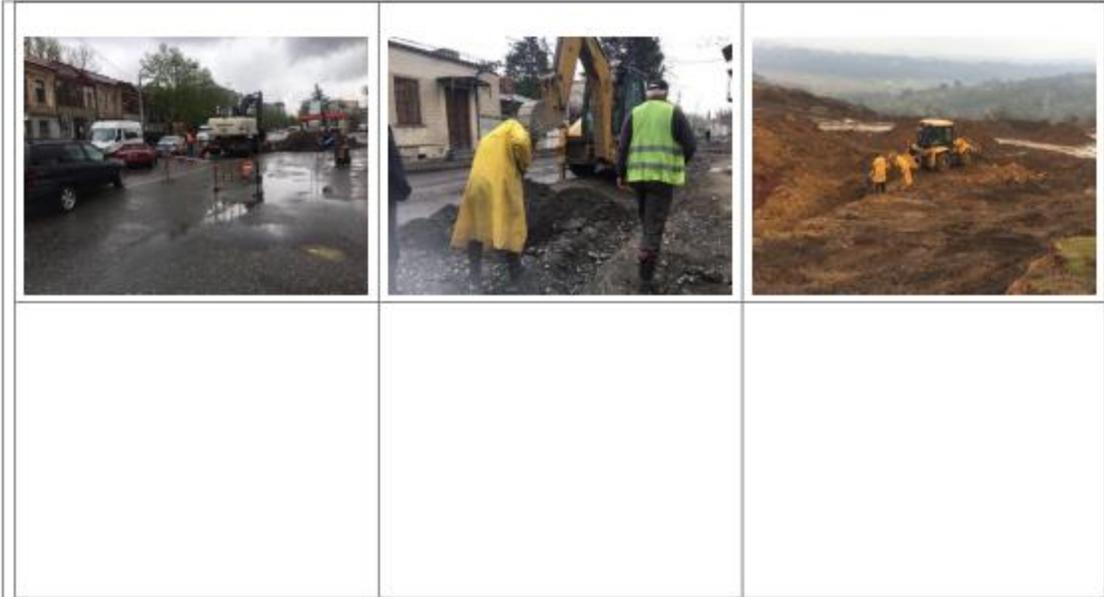
**Photos of Network**

- SMK took action and safety signs are installed to all open trenches to avoid accidents.
- Deep trenches are strengthened by boards to avoid workers damage.
- SMK took action and Information signs are installed at each construction segment.
- SMK took action and construction materials are brought when needed to avoid its long time disposal in the streets and disturbance of resident and business.
- All transmission line construction segments are cleaned and well organized.
- Workers are using complete (PPE)

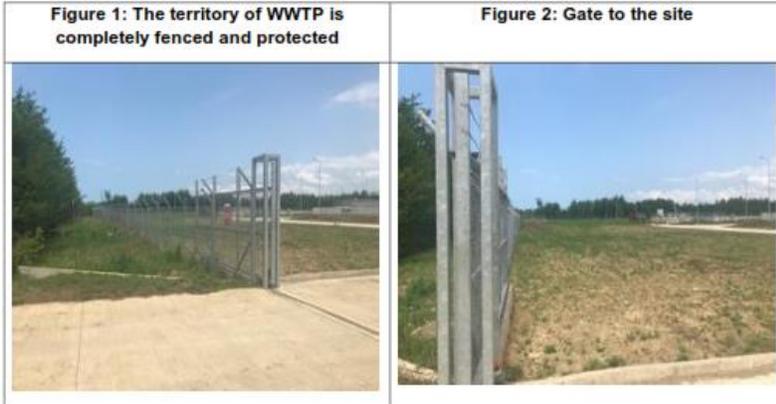
27. The construction of WWTP was fully accomplished satisfactorily, all kinds of waste, including construction waste were removed from the site, and territory of the WWTP construction site was fully fenced and cleared (Figures 1 and 2).

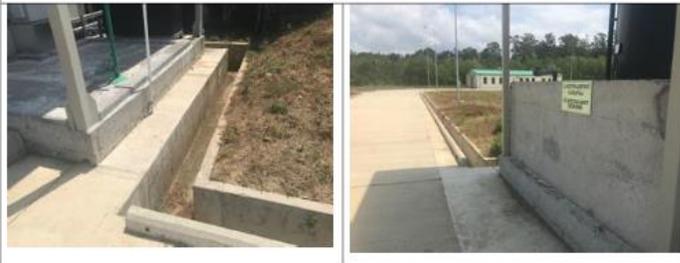
**Figure 3 and 4: Drainage system in the project area**

28. The drainage system well installed on all the territory of WWTP (Figures 3 and 4).

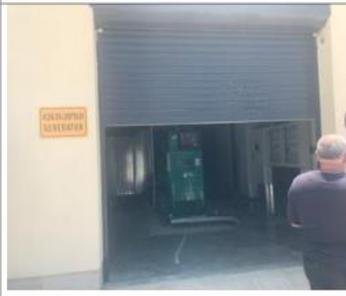
**Figure 5: The generator is placed in a covered area**

29. The generator is also installed according to the standards. The given generator is placed on the secondary protective container, at the location protected against the precipitations (Figure 5 and 6).

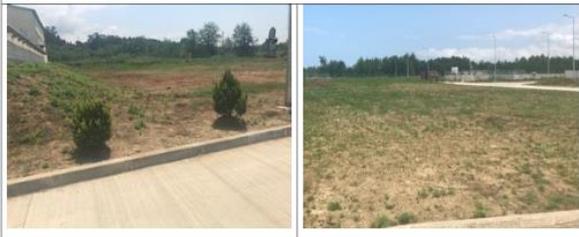
**Figure 9 and 10: Self-restored section on the WWTP territory**

35. The topsoil stripped during the construction phase is placed on the territory of WWTP and was not used for reinstatement activities of the WWTP territory. After some time, the lower layers of the topsoil may lose the original properties and as a result, the valuable resource may be destroyed.

- The topsoil placed on the territory of the Waste Water treatment Plant in Ureki is desirable to return to the stripping sites and use for reinstatement of the WWTP territory or handed over to the local self-government (4 months);
- Before the bathroom on the territory is put to operation, a container is to be installed for the wash basin arranged near the aeration tank to collect the used water (1 months);
- The waste containers must be duly labeled as “Domestic waste” and “Hazardous waste” (1 months);

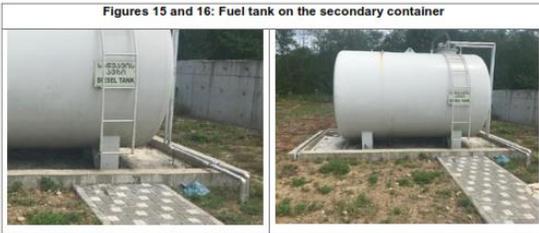
47. The hazardous substance container is placed on the secondary containment. The volume of the secondary containment is 110% less the volume of the container containing hazardous substances.

- The volume of the protection tank for hazardous substance container must be increased at least by increasing the walls of the tank (4 months).

48. The volume of the protection tank must be increased at least by increasing the walls of the tank.
