# ENVIRONMENTAL MONITORING REPORT

## #8 Semiannual Report

(Reporting Period: January-June 2021)

**GEORGIA: URBAN SERVICES IMPROVEMENT INVESTMENT PROGRAM  
(TRANCHE 6)**

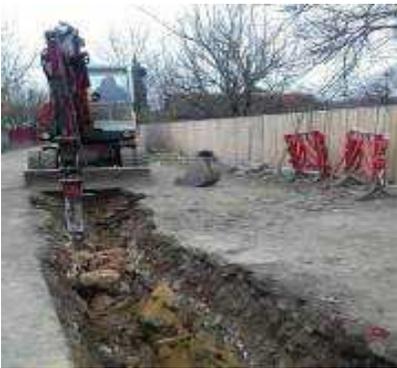
Date of Visit	Name of Company  Name of Contract	Auditors Name	Purpose of audit	Summary of any Significant Findings	Implemented Actions	Implementation Status
				<p><b>photo No1</b></p>

15 January 2021		Environmental Specialist of SC Mr. Rezo Enukidze	Regular monitoring of sites	Provide warning and information signs or safety tapes around to all open tranches and excavations.  (Photo-Documentations are provided below and in the Annex B and Annex C of this report)  please see photo materials of Avarioni district below.	Verbal Instructions were given to contractor to improve the situation within five calendar days.	Completed in January 2021

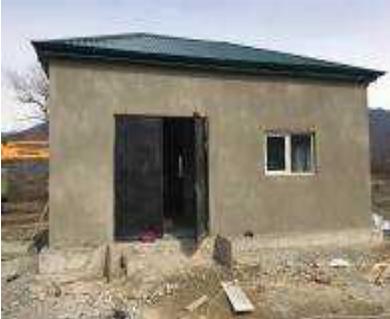
Date of Visit	Name of Company  Name of Contract	Auditors Name	Purpose of audit	Summary of any Significant Findings	Implemented Actions	Implementation Status
				<p>cleaned regularly, please see photo below</p> <p>Sachkhere wellfields chlorination building <b>Photo No1</b></p>

2021
May 2021		Environmental Specialist of SC Mr. Rezo E nukidze	Regular monitoring of sites	<p>Contractor must control any onsite burning. If this action will take place immediate Non-Compliance Report must be provided to Engineer.</p> <p>Contractor has few drip trays; they must be deployed during onsite refueling. Some refueling vehicles have drip trays but are not using them during refueling.</p> <p>No training or toolbox talks</p>	Verbal Instructions were given to contractor to improve the situation within five calendar days.	<p>Completed, May 2021</p> <p>Completed, May 2021</p>

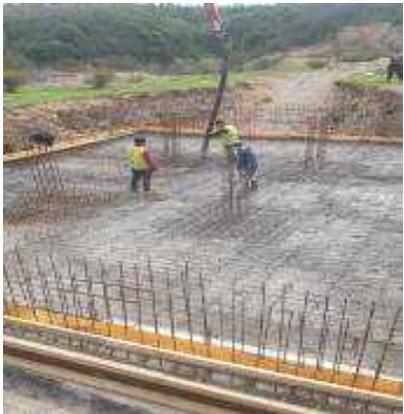
Date of Visit	Name of Company  Name of Contract	Auditors Name	Purpose of audit	Summary of any Significant Findings	Implemented Actions	Implementation Status
				<p>report have been submitted</p> <p>Contractor must provide sufficient waste bins mentioned in SSEMP and WMP to site where activities are on-going.</p> <p>Location of spoil disposal areas are not provided.</p> <p>Safety norms during working at height (ladder safety norms) should be provided, please see photos below:</p> <p><b>Avarioni Reservoir</b></p> <p><b>Photo No1</b></p>

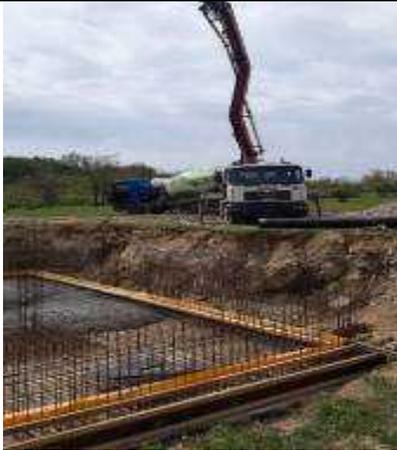
<p data-bbox="1099 759 1496 946">Contractor must control any onsite burning. If this action will take place immediate Non-Compliance Rport must be provided to Engineer.</p> <p data-bbox="1099 983 1496 1090">Contractor has few drip trays; they must be deployed during onsite refueling.</p>		<p data-bbox="1827 751 2080 810">Completed , June 2021</p> <p data-bbox="1827 1023 2080 1082">Completed, June 2021</p>
<p data-bbox="181 1121 398 1257"><sup>1</sup>Continuously during reporting period</p>	<p data-bbox="398 1121 622 1225">“Akelik Group OJSC” (Azerbaijan) MAR-01</p>	<p data-bbox="622 1121 869 1225">Environmental, H&amp;S Specialist of Contractor Mr. Paata</p>	<p data-bbox="869 1121 1088 1225">Day to day monitoring of sites Compliance</p>	<p data-bbox="1088 1121 1503 1225">Safety issues on construction sites, Workers always should use complete PPE</p>	<p data-bbox="1503 1121 1827 1257">Prepare Monthly Environmental Monitoring Reports and send to SC</p>

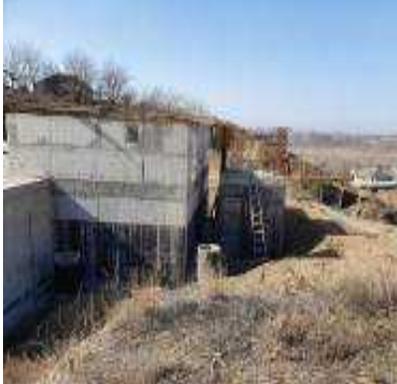
<p>Exclude public from the site – enclose construction area, provide security personnel.</p> <p>Ensure adequate fencing of construction area with lockable gate and relevant warning signs (visible at night and in local language) at the entrance.</p> <p>Provide adequate lighting to avoid accidents.</p> <p>Provide warning signs or</p>	<p>5 March 2021)</p> <p>Explanatory Note was issued by ES of USIIP and UWSCG/DEPP to IPMO and UWSCG Administration to immediately improve the situation (Please see Annex D to the report)</p> <p>Meeting was carried out with the representatives of the UWSCG's Environmental Team contractor and supervision consultant Hill.</p>	<p>Completed partially, no security personnel is available only fencing is done by CC</p> <p>Completed, May 2021</p> <p>Completed, May 2021</p> <p>Completed, June 2021</p>

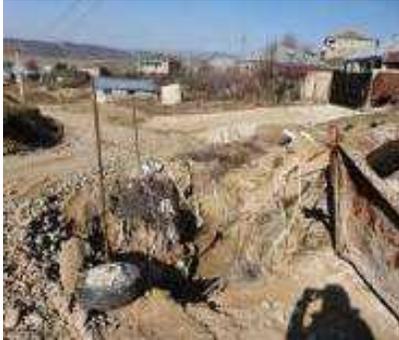
Date of Visit	Name of Company  Name of Contract	Auditors Name	Purpose of audit	Summary of any Significant Findings	Implemented Actions	Implementation Status
				<p>safety tapes around to all open tranches and excavations, please see photo below:</p> <p><b>Photo No2</b></p>

<p>There is a dangerous of moving land on the upper perimeter of the reservoir, especially in rainy and windy weather, and to prevent this, protection must be taken immediately on the slope along the reservoir. Measures require an appropriate technical decision, please see photo below and also non-compliance Notice in Annex C.</p> <p><b>Photo No3</b></p>		<p>Not completed, recommendations to address pending environmental issues under MAR-01 sub-project is provided in the table 21 below.</p>

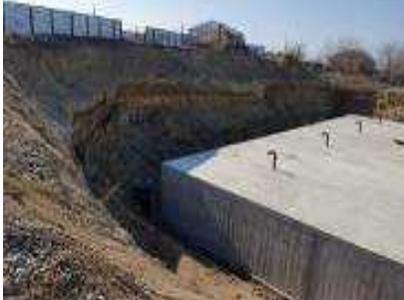
<p>Site internally should be arranged properly and cleaned regularly; Please see photo below: <b>Photo No4</b></p>

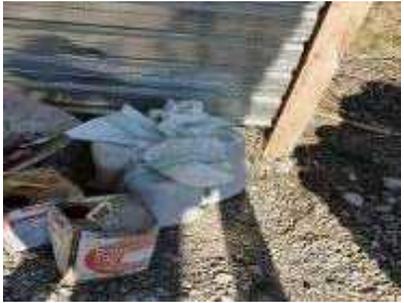
<p>Construction waste should be removed timely and properly disposed, please see the photo below: <b>Photo No5</b></p>		<p>Completed, March 2021</p> <p>Completed, March 2021</p>

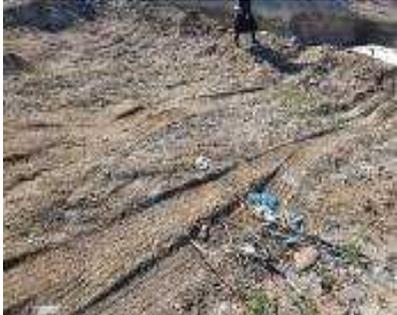
Date of Visit	Name of Company  Name of Contract	Auditors Name	Purpose of audit	Summary of any Significant Findings	Implemented Actions	Implementation Status
				<p>Hazardous materials (lubricants) are not stored properly, please see photo below:</p> <p><b>Photo No7</b></p>

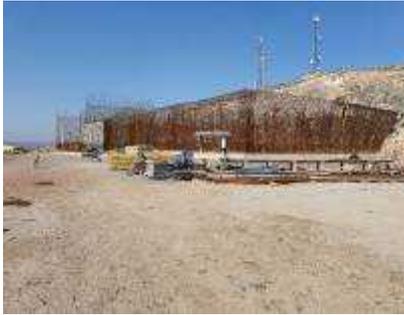
Date of Visit	Name of Company  Name of Contract	Auditors Name	Purpose of audit	Summary of any Significant Findings	Implemented Actions	Implementation Status
		HILL Mr.Rezo Enukidze		<p>at the entrance and perimeter (these should be visible at night and in local language understandable by workers and communities near worksites), please see photo No1:</p> <p><b>Photo No1</b></p>

<p>Provide adequate lighting to avoid accidents; Ensure proper storage of building materials at the construction site to avoid injury to workers during construction work.</p>	5 March 2021)  Corrective Action Plan was developed and improved photos of sites was sent by contractor (please see Annex D)	Partially completed, May 2021
5 March 2021 Marneuli		Head, Department of Environmental Protection and	Monthly monitoring of sites	The restoration of asphalt pavement after laying of trenches in the city center	Verbal instruction was given to contractor to immediately improve	Not Completed, recommendations to address pending

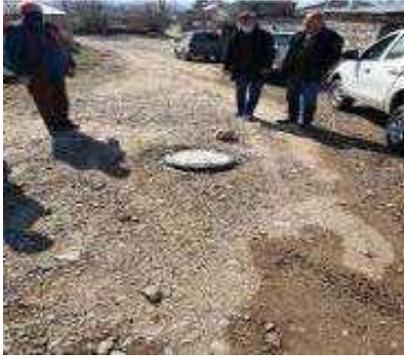
Date of Visit	Name of Company  Name of Contract	Auditors Name	Purpose of audit	Summary of any Significant Findings	Implemented Actions	Implementation Status
<p>Network</p> <p><b>GPS Coordinates:</b></p> <p><b>X44.79017</b> <b>Y41.48896</b></p>		<p>Permits, Ms. Maka Goderdzhishvili</p> <p>Environmental Specialist of USIIP Ms. Ketevan Chomakhidze</p> <p>Environmental Specialist of Supervision Consultant HILL Mr.Rezo E nukidze</p>	<p>Network</p>	<p>presents a driving hazard and a community annoyance.</p> <p>Proper reinstatement of the roads after laying of sewerage line should be implemented urgently, please see photo below.</p> <p><b>Photo No1</b></p>

<p>the situation.</p> <p>Non-Compliance Notice was issued and is presented in Annex C of this report.</p> <p>(Photo-documentations are presented in Annex C, non-compliance note, 5 March 2021)</p> <p>Corrective Action Plan was developed and improved photos of sites was sent by contractor (please see Annex E).</p>	<p>environmental issues under MAR-01 sub-project is provided in the table 21 below.</p>

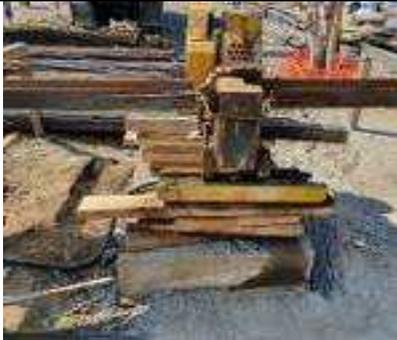
<p>The contractor is required to instruct and train their workforce in the storage and handling of materials and chemicals that can potentially cause soil contamination.</p> <p>Construction chemicals should be managed property, please see photo below:</p> <p><b>Photo #3</b></p>

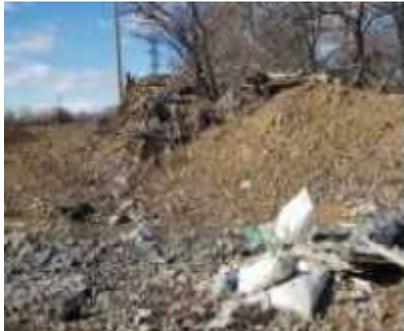
24.03.2021		Environmental Specialist of Supervision Consultant HILL Mr.Rezo E nukidze	Regular Environmental monitoring of sites	<p>Site internally should be arranged properly and cleaned regularly.</p> <p>All construction materials and wastes should be properly segregated and stored adequately, please see photo below</p> <p><b>Photo No1</b></p>

<p>Oil spill response kits should be placed at the appropriate locations.</p> <p>All equipment must be checked against lubricant and fuel leaking.</p> <p>Refuelling station/trucks</p>	<p>Verbal instruction was given to contractor to immediately improve the situation.</p> <p>Non-Compliance Notice was issued and is presented in Annex C of this report.</p> <p>(Photo-documentations are presented in Annex C, non-compliance note, 19 November 2020)</p>	<p>Completed in April 2021</p> <p>Completed in April 2021</p> <p>Completed in April 2021</p> <p>Completed in April 2021</p>

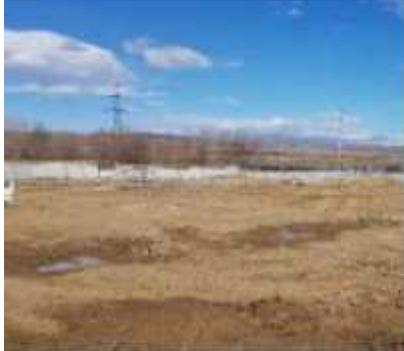
Date of Visit	Name of Company  Name of Contract	Auditors Name	Purpose of audit	Summary of any Significant Findings	Implemented Actions	Implementation Status
				<p>see photo below:</p> <p><b>Photo No2</b></p>

<p>Storage area for hazardous waste handling is prepared and will be roofed.</p>		<p>2021</p> <p>Completed in April 2021</p>

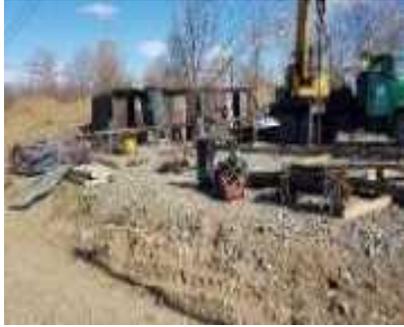
<p>Oil spill response kits should be placed at the appropriate locations.</p> <p>All equipment must be checked against lubricant and fuel leaking. Refuelling station/trucks should be equipped with the spill kit and relevant firefighting equipment; drip tray should be used for fuel spillage prevention. Relevant traffic signs and flagmen should control traffic movement properly.</p> <p>Top Soil must be prevented from damage.</p> <p>Environmental representative</p>		<p>Completed in May 2021</p> <p>Completed in May 2021</p> <p>Completed in May 2021</p> <p>Completed, Environmental</p>

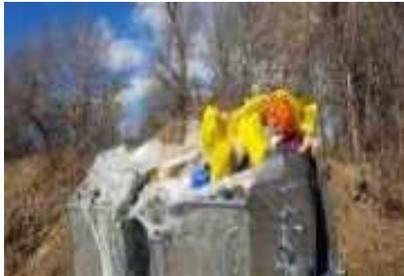
Date of Visit	Name of Company  Name of Contract	Auditors Name	Purpose of audit	Summary of any Significant Findings	Implemented Actions	Implementation Status
				<p>Flooding may destroy site surroundings and in case if during this year similar to last year flooding will have place it is possible that site itself will be flooded.</p> <p>Local population is using improperly stored waste soil as a spontaneous dumpsite.</p> <p>Access to the stored soil must be restricted.</p> <p>Waste containers used by Contractor must be regularly emptied, Please see photo below:</p> <p><b>Photo No3</b></p>

<p>Top soil and subsoil are mixed and dumped close to the riverbed;</p>		<p>Completed in May 2021</p> <p>Completed in May 2021</p> <p>Completed in May 2021</p> <p>Completed Completed in May 2021</p> <p>Completed in June 2021</p>

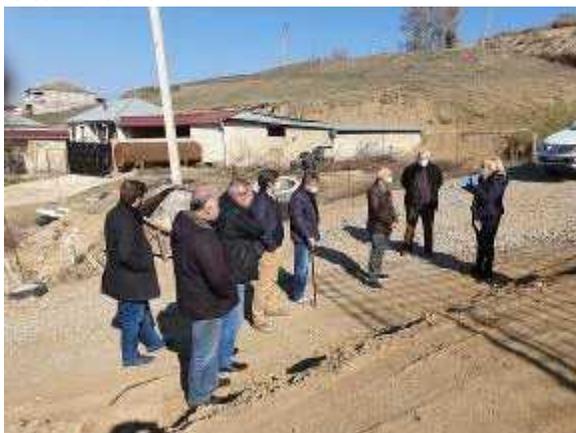
**Photo No1**

during the reporting period. The following issues used to be still opened until the end of the reporting period, June 2021 (i) The restoration of asphalt pavement after laying of trenches in the city center presents a driving hazard and a community annoyance, proper reinstatement of the roads after laying of sewerage line should be implemented urgently; (ii) While the situation was improved at Jandari reservoir in Q1 2021 and fencing was installed around the reservoir to protect the local population from the construction site, the area is not fenced in City reservoir, there is no security box, or appropriate personal, which allows any stranger to enter the construction site freely; (iii) There is a dangerous of moving land on the upper perimeter of the Jandari reservoir, especially in rainy and windy weather, and to prevent this, protection must be taken immediately on the slope along the reservoir. Above mentioned non-compliances require an appropriate technical decision. UWSCG/IPMO and SC immediately provided instructions to the contractor to stabilize the slopes of Jandary Reservoir and provide fencing in City Reservoir. Deadline for improvement is given until 31 of August. Progress of the implemented actions will be presented in the next SAEMR, July-December 2021.

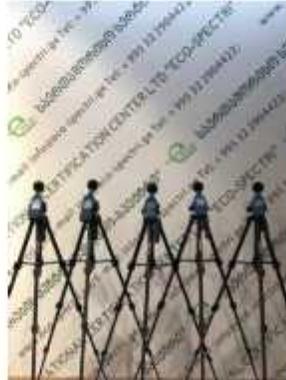
**სურათი N6.1.2: ორგანიზაციის საკუთრებაში არსებული ხმაურმზომები**

კვლევის დროს ხმაურმზომის კონფიგურაციები იყო:

- ხმაურის წნევის დიაპაზონი: საერთო 30 - 130 dB;
- ხმაურმზომის რეაგირების სისწრაფე: წელი (1 წამი);
- ხმაურის სიხშირის წონადობა: A წონადობა;
- მიკროფონის ტიპი: 0.5" (12.7მმ) ელ. კონდენსატორი.

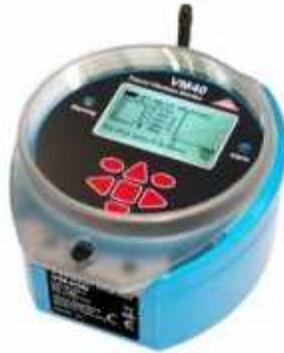
**სურათი 6.2.1: ვიბრაციის საზომი აპარატი**

VM40 მოწყობილობის დანიშნულებაა ვიბრაციის გაზომვა შენობებში, ხიდებზე, კოშკებზე, მილსადენებსა და სხვადასხვა დიდ კონსტრუქციებზე. გაზომვები წარმოებს იმ მიზნით, რომ თავიდან იქნას აცილებული შენობების კონსტრუქციული დაზიანება და ადამიანების შეწყუბება. VM40 აღჭურვილია სენსორით, ჩამწერი და შეფასების ელექტრონული მოწყობილობითა და აკუმულატორით - ეს მოწყობილობები მოთავსებულია VM40 მონიტორის მყარ კორპუსში. ამ მონიტორის გამოყენება განსაკუთრებით მოსახერხებელია დროის ხანგრძლივ პერიოდებში ავტონომიური მუშაობის რეჟიმში, მაგ., სამშენებლო უბნებზე.

ინსტრუმენტი აღჭურვილია სამი მაღალგრძობიარე პიეზოელექტრული სისტემით ვიზრაციის გასაზომად სამივე მიმართულებით. სიგნალის დამუშავების პროცესი იმართება მიკროპროცესორით. VM40 მონიტორი მუშაობს კლავიშების პანელზე განთავსებული შვიდი ღილაკისა და მანათობელი LCD ეკრანის დახმარებით. გაზომვის შედეგების გადატანა შესაძლებელია პერსონალურ კომპიუტერში USB ინტერფეისის დახმარებით. მოწყობილობას ასევე გააჩნია დამუხტვის მოწყობილობის მისაერთებელი პორტი და რელეური გამომყვანი ვიზრაციის მოვლენების გარე სიგნალირებისთვის.

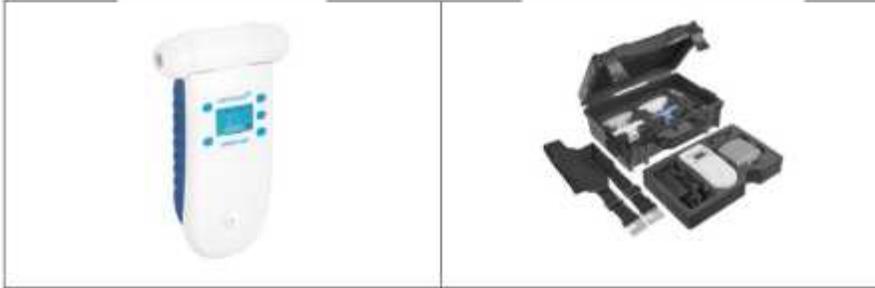
სურათი 6.3.1: „Aeroqual“ ბრენდის ჰაერის საზომი აპარატი	სურათი 6.3.2.: „Aeroqual“ ბრენდის ჰაერის საზომი აპარატი
--	---

ყოველი სახის მანვე ნივთიერებებისთვის აპარატს გააჩნია განსხვავებული სენსორები. აპარატს გააჩნია შემდეგი სახის სენსორები:

- გაზის მგრძობიარე ნახევარგამტარი სენსორი (GSS);
- გაზის მგრძობიარე ელექტროქიმიური სენსორი (GSE);
- ნაწილაკების ლაზერული მრიცხველი (LPC);
- ფოტოიონიზაციის დეტექტორი (PID).

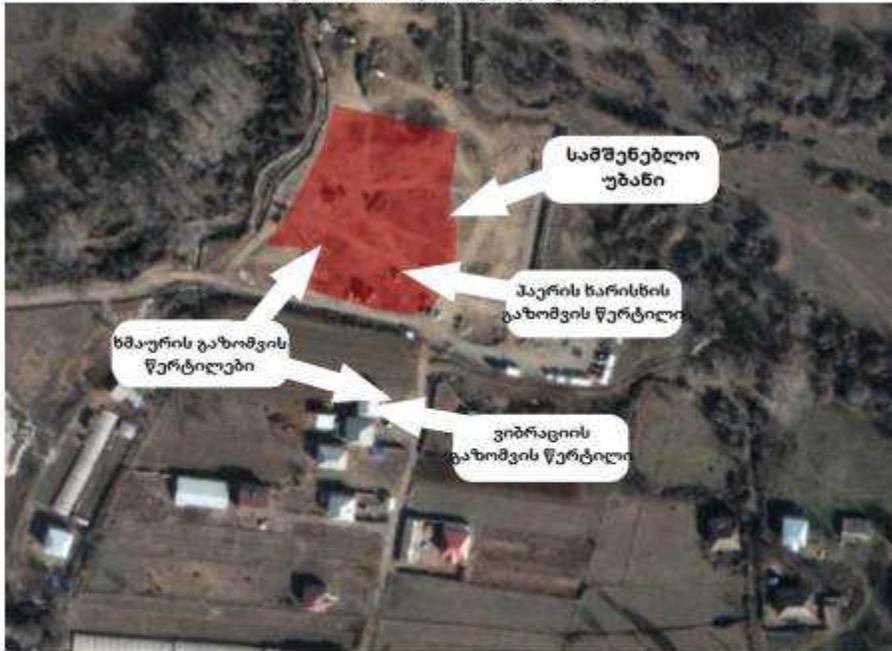
**სურათი N7.1: გაზომვის წერტილები**

ქვემოთ სურათზე N7.1 და N7.2 მოცემულია გაზომვის წერტილები.

საბაზისო გაზომვა ჩატარდა ხმაურის ზეგავლენის დონის დასადგენად. მიღებული შედეგების დეტალური მაჩვენებლები მოცემულია დანართებში:

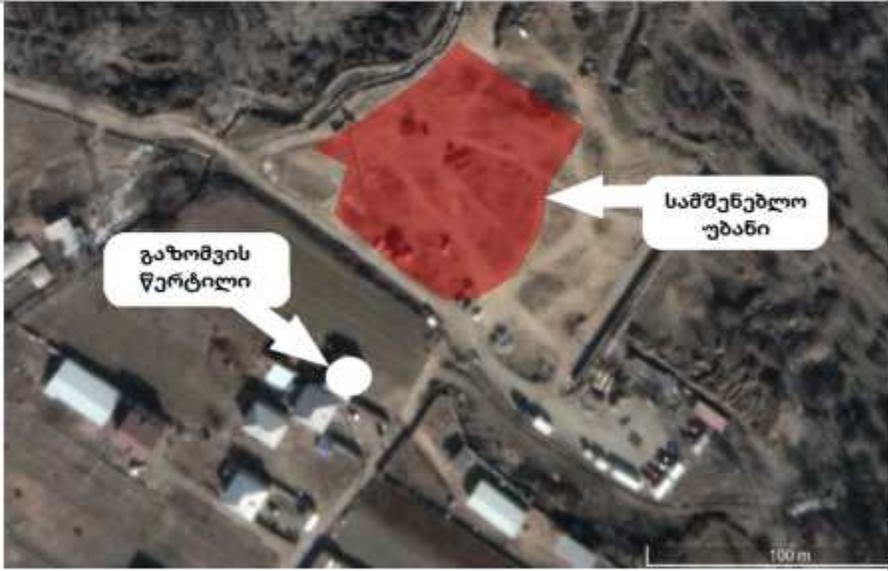
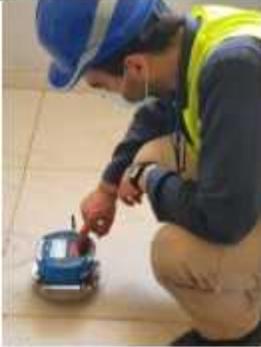
<b>გაზომვის პროტოკოლი N1</b>	
<b>1. ძირითადი</b>	
1.1 პასუხისმგებელი პირი	არჩილ რევაზიშვილი - საგამოცდო ლაბორატორიის უფროსი
1.2 გაზომვის პერიოდი	18.06.2021 09:21:47 - 18.06.2021 11:32:47
<b>2. ვიზრაციის სახეობა</b>	
2.1 წყარო	სამშენებლო სამუშაოები
2.2 ოპერირების პირობები	ინტენსიური მუშაობა
<b>3. სტრუქტურა</b>	
3.1 სახელი და მისამართი	ქ. მარნეული
3.2 კლასიფიკაცია	საცხოვრებელი სახლი, დახურული სივრცე
3.3 აღწერა	DIN 4150-3 სტანდარტის მიხედვით 2 კატეგორიის შენობა (საცხოვრებელი სახლი)
<b>4. მდებარეობა და პოზიცია</b>	
4.1 ვიზრაციის წყარო

<b>5. გარემო პირობები</b>		დახურული სივრცე; იატაკის სწორი ზედაპირი				
<b>6. სუბიექტური დაკვირვება</b>		სამუშაო სპეციფიკის ვიბრაციას საერთო მდგომარეობაზე ზეგავლენა არ გააჩნია				
<b>7. საზომი ჯაჭვი</b>		Triaxial Vibration Meter VM40B სერიული ნომერი: 180665; კალიბრაციის თარიღი: ივნ 2021; გაზომვის მეთოდი: DIN 4150-3; პარამეტრები: Short-Time; სიხშირის დიაპაზონი: 1-80 ჰც; გამოწვევის რეჟიმი: 1 წ. + ღონისძიება; გაზომვის რეჟიმი და ანგარიშის შედეგადად ხორციელდება VM40MDB-ს პროგრამული უზრუნველყოფით.				
<b>8. გაზომვის შედეგი</b>						
8.1 ღონისძიების დიაგრამა

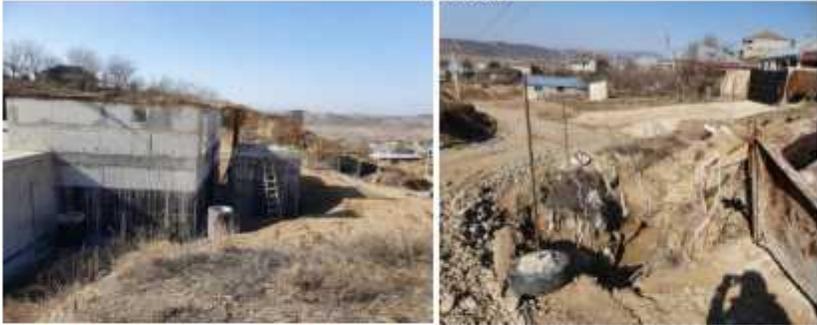
<p>There is a dangerous of moving land on the upper perimeter of the reservoir, especially in rainy and windy weather, and to prevent this, protection must be taken immediately on the slope along the reservoir. Measures require an appropriate technical decision.</p>

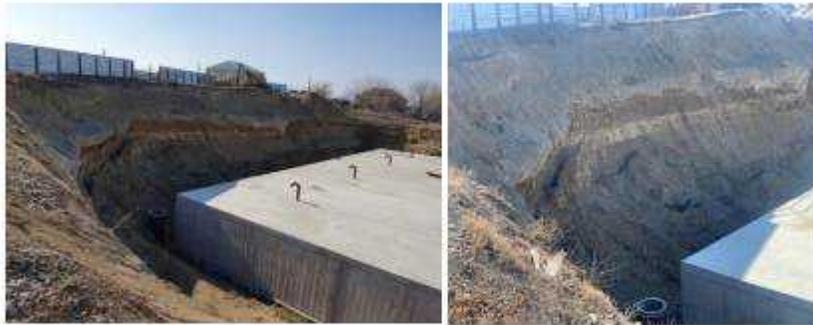
- Site internally should be arranged properly and cleaned regularly;
- Construction waste should be removed timely and proper disposed;

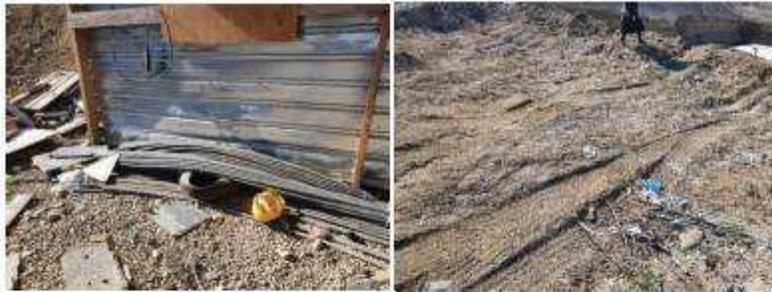
**Photo #3**

- Safety rules during electric cable use should be respected

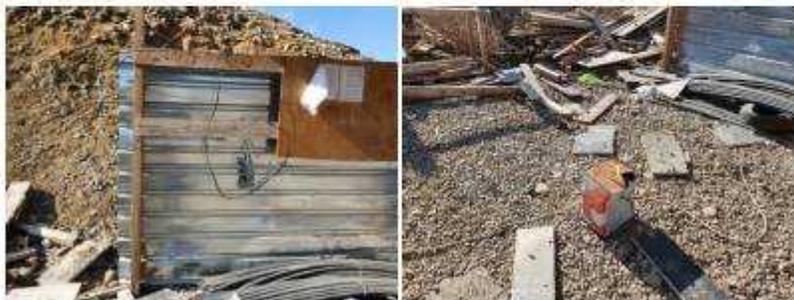
- There is no special designated area for disposal of hazardous and municipal waste;
- Hazardous materials (lubricants) are not stored properly;

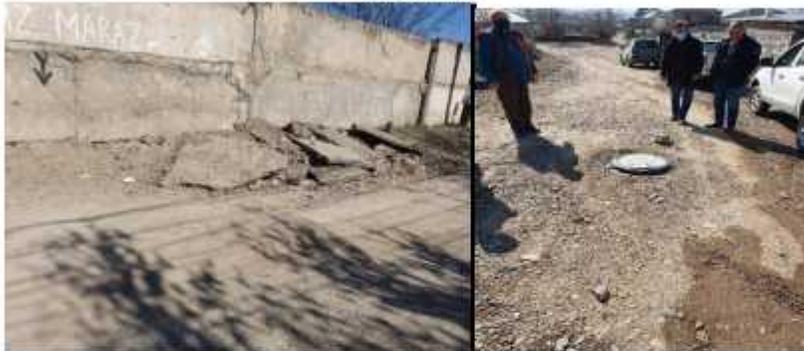
**Photo #6**

The restoration of asphalt pavement after laying of trenches in the city center presents a driving hazard and a community annoyance.

- Proper reinstatement of the roads after laying of sewerage line should be implemented **urgently**

All these conditions have to be remedied within the 15 calendar days by Contractor "Akelik Group OJSC" (Azerbaijan) and Monitored by Supervision Consultant Hill International N.V. (Netherlands)

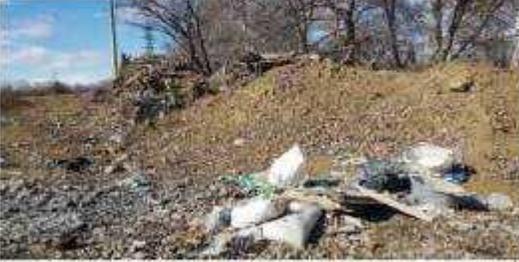
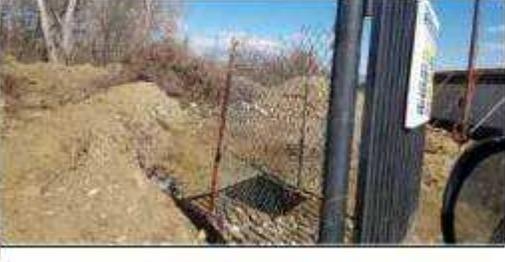
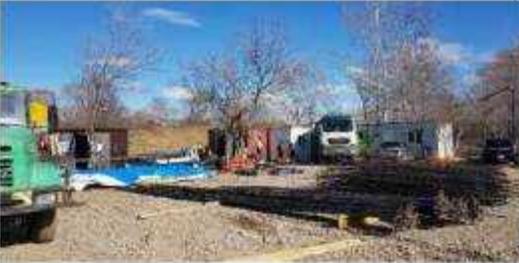
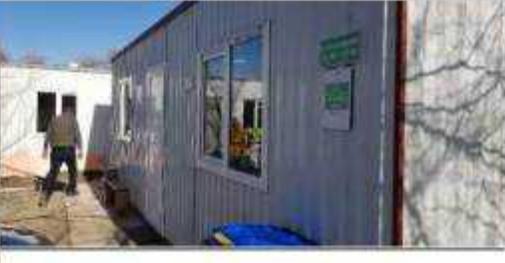
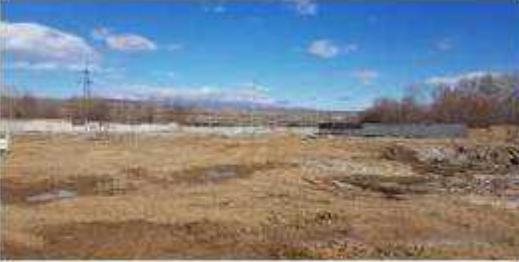
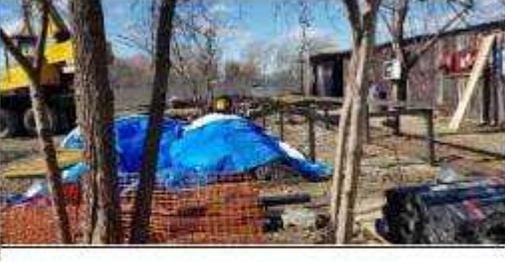
<b><u>NON-COMPLIANCE IN Marneuli WWTP</u></b>	
<b>Marneuli WWTP</b>	
<ul style="list-style-type: none"> <li>- Remaining soil must be fenced and protected from illegal dumping of construction waste of Local population;</li> <li>- Environmental representative must to conduct a meeting with local population to explain that it is prohibited dumping of waste in this manner.</li> <li>- Contractor have to conduct environmental measurement and have to follow Engineers instruction at which points these measurements have to take place.</li> <li>- Waste Soil is dumped along the access road, according to SSEMP it should be removed, but based on the local population information this soil at the moment is protecting their property from flooding. Flooding may destroy site surroundings and in case if during this year similar to last year flooding will have place it is possible that site itself will be flooded.</li> <li>- Cement washing pit must be organized correctly using geotextile to avoid pollution of ground water, verbal instruction was given;</li> <li>- Storage area for hazardous waste handling is prepared and will be roofed.</li> </ul>

<p>All these conditions have to be remedied within 10 days by the prime Contractor</p>	
<p>✓ Soil materials must be removed and stored in a proper way without damage of topsoil;</p>	
<p><b>Date of site visit: 2021.03.24</b></p>	
<p>Environmental Specialist – Revaz Erukidze</p>

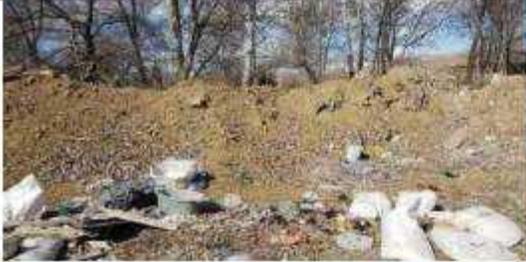
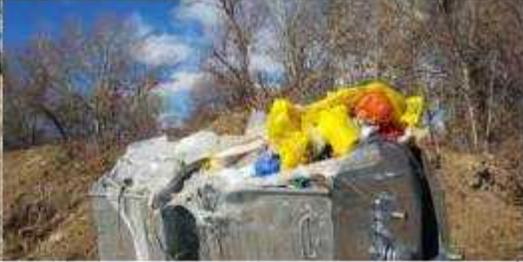
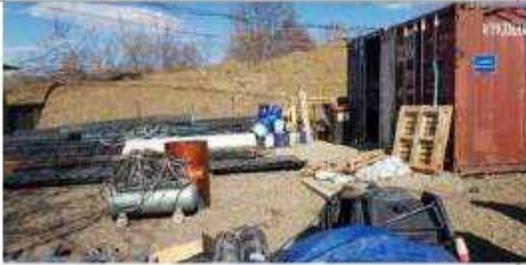
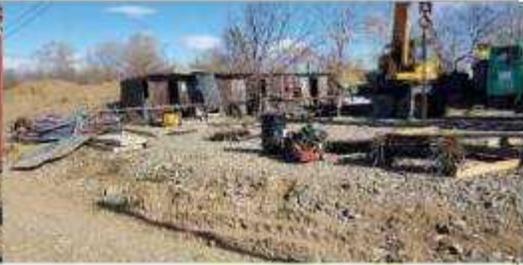
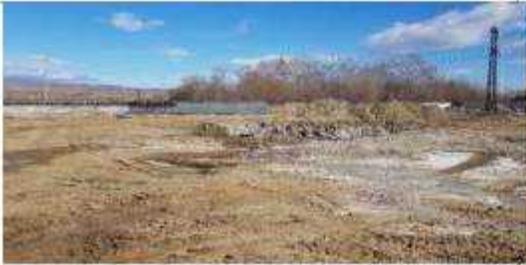
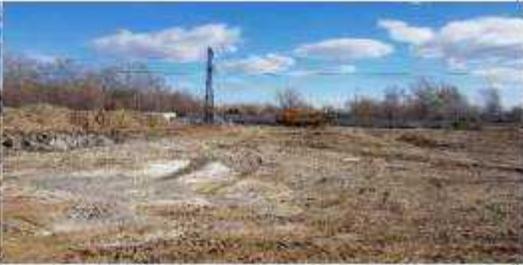
Environmental representative not nominated, the candidate where presented at site;	
Training records are not provided;	
Waste Management Plan and Updated SSEMP is not provided;	
<b>NON-COMPLIANCE IN Marneuil WWTP</b>	
<b>Marneuil WWTP</b>	
<ul style="list-style-type: none"> <li>- Waste Soil is dumped along the access road, according to SSEMP it should be removed, but based on the local population information this soil at the moment is protecting their property from flooding. Flooding may destroy site surroundings and in case if during this year similar to last year flooding will have place it is possible that site itself will be flooded.</li> <li>- Local population is using improperly stored waste soil as a spontaneous dumpsite. Access to the stored soil must be restricted.</li> <li>- Waste containers used by Contractor must be regularly emptied.</li> <li>- Top soil and subsoil are mixed and dumped close to the riverbed;</li> <li>- Cement washing pit must be organized correctly using geotextile to avoid pollution of ground water, verbal instruction was given;</li> <li>- Storage area for hazardous waste handling is prepared and will be roofed.</li> </ul>

<p>All these conditions have to be remedied within 10 days by the prime Contractor</p>	
<p>✓ Soil materials must be removed and stored in a proper way without damage of topsoil;</p>	
<p><b>Date of site visit: 2021.03.05</b></p>	
<p>Environmental Specialist – Revaz Enukidze</p>

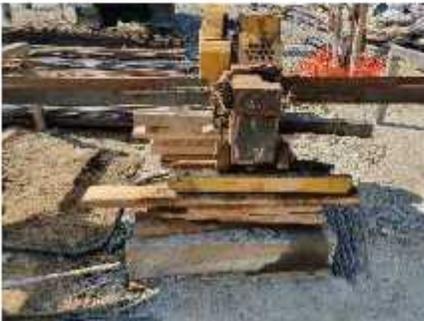
- The contractor is required to instruct and train their workforce in the storage and handling of materials and chemicals that can potentially cause soil contamination
- Construction chemicals should be managed properly

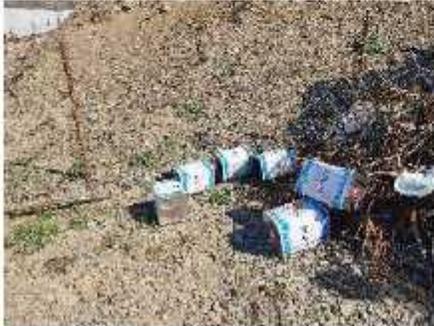
- Storage of all hazardous material to be safe, under strict control and clearly labelling all dangerous products
- There should be a special designated area for municipal and hazardous waste with concrete base, roofing and drainage system

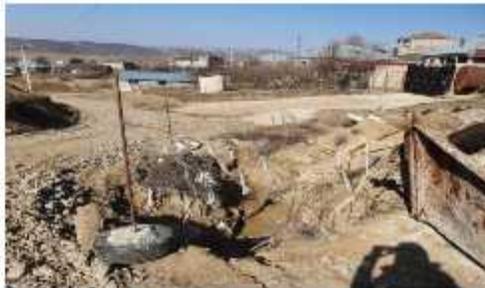
რეზერვუარის ტერიტორიაზე არსებული ღია და დაუცველი თხრილები, ასევე, კატლავანის კედლებზე ჩამოშლილი გრუნტი საფრთხეს უქმნის რეზერვუარის მიმდებარედ, 20-30მ. მანძილზე მცხოვრებ მოსახლეობას და ფეხით მოსიარულეებს. შეიმჩნევა კატლავანის კედესთან ახლოს სატრასპორტო საშუალებების მოძრაობის კვალი (იხ. ფოტო #1, ფოტო #2, ფოტო #3), შესაბამისად, უცხო პირთა სამშენებლო მოედანზე შესვლის თავიდან ასაცილებლად დაუყოვნებლივ უნდა მოეწყოს შესაბამისი ბარიერები და დამცავი ღობე სამშენებლო მოედნის მთელს პერიმეტრზე, ხოლო უშუალოდ შესასვლელთან, გამაფრთხილებელი დაფა და საინფორმაციო ნიშნები.

**ფოტო #1: ღია თხრილები სამშენებლო მოედანზე**

აღნიშნულთან დაკავშირებით, აზიის განვითარების ბანკის გარემოსდაცვითი რეგულაციების (SPS 2009) მოთხოვნების შესაბამისად, დაუყოვნებლივ უნდა განხორციელდეს სამშენებლო მოედნის განათება ღამის საათებში, რათა უზრუნველყოფილი იქნას ადგილობრივი მოსახლეობის დაცვა 24 საათის განმავლობაში.

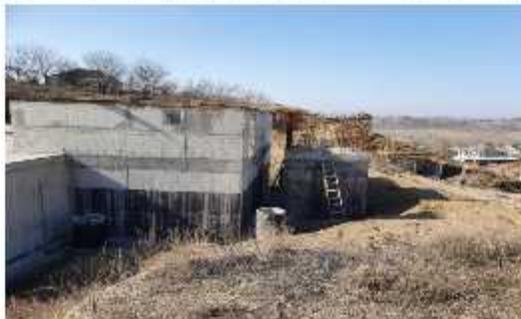
**ფოტო #2: ღია და დაუცველი კატლავანი სამშენებლო მოედანზე**

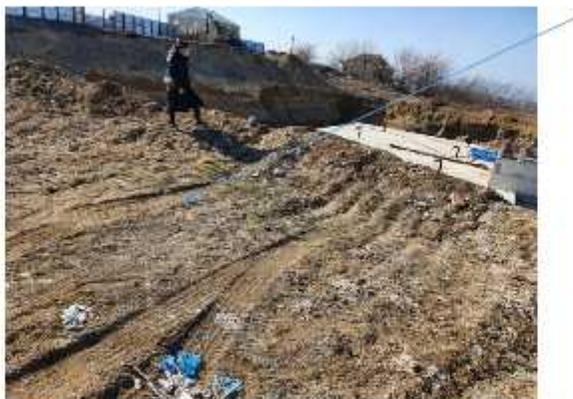
**ფოტო #3: კატლანის კიდედან სატრანსპორტო საშუალებების მოძრაობის კვალი**

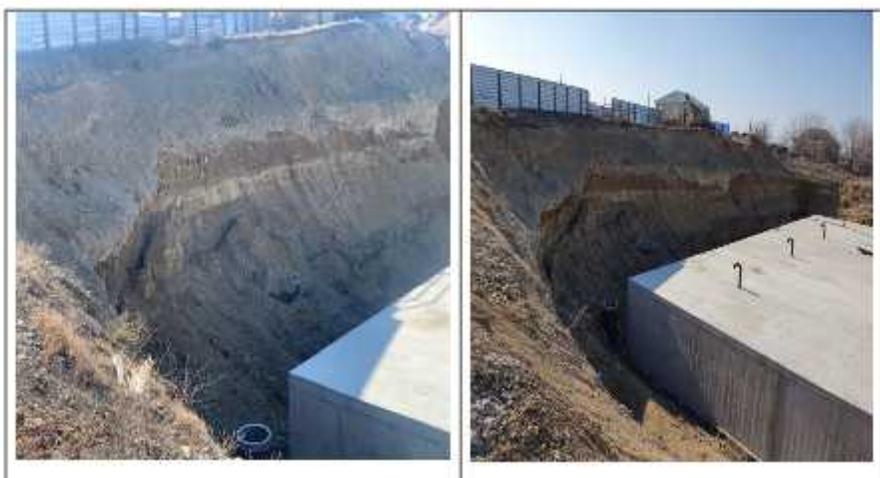
ასევე აღსანიშნავია, რომ სამშენებლო მოედანი მიტოვებულია, ხოლო სამშენებლო კომპანიის მიერ არ ხდება ტერიტორიის დასუფთავება და ნარჩენების უტილიზაცია, მათ შორის სახიფათო ნარჩენების, რაც მოითხოვს დროულ რეაგირებას და ტერიტორიის სათანადოდ დასუფთავებას. სამშენებლო მოედანზე ასევე თვალშისაცემია დაუცველი ელექტროკაბელების არსებობა, რაც ასევე საფრთხეს უქმნის ადგილობრივ მოსახლეობას, რომელიც თავისუფლად, ყოველგვარი შეზღუდვის გარეშე გადაადგილდება სამშენებლო მოედნის ტერიტორიაზე.

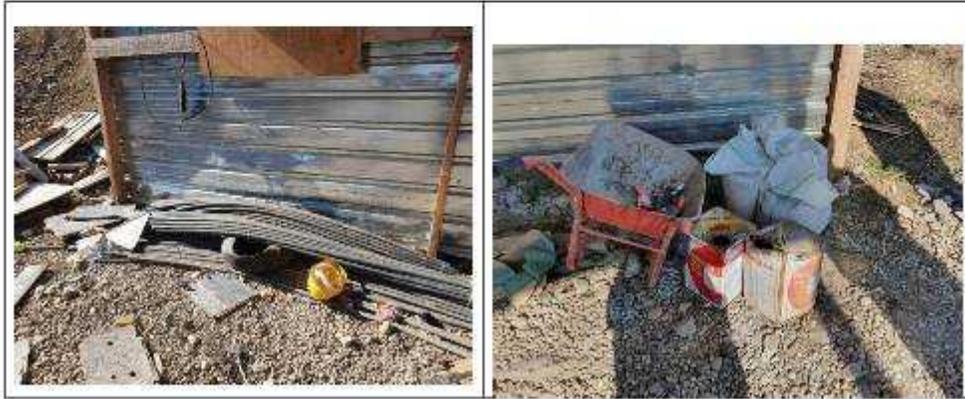
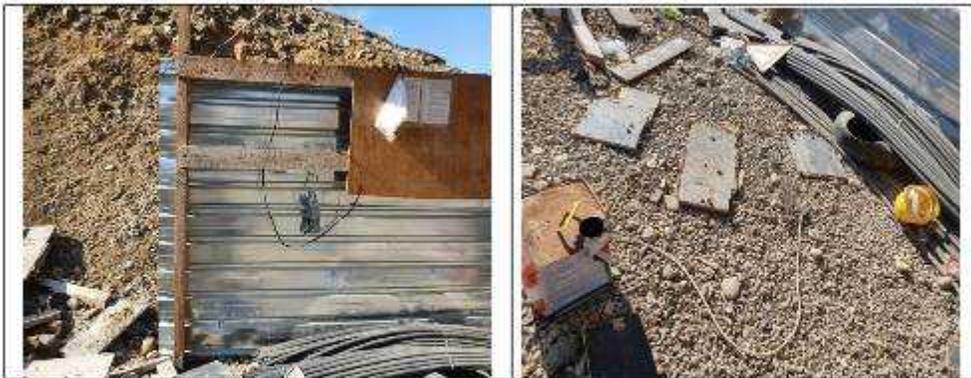
**ფოტო #5: სამშენებლო ტერიტორიაზე არსებული მყარი ნარჩენები**

ზემოაღნიშნულიდან გამომდინარე MAR-01 ქვე-პროექტის ფარგლებში, სამშენებლო კომპანია „Akelik“-მა, დარღვევების გამოსწორება უნდა უზრუნველყოს 10 კალენდარული დღის განმავლობაში და წარმოადგინოს ადგილზე გამოსწორებული სიტუაციის ამსახველი ფოტომასალა და შესაბამისი ანგარიში.

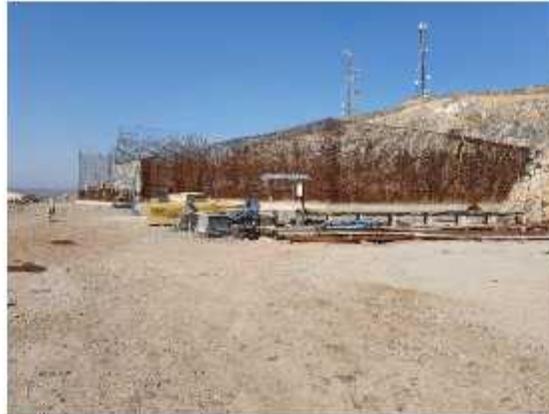
მოუხედავად იმისა, რომ მონიტორინგის მსვლელობისას არ მიმდინარეობდა სამშენებლო სამუშაოები, აღინიშნებოდა სამშენებლო მასალების, კერძოდ რკინის არმატურის დროებით დასაწყობებასთან დაკავშირებული პრობლემები, რაც საფრთხეს შეუქმნის მუშა პერსონალის უსაფრთხო გადაადგილებას სამშენებლო მოედანზე. შესაბამისად მიზანშეწონილია სამშენებლო მასალის სათანადო დასაწყობება შესაბამისი ნორმების დაცვით.

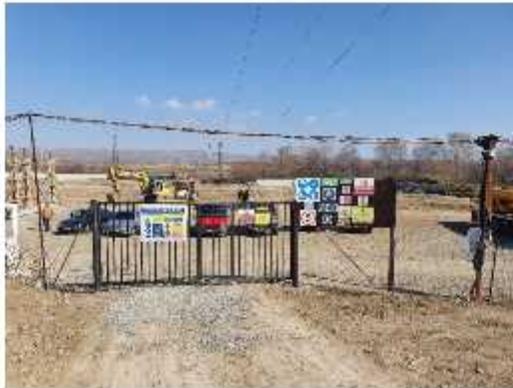
რაც შეეხება ქ. მარნეულის ჩამდინარე წყლების გამწმენდი ნაგებობის მშენებლობის ქვე-პროექტის (MAR-02) ფარგლებში სამშენებლო მოედანზე, მშენებლობის პროცესში აღმოჩენილ დარღვევებს, გარემოსდაცვითი და შრომითი უსაფრთხოების კუთხით, იგი ლოკალური ხასიათისაა და ადგილზე შესაბამისი მითითებების შედეგად ადვილად გამოსასწორებელი. აღნიშნულ პროექტთან დაკავშირებით უფრო პრობლემურია, სამშენებლო მოედნის ადგილობრივი მოსახლეობის უახლოესი საცხოვრებელი სახლებიდან (მაქსიმუმ 50მ მანძილზე) გამიჯვნის საკითხი, რაც ამჟამად რკინის მსუბუქი ლობით შემოიფარგლება (იხ.ფოტო #14), თუმცა სამშენებლო მოედნის მთლიანი პერიმეტრი დაცულია ბეტონის ლობით. შესაბამისად რეკომენდირებულია აღნიშნული ბეტონის ლობე მოეწყოს სამშენებლო მოედნის წინა პერიმეტრზე, საცხოვრებელ სახლებთან ახლოს, რათა ადგილობრივი მოსახლეობა დაცული იყოს, ხმაურისა და მტვრის გავრცელებისგან მშენებლობის/ექსპლუატაციის პროცესში, ხოლო გამწმენდი ნაგებობის ოპერირების პროცესში ხმაურისა და სუნის გავრცელების, აგრეთვე ვიზუალურ-ლანდშაპტური ზემოქმედებისგან.

**ფოტო #10: სამშენებლო მოედნის რკინის ლობე**

რაც შეეხება MAR-02 ქვე-პროექტს, მიზანშეწონილად მიგვაჩნია გარემოზე ზემოქმედების მინიმუმამდე დაყვანის უზრუნველსაყოფად მოსახლეობის მხარეს აშენდეს მყარი კედელი.

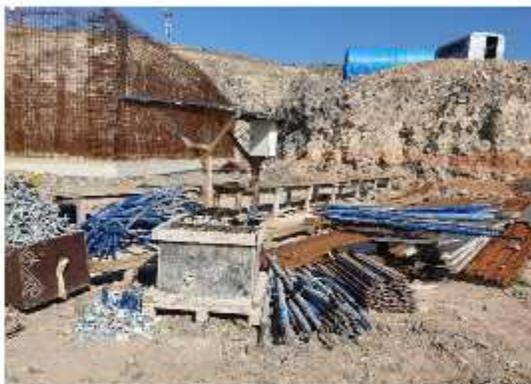
**ფოტო # 7: არასათანადოდ დასაწყობებული სამშენებლო მასალები**

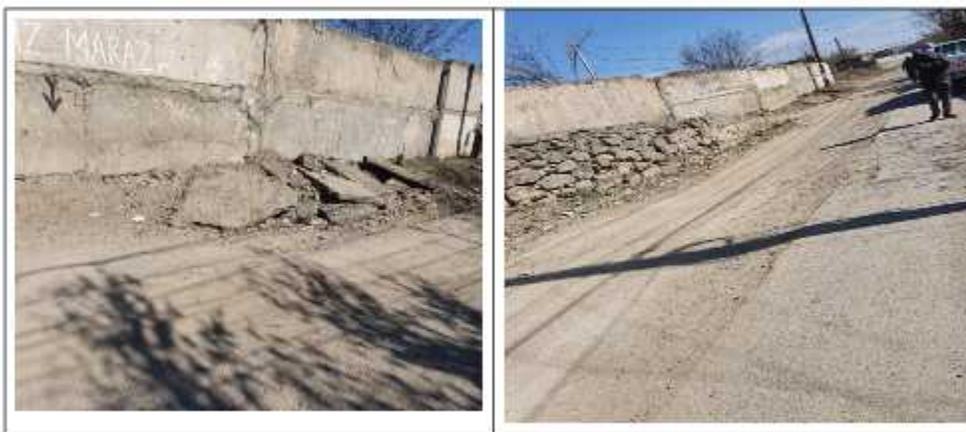
მონიტორინგის პროცესში ვერ მოხერხდა ქსელის მოწყობის სამშენებლო სამუშაოების დაკვირვების პროცესში წარმოქმნილი დარღვევების აღმოჩენა, გარემოსდაცვითი და შრომითი უსაფრთხოების კუთხით, რადგან საზუდამხედველო კომპანიის მიერ მოწოდებული ინფორმაციის თანახმად აქტიური სამშენებლო სამუშაოები ამჟამად არ მიმდინარეობს, თუმცა თვალშისაცემია ქალაქის მიწის ტერიტორიაზე, არასათანადოდ აღდგენილი და რეაბილიტირებული საგზაო საფარი, წყალმომარაგებისა და საკანალიზაციო ქსელის მოწყობის შემდეგ, რაც საფრთხეს უქმნის ადგილობრივი მოსახლეობის უსაფრთხო გადაადგილებას და მოითხოვს დაუყოვნებლივ რეაგირებას (იხ. ფოტო #8, #9).

**ფოტო #8, ფოტო #9 : არასათანადოდ აღდგენილი გზის საფარი**
