SEMI-ANNUAL ENVIRONMENTAL MONITORING REPORT

Project Number: 43405-023

Reporting Period: July-December 2018

GEORGIA: URBAN SERVICES IMPROVEMENT INVESTMENT PROGRAM (TRANCHE 1) (FINANCED BY THE ASIAN DEVELOPMENT BANK)

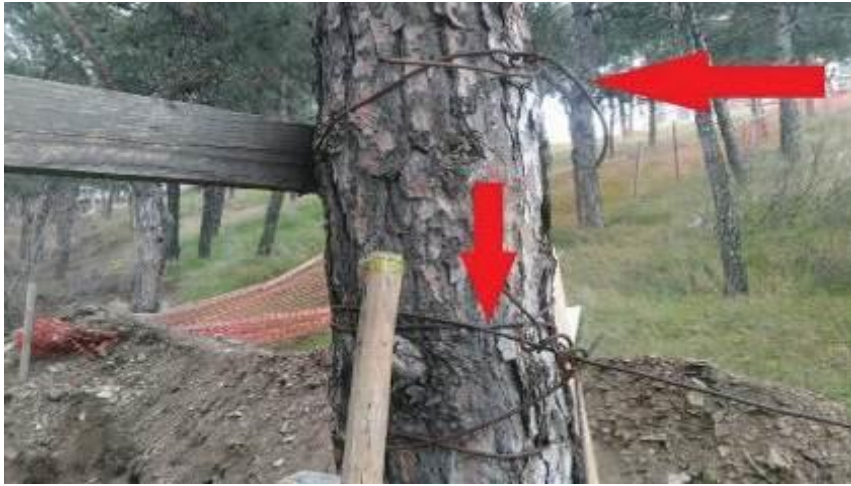
Photo 1: Incorrectly attached wire on the tree

79. Example No2: Wire is not properly affixed and damaged the tree (Please see photo below).

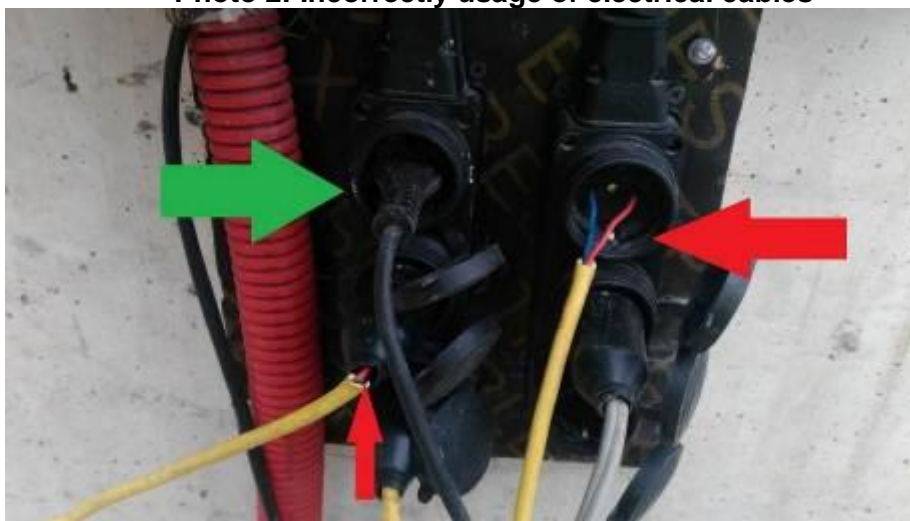
Photo 2: Incorrectly usage of electrical cables

80. Example No3: Electrical cables are not properly used. Electrical plug missing, no insulation.

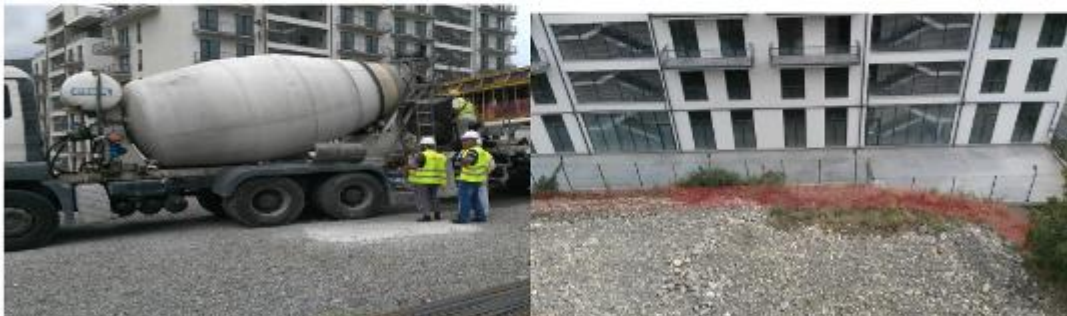
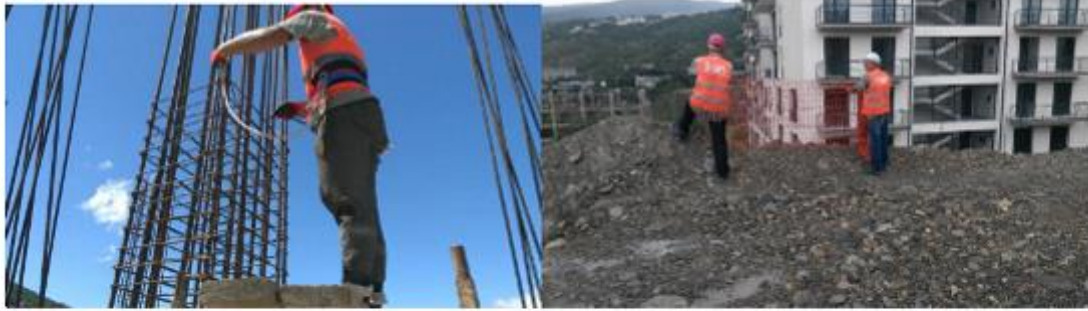
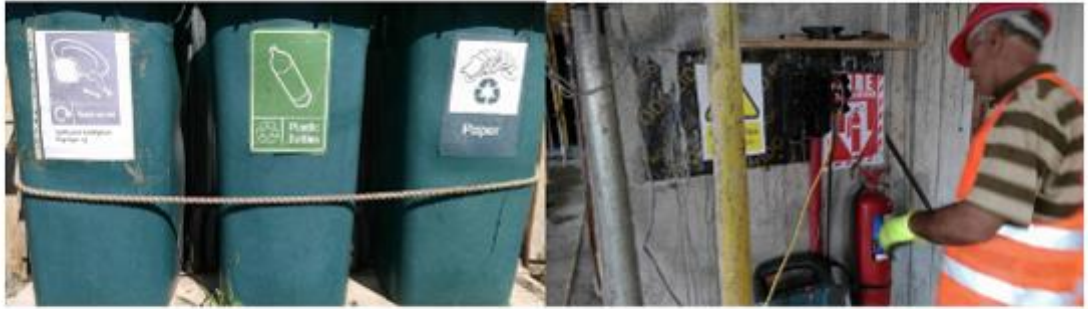
Corrective Action Evidence Photos

#	Non-Compliance	Corrective Action Taken	Evidence Provided	Date of Corrective Action	Responsible person(s)
1	Trees at the construction area should be protected on proper way to avoid its damage	Trees at the construction area protected to avoid its damage	✓	15.08.18.	HSE MANAGAR A.CHUMBURIZE
2	High visible safety tapes should be installed around	Hard and warning fence installed around	✓	15.08.18.	HSE MANAGAR A.CHUMBURIZE
3	Enough and relevant warning/information signs should be placed within site	Safety signs placed on the construction site	✓	15.08.18.	HSE MANAGAR A.CHUMBURIZE
4	Safety norms during works at the height should be respected to avoid workers damage	All workers equipped with complete PPE	✓	15.08.18.	HSE MANAGAR A.CHUMBURIZE
5	Fuel containers should be placed in a properly arranged place with roofing to avoid spillage	Fuel containers placed properly arranged place on the roofing to avoid spillage	✓	15.08.18.	HSE MANAGAR A.CHUMBURIZE

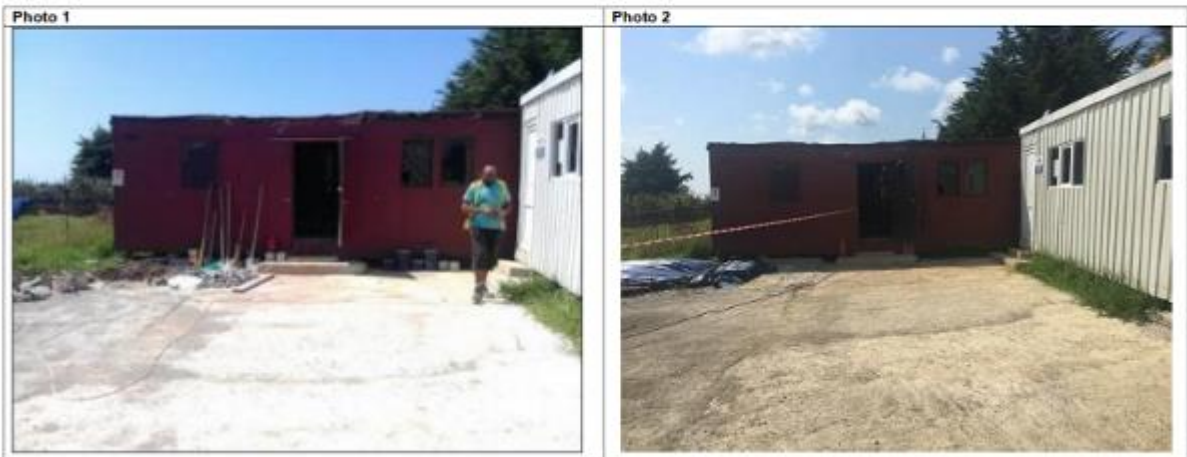
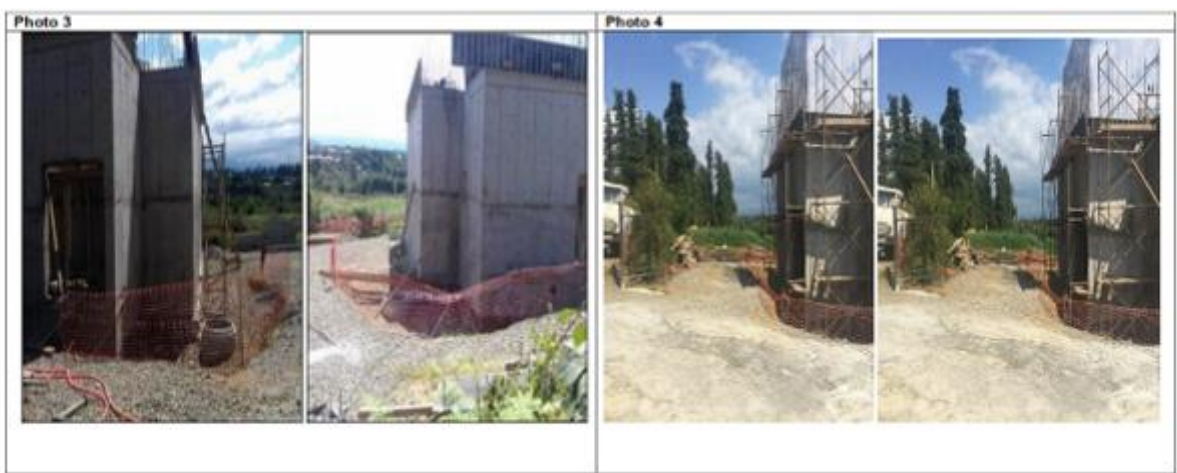
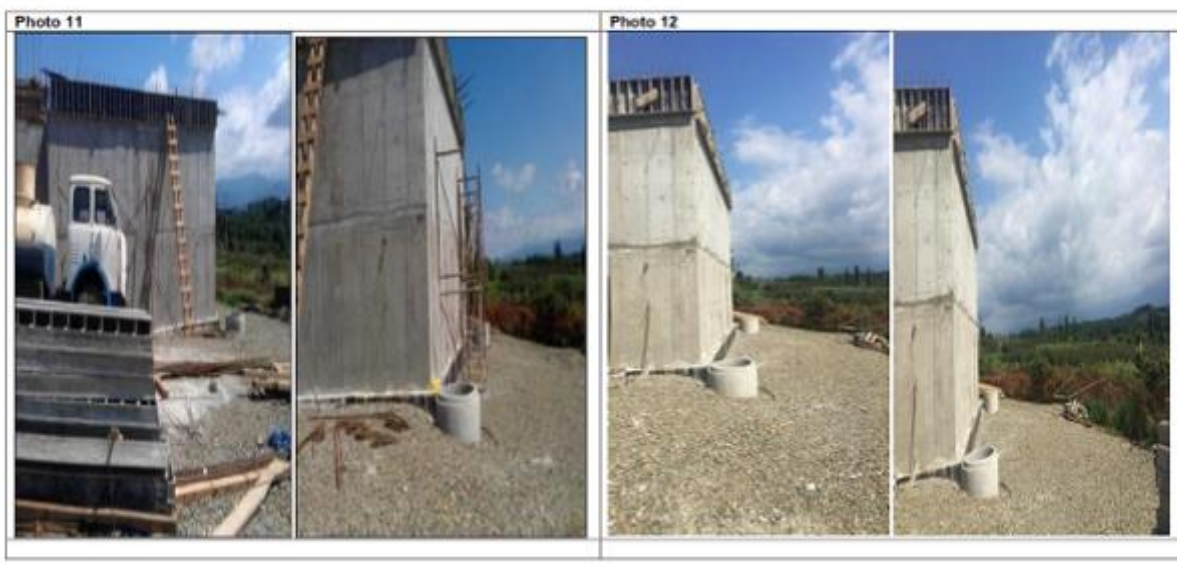
Evidence Photos

Corrective Action Plan
22.08.2018
