SEMI-ANNUAL ENVIRONMENTAL MONITORING REPORT

Project Number: 43405-023

Reporting Period: July-December 2018

**GEORGIA: URBAN SERVICES IMPROVEMENT INVESTMENT PROGRAM
(TRANCHE 2)
(FINANCED BY THE ASIAN DEVELOPMENT BANK)**

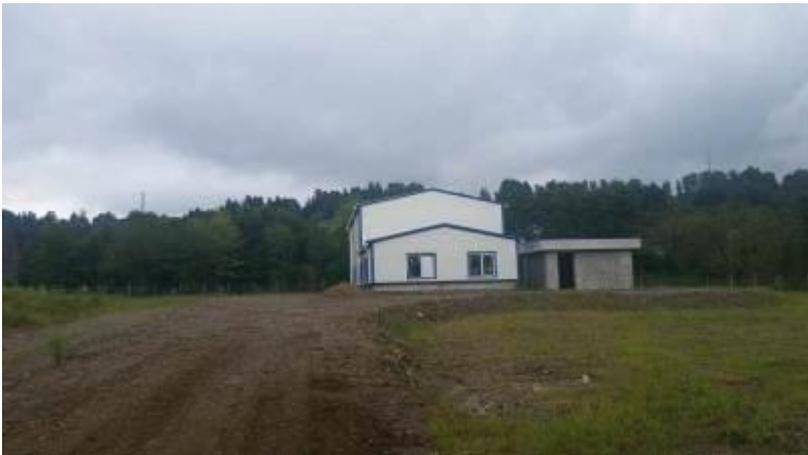
Water Supply Pumping Station

32. At Pumping Station excavation and sheet piling works and installation of ground drainage system is ongoing. Pipelines were connected to the PSs. Plastic chambers and precast concrete cabinet are installed.

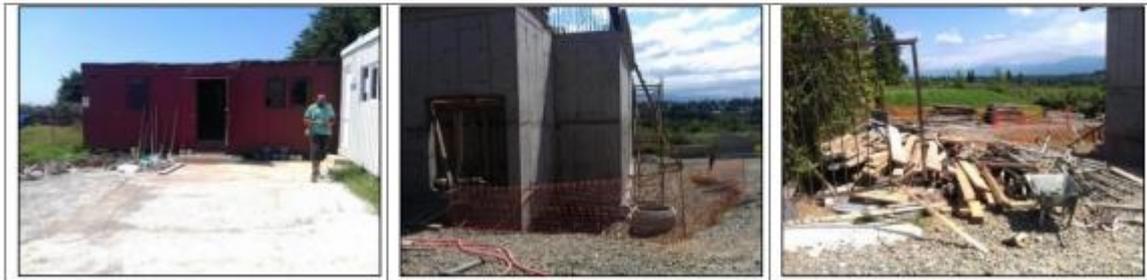
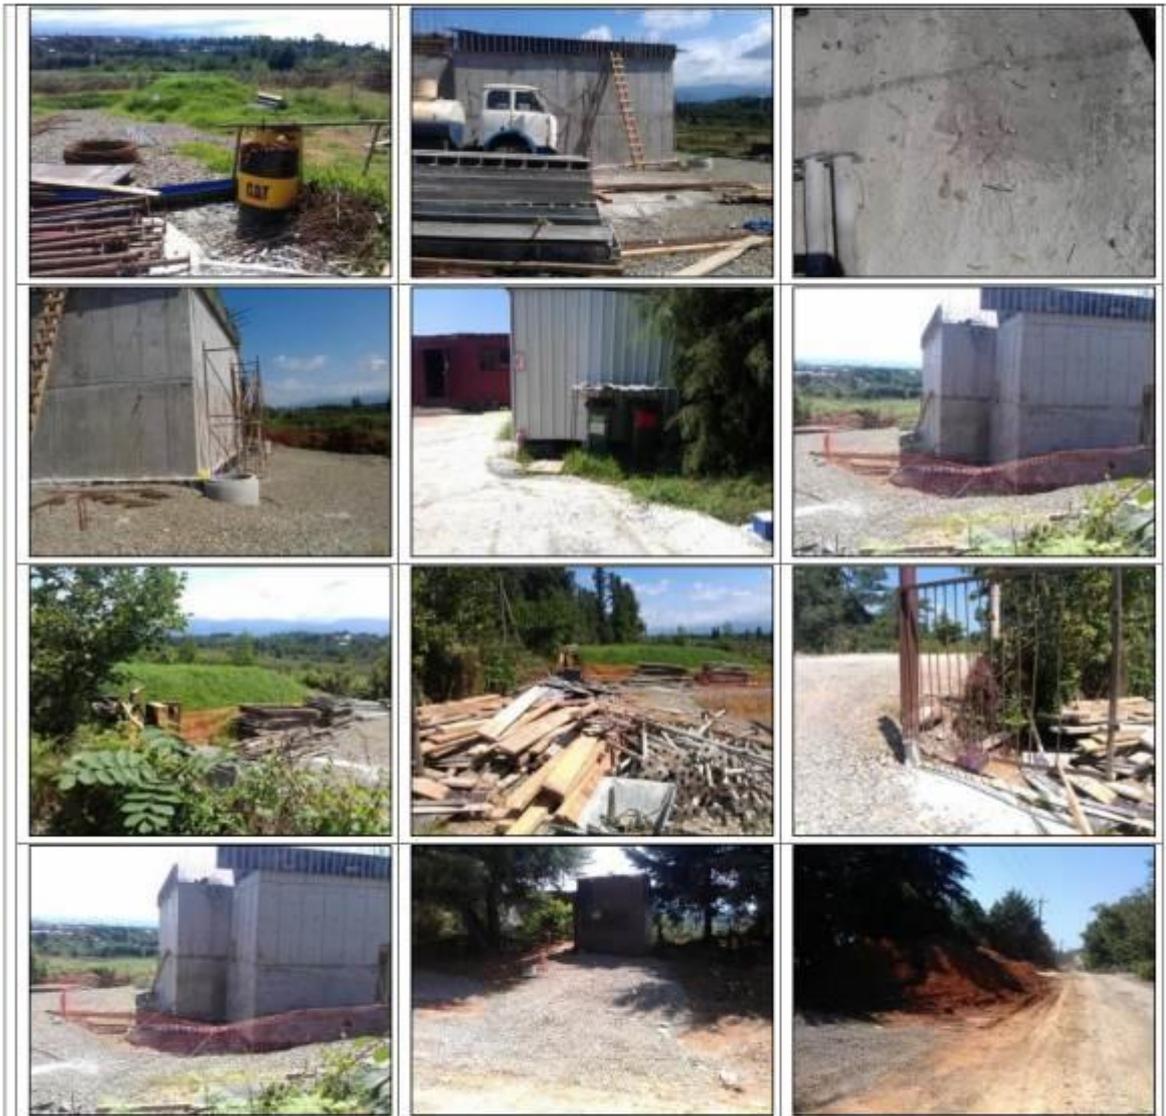
- Proper toilet with relevant sign should be arranged
- Construction territory and wooden materials should be freed from big nails to avoid personnel damage

- Containers with fuel/lubricant should be managed properly (stored at the proper organized place with concrete floor and roofing) to avoid leakage and ground contamination

- All construction materials should be properly segregated and stored adequately
- Workers always should use complete PPE
- Site internally should be arranged properly and cleaned regularly

All these conditions have to be remedied within six days (by the 22 August 2018) by the prime Contractor (Peri).

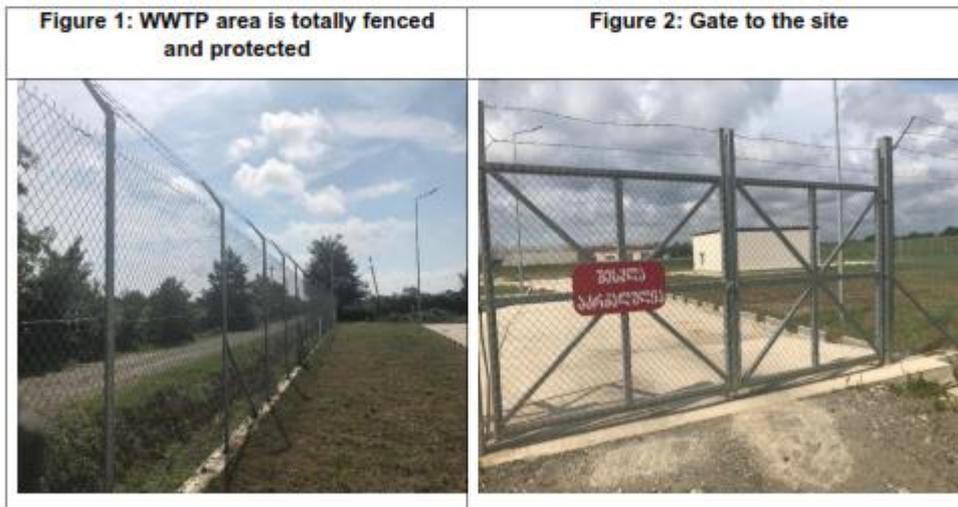
26. The construction works were fully accomplished satisfactorily, all kinds of waste, including construction waste were removed from the site, and territory of the WWTP construction site was fully fenced and kept clean (**Figures 1 and 2**).

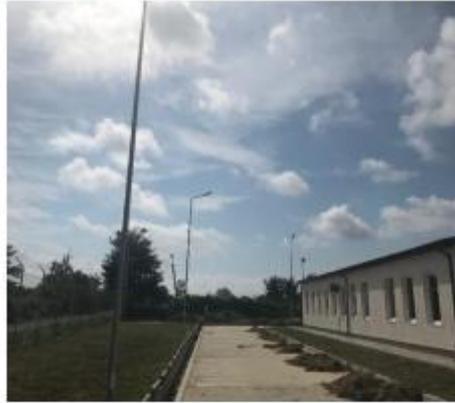
Figure 3: WWTP area with lightning system

27. Lightning system around the whole perimeter of the WWTP site is installed and works properly (**Figure 3**).

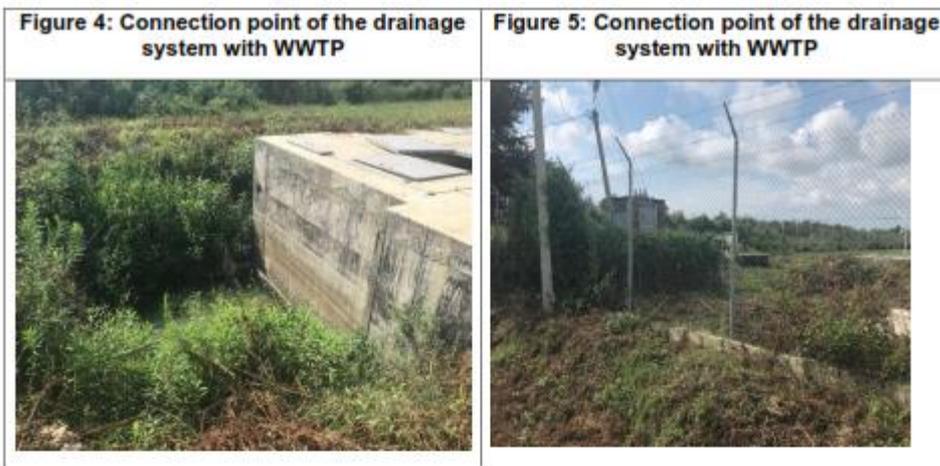
31. The trench left in the area where the central water drainage system must be connected to the water treatment works in the project zone is not duly labeled and is hazardous for the employees working on the given territory.

32. Due to the fact that it is not clear when it will be technically possible to connect the water drainage system to the water treatment facility (WWTP), following the safety requirements of the employees, the area must be duly labeled or the safety standards of the given area must be conserved by using the due requirements.

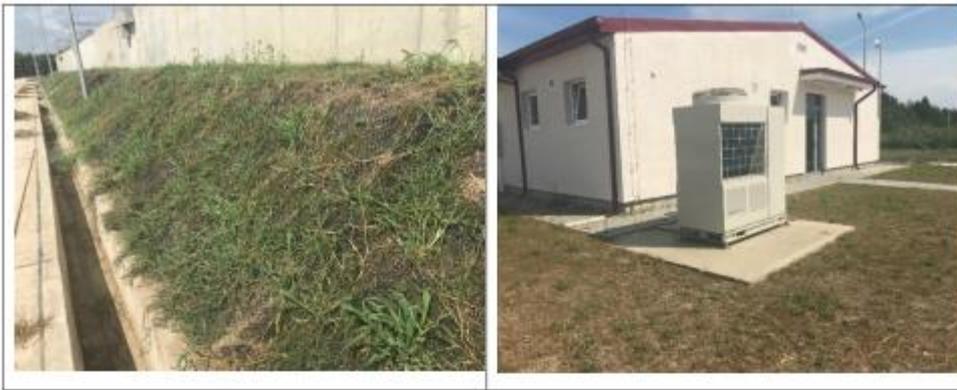
34. The topsoil removed during the construction phase is returned totally and placed in the project zone. After the topsoil placement, as it was envisaged by SSEMP developed within the scope of the Project, Construction Company JV "Pfeiffer-Protectno" with the aim to protect the small slopes against erosion, had to plant the relevant grass species. It is true that the grass was planted in the given area, but as it was fixed at the stage of audit, there is need of additional care and time to reach best growing progress (**Figures 6 and 7**).

35. Grass planting in the project area with the aim of protecting the territory against erosion did some desirable results. The local grass species planted by the Construction Contractor needs additional care and time to reach best growing progress.

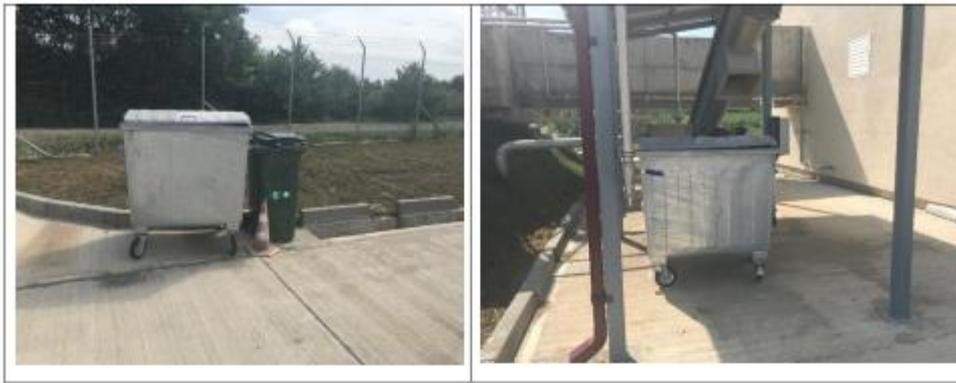
Figure 8: Containers in the project zone	Figure 9: Containers in the project zone
---	---

38. At the stage of the audit, the project zone was totally cleared off the waste. There were both, metal and plastic containers in the area. However, none of them were duly labeled (**Figures 8 and 9**).

39. The containers found in the project zone are not duly labeled.

40. It is necessary to make relevant marking on the waste containers, such as "Domestic waste" and "Hazardous waste".
