Semi-annual Environmental Monitoring Report

Project Number: 43405-025

Reporting Period: July-December 2018

GEORGIA: URBAN SERVICES IMPROVEMENT INVESTMENT PROGRAM (TRANCHE 3)

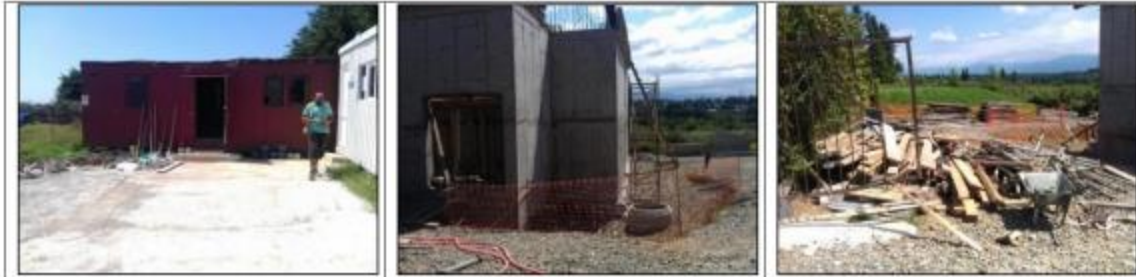
- Proper toilet with relevant sign should be arranged
- Construction territory and wooden materials should be freed from big nails to avoid personnel damage

- Containers with fuel/lubricant should be managed properly (stored at the proper organized place with concrete floor and roofing) to avoid leakage and ground contamination

- All construction materials should be properly segregated and stored adequately
- Workers always should use complete PPE
- Site internally should be arranged properly and cleaned regularly

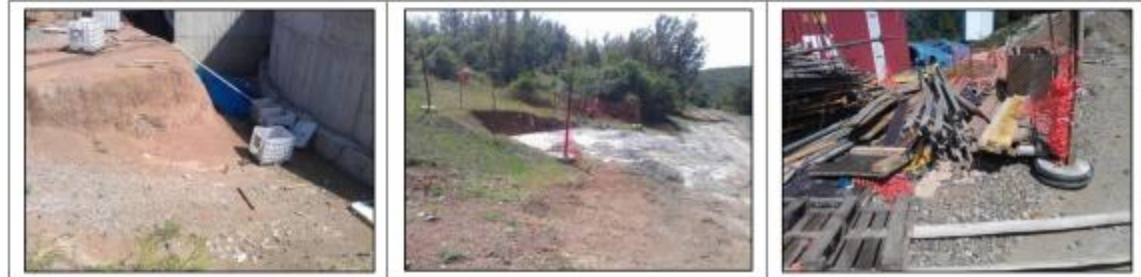
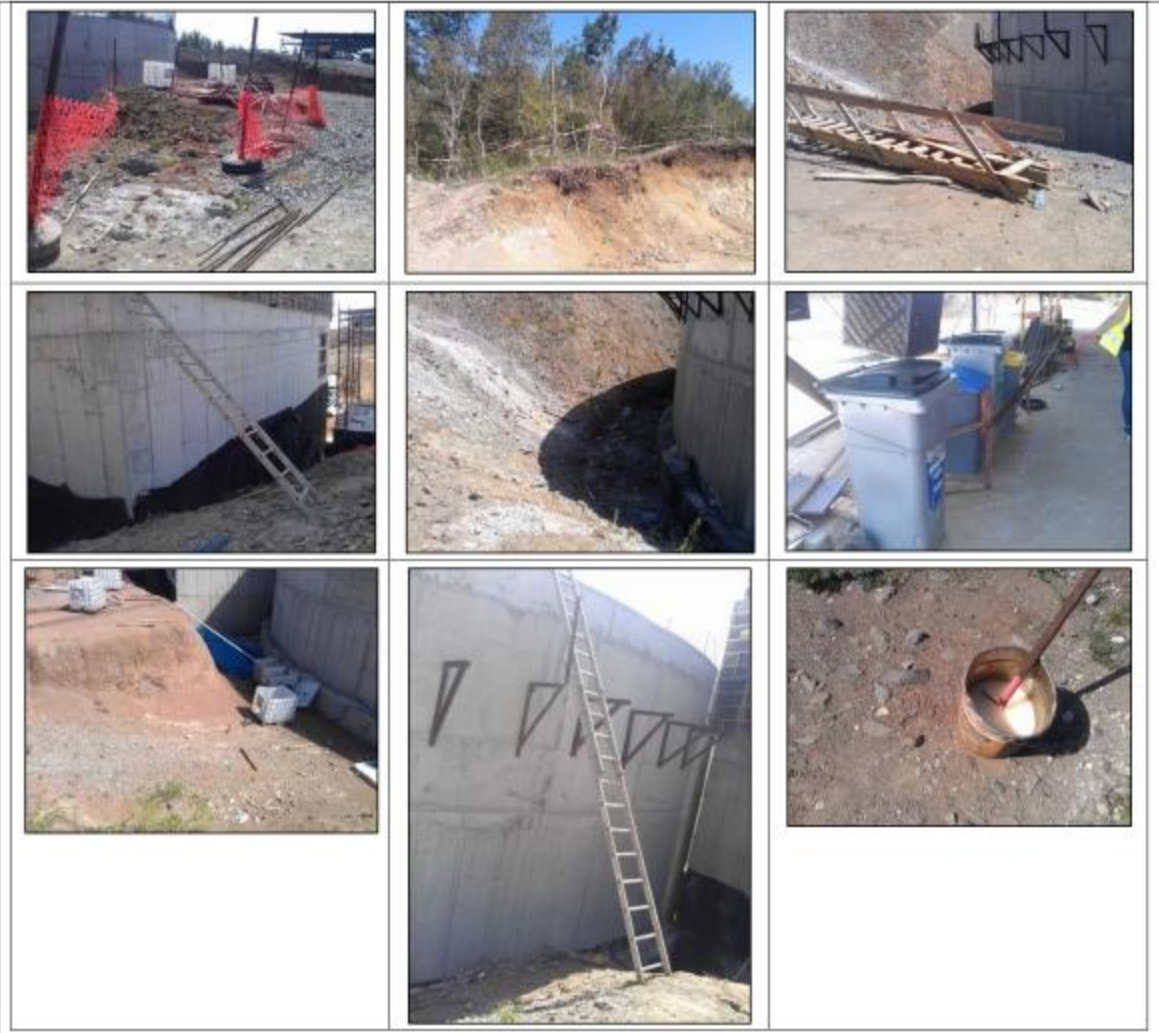
Photos of Godogani Reservoir

- Trees at the construction site and nearby deep excavation zone should be protect to avoid its damage
- Construction waste should be timely removed from the construction site and disposed properly

- Containers with fuel/lubricant should be managed properly (stored at the proper organized place with concrete floor and roofing) to avoid leakage and ground contamination

- Workers always should use complete PPE
- Site internally should be arranged properly and cleaned regularly

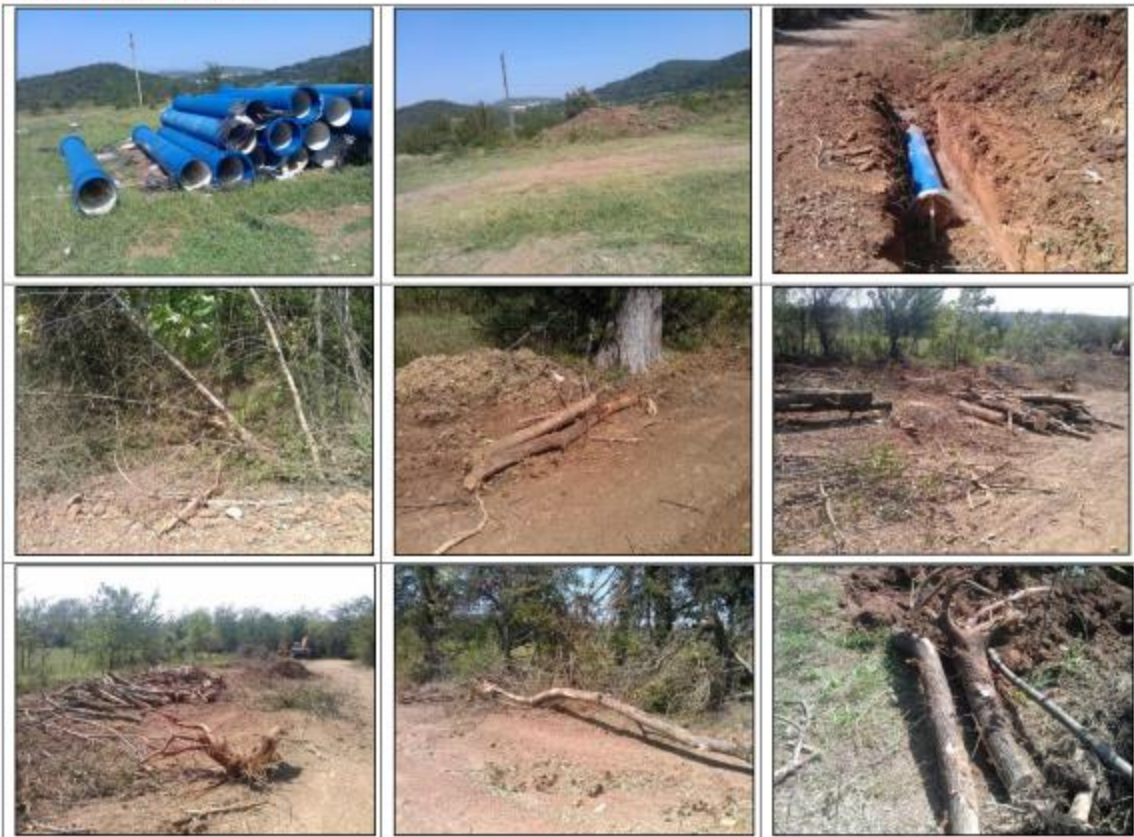
Photos of Kutaisi Network

- Construction activities information signs should be installed at each construction segment
- Safety signs/tapes around of all open trenches should be installed to avoid accident of population

- Trees nearby construction works and excavation zone should be protect to avoid its damage
- Trees cutting without proper agreement/permit is prohibited

- Workers always should use complete PPE
- Refilling/compaction and reinstatement process should bring site at the same or better condition as it was before construction

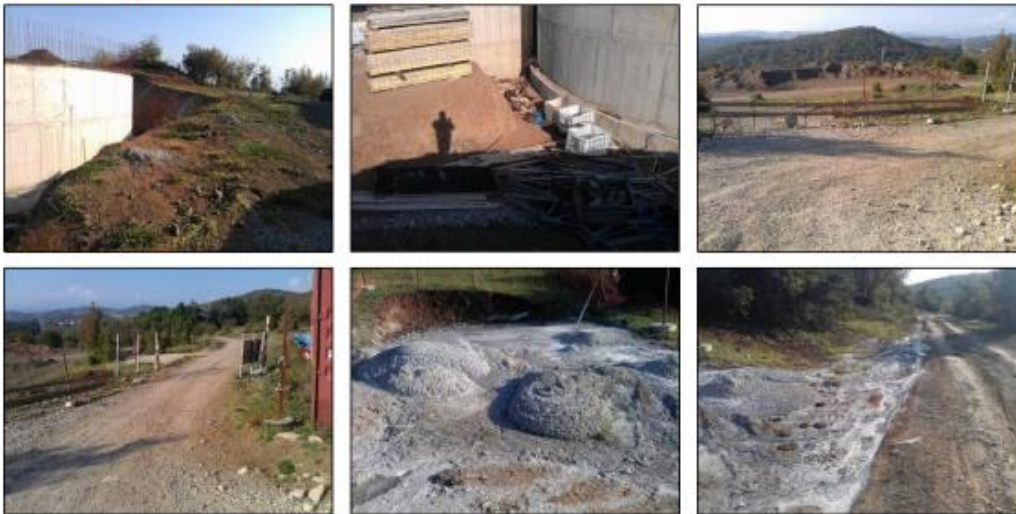
Photos of Godogani Reservoir

- Complain box should be properly signed and place at the entrance of the site
- Concrete washout pit should be managed properly, discharged, fenced and signed. With current condition ground needs urgent remediation

- Workers always should use complete PPE
- Safety norms during working at height should be respected
- Site internally should be arranged properly and cleaned regularly

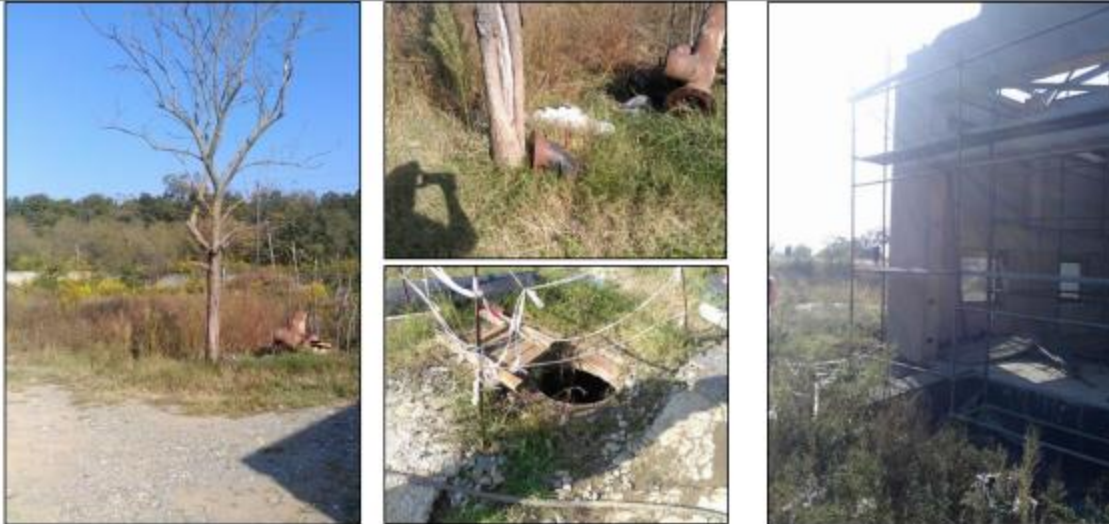
Photos of Mukhnari Reservoir

- Construction waste should be timely removed from the construction site and disposed properly
- Equipment & vehicles used for construction activities should be in good condition (no leakage) to avoid leakage and ground/water contamination
- Proper fuel/oil spill response items (sand, sawdust, special containers) should be available at the construction site
- Trees nearby/at the construction zone should be protected/fenced to avoid its damage
- All construction materials should be properly segregated and stored adequately
- All workers should be equipped with complete PPE
- Safety norms during works at the height should be respected
- Ladder safety should be ensured
- Site internally should be arranged properly and cleaned regularly

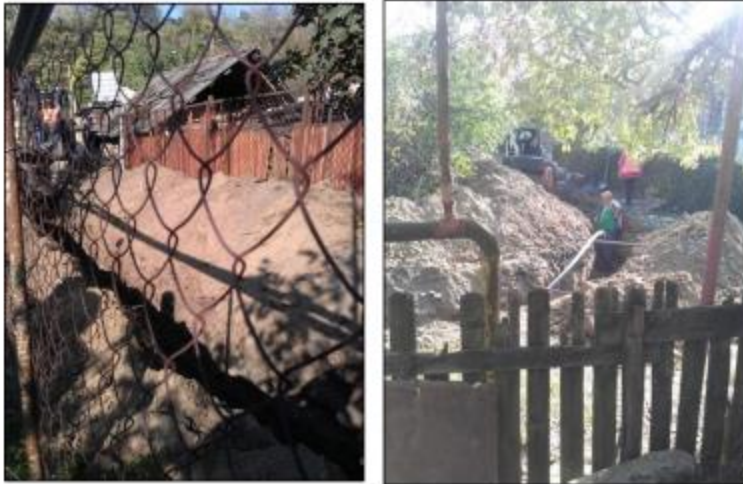
Photos of Network

- Safety signs/tapes around of all open trenches should be installed to avoid accident of population
- Construction activities information signs should be installed at each construction segment

- Surplus waste soil should be removed and disposed in a proper place
- Trees nearby/at the construction activities zone should be protected/fenced to avoid its damage

- Workers always should use complete PPE
- All transmission line construction segments should be cleaned/well organized on regular bases
- Refilling/compaction and reinstatement process should bring site at the same or better condition as it was before construction

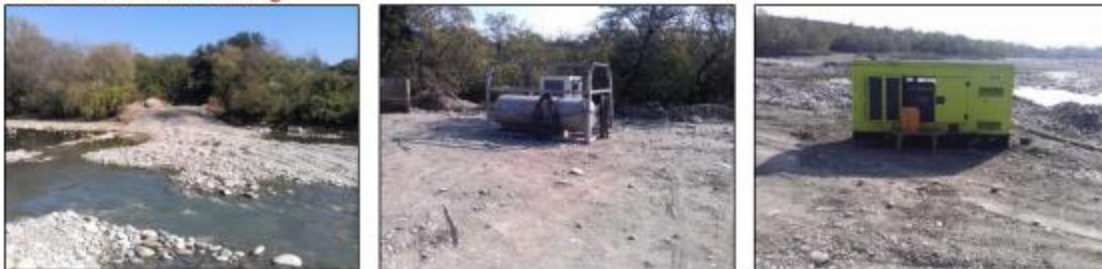
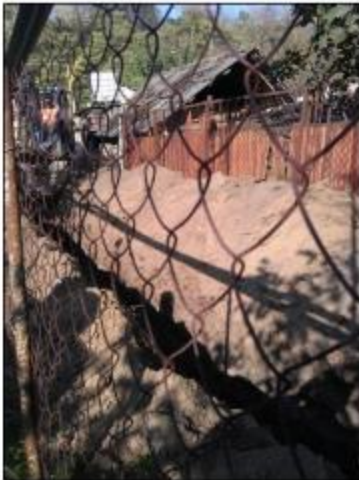
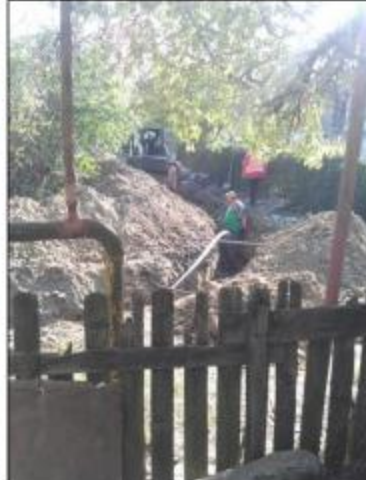
Photos of Rioni river crossing

- Construction activities information and warning signs should be installed along the construction site
- High visible safety signs/tapes should be installed around excavation/construction works area and open trenches to avoid accidents

- Trees nearby construction activities zone should be protect to avoid its damage
- Proper fuel/oil spill response items (sand, sawdust, special containers) should be available

- Containers with fuel/lubricant should be managed properly (stored at the proper organized place with concrete floor and roofing) to avoid leakage and ground/water contamination

- Oil spill signs on the ground should be remediated immediately with oils spill kit
- Equipment & vehicles used for construction activities should be in good condition (no leakage) to avoid leakage and ground/water contamination

- Proper waste containers should be places at the site (with signs, hazardous/non-hazardous waste)
- Construction waste and other waste should be timely removed from the construction site and properly disposed

- Workers always should use complete PPE
- Construction area should be arranged properly and cleaned regularly

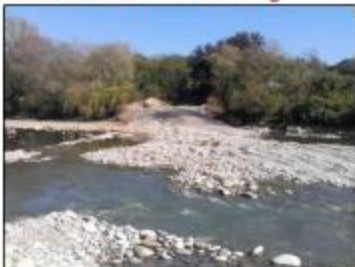
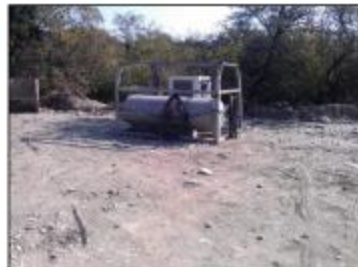
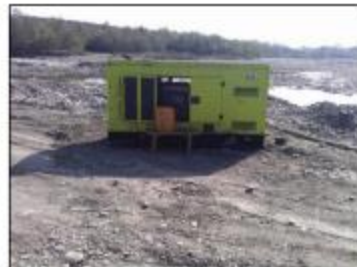
Photos of Rioni river crossing

- Construction activities information and warning signs should be installed along the construction site
- High visible safety signs/tapes should be installed around excavation/construction works area and open trenches to avoid accidents

- Workers always should use complete PPE
- Construction area should be arranged properly and cleaned regularly

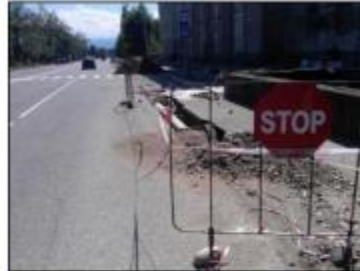
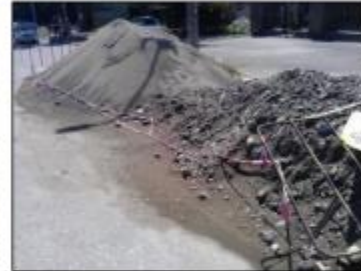
Photos of Kutaisi Network

- Construction activities information signs should be installed at each construction segment
- Surplus waste soil should be removed and disposed in a proper place
- Construction materials should be brought when needed to avoid its long time disposal in the streets and disturbance of residents and businesses
- All transmission line construction segments should be cleaned/well organized on regular bases
- Refilling/compaction and reinstatement process should bring site at the same or better condition as it was before construction

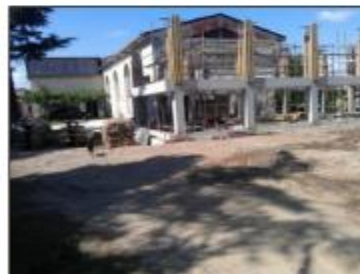
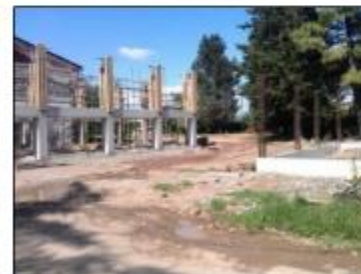
Photos of Kutaisi Pumping station

- Proper warning and information signs should be arranged at the construction territory and perimeter of the site
- Safety norms during working at height should be provided
- Special equipment during working at heights should be used
- Trees at the construction site should be protect (trees should be exempt from materials) to avoid its damage
- All construction materials should be properly segregated and stored adequately
- Workers always should use complete PPE
- Site internally should be arranged properly and cleaned regularly

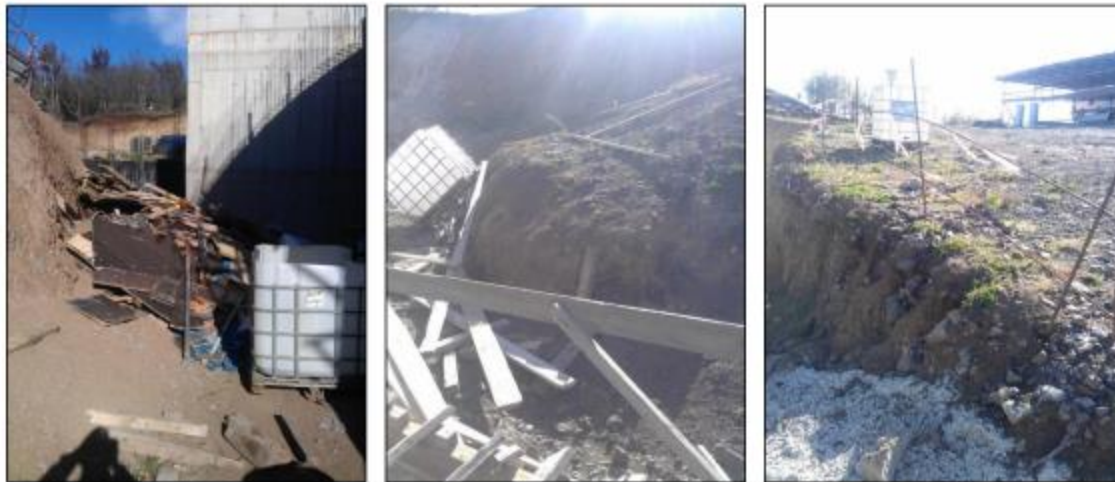
Photos of Godogani Reservoir

- Tree nearby to deep excavation zone should be protect to avoid its falling and damage
- Trench side barriers (mesh material) around of deep excavation should be installed from all sides to avoid accidents
- Entrance gate of the construction site should be repaired
- Construction waste should be timely removed from the construction site and disposed properly (construction site should be cleaned regularly)
- Concrete washout pit should be lined with the geomembrane
- Workers always should use complete PPE

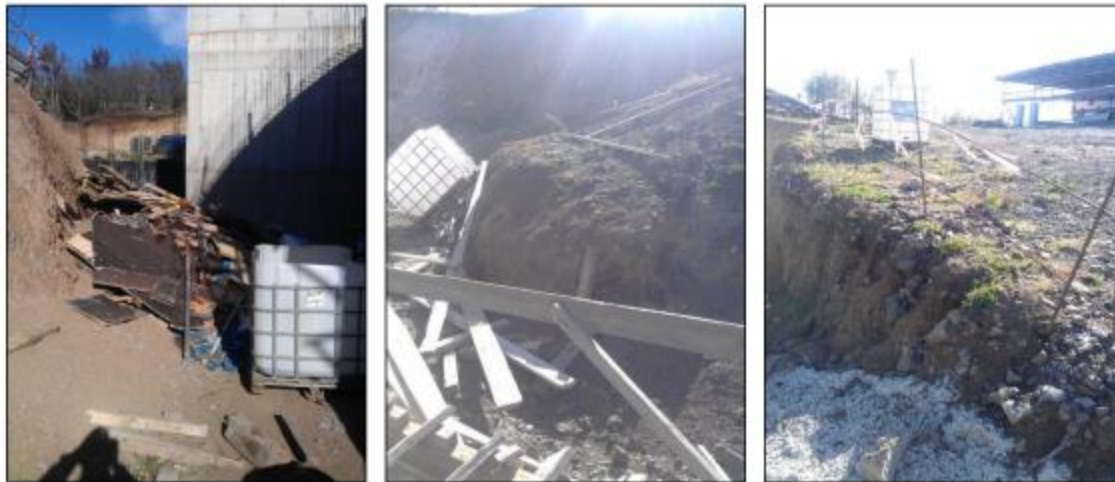
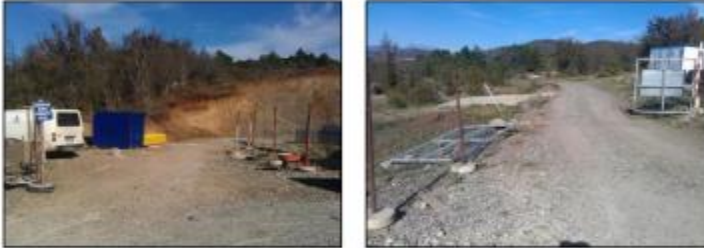
Photos of Godogani Reservoir

- Tree nearby to deep excavation zone should be protect to avoid its falling and damage
- Trench side barriers (mesh material) around of deep excavation should be installed from all sides to avoid accidents
- Entrance gate of the construction site should be repaired
- Construction waste should be timely removed from the construction site and disposed properly (construction site should be cleaned regularly)
- Concrete washout pit should be lined with the geomembrane
- Workers always should use complete PPE

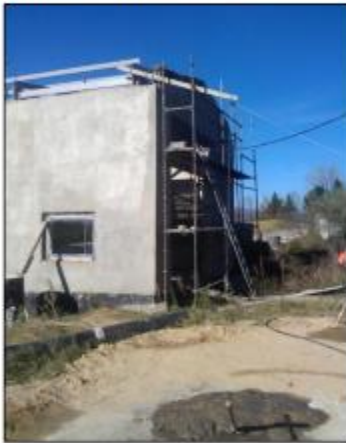
Photo of Mukhnari Reservoir

- All workers should be equipped with complete PPE
- Safety norms during works at the height should be respected (special equipment during high altitude works should be used)
- Ladder safety should be ensured

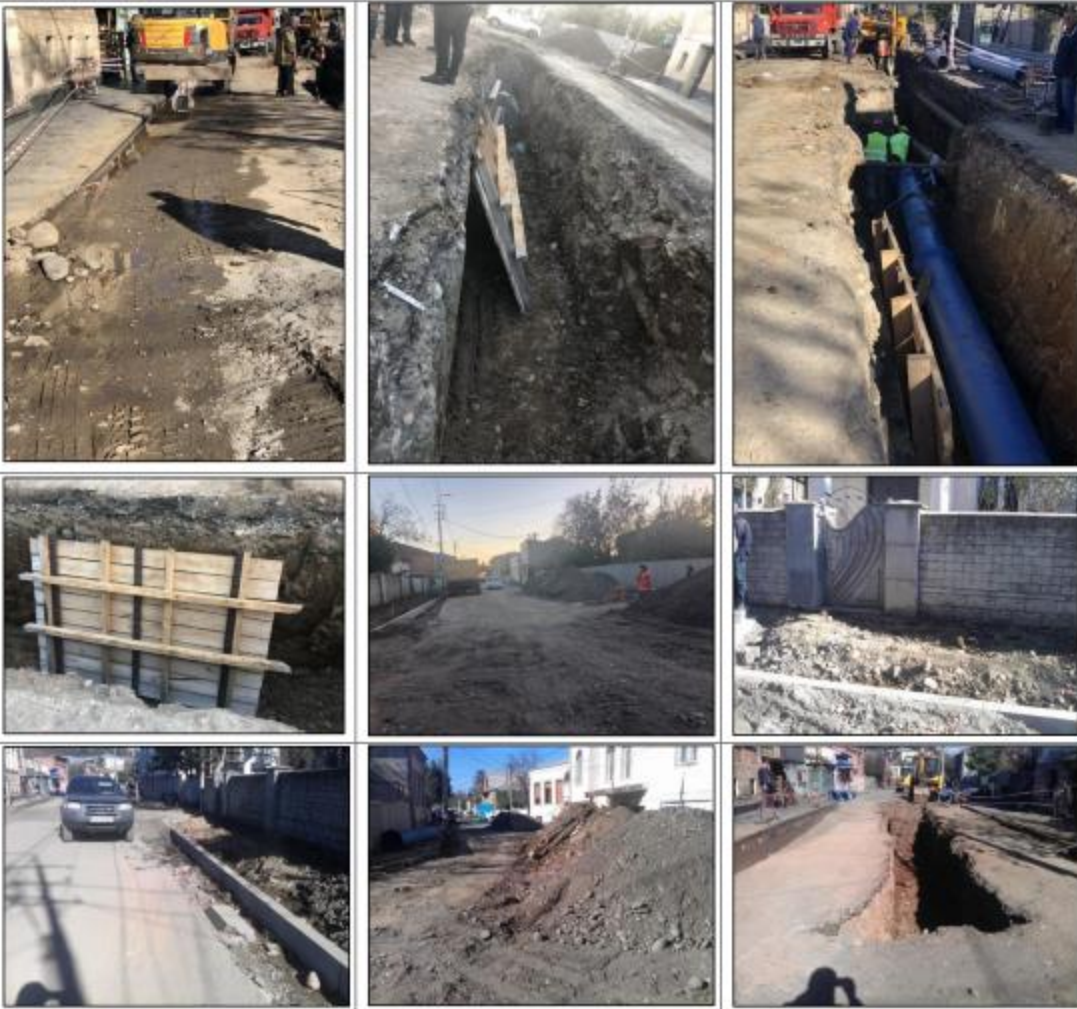
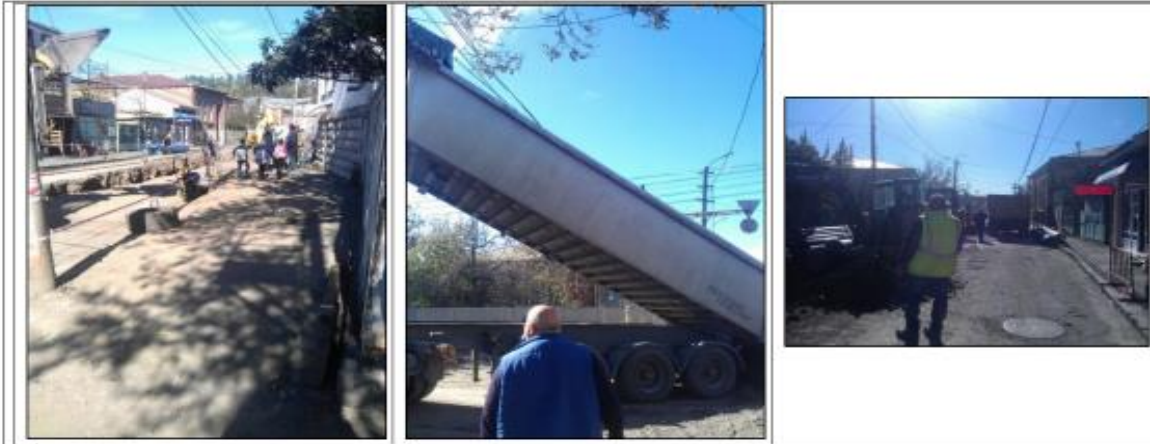
Photos of Network

- Construction activities information signs should be installed at each construction segment
- Safety signs/tapes and trench side barriers around of open trenches should be installed to avoid accident of population
- Walls of the deep trenches (>1.5m) should be strengthened by boards to avoid landfall of the soil and accidents
- During materials transportation tarpaulins cover should be used every time
- Sidewalks should be cleaned from the surplus waste soil and construction materials
- Surplus waste soil should be removed and disposed in a proper place
- Dust prevention activities should be carried out
- During construction works careful operation is needed with high voltage cables to avoid its break and damage of personnel
- Construction materials should be brought when needed to avoid its long time disposal in the streets and disturbance of residents and businesses

- Nearby area of residential houses (entrance) should be cleaned from the construction materials/surplus waste soil
- Regulation of transport/pedestrian movement should be provided. Permanent dedicated personnel should be on site to regulate population movement nearby to construction site
- Workers always should use complete PPE
- Refilling/compaction and reinstatement process should bring site at the same or better condition as it was before construction

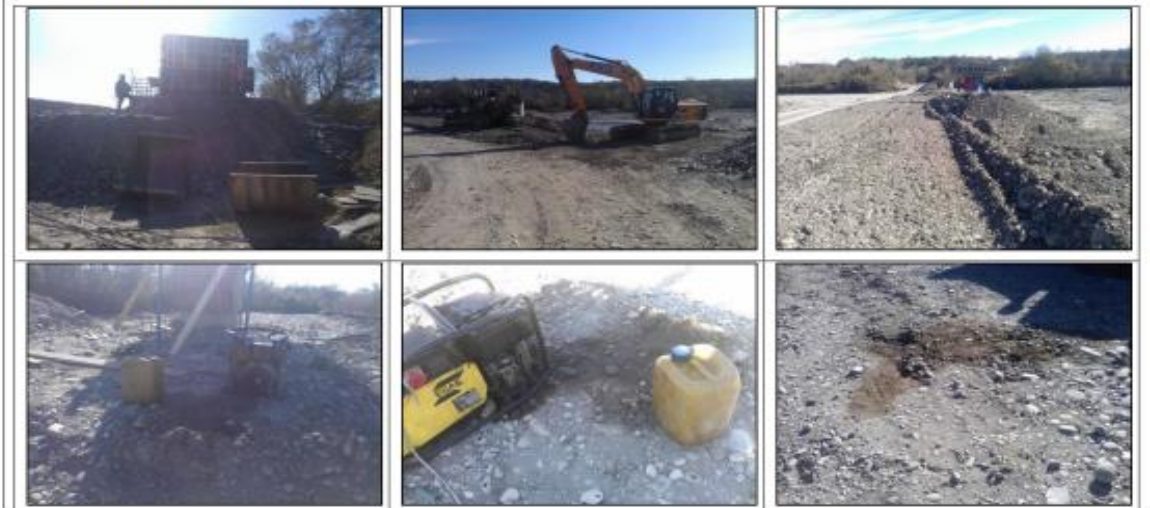
Photos of Rioni river crossing

- High visible safety signs/tapes should be installed around excavation/construction works area
- Trees nearby construction activities zone should be protect to avoid their damage
- Containers with fuel/lubricant should be managed properly (stored at the proper organized place with concrete floor and roofing) to avoid leakage and ground/water contamination
- Equipment used (power generator) should be in good condition (no leakage) to avoid leakage and ground/water contamination. Urgent mitigation should take place and contaminate ground removed/treated
- Workers always should use complete PPE
- Construction area should be arranged properly and cleaned regularly

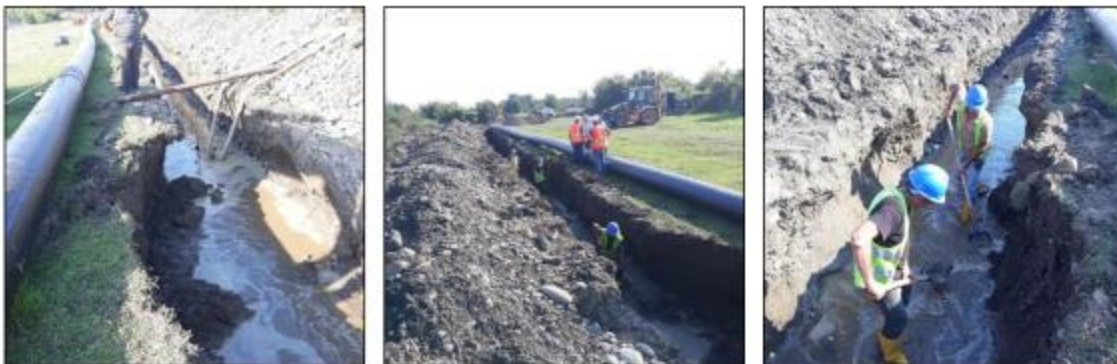
Photos of Abasha Network

- Trees of nearby construction zone should be protected to avoid its damage
- Refilling/compaction and reinstatement process should bring site at the same or better condition as it was before construction

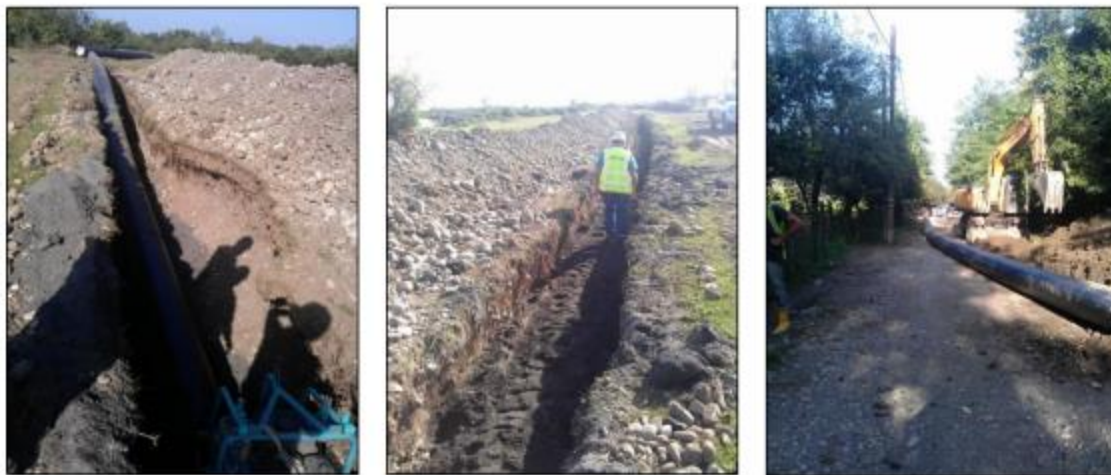
Photos of Abasha Network

- Workers always should use complete PPE
- Refilling/compaction and reinstatement process should bring site at the same or better condition as it was before construction
