SEMI-ANNUAL ENVIRONMENTAL MONITORING REPORT

Project Number: 43405-023

Reporting Period: January-June 2019

GEORGIA: URBAN SERVICES IMPROVEMENT INVESTMENT PROGRAM (TRANCHE 1) (FINANCED BY THE ASIAN DEVELOPMENT BANK)

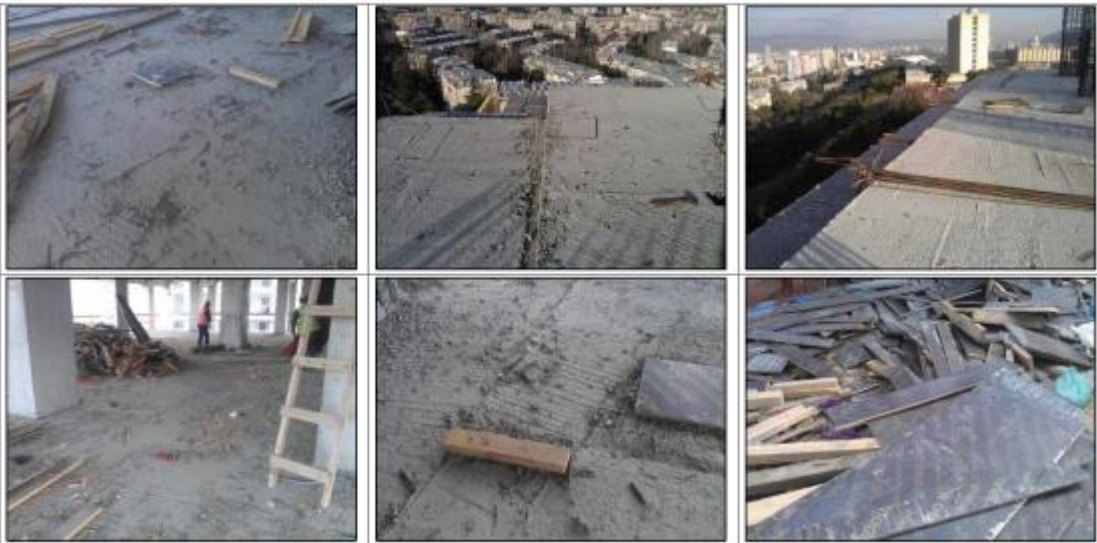
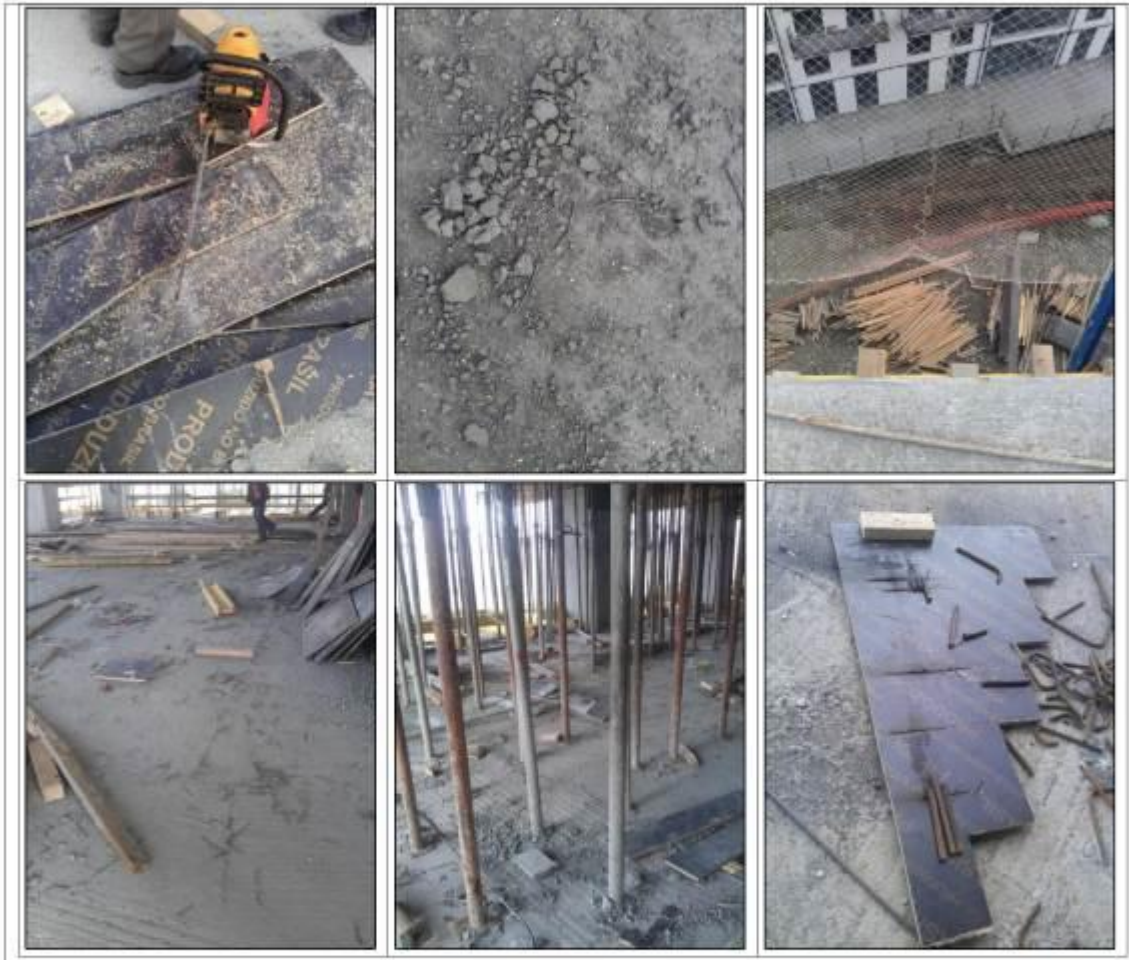
Construction of New Office Building for UWSCG

- High visible safety signs/tapes and barriers should be installed at the each floor of the building (complete perimeter of the floor) to avoid workers falling
- Safety norms during works at the height should be respected to avoid workers damage
- Ladder safety norms should be insured
- Safety rules during equipment (chainsaw) use should be respected
- All construction materials should be properly segregated and stored adequately
- Construction territory and wooden materials should be freed from big nails to avoid personnel damage. Huge number of waste nails should be collected immediately
- Construction waste should be removed timely
- Site internally should be arranged properly and cleaned regularly
- Everyday safety related briefing should be carried out with relevant signature from personnel

All these conditions have to be remedied within two days (by the 18 January 2019) by the prime Contractor (Dagi).

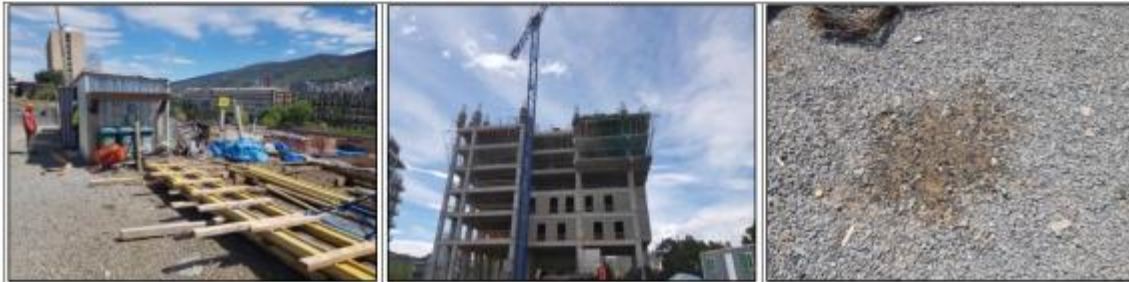
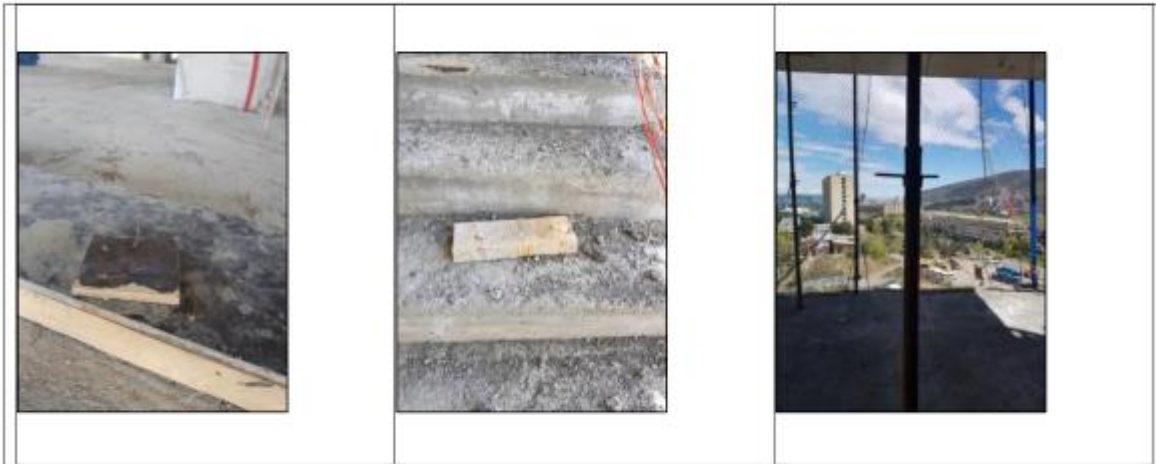
- Trees at the construction area and nearby should be fenced (freed from construction materials) and protected on proper way to avoid its damage
- Safety norms during works at the height should be respected to avoid workers damage

- Jacks fixator should be properly installed to avoid damage of workers. High risk of workers health damage
- Special equipment during working at heights should be used

- Safety rules during electric cable use should be respected
- Construction area and wooden materials should be freed from big nails to avoid personnel damage. Used nails should be collected regularly to avoid workers damage

- The access to the waste containers should be freed from construction materials
- Fuel/oil spill response items (sand, sawdust, special containers) should be available at the site and used as needed

- All workers should be equipped with complete PPE
- Site internally should be arranged properly and cleaned regularly

All these conditions have to be remedied within three days (by the 22 April 2019) by the prime Contractor (Dagi).

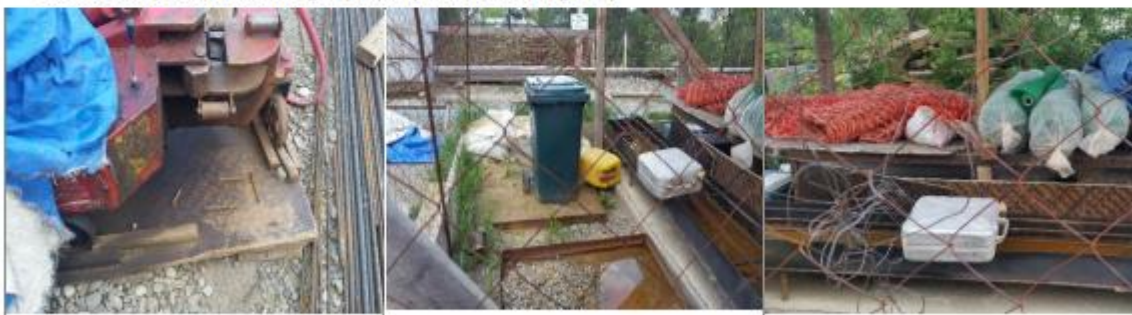
Construction of New Office Building for UWSCG

- Daily presence of HSE officer at the construction territory is necessary
- High visible safety signs/tapes, grids and barriers should be installed at the each floor of the building to avoid incidents of workers falling
- Safety rules during electric cable use should be respected
- Construction area and wooden materials should be freed from big nails to avoid personnel damage. Used nails should be collected regularly to avoid workers damage
- The access to the waste containers should be freed from construction materials
- Fuel/oil spill response items (sand, sawdust, special containers) should be available at the site and used as needed
- All workers should be equipped with complete PPE
- Site internally should be arranged properly and cleaned regularly

All these conditions have to be remedied within three days (by the end of April 2019) by the prime Contractor (Dagi).

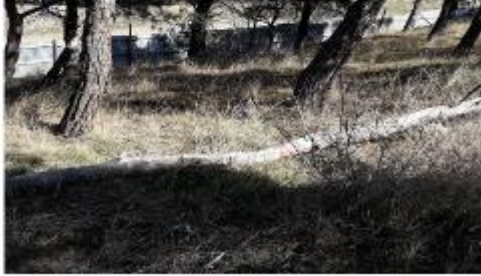
შესაბამისი ფოტომასალა/Photo materials:

შენიშვნა/Comment: ობიექტზე ძლიერი ქარების გამო ელდარის ფიჭვის ნარგავის ზოლში 5 ერთეული დანომრილი გამხმარი ხე წაიქცა.
