SEMI-ANNUAL ENVIRONMENTAL MONITORING REPORT

Project Number: 43405-023

Reporting Period: July-December 2019

GEORGIA: URBAN SERVICES IMPROVEMENT INVESTMENT PROGRAM (TRANCHE 1) (FINANCED BY THE ASIAN DEVELOPMENT BANK)

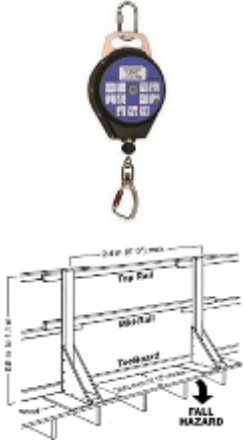
Near Miss Description of Near Miss (Include Details of Operations & activities)	D.M.Y.	Corrective/Preventive, Action Taken or Recommendation
<p>Danger open hole on the roof</p>

<p>Worker not used fall arrest system (safety belt). Not installed safety hard barricade, High risk of workers health damage</p>

09.10.19.	<p>Stop work. All person must use fall arrest or (safety belt) arrest who works at the Height (need to be fined, so as not to be repeated again) timely installed safety hard barricade.</p>

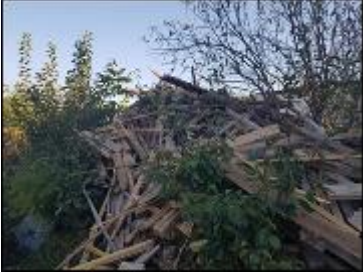
<p>On the wooden material there are nails, which can damage the all personals on the site. Construction rubbish, all site need housekeeping and removal waste.</p>

15.11.19.	<p>Must be cleaned all wood materials or sealed separately storage. Need housekeeping. All rubbish must be removed, housekeeping all site and timely discharge waste.</p>

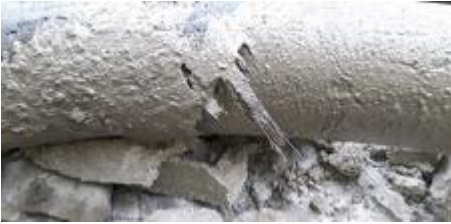
Near Miss Description of Near Miss (Include Details of Operations & activities)	D.M.Y.	Corrective/Preventive, Action Taken or Recommendation
<p>Concrete stationary pump, the hose not quality is a dangerous, when concrete casting, to be Damage to workers</p>

<p>15.11.19.</p>	<p>Concrete stationary pump hose must be replaced before work begins Techniques should be checked.</p>

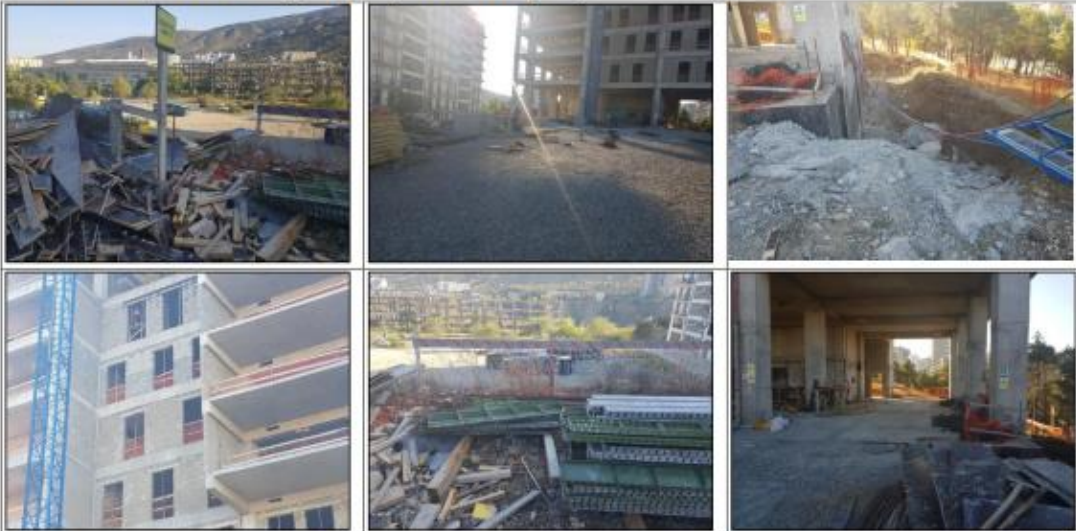
Construction of New Office Building for UWSCG

- Daily presence of HSE officer at the construction territory is necessary
- High visible safety signs/tapes, grids and barriers should be installed at the each floor of the building to avoid incidents of workers falling
- Trees at the construction area drying at visual observation. Needs proper investigation. In case trees are dried it should be replaced with new once
- Safety norms during works at the height should be respected to avoid workers damage
- Special equipment during working at heights should be used
- Safety rules during electrical equipment use should be respected
- Construction waste should be removed timely and proper disposed
- All workers should be equipped with complete PPE
- Site internally should be arranged properly and cleaned regularly

All these conditions have to be remedied within three days (by the 7 October 2019) by the prime Contractor (Dagi).
