Semi-annual Environmental Monitoring Report

Project Number: 43405-026

Reporting Period: January-June 2020

**GEORGIA: URBAN SERVICES IMPROVEMENT INVESTMENT PROGRAM
(TRANCHE 4)
(FINANCED BY THE ASIAN DEVELOPMENT BANK)**

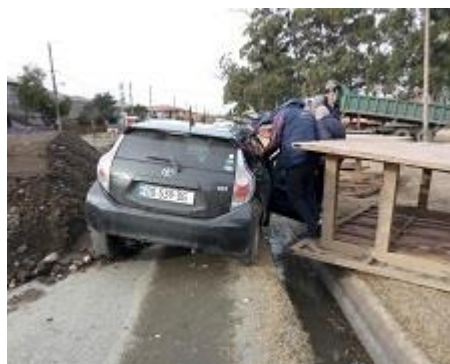
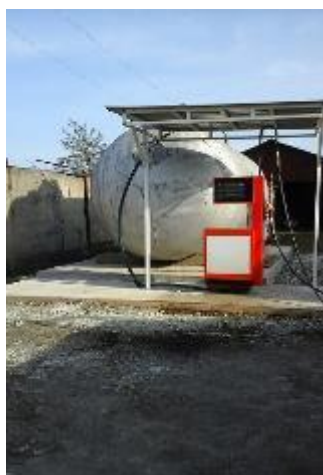
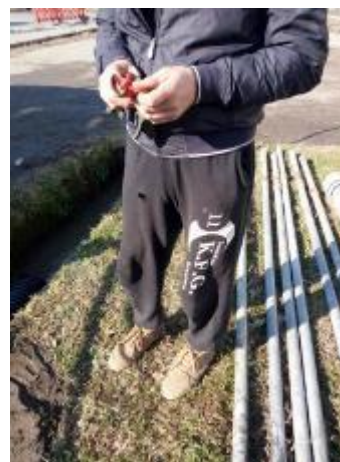
WWTP Poti 01

- Lack of warning signs and flagmen's negligence and associated traffic accident.
- Refueling safety violation. Special training should be provided to the relevant staff regarding refueling rules and the equipment used for vehicle/heavy equipment refueling to avoid spills and consequent ground contamination.
- Observe H&S relevant standards (Tripping & Slipping hazard prevention) ; Use relevant barriers and warning signs at the excavated pits and trenches
- Site staff without relevant PPE

All these conditions have to be remedied within 10 days by the prime Contractor **TAHAL GROUP**

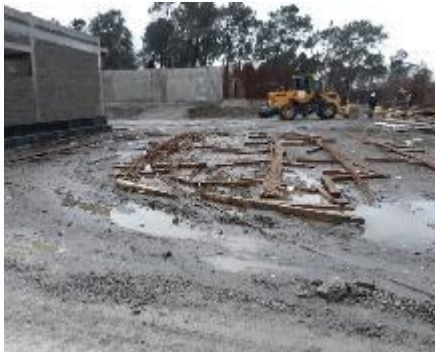
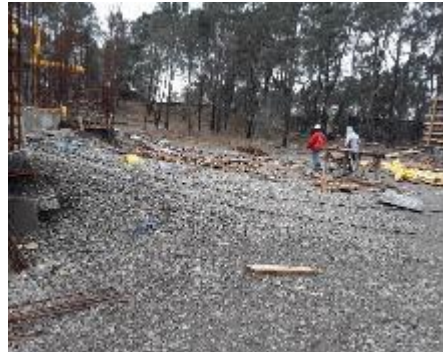
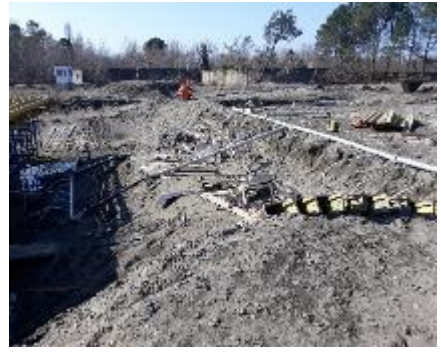
WWTP Poti 02

- Clean all kind of waste daily and store properly under shelters of in the buildings, don't mix waste and construction materials
- Special training should be provided to the staff regarding Housekeeping at the construction site and include this issue in daily Toolbox talks.
- Observe H&S relevant standards (Tripping & Slipping hazard prevention) ; Use relevant barriers and warning signs at the excavated pits and trenches

All these conditions have to be remedied within 10 days by the prime Contractor **Ludwig Pfeiffer**

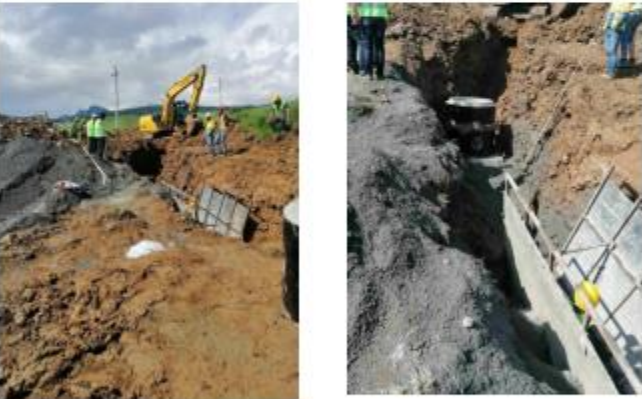
Project: Construction Supervision (under USIIP, Tranche 4 Projects), UWSCG/USIIP/QCBS/02-2014	Non-compliance Notice Gudauri
Contract No: UWSCG-ICB-GUD-02-2018	
Contractor: China Nuclear Industry 23 Construction Co., Ltd	
Reference:	
<p>This notice is to advise the prime Contractor, on the referenced Contract, of the following notice on health, safety and environmental measures to be implemented urgently.</p> <p>GENERAL COMMENT FOR ALL SITES: Site internally should be arranged properly and cleaned regularly. All construction materials and wastes should be properly segregated and stored adequately, Oil spill response kits should be placed at the appropriate locations. Refuelling station should be equipped with the spill kit and fire relevant fighting equipment; drip tray should be used for fuel spillage prevention. Relevant traffic signs and flagmen should control traffic movement properly. H&S standards and rules should be addressed and implemented.</p> <p>NON-COMPLIANCE IN Gudauri</p> <p>Construction of Sewage Collection and Water Supply Systems in Gudauri</p> <ul style="list-style-type: none"> - Topsoil should be stripped before construction activity and stored separately (not mixed with subsoil). - Shoring in the trenches should be installed properly and inspected before usage, whether they are reliable.

<p>All these conditions have to be remedied within 10 days by the Contractor China Nuclear Industry 23 Construction Co., Ltd</p>	
Date of site visit: 25.06.2020	
Shalva Bosikashvili - Environmental specialist - "SAFEGE"	
Ketevan Chomakhidze - Environmental specialist "UWSCG"

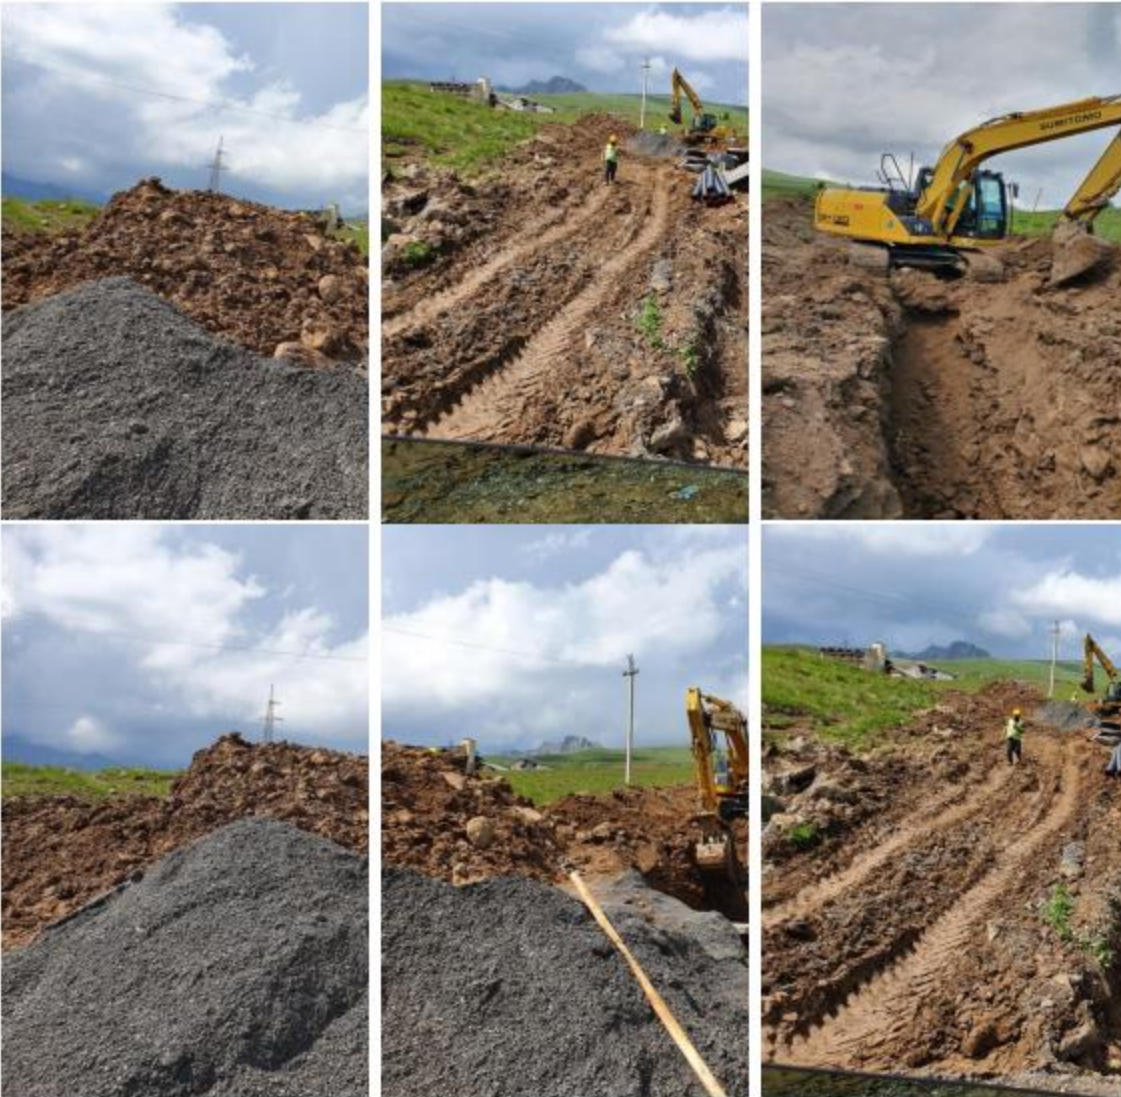
Photos of CoGudauri WWS Network

<p>Excavation works</p> <p>Flagman is also required to control the movement of the Excavator on site</p> <ul style="list-style-type: none"> - Choose the right size equipment/excavator for a digging trenches - Help driver during the excavation works move safely in their work areas, and help the drivers & operators avoid hazards and the potential of hitting people, other equipment and electrical cable - Walls of the deep trenches (>1.5m) should be strengthened by boards to avoid landfall of the soil and accidents (workers damage) - Safe distance from rotating equipment & excavation edges, giving Signals. - Provide H&S orientation training to all new workers to ensure that they are apprised of the basic site rules of work at the site, personal protective protection, and preventing injuring to

All these conditions have to be remedied immediately by contractor and Supervisor	
Date of site visits: 24.06.2020	
Maka Goderdzishvili, Head, Department of Environmental Protection and Permits, UWSCG Ana Onashvili, Head, Projects Management Department, UWSCG Kate Chomakhidze, Environmental Consultant UWSCG/USIIP

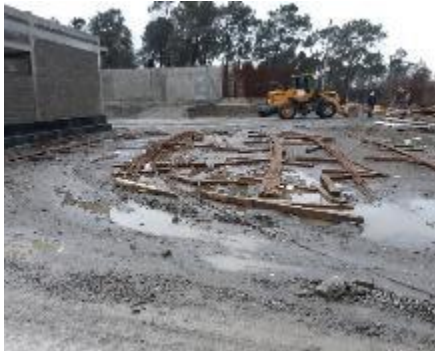
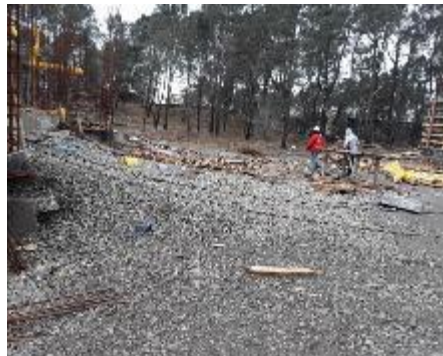
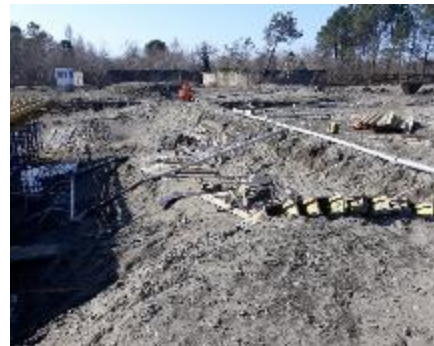
WWTP Poti 02

- Clean all kind of waste daily and store properly under shelters of in the buildings, don't mix waste and construction materials
- Special training should be provided to the staff regarding Housekeeping at the construction site and include this issue in daily Toolbox talks.
- Observe H&S relevant standards (Tripping & Slipping hazard prevention) ; Use relevant barriers and warning signs at the excavated pits and trenches

All these conditions have to be remedied within 10 days by the prime Contractor **Ludwig Pfeiffer**

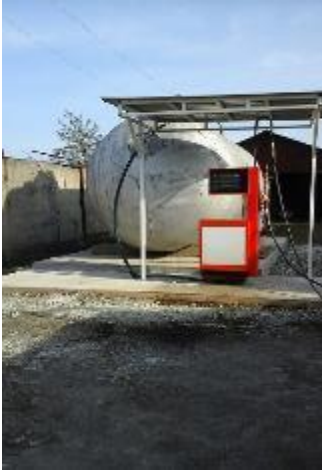
Refueling safety violation. Special training should be provided to the relevant staff regarding refueling rules and the equipment used for vehicle/heavy equipment refueling to avoid spills and consequent ground contamination.

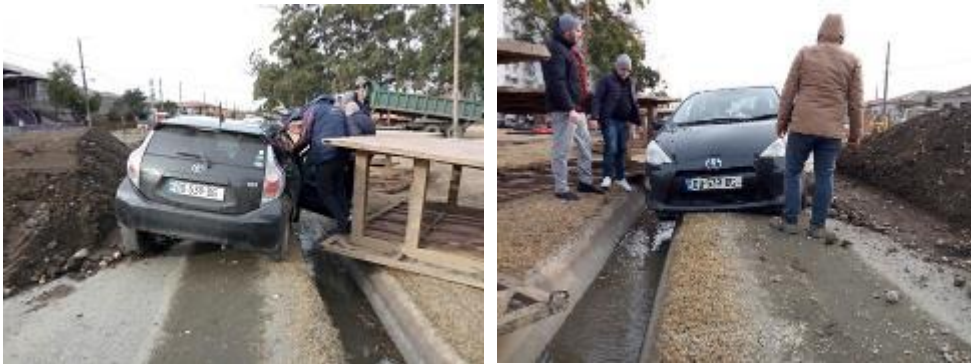
Lack of warning signs and flagmen's negligence and associated traffic accident.

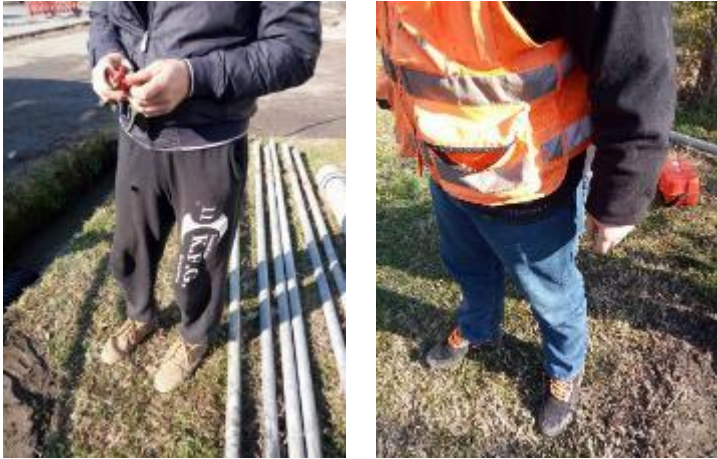
Worker without PPE at the construction site

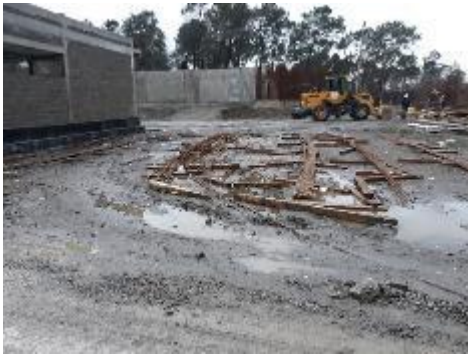
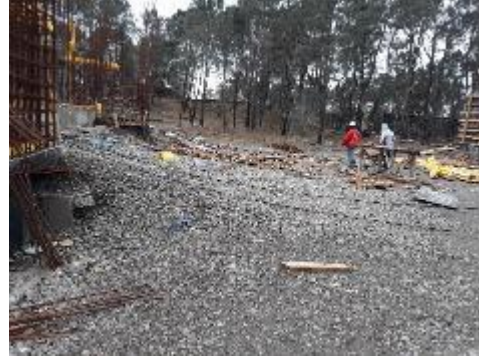
Unacceptable housekeeping. Special training should be provided to the staff regarding Housekeeping at the construction site and include this issue in daily Toolbox talks.
Also tripping/Slipping hazard.

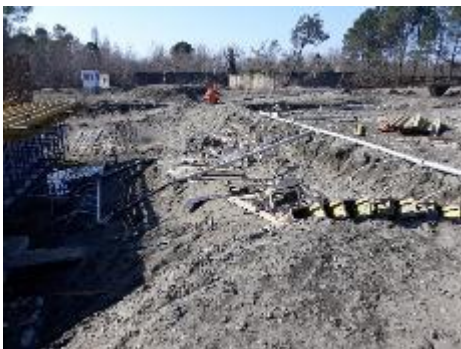
Observe H&S relevant standards (Tripping & Slipping hazard prevention) ; Use relevant barriers and warning signs at the excavated pits and trenches

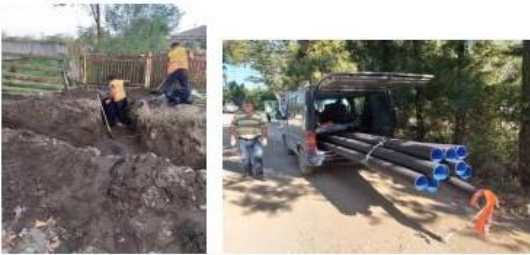
1. No shoring. Worker without PPE in the trench
2. Transportation with improper equipment.

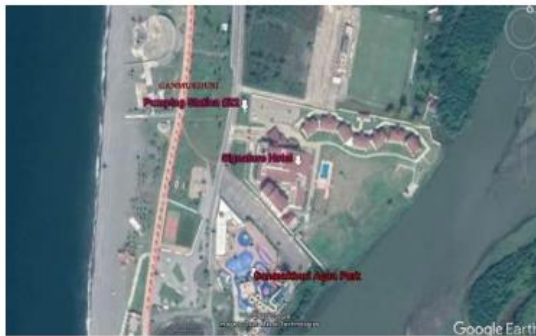
Map 2: Location of Pumping Station #22
GANMUKHURI PS #22 42°23'57.48"N 41°33'23.45"E

17. Coordinates and location of the main sewage system and two pumping stations under the ZUG-01 sub-project is presented on the Map 2, Map 3 and Map 4 below.

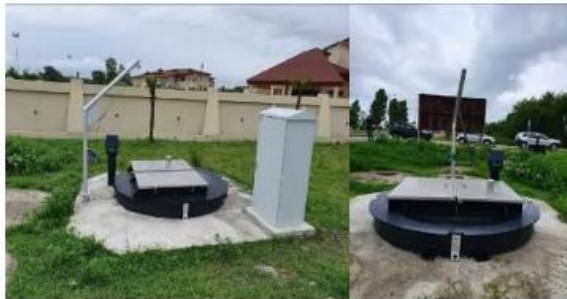
34. Restoration works on the territory adjacent to pumping stations have been performed to different degrees, predominantly to the satisfactory level (**Figures 1, 2**).

**Figures 1: Reinstatement activities,
Ganmukhuri – Installed # 22 Pumping Stations (PS # 22).**

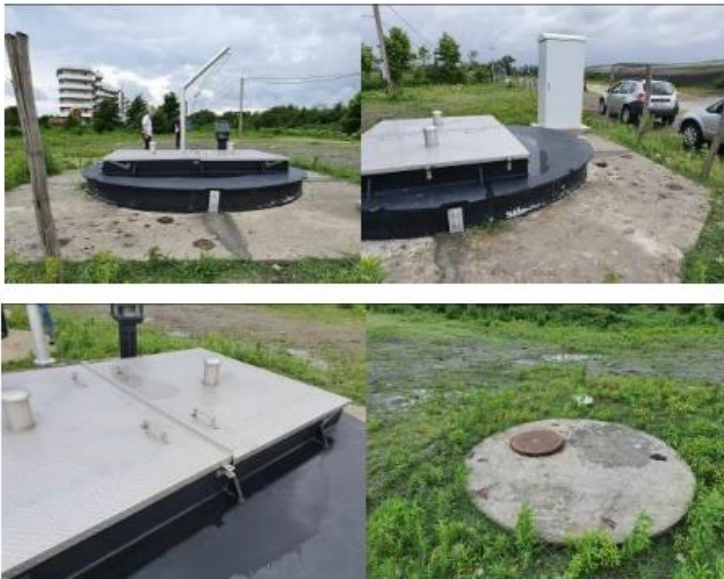
**Figures 2: Reinstatement activities,
Anaklia – Installed # 33 Pumping Stations (PS # 33);**

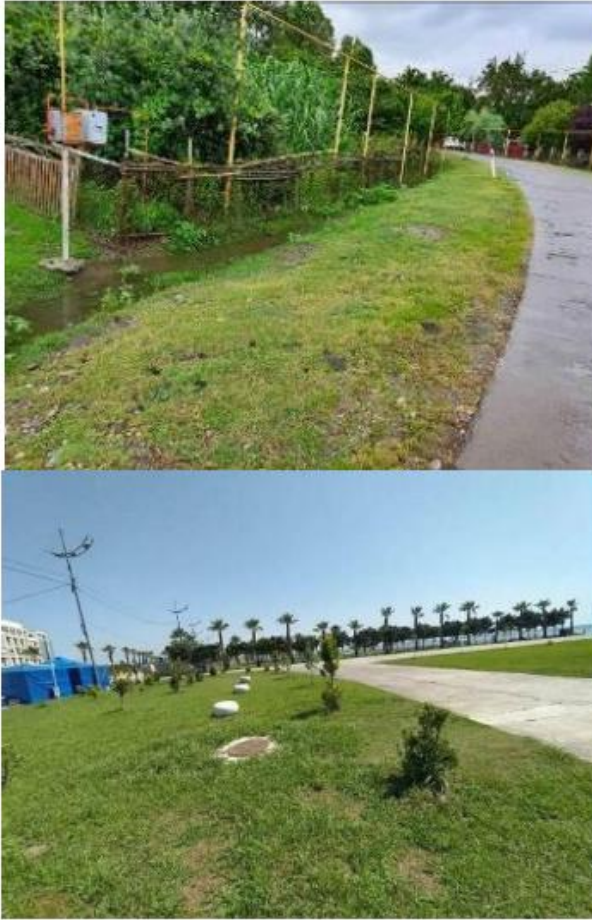
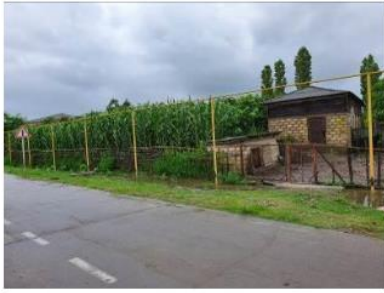
35. For the audit of the quality of restoration works performed by the contractor the site audit was conducted to the sewerage network in Anaklia and Ganmukhuri. The tracks of placement of pipes have been restored well. Satisfactory restoration works by the Contractor are facilitated by Anaklia climate conditions as well, specifically, damp climate promotes fast growth of grass (**Figures 3**).

Figure 3. Restoration Works for installation of pipes in urban area of Anaklia and Ganmukhuri

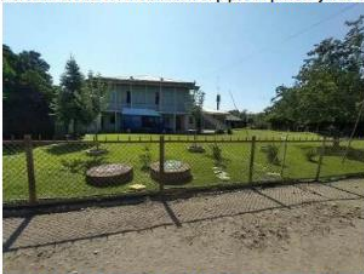
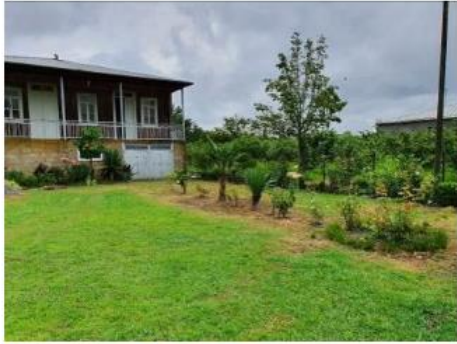
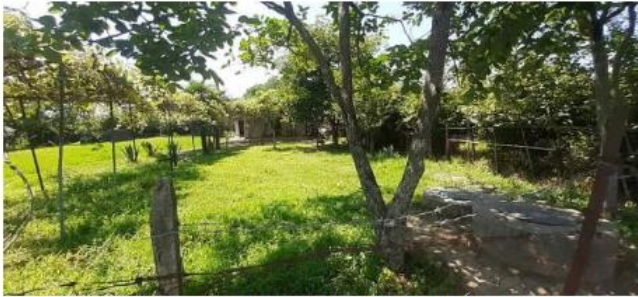
36. Furthermore, under the project the residents were connected to the sewerage system. During the audit the quality of the restoration works of the trenches dug for laying the pipes to up to 571 families were inspected. At all those sections the consultant visited, the quality of restoration works was satisfactory (Figures 4).

Figure 4. Restoration Works for installation of pipes in private yards of the families

Connection of residential houses in Ganmukhuri resort to main sewer line: $\varnothing=11407m$, $n=359$ houses; Rustaveli street.

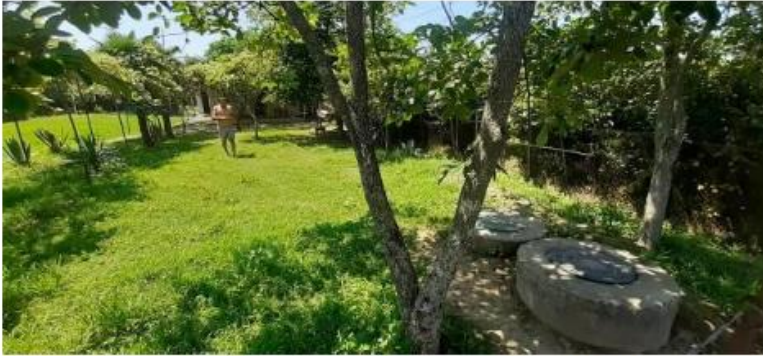
Connection of residential houses in Anaklia to main sewer line. Corrugated $d=150\text{mm}$ sewer pipe. Pirosmani street.

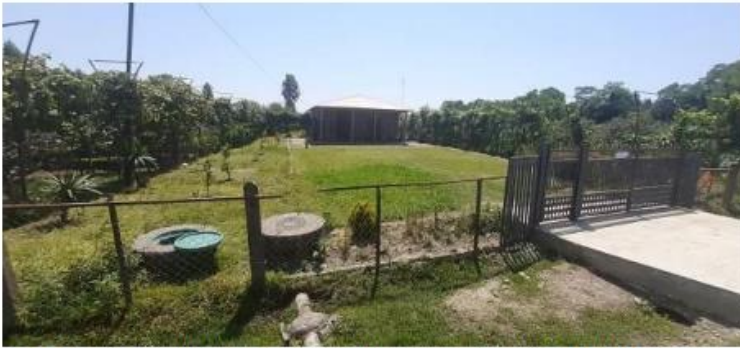
Connection of residential houses in Anaklia resort to main sewer line. Corrugated d=150mm

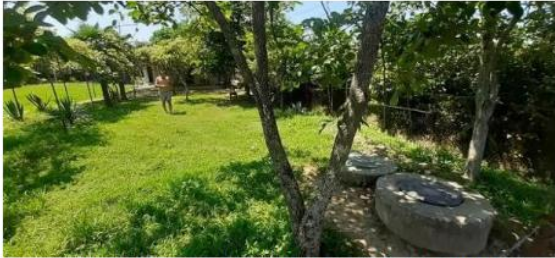
Connection of residential houses in Anaklia resort to main sewer line. Corrugated d=150mm sewer pipe. Rustaveli street.

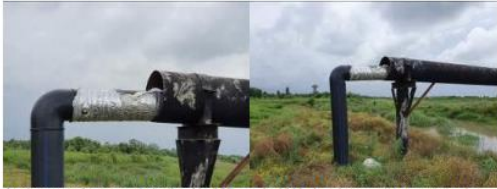
37. During the Audit of the pressured pipeline ($d= 355 \text{ mm}$, $l= 1813\text{m}$) and connection to existing $l=2400\text{m}$ same pipe, it was revealed that open part of penoplastic pipe should be totally closed by steel casing pipe.

Figure 5. Installation of pressured pipeline

Arraignment of pressured pipeline ($d= 355 \text{ mm}$, $l= 1813\text{m}$) and connection to existing $l= 2400\text{m}$ same pipe; Arraignment ramp connection on the main channel with a steel casing pipe ($d=630\text{mm}$ l 9mm , $l= 21\text{m}$)

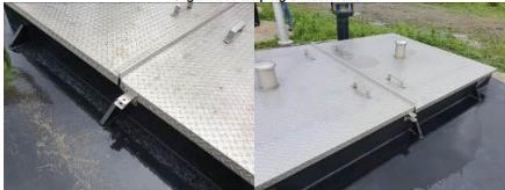
38. During the audit of pumping stations N22 and N33, it was revealed that iron cover of the pumping stations should be properly locked.

Figure 7. Pumping Station N33

39. Three iron covers of small size underground manholes adjacent to the pumping station N33 should be of a proper size.

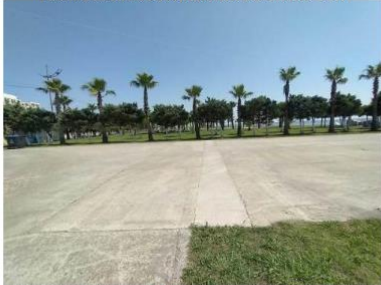
40. According to the design with the purpose of installation of sewerage pipes on many locations it was necessary to dig trenches on the motor road, mainly on Anaklia main street, respectively, it was necessary to damage the existing asphalt layer. During the audit the quality of damaged asphalt restoration works is satisfactory near the Anaklia Hotel and this layer fully covered damaged sections of asphalt (Figures 8).

Figures 9: Restored asphalt layer near the "Anaklia" Hotel

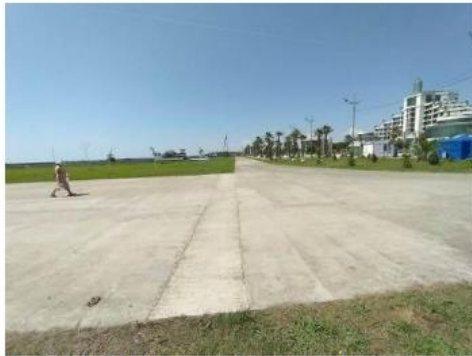
The existing water supply – d=250mm rehabilitation and replacement was carried out using d= 200 mm, l= 940m of the new pipeline, the old one was not removed and remains as a backup pipeline. Anaklia – seaside.

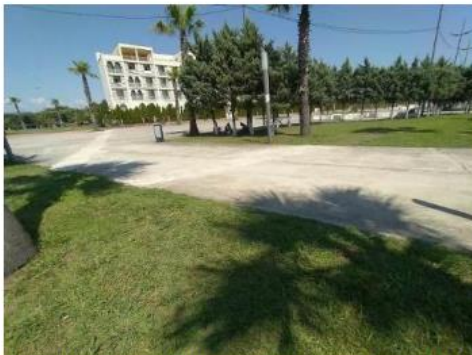
The existing water supply – d=250mm rehabilitation and replacement was carried out using d= 200 mm, l= 940m of the new pipeline, the old one was not removed and remains as a backup pipeline. Anaklia – seaside.

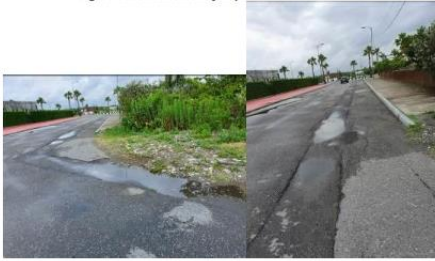
41. The degree of restoration of damaged asphalt layer on sections between the "Anaklia" and "Golden Fleece" hotels, due to lack of space and incompatibility with other underground utilities 110 meter length 0.8 meter width tranche was cut directly on the road shoulder; therefore, asphalt restoration work was carried out at this location, but the quality of restoration works of this section of the road is unsatisfactory (Figures 9).

Figure 10. Unsatisfactory asphalt restoration works

42. **Recommendation:** In case the laying of new asphalt on the mentioned section is not planned under another project contractor has to restore the mentioned section within one month from the receipt of audit report; the draft audit report will be shared with the Local Government and officials.
