SEMI-ANNUAL ENVIRONMENTAL MONITORING REPORT

GEORGIA: URBAN SERVICES IMPROVEMENT INVESTMENT PROGRAM (TRANCHE 2) (FINANCED BY THE ASIAN DEVELOPMENT BANK)

ANNEX A: POST CONSTRUCTION ENVIRONMENTAL AUDIT REPORT, URE-01

Project: Construction of Water Supply and Wastewater Network in Ureki (URE-01)

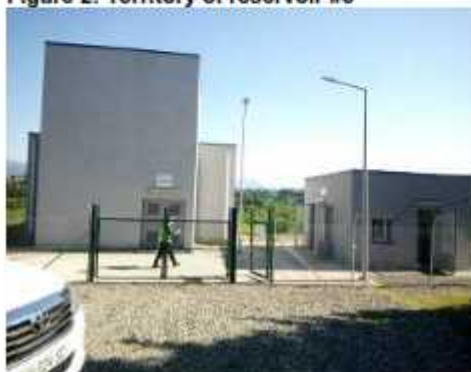
Figure 2: Territory of reservoir #3

18. All the above-mentioned sites were fenced and it was impossible for strangers as well as domestic animals to enter the site (see **Figure 2 - 5**).

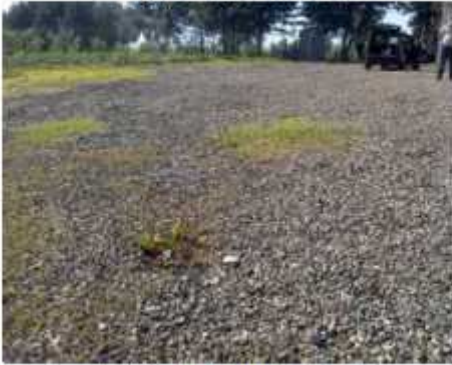
Figure 6: Reservoir #3

19. The construction waste was disposed from all facilities except some minor exceptions (see non-compliance 1) and the area was cleaned (Figures 6 - 9).

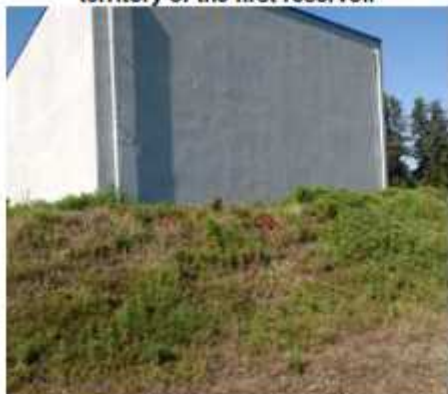
20. The restoration works are completed all over the area and the topsoil was taken back to the project area. It should be noted that no artificial plantings were done in the area. So, it is clear that the self-restoration process took place in the project area (see **Figures 10 and 11**).

Figure 10: Self-restored grass – the territory of the first reservoir

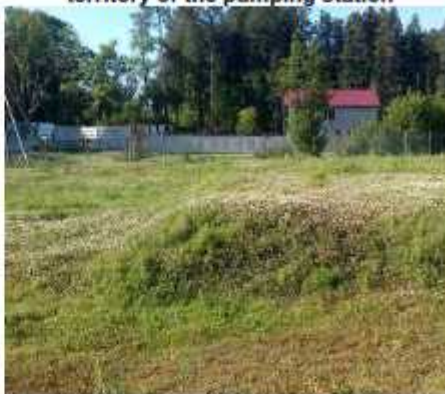
Figure 11: Self-restored grass – the territory of the pumping station

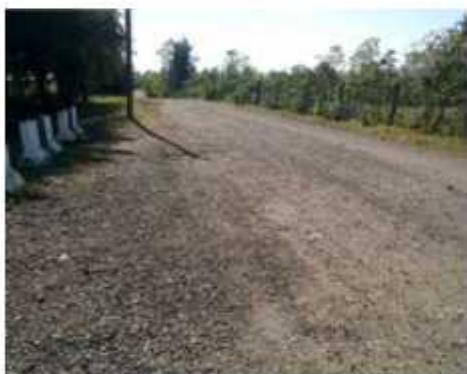
21. The access roads to the project area were restored and paved. Their physical state corresponds to the IEE requirements (**Figures 12 and 13**).

Figure 12: Access road to the first reservoir

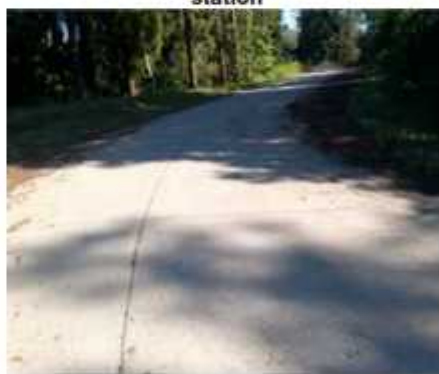
Figure 13: Access road to the pumping station

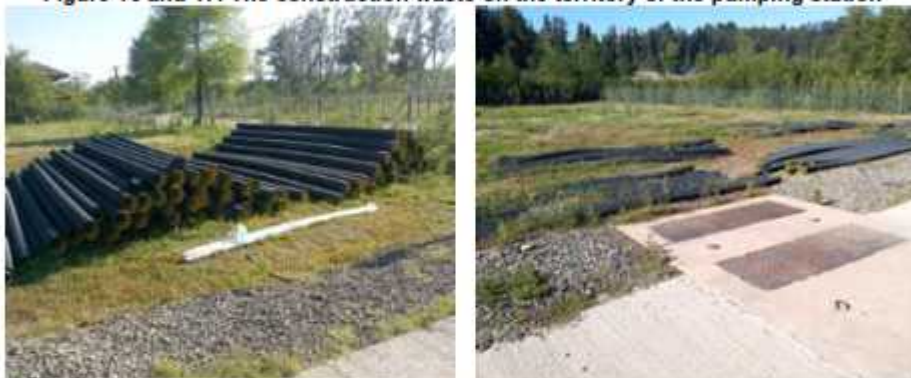
22. As mentioned above, no significant non-compliances were observed during the environmental audit and all corrective actions that need to be taken do not require additional funding and time.
23. **Non-compliance #1:** There was chaotically disposed construction and household waste observed on the territory of the pumping station (see **Figures 14 and 15**).

Figure 16 and 17: The construction waste on the territory of the pumping station

- 24. **Requirement:** Following the completion of the project, the waste must be handed over to a duly licensed company.
- 25. **Corrective action:** The waste must be collected and disposed from the project area. The waste must be handed over only to duly licensed contractors for further management.
- 26. **Non-compliance #2:** The area of the construction materials on the territory of the pumping station was not fenced and was not protected from the impact of the atmospheric precipitation (**Figures 16 and 17**).

#	Non-compliance	Corrective action	Terms of accomplishment	Note
1.	There was chaotically disposed construction and household waste observed on the territory of the pumping station	The waste must be collected and disposed from the project area. The waste must be handed over only to duly licensed contractors for further management.	1 month	
2	The area of the construction materials on the territory of the pumping station was not fenced and was not protected from the impact of the atmospheric precipitation	The territory of the construction materials area must be duly fenced. The construction materials must be disposed in the project area more compactly and must be protected from the atmospheric precipitation by using an appropriate protective cover.	1 month

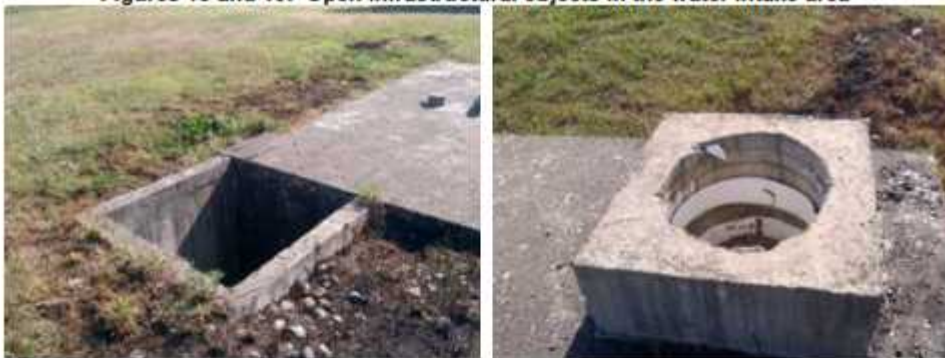
- 27. **Requirement:** The area with the construction waste must be fenced and have relevant information signs.
- 28. **Corrective action:** The territory of the construction materials area must be duly fenced. The construction materials must be disposed in the project area more compactly and must be protected from the atmospheric precipitation by using an appropriate protective cover.
- 29. A number of violations of the rules of safety were observed in the water intake area.
- 30. **Non-compliance #3:** The underground infrastructure and the well in the project area were not duly covered (**Figures 18 and 19**).

Figures 18 and 19: Open infrastructural objects in the water intake area

31. **Requirement:** All underground infrastructural facilities must be closed after the project is complete to prevent service personnel or animals from falling into them.
32. **Corrective action:** In the first stage, the area must be fenced or warning signs must be installed. And finally, it will be necessary to provide a capital cover or a hatch over such underground facilities.
33. **Non-compliance #4:** A power cable was fixed near the power transmission pole located in the water intake area, which was cut off for unknown reasons and lying on the ground in an uncontrolled manner (see **Figures 20 and 21**).

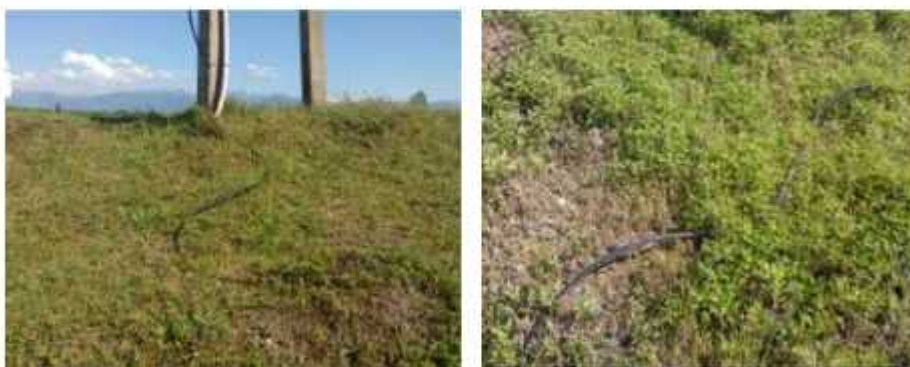
Figures 20 and 21: The wire cable on the earth surface

34. **Requirement:** A power transmission line is not admitted to be on the ground in an uncontrolled manner.
35. **Corrective action:** First of all, the given area must be marked. Then, owner of the given cable must be identified and addressed immediately to carry out relevant repair works. If the given wire is used to supply power to the wells, it is necessary to install them in compliance with the requirements of the relevant instructions.

4.	A power cable was fixed near the power transmission pole located in the water intake area, which was cut off for unknown reasons and lying on the ground in an uncontrolled manner	First of all, the given area must be marked. Then, owner of the given cable must be identified and addressed immediately to carry out relevant repair works. If the given wire is used to supply power to the wells, it is necessary to install them in compliance with the requirements of the relevant instructions.	2 weeks	The area must be fenced or the warning signs must be installed in the shortest possible time, in maximum 2 or 3 days
