Semi-annual Environmental Monitoring Report

Project Number: 43405-026

Reporting Period: January-June 2021

**GEORGIA: URBAN SERVICES IMPROVEMENT INVESTMENT PROGRAM
(TRANCHE 4)
(FINANCED BY THE ASIAN DEVELOPMENT BANK)**

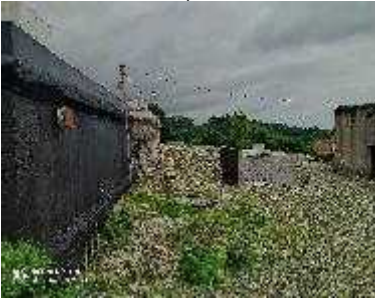
Date of Visit	Name of Company	Auditors Name	Purpose of audit	Summary of any Significant Findings	Cross Reference to Audit Report	Status of implementation
				<p>of construction activates</p> <p>Photo No2 (Construction of water reservoir)</p>

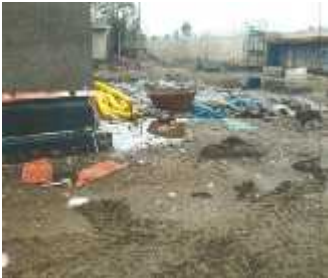
<p>Construction area should be cleaned regularly, please see photo below Photo No2 (Construction of WWTP in Poti)</p>

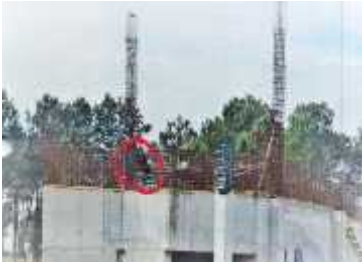
17.03.2021		EH&S Specialist of Contractor Mr. Nikoloz Neparidze	Day to day monitoring of sites.	<p>All safety norms must be protected at the construction area (Workers should be equipped with full PPE). Please see photo below.</p> <p>Photo No1 (Construction of WWTP in Poti)</p>

<p>Construction area should be cleaned regularly</p>	Non- Compliance Notice Issued by contractor to sub-contractor (Please see Annex C)	Completed (20.03.2021)

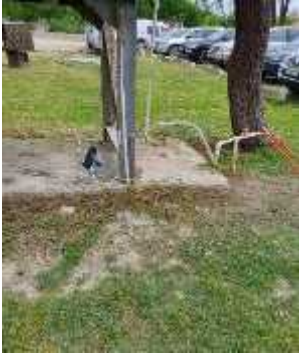
Date of Visit	Name of Company	Auditors Name	Purpose of audit	Summary of any Significant Findings	Cross Reference to Audit Report	Status of implementation
				<p>power socket should be immediately improved</p> <p>Photo #6 (Construction of WWTP in Poti)</p>

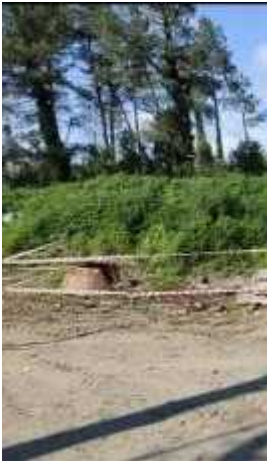
<p>Top soil of about 15 cm depth shall be removed and stored separately in appropriate location and not damaged by improper storage of construction materials</p>		<p>Completed (04.06.2021), please see photo below</p> <p>Photo #5</p>

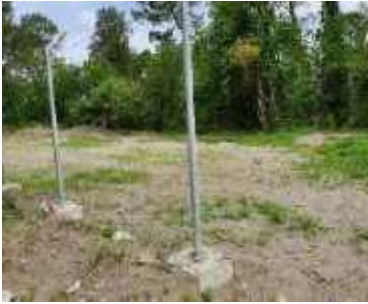
Date of Visit	Name of Company	Auditors Name	Purpose of audit	Summary of any Significant Findings	Cross Reference to Audit Report	Status of implementation
				<p>The whole construction area should be fenced adequately</p> <p>Photo #7 (Fencing of WWTP in Poti)</p>

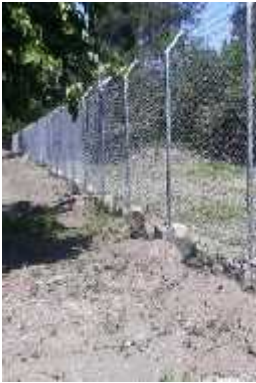
<p>Completed (04.06.2021), please see photo below</p> <p>Photo #6</p>

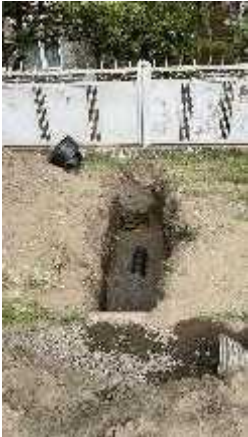
Date of Visit	Name of Company	Auditors Name	Purpose of audit	Summary of any Significant Findings	Cross Reference to Audit Report	Status of implementation
				<p>Photo No2 (Construction of Waste Water network in Poti)</p>

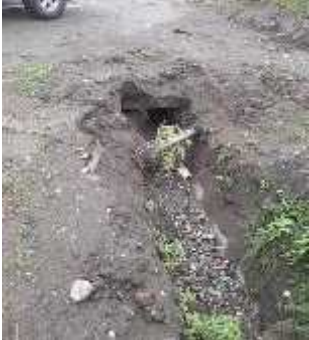
<p>Drainage channel contaminated with inert material and solid waste</p> <p>Photo No3 (Construction of Waste Water network in Poti)</p>		<p>Completed (28.05.2021)</p>

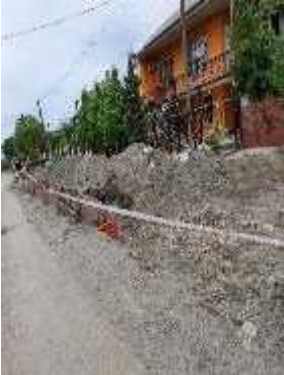
<p>Trench construction shall be taken up in small segments, so that work (excavation, pipe laying and refilling) in each segment is completed in a day.</p> <p>No trenches shall be kept open in the night/after work hours</p> <p>Photo No4</p>

<p>Completed (30.05.2021)</p> <p>Completed (29.05.2021)</p>

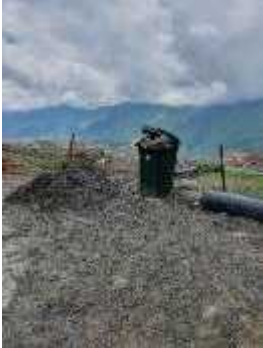
Date of Visit	Name of Company	Auditors Name	Purpose of audit	Summary of any Significant Findings	Cross Reference to Audit Report	Status of implementation
				<p>municipal and hazardous waste with concrete base, roofing and drainage system</p> <p>Hazardous Waste container with relevant indication sign should be installed at the construction area (at the proper organized place with concrete floor and roofing)</p> <p>Construction waste should be removed timely and proper disposed</p> <p>Photo No4 (Construction of Water Reservoir in Gudauri)</p>

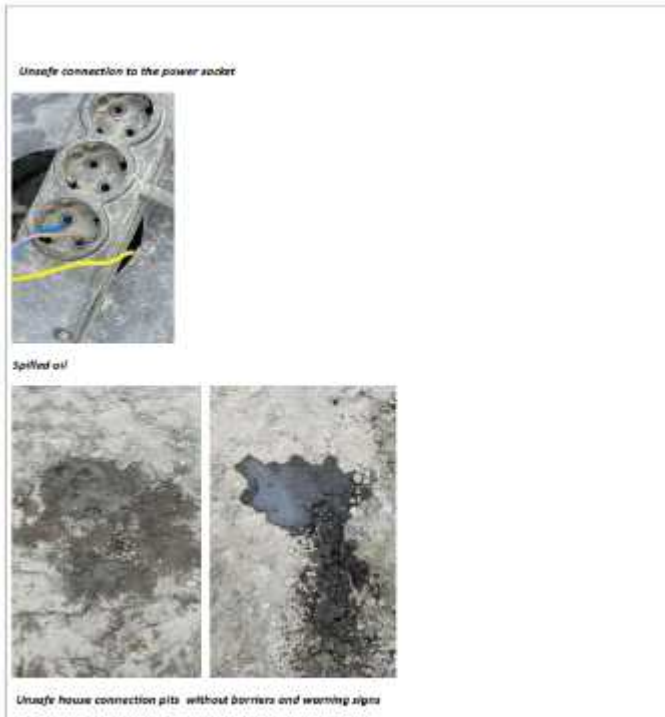
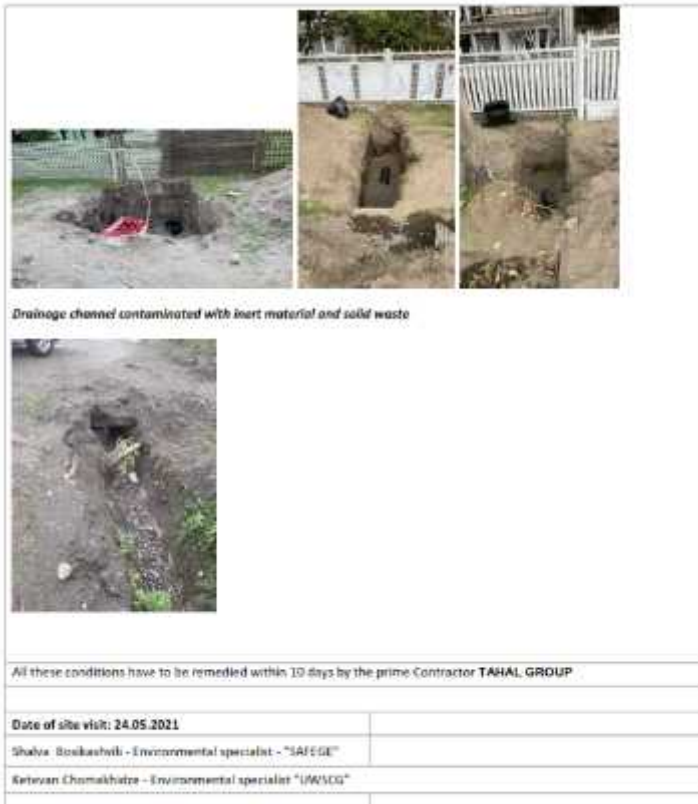
Project: Construction Supervision (under USIP, Tranche 2 Project) UWSC/USIP/Oct/Nov 2018 Contract No: P43409-ICB-POT-01 Contractor: TAMAL GROUP	Non-compliance Notice Pot 01
Reference: This notice is to advise the prime Contractor, on the referenced Contract, of the following notice on health, safety and environmental measures to be implemented urgently .	
GENERAL COMMENT FOR ALL SITES: Site internally should be arranged properly and cleaned regularly. All construction materials and wastes should be properly aggregated and stored adequately. Oil spill response kit should be placed at the appropriate locations. Refueling station should be equipped with the spill kit and fire relevant fighting equipment; drip tray should be used for fuel spillage prevention. Relevant traffic signs and flagmen should control traffic movement properly. PPE wearing is obligatory at the construction site.	
NON-COMPLIANCE IN POT 01: WWTP Pot 01 <ul style="list-style-type: none"> • Tree damage • Electrical safety violation • Spilled oil • Unsafe house connection pits without barriers and warning signs • Drainage channel contaminated with inert material and solid waste

Backhoe has damaged the tree.

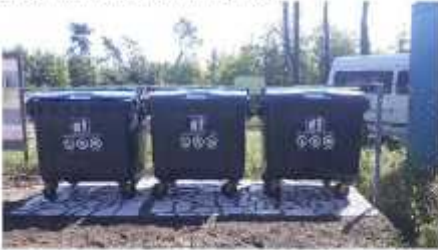
Corrective actions for Photo #5-6

Concrete base for household waste is prepared.
