SEMI-ANNUAL ENVIRONMENTAL MONITORING REPORT

(Reporting Period: July-December 2021)

**GEORGIA: URBAN SERVICES IMPROVEMENT INVESTMENT PROGRAM
(TRANCHE 1)
(FINANCED BY THE ASIAN DEVELOPMENT BANK)**

**Project: Construction of Mestia Water Treatment
Plant and Reservoirs**

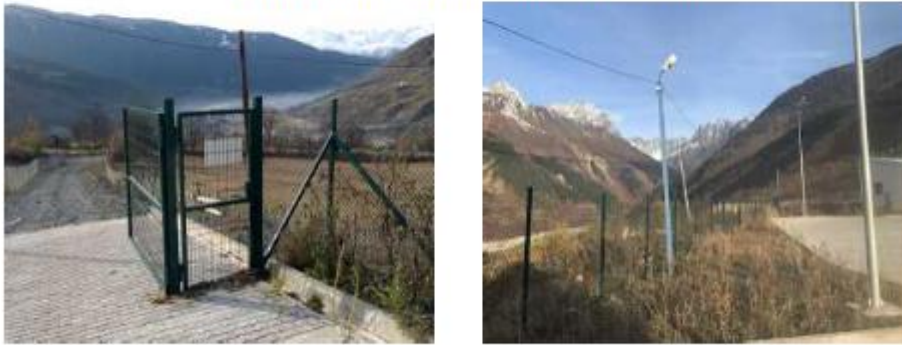
Figures 1 and 2: All project areas are fenced

22. All the above-mentioned sites were fenced and it was impossible for strangers as well as domestic animals to enter the site (see **Figure 1 and 2**).

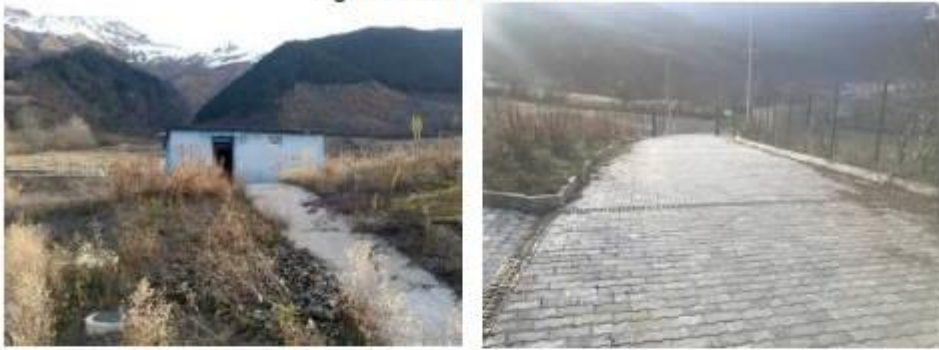
Figures 3 and 4: Local roads

23. The territories were restored in a timely manner; the removed topsoil was used for the rehabilitation works. The local roads of all objects are improved (see **Figures 3 and 4**)

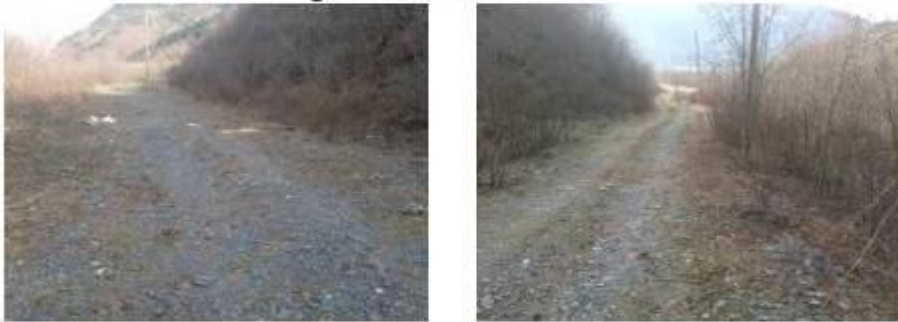
Figures 5 and 6: Access roads

24. No grass was planted on the territory. The vegetation cover was self-restored (**Figures 3 and 4**). The ground access roads to the facility are also restored (**Figures 5 and 6**).

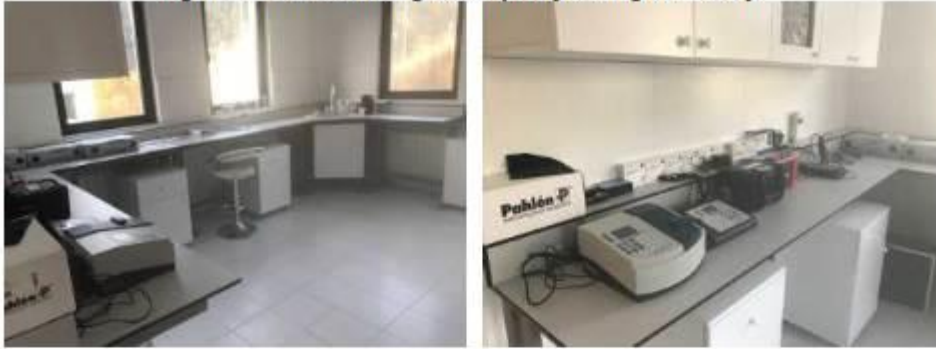
Figures 7 and 8: Drinking water quality testing laboratory

25. Both, the hazardous and household waste was totally disposed from the project zone. Besides, the construction techniques and construction materials were removed as well, and lighting poles were installed all over the area.
26. The water quality testing laboratory was fully equipped (see **Figures 7 and 8**).

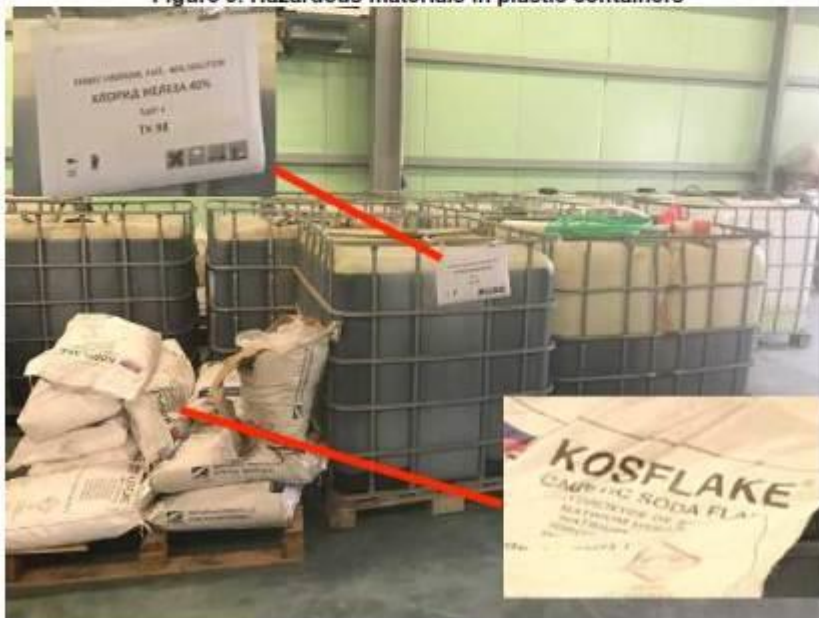
27. **Non-compliance #1:** Large quantities of hazardous materials (see **Figure 9**), namely Ferric chloride FeCl_2 40% solution, were in the plastic containers in the closed space of the given territory. There are also approximately 10 pieces of 50-kg paper bags of caustic soda near the plastic containers.

Figure 9. Hazardous materials in plastic containers

45. As the contractors is no longer available at construction site and the facility has already been turned-over to the UWSCG the following corrective actions have been implemented by the UWSCG/facility operator by the 30 November 2021: the plastic containers with hazardous materials were placed on secondary containment with its volume of 25% of the containers with hazardous materials in them; 50-kg bags with caustic soda were removed to a separate building.

28. **Requirement:** (i) The hazardous liquid material containers must be placed on secondary containment with its volume of 110% of the main container. If the hazardous materials are placed in several containers, the volume of the secondary container must be 25% of the total volume of all containers with hazardous liquid materials in them. (ii) It is forbidden to place the materials near one another that can react with each other.

29. **Corrective action:** The plastic containers with hazardous materials must be placed on secondary containment with its volume of 25% of the containers with hazardous materials in them. Besides, the 50-kg bags with caustic soda must be removed to a separate building.

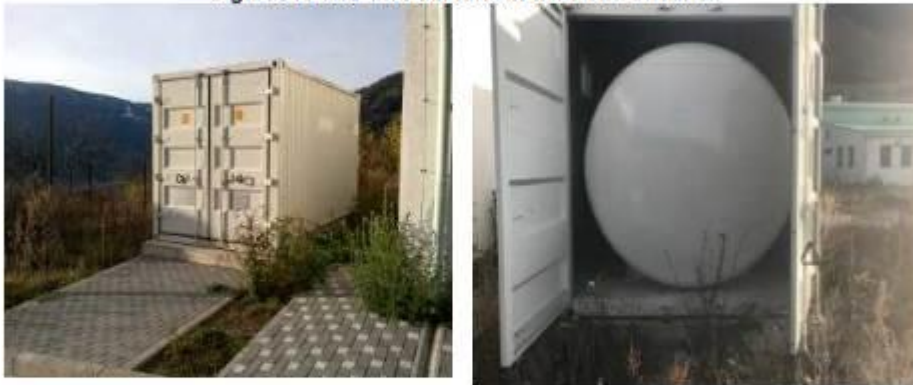
30. **Non-compliance #2:** The tank with hazardous materials in the area is not placed on a secondary containment (**Figures 10 and 11**). Despite the fact that the given tank is placed in an iron container, there is a risk of soil pollution in case of spills.

Figures10 and 11: Fuel tank in the iron container

31. **Requirement:** The hazardous liquid material containers must be placed on secondary containment with its volume of 110% of the main container.
32. **Corrective action:** The fuel tank must be placed on a secondary containment with its volume of 110% of the main container.

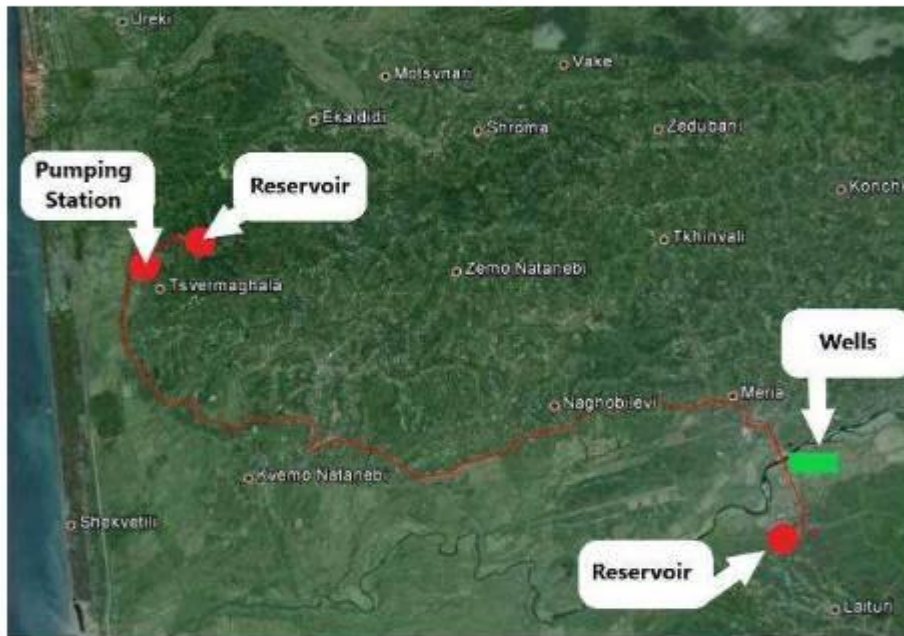
Figure 1: Location Map of the Project

km water supply pipelines (distribution network will be divided into 3 areas); laying of approximately 70 km sewage pipelines; installation of approximately 1,500 water meters; wells - drilling of 10 drinking water wells (Figure 1).

17. The audit team visited the following facilities: (i) the water intake area; (ii) Reservoir #1; (iii) Reservoir #3; and (iv) pumping station. For the locations of the mentioned facilities, see **Figure 1** above. Besides, the access roads to the mentioned facilities are restored/built.

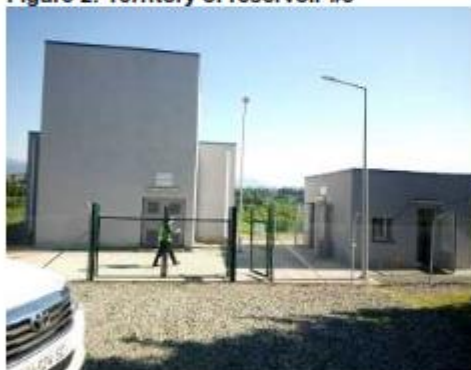
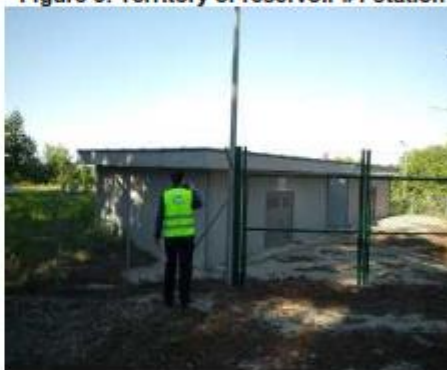
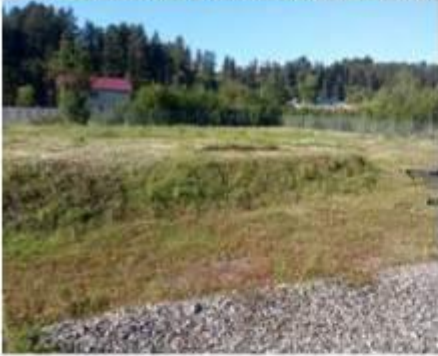
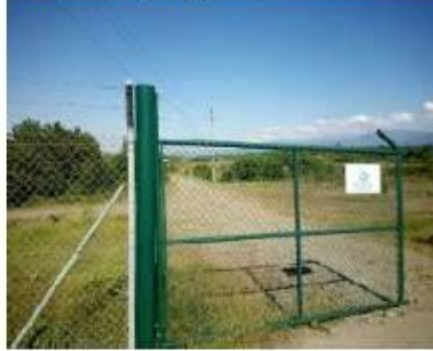
18. All the above-mentioned sites were fenced and it was impossible for strangers as well as domestic animals to enter the site (see **Figure 2 - 5**).

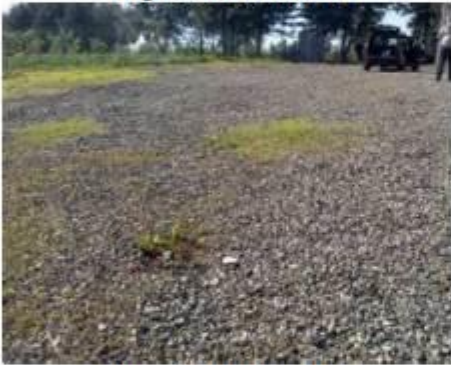
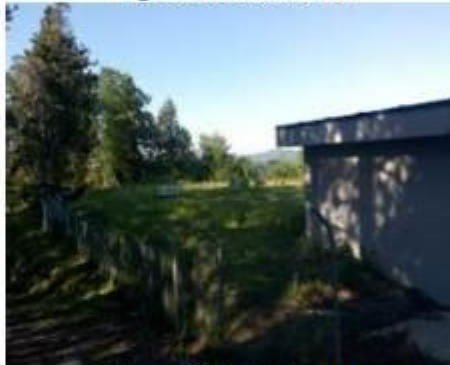
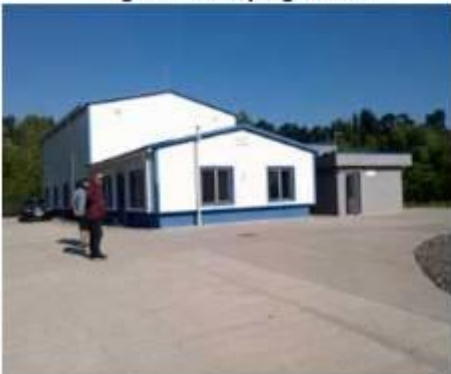
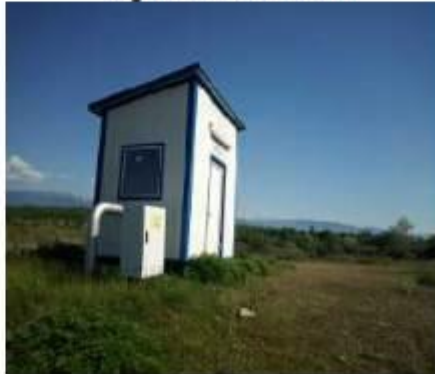
19. The construction waste was disposed from all facilities except some minor exceptions (see non-compliance 1) and the area was cleaned (Figures 6 - 9).

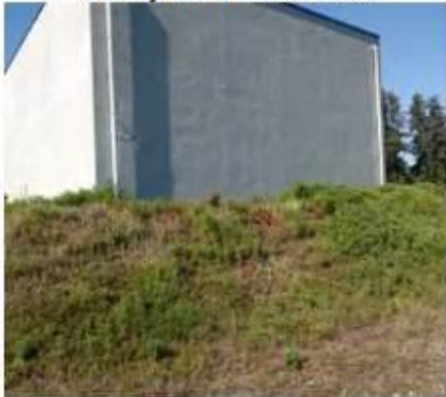
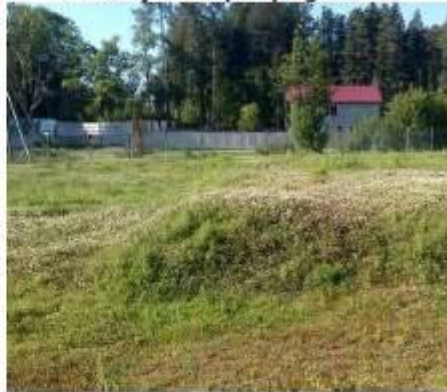
20. The restoration works are completed all over the area and the topsoil was taken back to the project area. It should be noted that no artificial plantings were done in the area. So, it is clear that the self-restoration process took place in the project area (see **Figures 10 and 11**).

Figure 10: Self-restored grass – the territory of the first reservoir

Figure 11: Self-restored grass – the territory of the pumping station

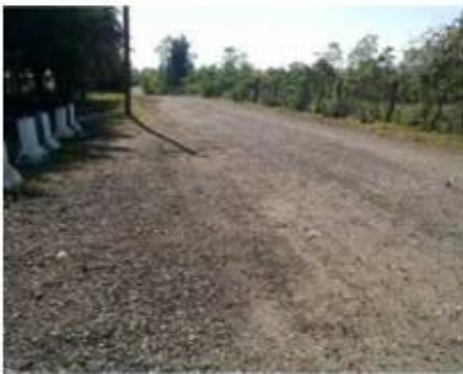
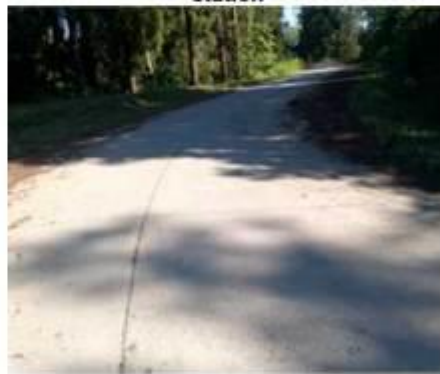
21. The access roads to the project area were restored and paved. Their physical state corresponds to the IEE requirements (**Figures 12 and 13**).

Figure 12: Access road to the first reservoir

Figure 13: Access road to the pumping station

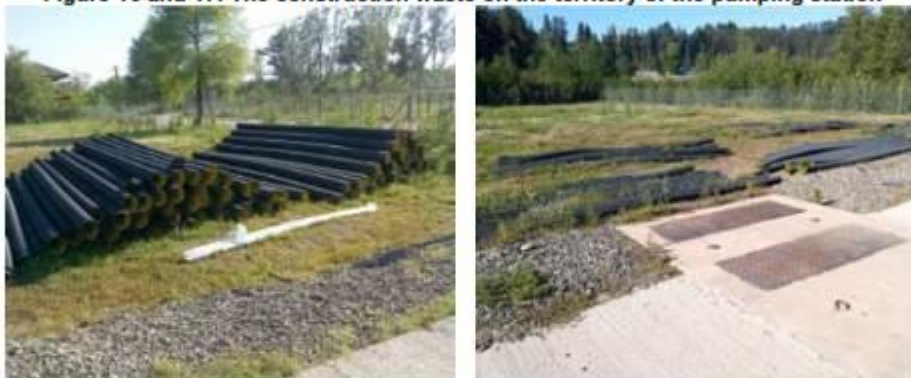
24. **Requirement:** Following the completion of the project, the waste must be handed over to a duly licensed company.
25. **Corrective action:** The waste must be collected and disposed from the project area. The waste must be handed over only to duly licensed contractors for further management.
26. **Non-compliance #2:** The area of the construction materials on the territory of the pumping station was not fenced and was not protected from the impact of the atmospheric precipitation (**Figures 16 and 17**).

Figure 16 and 17: The construction waste on the territory of the pumping station

27. **Requirement:** The area with the construction waste must be fenced and have relevant information signs.
28. **Corrective action:** The territory of the construction materials area must be duly fenced. The construction materials must be disposed in the project area more compactly and must be protected from the atmospheric precipitation by using an appropriate protective cover.
29. A number of violations of the rules of safety were observed in the water intake area.
30. **Non-compliance #3:** The underground infrastructure and the well in the project area were not duly covered (**Figures 18 and 19**).

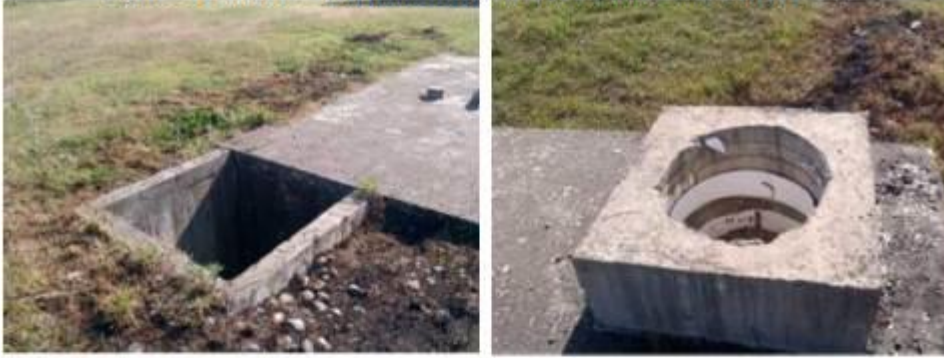
Figures 18 and 19: Open infrastructural objects in the water intake area

31. **Requirement:** All underground infrastructural facilities must be closed after the project is complete to prevent service personnel or animals from falling into them.
32. **Corrective action:** In the first stage, the area must be fenced or warning signs must be installed. And finally, it will be necessary to provide a capital cover or a hatch over such underground facilities.
33. **Non-compliance #4:** A power cable was fixed near the power transmission pole located in the water intake area, which was cut off for unknown reasons and lying on the ground in an uncontrolled manner (see **Figures 20 and 21**).

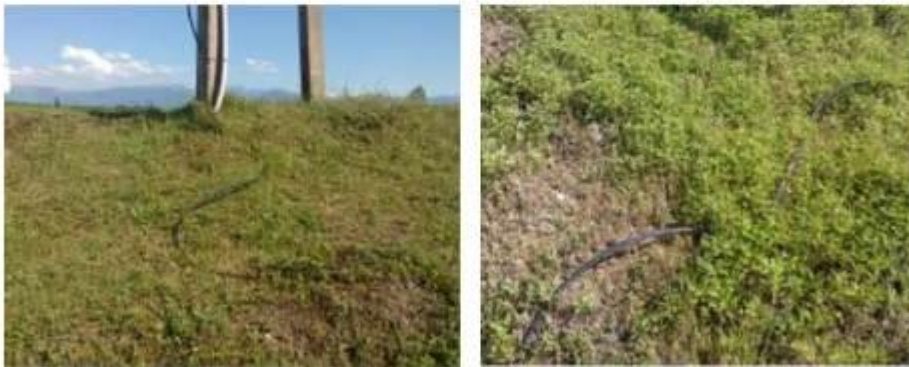
Figures 20 and 21: The wire cable on the earth surface

34. **Requirement:** A power transmission line is not admitted to be on the ground in an uncontrolled manner.
35. **Corrective action:** First of all, the given area must be marked. Then, owner of the given cable must be identified and addressed immediately to carry out relevant repair works. If the given wire is used to supply power to the wells, it is necessary to install them in compliance with the requirements of the relevant instructions.
