Semi-Annual Environmental Monitoring Report

#12 Semiannual Report

(Reporting Period: July-December 2021)

**GEORGIA: URBAN SERVICES IMPROVEMENT INVESTMENT PROGRAM
(TRANCHE 3)**

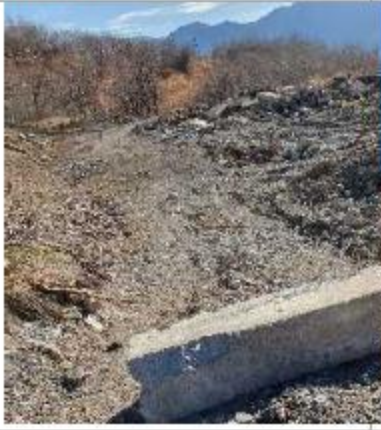
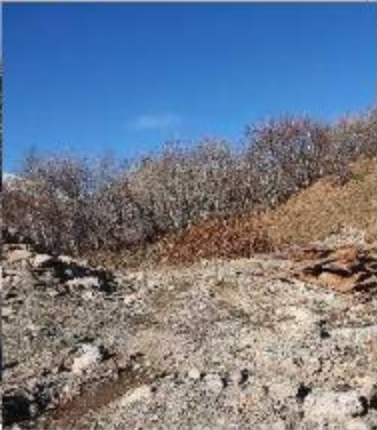
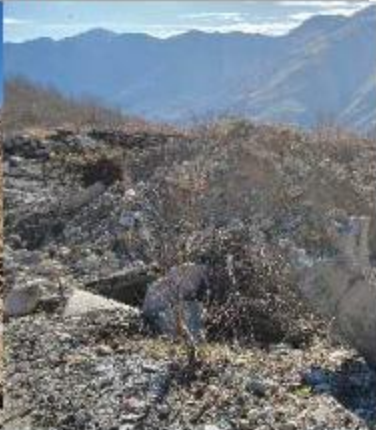
| Photo #1 | Photo #2 | Photo #3 |

| <p>#1)</p> <ul style="list-style-type: none"> • Proper warning and safety signs should be provided at the entrance gate and perimeter of the construction territory • Demolition waste in the amount agreed initially should be removed from site and disposed according agreement with the local Municipality (Photo #2, Photo #3) | | |

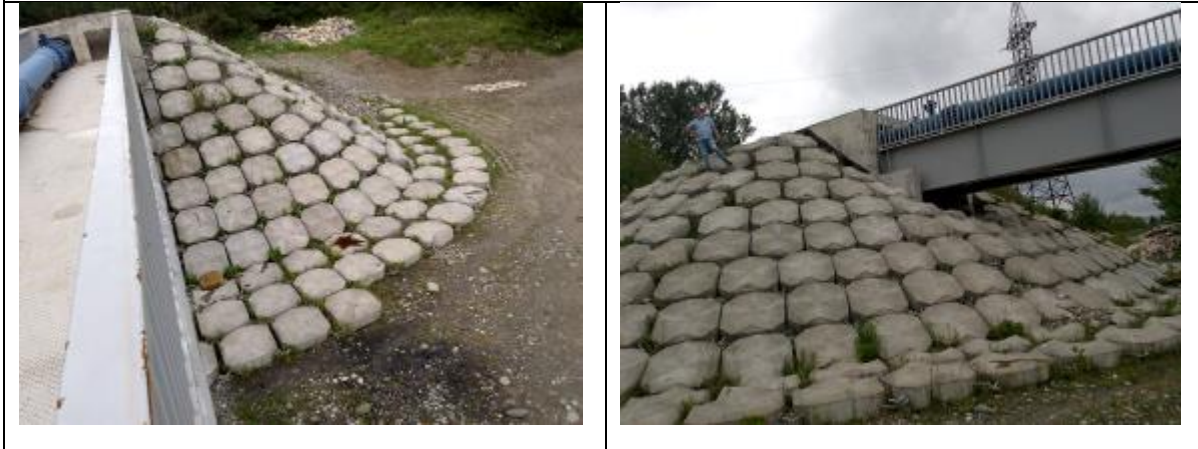
Figure 6 and 7: The restored slopes in the area where the Rioni River is intersected with the water supply pipeline

19. The quality of the rehabilitation works was satisfactory in the area where the Rioni River is intersected with the water supply pipeline (Figures 6 and 7).

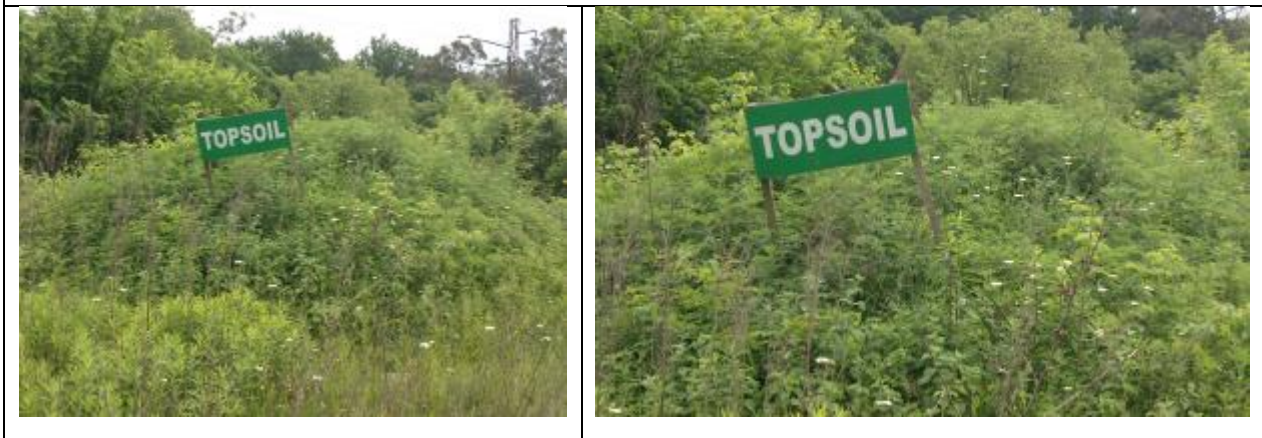
Figures 8 and 9: Topsoil left uncontrolled in the area of temporary disposal (Mukhrani Pumping Station)

21. **Observation:** Particular attention must be paid to the non-compliance observed near Mukhrani pumping station related to the improper management of the topsail (Figure 8 and 9).

22. **Requirement:** according to the IEE document developed within the scope of the project (IEE, paragraph 54):“(i) The top soil of about 1 ft depth (0.3 m) shall be removed and stored separately during excavation work, and after the construction of the main trunk the same soil shall be replaced on the top, in unpaved areas; (ii) Subject to advance consent of local self-governance authorities, the excess topsoil remained after construction of the New East Reservoir, two new

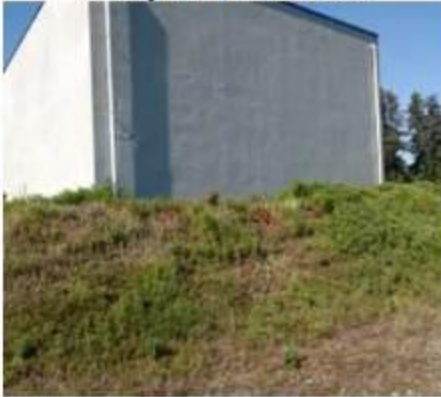
Figure 10: Self-restored grass – the territory of the first reservoir

20. The restoration works are completed all over the area and the topsoil was taken back to the project area. It should be noted that no artificial plantings were done in the area. So, it is clear that the self-restoration process took place in the project area (see **Figures 10 and 11**).

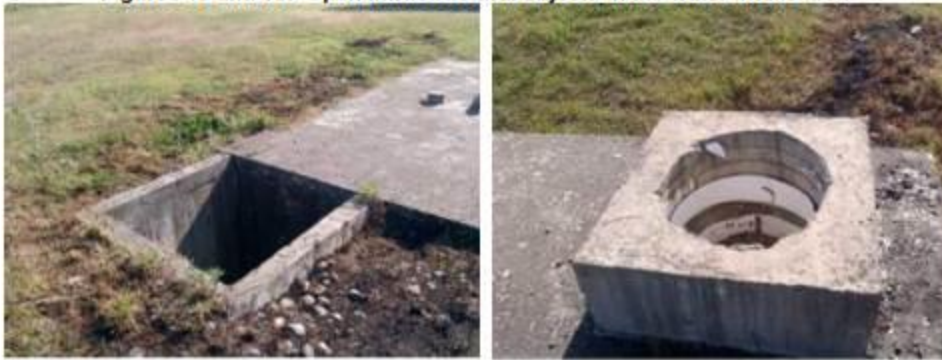
Figures 18 and 19: Open infrastructural objects in the water intake area

27. **Requirement:** The area with the construction waste must be fenced and have relevant information signs.
28. **Corrective action:** The territory of the construction materials area must be duly fenced. The construction materials must be disposed in the project area more compactly and must be protected from the atmospheric precipitation by using an appropriate protective cover.
29. A number of violations of the rules of safety were observed in the water intake area.
30. **Non-compliance #3:** The underground infrastructure and the well in the project area were not duly covered (**Figures 18 and 19**).

31. **Requirement:** All underground infrastructural facilities must be closed after the project is complete to prevent service personnel or animals from falling into them.
32. **Corrective action:** In the first stage, the area must be fenced or warning signs must be installed. And finally, it will be necessary to provide a capital cover or a hatch over such underground facilities.
33. **Non-compliance #4:** A power cable was fixed near the power transmission pole located in the water intake area, which was cut off for unknown reasons and lying on the ground in an uncontrolled manner (see **Figures 20 and 21**).
