ENVIRONMENTAL MONITORING REPORT

#9 Semiannual Report

(Reporting Period: July-December 2021)

**GEORGIA: URBAN SERVICES IMPROVEMENT INVESTMENT PROGRAM
(TRANCHE 6)**

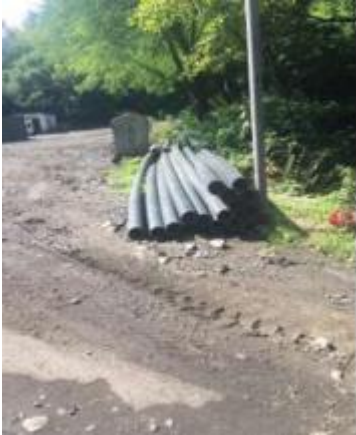
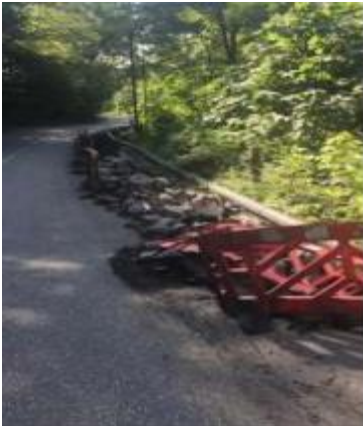
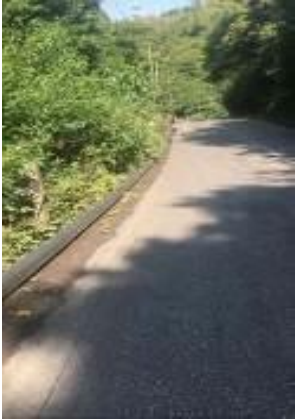
| Date of Visit | Name of Company Name of Contract | Auditors Name | Purpose of audit | Summary of any Significant Findings | Implemented Actions | ¹ Implementation Status |
|---|---|---|---|--|--|--|
| 8 August 2021 | | Environmental Specialist of SC Mr. Rezo E nukidze | Regular monitoring of sites | Abandoned, unfinished construction activities were observed during the site visit. Roads are not reinstated; materials are left in the street. The Contractor shall | Verbal instruction was given to contractor to immediately improve the situation. Non-Compliance Notice was issued and | Completed in August 2021 |

| Date of Visit | Name of Company Name of Contract | Auditors Name | Purpose of audit | Summary of any Significant Findings | Implemented Actions | Implementation Status |
|---|---|---|---|--|---|---|
| | | | | <p>complete activities, which are abandoned and might cause complaints from locals.</p> <p>photo No1</p> <p>Photo No2</p> | <p>is presented in Annex C to this report.</p> <p>Corrective Action Plan was developed and improved photos of sites was sent by contractor (please see Annex E),</p> <p>Please see improved Photo N1 of site</p> | |

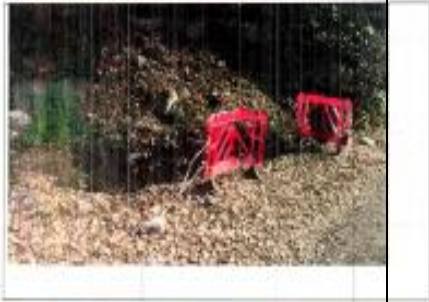
| Date of Visit | Name of Company Name of Contract | Auditors Name | Purpose of audit | Summary of any Significant Findings | Implemented Actions | Implementation Status |
|---|---|--|---|--|---|---|
| 16 November 2021 | | Environmental Specialist of SC Mr. Rezo Ehlukidze | Regular monitoring of sites | <p>Occupational safety issues must be taken into consideration, during the visit it observe that some excavations at narrow streets are barricaded only with safety tapes light barricades, please see Photo N1 below</p> <p>Photo N1</p> <p>Proper signage at the narrow streets should be arranged to provide proper barricades</p> | <p>Verbal instruction was given to contractor to immediately improve the situation.</p> <p>Non-Compliance Notice was issued and is presented in Annex C of this report.</p> | <p>Completed, December 2021</p> <p>Completed, December 2021</p> |

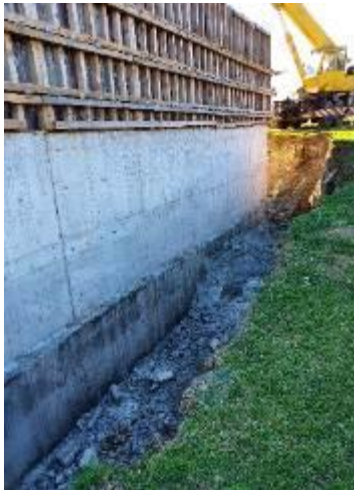
| Date of Visit | Name of Company Name of Contract | Auditors Name | Purpose of audit | Summary of any Significant Findings | Implemented Actions | Implementation Status |
|---|---|--|---|--|---|---|
| 17 November 2021 | | <p>Environmental Specialist of SC Mr. Rezo Ehlukidze</p> <p>USIIP Environmental Specialist Ms.Kate Chomakhidze</p> <p>Site visit was attended by the Head of the Department of Environmental Protection and Permits Ms.Maka Goderdzishvili</p> | Regular monitoring of sites | <p>Provide warning signs or safety tapes around open trenches (Please see Photo N1)</p> <p>Photo N1</p> <p>The top soil of about 1 ft depth (0.3 m) shall be removed and stored separately during excavation work, and after the construction of the main trunk the same soil shall be replaced on the top, in unpaved areas</p> | <p>Verbal instruction was given to contractor to immediately improve the situation.</p> <p>Explanatory Note was issued and is presented in Annex D of this report.</p> <p>(Photo-documentations are presented in Annex D, 17 November 2021)</p> | <p>Completed, December 2021</p> <p>Corrective Action Plan was developed and improved photos of sites was sent by contractor, please see Photo N1</p> <p>Partially Completed, December 2021</p> |

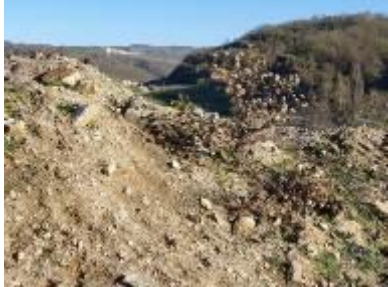
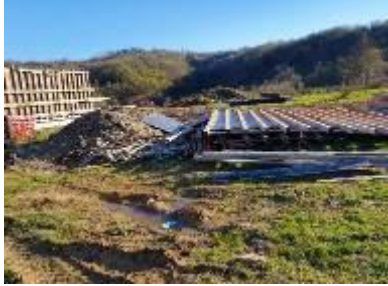
| Date of Visit | Name of Company Name of Contract | Auditors Name | Purpose of audit | Summary of any Significant Findings | Implemented Actions | Implementation Status |
|---|---|---|---|--|---|---|
| | | | | <p data-bbox="1099 277 1227 304">Photo N2</p> <p data-bbox="1099 635 1485 1007">All construction material should be properly segregated and stored adequately in proper waste (Hazardous Household) containers with roof & should be installed at the storage area, waste should be placed only at the proper waste container, please see Photo N1</p> <p data-bbox="1099 1043 1227 1070">Photo N1</p> | | <p data-bbox="1827 852 2098 916">Completed in December 2021</p> |

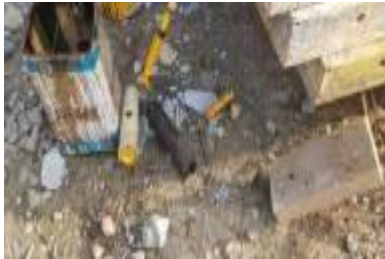
| Date of Visit | Name of Company Name of Contract | Auditors Name | Purpose of audit | Summary of any Significant Findings | Implemented Actions | 'Implementation Status |
|---|---|---|---|---|---|--|
| | | | | <p>Waste containers used by Contractor must be regularly emptied.</p> <p>Remaining from Concrete washing pit is excavated, but it there is no information that it was disposed according to WMP; Seems lots of concrete works are ahead proper concrete washing pit must be organized</p> <p>Storage area for hazardous waste handling is prepared, but it is not managed properly, please see Photo No1</p> <p>Photo N1:</p> <p>Not properly segregated waste is observed in the</p> | | <p>December 2021, please see improved photo of site, Photo N1</p> <p>Also, Annex E, Corrective Action Plan</p> <p>Completed in December 2021</p> <p>Completed in November 2021</p> <p>Completed in December 2021, please see</p> |

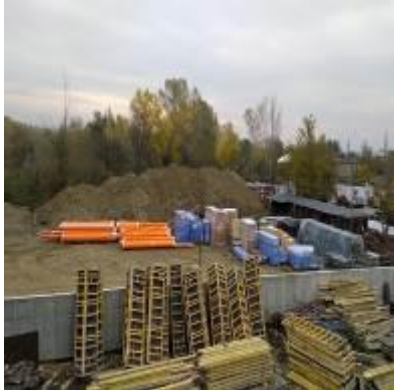
| Date of Visit | Name of Company Name of Contract | Auditors Name | Purpose of audit | Summary of any Significant Findings | Implemented Actions | Implementation Status |
|---|---|---|---|--|---|---|
| | | | | <p>provided as soon as possible.</p> <p>The construction works of the MCC-1 building can be completed quickly and a suitable storage for electrical materials can be provided. Please see relevant Photo N1 below</p> | <p>Non-Compliance Notice was issued and is presented in Annex C of this report.</p> | <p>Completed in November 2021</p> |

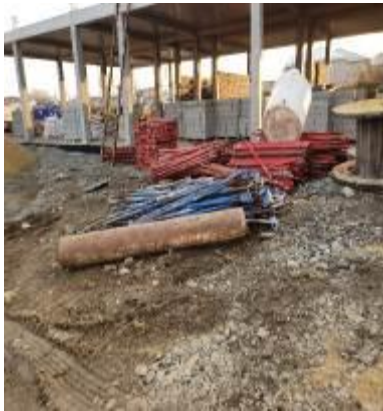
| Date of Visit | Name of Company Name of Contract | Auditors Name | Purpose of audit | Summary of any Significant Findings | Implemented Actions | 'Implementation Status |
|---|---|---|---|--|---|--|
| 08.12.2021 | | USIIP Environmental Specialist Ms.Kate Chomakhidze Site visit was attended by the Head of the Department of Environmental Protection and Permits Ms.Maka Goderdzishvili | Monthly Environmental monitoring | Site internally should be better arranged, materials should be better segregated/stored and cleaned regularly, please see Photo #1 Photo N1 Cable should be relocated to avoid any damages on users of power source; Unsafe connection to the power socket should be immediately improved, please see Photo #2. Photo N2 | Verbal instruction was given to contractor to immediately improve the situation. Non-Compliance Notice was issued and is presented in Annex C of this report. (Photo-documentations are presented in Annex C, non-compliance note, 8 December 2021) | Completed in December 2021, please see improved photo of site below Photo N1 Completed in December 2021, please see improved photo of site below Photo N1 |

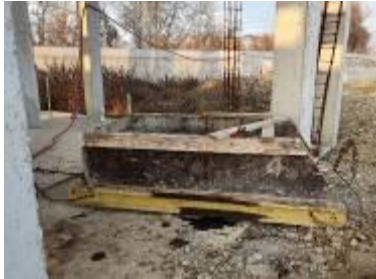
| Date of Visit | Name of Company Name of Contract | Auditors Name | Purpose of audit | Summary of any Significant Findings | Implemented Actions | 'Implementation Status |
|---|---|---|---|---|---|--|
| | | | | <p>site to avoid soil contamination, please see Photo N4</p> <p>Photo N4</p> <p>Top Soil should be stored properly (height of the top soil should not exceed 2 m) in requested amount, and managed in accordance with the required regulations please see Photo N5.</p> <p>Photo N5</p> | | <p>Partially Completed in December 2021, contractor is given strong instruction to improve the situation and provide improved photos of sites by the mid-January 2022.</p> |

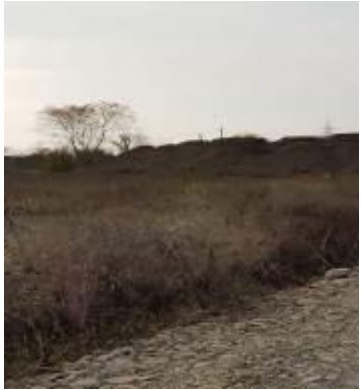
| Date of Visit | Name of Company Name of Contract | Auditors Name | Purpose of audit | Summary of any Significant Findings | Implemented Actions | 'Implementation Status |
|---|---|--|---|---|---|--|
| 15.12.2021 | | Environmental Specialist of Supervision Consultant HILL Mr.Rezo E nukidze | Regular Environmental monitoring of sites | <p>According to SSEMP and project requirements location of the temporary dump site of the sub-soil had to be agreed with engineer.</p> <p>Prior to dumping top soil had to be removed. Only after removal and proper storage of top soil temporary dumping of sub-soil should allowed. Please see photo N1 below.</p> <p>Photo N1:</p> <p>Storage is used by the project must be properly marked and warning signs must be provided at the location.</p> | <p>Verbal instruction was given to contractor to immediately improve the situation.</p> <p>Non-Compliance Notice was issued and is presented in Annex C of this report.</p> <p>(Photo-documentations are presented in Annex C, non-compliance note, 15 December 2021)</p> | <p>Partially Completed deadline for improvement is given until the end of January 2022</p> <p>Completed, December 2021</p> |

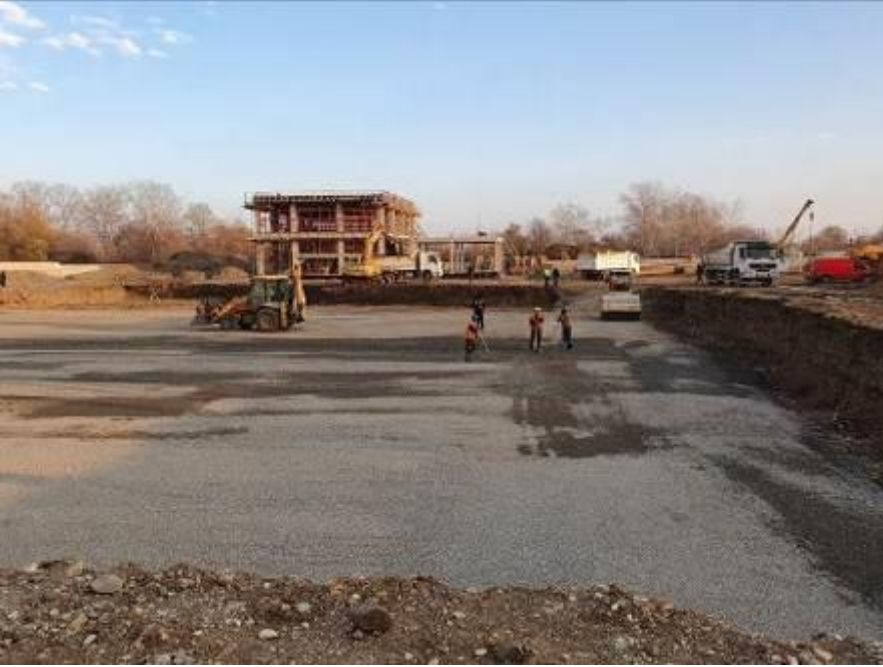
Photo N1

Constraction of WWTP in Marneuli (MAR-02)

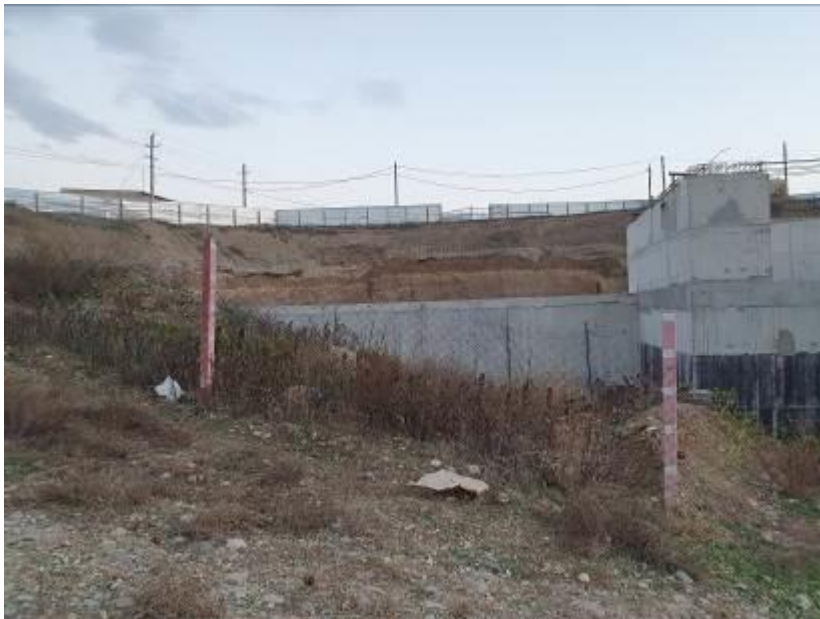
Photo No1

Fencing of Jandari Reservoir

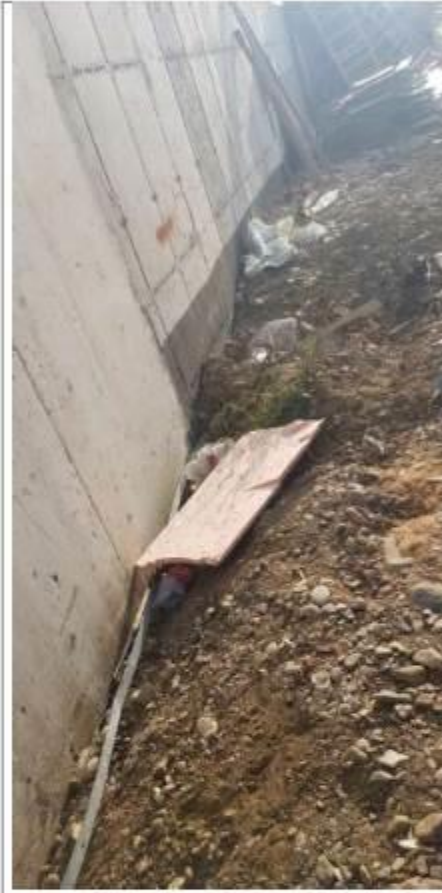
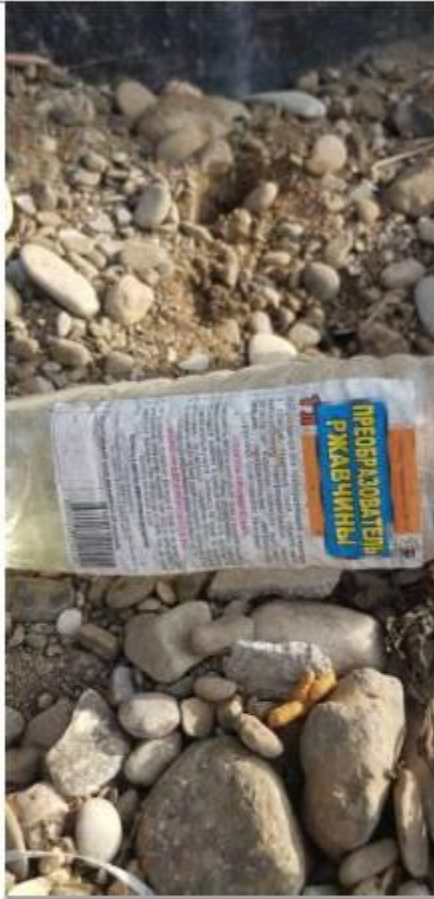
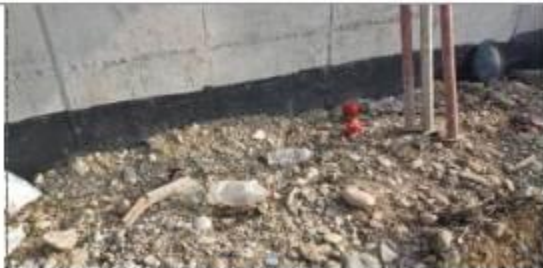
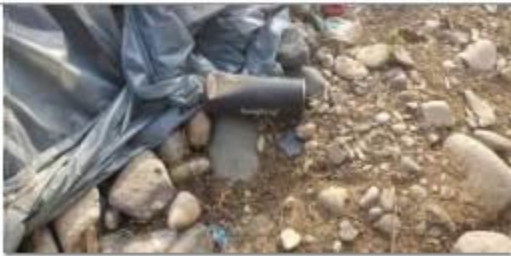
| <p><u>NON-COMPLIANCE IN Marneuli WWTP</u></p> <p>Marneuli WWTP</p> <ul style="list-style-type: none"> - Waste Soil is dumped along the access road, according to SSEMP it should be removed, but based on the local population information this soil at the moment is protecting their property from flooding. Flooding may destroy site surroundings and in case if during this year similar to last year flooding will have place it is possible that site itself will be flooded. At the same time Client was requested to consider retaining wall along the channel to protect locals from possible flooding; - Construction waste possibly dumped by Local population is observed on waste soil along the access road. Access to the stored soil must be restricted and additional explanations to locals must be done. Also it is possible to inform local municipality that illegal waste area has appeared; - Waste containers used by Contractor must be regularly emptied; - Remaining from Concrete washing pit is excavated, but it there is no information that it was disposed according to WMP; Seems lots of concrete works are ahead proper concrete washing pit must be organized; - Storage area for hazardous waste handling is prepared, but it is not managed properly; - Not properly segregated waste is observed in waste containers; | |

All these conditions have to be remedied within 10 days by the prime Contractor

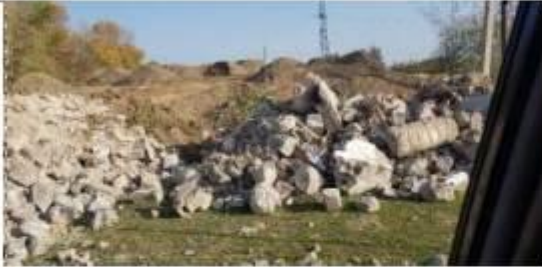
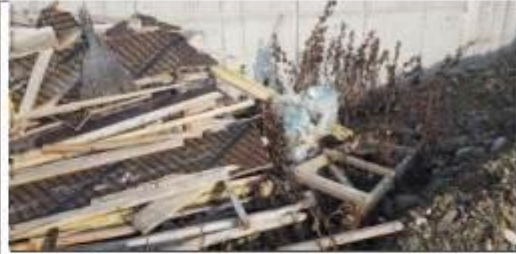
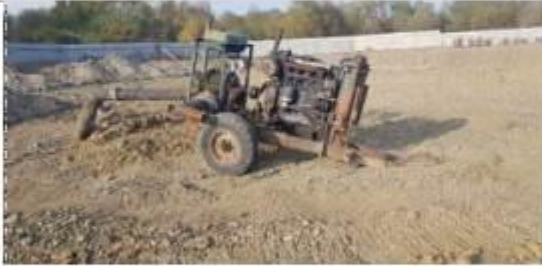
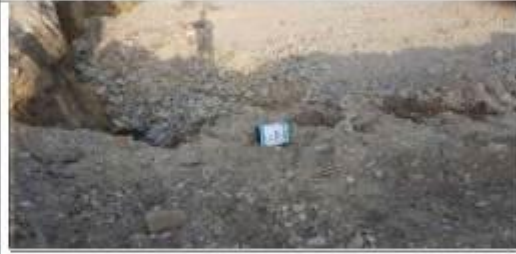
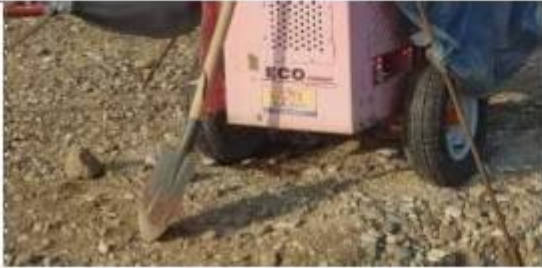
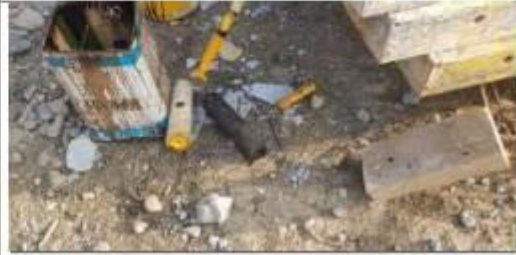
- Housekeeping have to be improved;
- Smoking areas are marked, but they are not used, cigarette packs and butts are thrown all around the site. Additional training on this subject is needed.

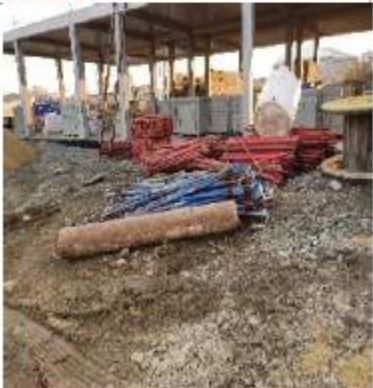
| <p style="text-align: center;">Photo #1</p> | <p style="text-align: center;">Photo #2</p> | <p style="text-align: center;">Photo #3</p> |

| <ul style="list-style-type: none"> • Site internally should be better arranged, materials should be better segregated/stored and cleaned regularly (photo #1) • Cable should be relocated to avoid any damages on users of power source; Unsafe connection to the power socket should be immediately improved (photo #2) • Concrete wash out pit should be arranged at construction site, "Concrete Rivers" should be immediately removed from the soil (Photo #3) • Fuel and lubricants spill elimination items (sand, sawdust, special containers) should be stored at the construction site (Photo #4, #5) to avoid soil contamination • Top Soil should be stored properly in requested amount, and managed in accordance with the required regulations (Photo #6) | | |

All these conditions have to be remedied within 7 days by the prime Contractor (JV TWS-INSI)

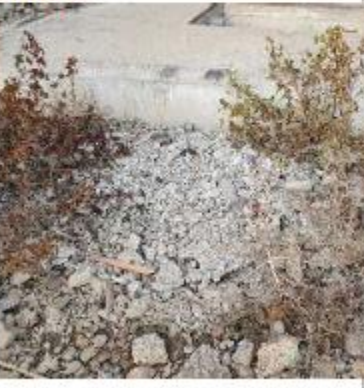
| Date of Visit | Name of Company Name of Contract | Auditors Name | Purpose of audit | Summary of any Significant Findings | Implemented Actions | 'Implementation Status |
|---|---|---|---|---|---|--|
| | | | | <p>Concrete wash out pit should be arranged at construction site, spoiled soil should be immediately removed from the site Photo #3 Photo N3</p> <p>Fuel and lubricants spill elimination items (sand, sawdust, special containers) should be stored at the construction</p> | | <p>Completed in December 2021, please see improved photo of site below Photo N1</p> <p>Completed in December 2021</p> |

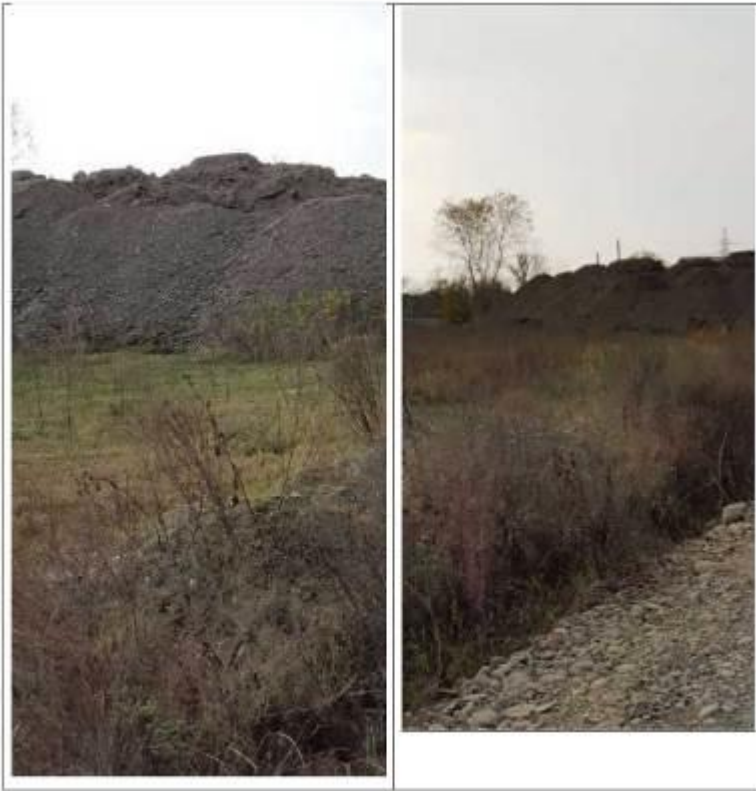
| <p><u>GENERAL COMMENT FOR ALL SITES:</u></p> <p>Environmental representative – Mr. Guram Tandilashvili;</p> <p>As it was mentioned in previous reports that top soil striped from site is stored separately from sub-soil on the east adjacent to the construction site.</p> <p>Additionally, Contractor rented the peace of land from local person to temporarily store sub-soil, which will be used for the refill of excavations. Land is located on the waste side of the site, along the access road.</p> <p><u>NON-COMPLIANCE IN Marneuli WWTP</u></p> <p>Marneuli WWTP</p> <ul style="list-style-type: none"> - According to SSEMP and project requirements location of the temporary dump site had to be agreed with engineer and sufficient documentation such as storage methodology had to be agreed with Engineer. - Prior to dumping top soil had to be removed. Only after removal and proper storage of top soil temporary dumping was allowed. - This action is against Georgian law on Top Soil Protection and may cause penalties from state authorities. - After removal of the material top soil layer must be reinstated. - Storage are used by the project must be properly marked and warning signs must be provided at the location; | |

| ✓ Soil materials must be removed and stored in a proper way without damage of topsoil; | |

| All these conditions have to be remedied within 10 days by the prime Contractor | |

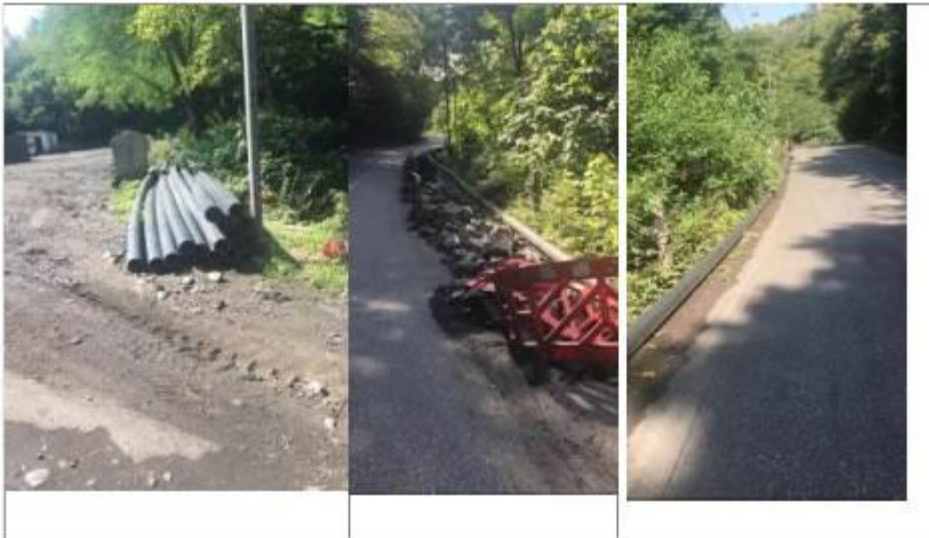
The pictures of the inspection:

1. The Contractor shall complete activities, which are abandoned and might cause complaints from locals.

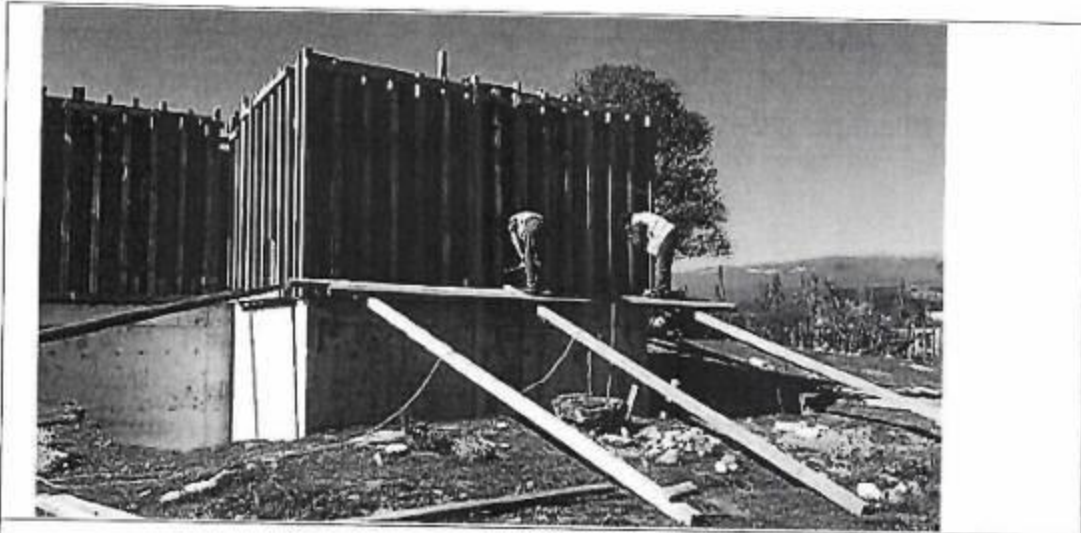
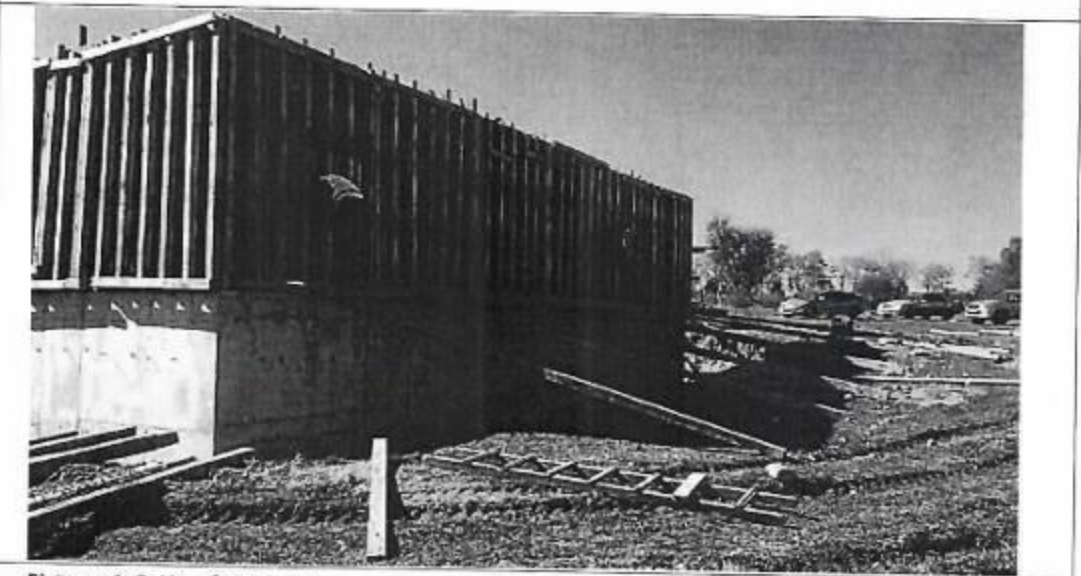
Pictures 1. 2. Unsafe activities

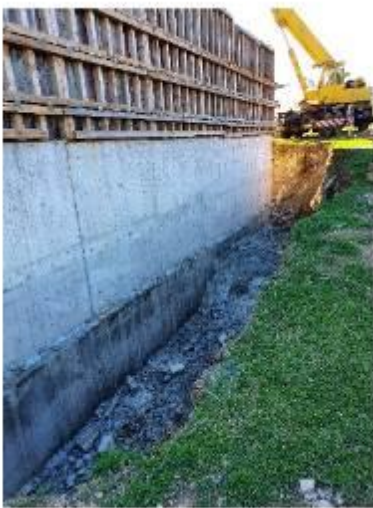
ქვემოთ წარმოდგენილია ჩვენს მიერ 2021 წლის 17 ნოემბერს მონიტორინგის შედეგად გამოვლენილი დარღვევები, რომლებიც ეხება ავარიონის რეზერვუარის მშენებლობას, ასევე, მასთან დამაკავშირებელი წყალმომარაგების ქსელისა და ძირითადი გადამცემი ხაზის მოწყობას CHI-01 ქვე-პროექტის ფარგლებში.

- უცხო პირთა სამშენებლო მოედანზე შესვლის თავიდან ასაცილებლად დაუყოვნებლივ უნდა მოეწყოს საინფორმაციო დაფა, კარიბჭე და დამცავი ღობე სამშენებლო მოედნის მთელს პერიმეტრზე;
- დროებითი დამცავი ბარიერები უნდა მოეწყოს ღია თხრილებისა და კატლანის გასწვრივაც, რათა თავიდან იქნას აცილებული სამშენებლო მოედანზე დასაქმებული პერსონალისა და ადგილობრივი მოსახლეობის დაზიანება;
- დაუყოვნებლივ უნდა განხორციელდეს სამშენებლო მოედნის განათება ღამის საათებში, რათა უზრუნველყოფილი იქნას ადგილობრივი მოსახლეობის დაცვა 24 საათის განმავლობაში.

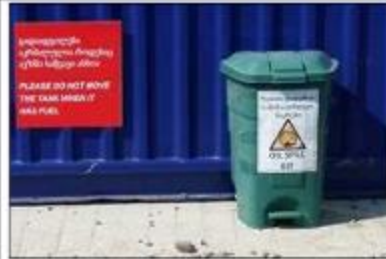
Oil spill kit is available at the site

4. Fuel and lubricants spill elimination items (sand, sawdust, special containers) should be stored at the construction site to avoid soil contamination
