SEMI-ANNUAL ENVIRONMENTAL MONITORING REPORT

**GEORGIA: URBAN SERVICES IMPROVEMENT INVESTMENT PROGRAM
(TRANCHE 2)**

ANNEX A: POST CONSTRUCTION ENVIRONMENTAL AUDIT REPORT, URE-01

Project: Construction of Water Supply and Wastewater Network in Ureki (URE-01)

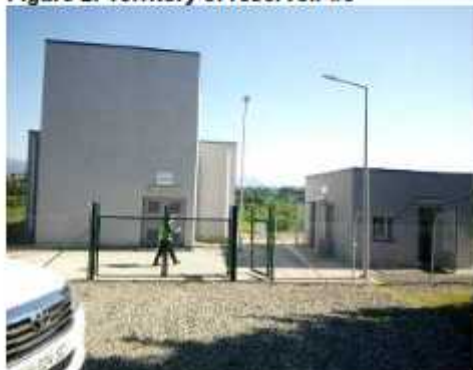
Figure 2: Territory of reservoir #3

18. All the above-mentioned sites were fenced and it was impossible for strangers as well as domestic animals to enter the site (see **Figure 2 - 5**).

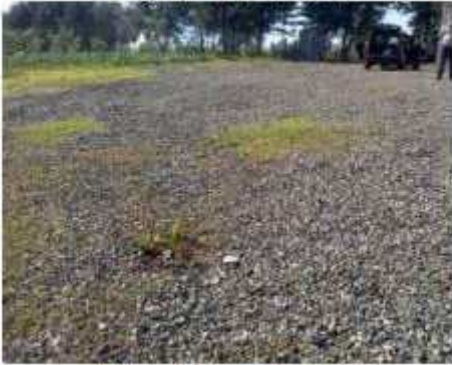
Figure 6: Reservoir #3

19. The construction waste was disposed from all facilities except some minor exceptions (see non-compliance 1) and the area was cleaned (Figures 6 - 9).

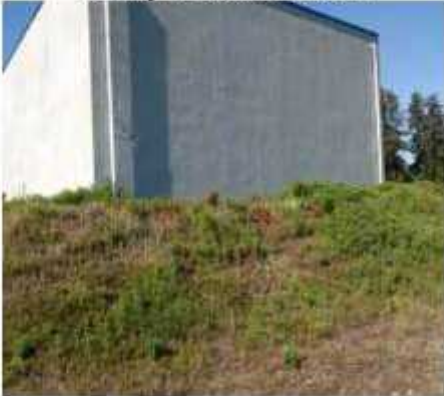
20. The restoration works are completed all over the area and the topsoil was taken back to the project area. It should be noted that no artificial plantings were done in the area. So, it is clear that the self-restoration process took place in the project area (see **Figures 10 and 11**).

Figure 10: Self-restored grass – the territory of the first reservoir

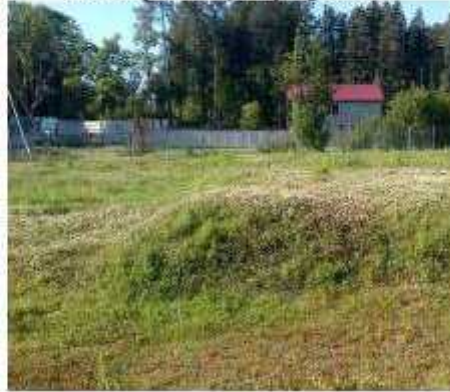
Figure 11: Self-restored grass – the territory of the pumping station

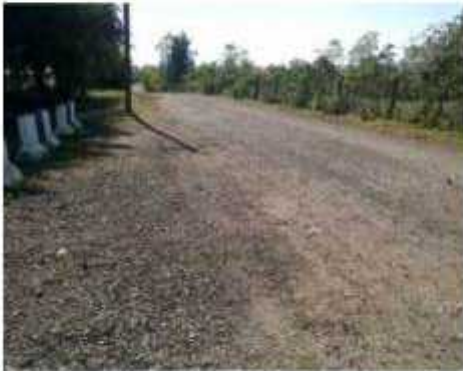
21. The access roads to the project area were restored and paved. Their physical state corresponds to the IEE requirements (**Figures 12 and 13**).

Figure 12: Access road to the first reservoir

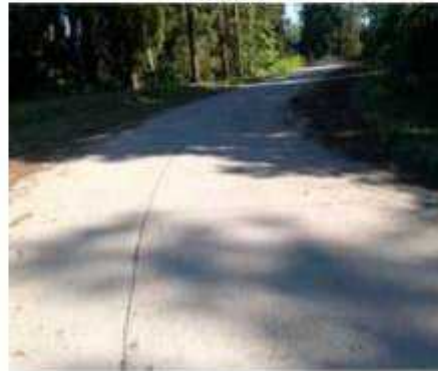
Figure 13: Access road to the pumping station

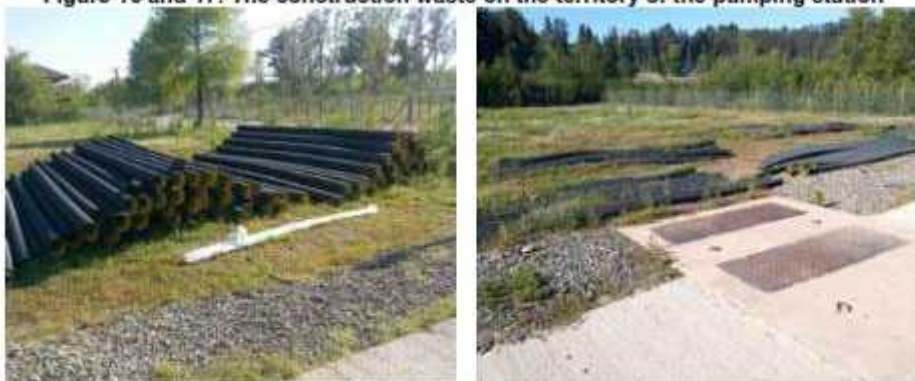
24. **Requirement:** Following the completion of the project, the waste must be handed over to a duly licensed company.
25. **Corrective action:** The waste must be collected and disposed from the project area. The waste must be handed over only to duly licensed contractors for further management.
26. **Non-compliance #2:** The area of the construction materials on the territory of the pumping station was not fenced and was not protected from the impact of the atmospheric precipitation (**Figures 16 and 17**).

Figure 16 and 17: The construction waste on the territory of the pumping station

2	The area of the construction materials on the territory of the pumping station was not fenced and was not protected from the impact of the atmospheric precipitation	The area with the construction waste must be fenced and have relevant information signs	The territory of the construction materials area must be duly fenced. The construction materials must be disposed in the project area more compactly and must be protected from the atmospheric precipitation by using an appropriate protective cover. To identify more-cost effective and practical corrective action further discussion of the proposed corrective action will be held with the UWSCG and the project engineer as well	10 September 2021	DONE Please see photo below

27. **Requirement:** The area with the construction waste must be fenced and have relevant information signs.
28. **Corrective action:** The territory of the construction materials area must be duly fenced. The construction materials must be disposed in the project area more compactly and must be protected from the atmospheric precipitation by using an appropriate protective cover.
29. A number of violations of the rules of safety were observed in the water intake area.
30. **Non-compliance #3:** The underground infrastructure and the well in the project area were not duly covered (**Figures 18 and 19**).

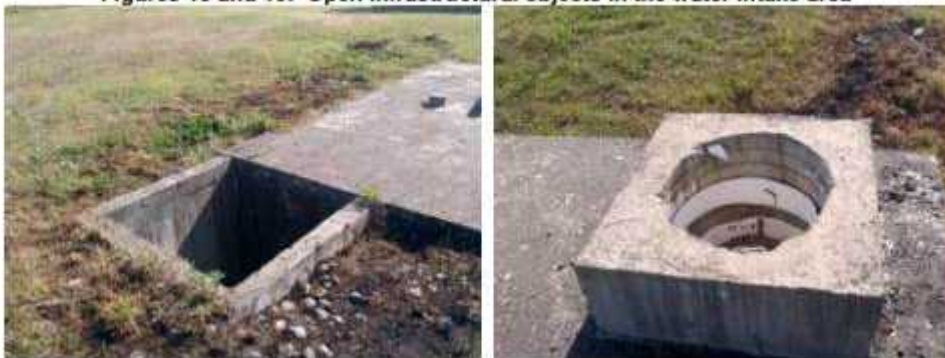
Figures 18 and 19: Open infrastructural objects in the water intake area

3	The underground infrastructure and the well in the project area were not duly covered	All underground infrastructural facilities must be closed after the project is complete to prevent service personnel or animals from	In the first stage, the area must be fenced or warning signs must be installed. And finally, it will be necessary to provide a capital cover or a hatch over such underground	10 September 2021	DONE

31. **Requirement:** All underground infrastructural facilities must be closed after the project is complete to prevent service personnel or animals from falling into them.
32. **Corrective action:** In the first stage, the area must be fenced or warning signs must be installed. And finally, it will be necessary to provide a capital cover or a hatch over such underground facilities.
33. **Non-compliance #4:** A power cable was fixed near the power transmission pole located in the water intake area, which was cut off for unknown reasons and lying on the ground in an uncontrolled manner (see **Figures 20 and 21**).

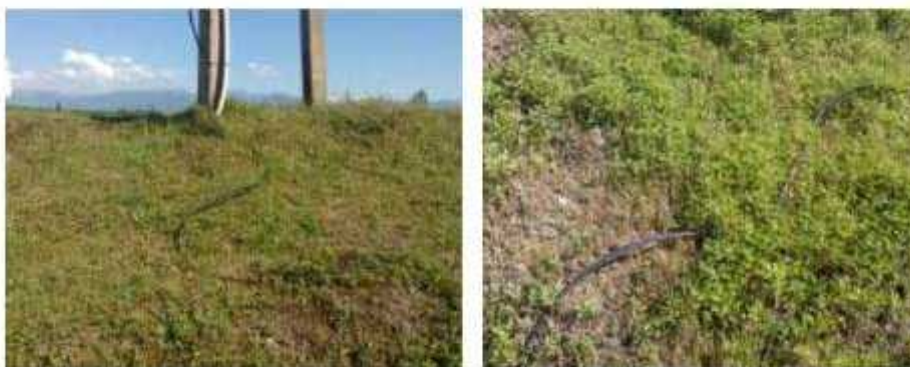
Figures 20 and 21: The wire cable on the earth surface

#	Observed Non-compliance	Requirements	Corrective action	¹ Terms of accomplishment	Implementation Status
		falling into them	facilities.		
4	A power cable was fixed near the power transmission pole located in the water intake area, which was cut off for unknown reasons and lying on the ground in an uncontrolled manner	A power transmission line is not admitted to be on the ground in an uncontrolled manner	First of all, the given area must be marked. Then, owner of the given cable must be identified and addressed immediately to carry out relevant repair works. If the given wire is used to supply power to the wells, it is necessary to install them in compliance with the requirements of the relevant instructions.	31 August 2021	DONE

34. **Requirement:** A power transmission line is not admitted to be on the ground in an uncontrolled manner.
35. **Corrective action:** First of all, the given area must be marked. Then, owner of the given cable must be identified and addressed immediately to carry out relevant repair works. If the given wire is used to supply power to the wells, it is necessary to install them in compliance with the requirements of the relevant instructions.
