# Semi-Annual Environmental Monitoring Report

## #14 Semiannual Report

Project Number: 43405-025

**GEORGIA: URBAN SERVICES IMPROVEMENT INVESTMENT PROGRAM  
(TRANCHE 3)**

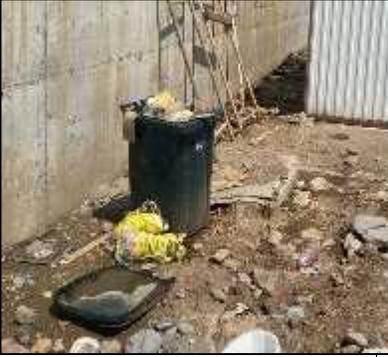
| Date of visit | Name of Company<br>Name of Contract | Auditors name | Purpose of audit | Summary of any significant findings | Cross reference to Audit report | Implementation progress |
|---|---|--|--|---|--|--|
| 3 August 2022 | | <p>Environmental monitoring specialists of SC/EPTISA<br/>Mr.Irakli Legashvili</p> <p>Environmental Specialist, USIP, Ms.Kate Chomakhidze</p> | Monthly monitoring of construction sites | <p><b>WWTP 2</b></p> <p>Construction waste materials should be fully removed from construction area and disposed according agreement, please see Photo N1 below</p> <p>Trees at the construction site should be fenced (freed from the surplus soil, waste and materials) and protected, please see Photo N2 below</p> | <p>Verbal Instruction were given to contractor to immediately improve the situation</p> <p>Non-Compliance Notice issued on 4 August 2022</p> <p>(Please see Annex C)</p> <p>Photo-materials are presented in (Annex B)</p> <p>Corrective Action Plan was prepared by contractor, within the proposed deadlines, please see</p> | <p>Completed September 2022</p> <p>Completed in August 2022, please see Photo N1 below</p> |

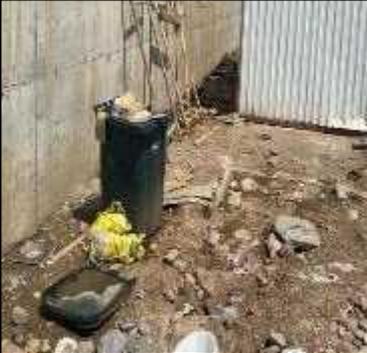
| Date of visit | Name of Company<br>Name of Contract | Auditors name | Purpose of audit | Summary of any significant findings | Cross reference to Audit report | Implementation progress |
|---|---|---|---|---|---|---|
| | | | | <p>Workers always should use complete PPE. Safety norms during construction works should be respected</p> <p>Electric Generator should be placed at the concrete surface to avoid soil contamination by fuel or lubricants</p> <p><b>WWTP 4</b></p> | | <p>Completed in August 2022, please see Photo N3 below</p> <p>Completed in August 2022</p> |

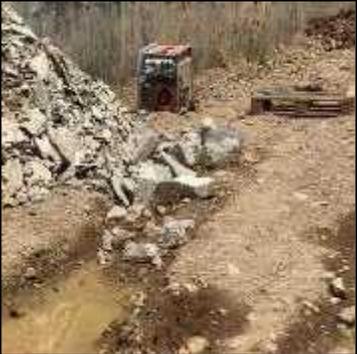
| Date of visit | Name of Company<br>Name of Contract | Auditors name | Purpose of audit | Summary of any significant findings | Cross reference to Audit report | Implementation progress |
|---|---|---|---|--|---|---|
| | | | | <p>Construction sites should be properly fenced from all sides</p> <p>Construction waste materials should be fully removed from construction area and disposed according agreement, please see Photo N5 below</p> <p>Workers always should use complete PPE. Also special equipment during high altitude works should be always used to avoid accidents (workers damage)</p> <p>Hazardous Waste container with should</p> | | <p>Completed in August 2022</p> <p>Completed in August 2022</p> <p>Completed in August 2022</p> <p>Completed in August 2022</p> |

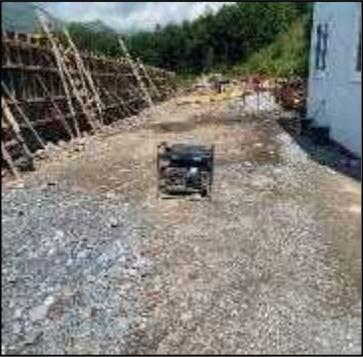
| Date of visit | Name of Company<br>Name of Contract | Auditors name | Purpose of audit | Summary of any significant findings | Cross reference to Audit report | Implementation progress |
|---|---|---|--|--|--|---|
| | | | | <p>Electric Generator should be placed at the concrete surface to avoid soil contamination by fuel or lubricants, please see Photo N6 below</p> | | <p>Completed in August 2022</p> |

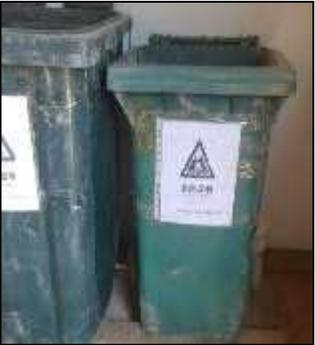
| Date of visit | Name of Company<br>Name of Contract | Auditors name | Purpose of audit | Summary of any significant findings | Cross reference to Audit report | Implementation progress |
|---|---|---|---|---|--|--|
| | | <p>Mr.Irakli Legashvili</p> <p>Environmental Specialist, USIIP, Ms.Kate Chomakhidze</p> | | <p>“Household Waste”, please see Photo N1</p> <p>Top soil should be stored stored properly, better managed (height of fill must not exceed 2 m and the inclination of the fill slope must not exceed 45°), fenced by tape and signed, please see Photo N2</p> <p>Construction waste should be removed from site</p> | <p>immediately improve the situation</p> <p>Non-Compliance Notice issued on 29 August 2022</p> <p>(Please see Annex C)</p> <p>Photo-materials are presented in (Annex B)</p> <p>Corrective Action Plan was prepared by contractor, within the proposed deadlines, please see Annex D to this report.</p> | <p>Completed, end of September 2022, please see Photo N1 below</p> |

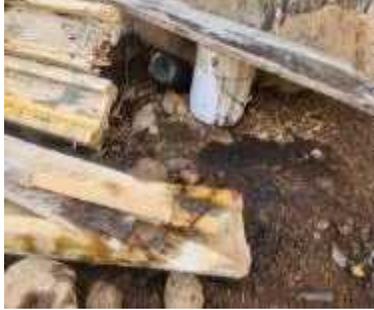
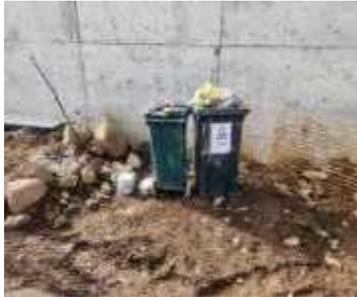
| Date of visit | Name of Company<br>Name of Contract | Auditors name | Purpose of audit | Summary of any significant findings | Cross reference to Audit report | Implementation progress |
|---|---|---|---|---|---|---|
| | | | | <p>Hazardous Waste container with should be installed at the proper organized place with concrete floor and roofing</p> <p>Waste should be placed only at the proper waste container and discharged timely, please see Photo N4</p> | | <p>Completed in November 2022</p> <p>Completed in November 2022</p> |

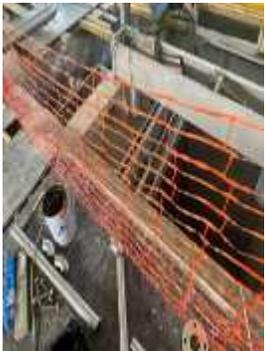
| Date of visit | Name of Company<br>Name of Contract | Auditors name | Purpose of audit | Summary of any significant findings | Cross reference to Audit report | Implementation progress |
|---|---|---|---|---|---|--|
| | | | | <p>Workers always should use complete PPE</p> <p>Electric Generator should be placed at the concrete surface to avoid soil contamination by fuel or lubricants</p> <p>Construction territory should be regularly cleaned</p> <p><b>WWTP 2</b></p> <p>Safety norms during construction works should be respect. Safe walkways with handrail on open trenches and wells should be used to avoid workers falling and damage, please see Photo N5</p> | | <p>Completed in November 2022</p> <p>Completed in November 2022</p> <p>Completed in November 2022</p> <p>Completed in November 2022, please see Photo N8</p> |

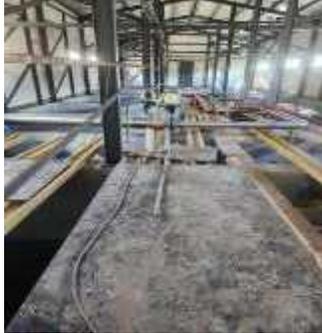
| Date of visit | Name of Company<br>Name of Contract | Auditors name | Purpose of audit | Summary of any significant findings | Cross reference to Audit report | Implementation progress |
|---|---|---|---|---|---|---|
| | | | | <p>Construction materials should be better stored/segreated, fenced and labeled</p> <p>Construction waste materials should be fully removed from construction area and disposed according agreement</p> <p>Excesses of excavation soil should be removed according the agreement</p> <p>Fuel and lubricants spill elimination items (sand, sawdust, special containers) should be</p> | | <p>Completed in November 2022</p> <p>Completed in November 2022</p> <p>Completed in November 2022</p> <p>Completed in November 2022</p> |

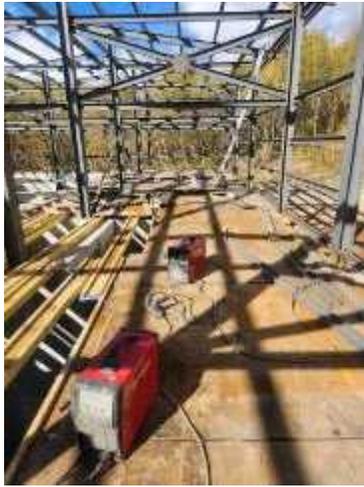
| Date of visit | Name of Company<br>Name of Contract | Auditors name | Purpose of audit | Summary of any significant findings | Cross reference to Audit report | Implementation progress |
|---|---|---|---|---|---|---|
| | | | | <p>provided at the construction site</p> <p>Containers with hazardous substance should be stored at the proper organized place with concrete floor and roofing</p> <p>During using electrical equipment safety norms should be respect (electric cables should be protected), please see Photo N6</p> <p>Hazardous Waste container with should be installed at</p> | | <p>Completed in November 2022</p> <p>Completed in November 2022</p> <p>Completed in November 2022</p> |

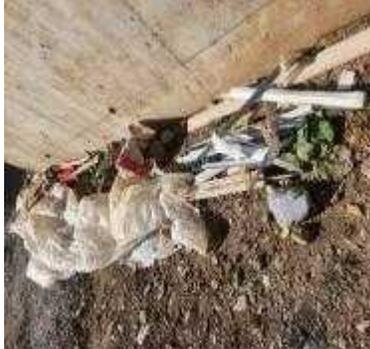
| Date of visit | Name of Company<br>Name of Contract | Auditors name | Purpose of audit | Summary of any significant findings | Cross reference to Audit report | Implementation progress |
|---|---|---|---|--|---|---|
| | | | | <p>Waste containers should be signed, please see Photo N8</p> | | Completed in November 2022 |

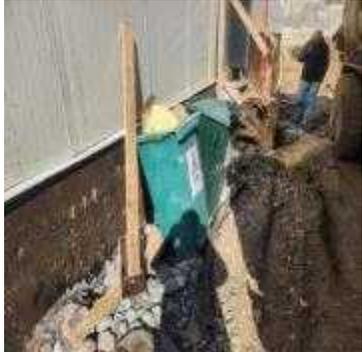
| Date of visit | Name of Company<br>Name of Contract | Auditors name | Purpose of audit | Summary of any significant findings | Cross reference to Audit report | Implementation progress |
|---|---|---|---|--|---|---|
| | | | | <p>Hazardous Waste container with should be installed at the proper organized place with concrete floor and roofing</p> | | Completed in November 2022 |

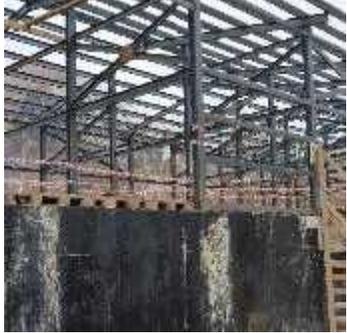
| Date of visit | Name of Company<br>Name of Contract | Auditors name | Purpose of audit | Summary of any significant findings | Cross reference to Audit report | Implementation progress |
|---|---|---|---|---|---|---|
| | | | | <p>Safety norms during construction works should be respect. Safe walkways with handrail on open trenches and wells should be used to avoid workers falling and damage, please see Photo N3 below</p> <p>Electric Generator should be placed at the concrete surface to avoid soil contamination by fuel or lubricants, please see Photo N4 below</p> | | <p><b>Not yet Completed,</b> Since the construction works are temporarily terminated, please see table 28 - Recommendations to Address Environmental Issues under USIIP/T3/GUD-03 sub-project below, will be completed by the end of January 2023 and reflected in the next SAEMR, January-June 2023</p> <p>Completed, end of November 2022</p> |

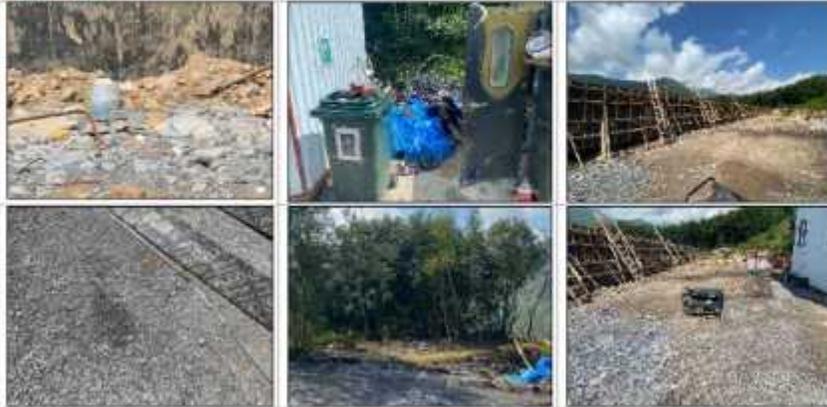
Photos of WWTP 2

| <ul style="list-style-type: none"> <li>- Construction waste materials should be fully removed from construction area and disposed according agreement</li> <li>- Trees at the construction site should be fenced (free from the surplus soil, waste and materials) and protected</li> <li>- At the construction territory are observed small spill spots of fuel/lubricant. These contaminated places should be remediated</li> <li>- Storage of construction materials should be better organized</li> <li>- Fuel and lubricants spill elimination items (sand, sawdust, special containers) should be provided at the construction site</li> <li>- Hazardous Waste container with should be installed at the proper organized place with concrete floor and roofing</li> <li>- Waste should be placed only at the proper waste container and discharged timely</li> <li>- Workers always should use complete PPE. Safety norms during construction works should be respected</li> <li>- Electric Generator should be placed at the concrete surface to avoid soil contamination by fuel or lubricants</li> </ul> | |

All these conditions have to be remedied within seven days (by the 12.08.2022) by the prime Contractor (China Nuclear Industry 23 Construction Co., Ltd)

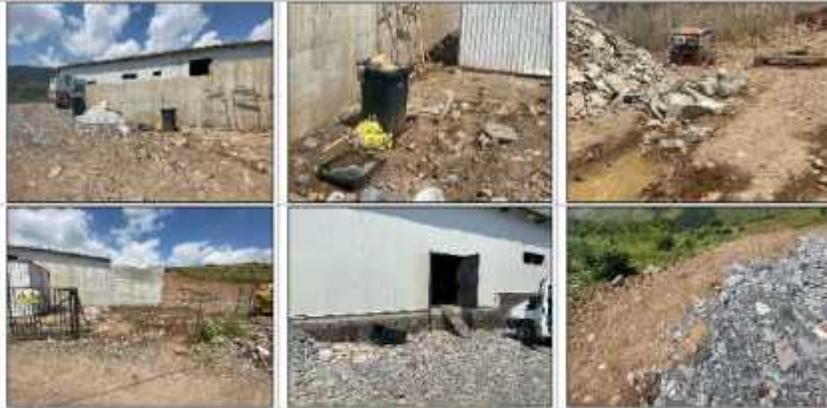
Photos of WWTP 4

| <ul style="list-style-type: none"> <li>- Construction site should be properly fenced from all sides</li> <li>- Construction waste materials should be fully removed from construction area and disposed according agreement</li> <li>- Workers always should use complete PPE. Also special equipment during high altitude works should be always used to avoid accidents (workers' damage)</li> <li>- Hazardous Waste container with should be installed at the proper organized place with concrete floor and roofing</li> <li>- Fuel and lubricants spill elimination items (sand, sawdust, special containers) should be provided at the construction site</li> <li>- Fuel and lubricants containers should be installed at the proper organized place with concrete floor and roofing</li> <li>- Household Waste container should be signed</li> <li>- Waste should be placed only at the proper waste container and discharged timely</li> <li>- Electric Generator should be placed at the concrete surface to avoid soil contamination by fuel or lubricants</li> </ul> | |

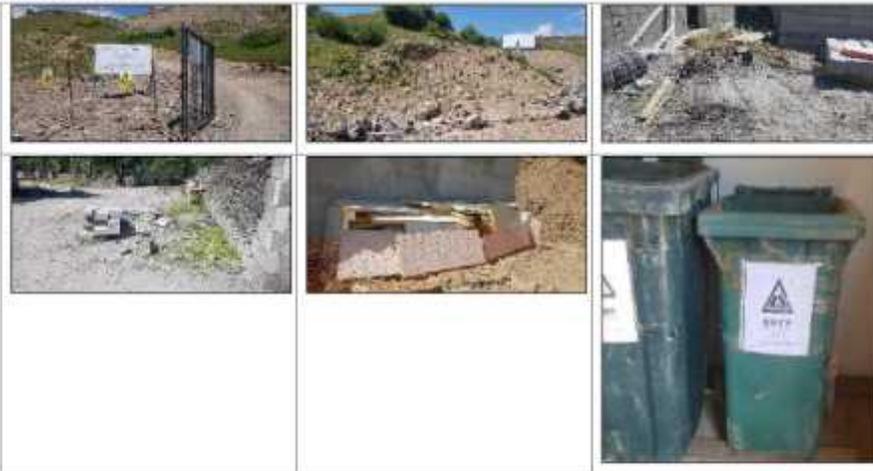
Photos of WWTP 1

- At the construction territory are presented small spill spots of fuel/lubricant. These contaminated places should be remediated
- Electric Generator should be placed at the concrete surface to avoid soil contamination by fuel or lubricants
- Proper Household Waste container should be installed and signed "Household Waste"
- Waste should be placed only at the proper waste container and discharged timely
- Workers always should use complete PPE

All these conditions have to be remedied within seven days (by the 06.09.2022) by the prime Contractor [China Nuclear Industry 23 Construction Co., Ltd]

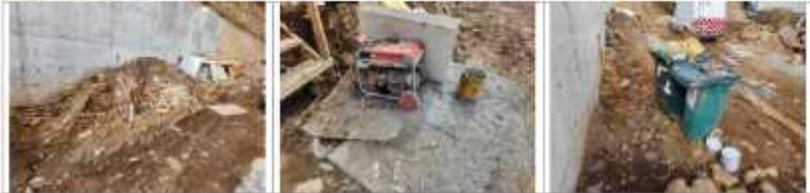
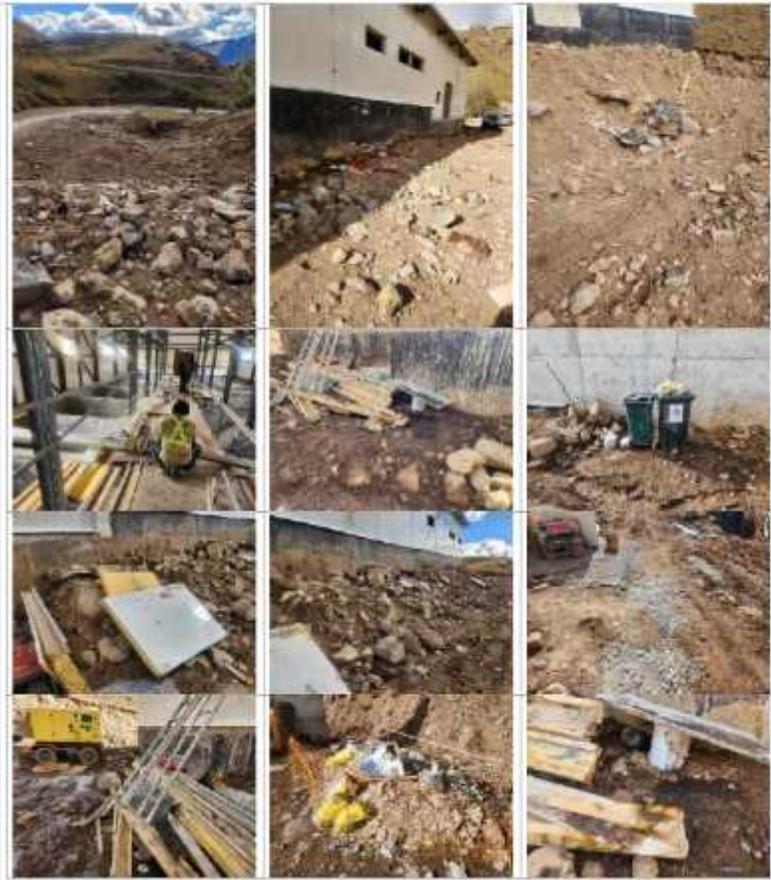
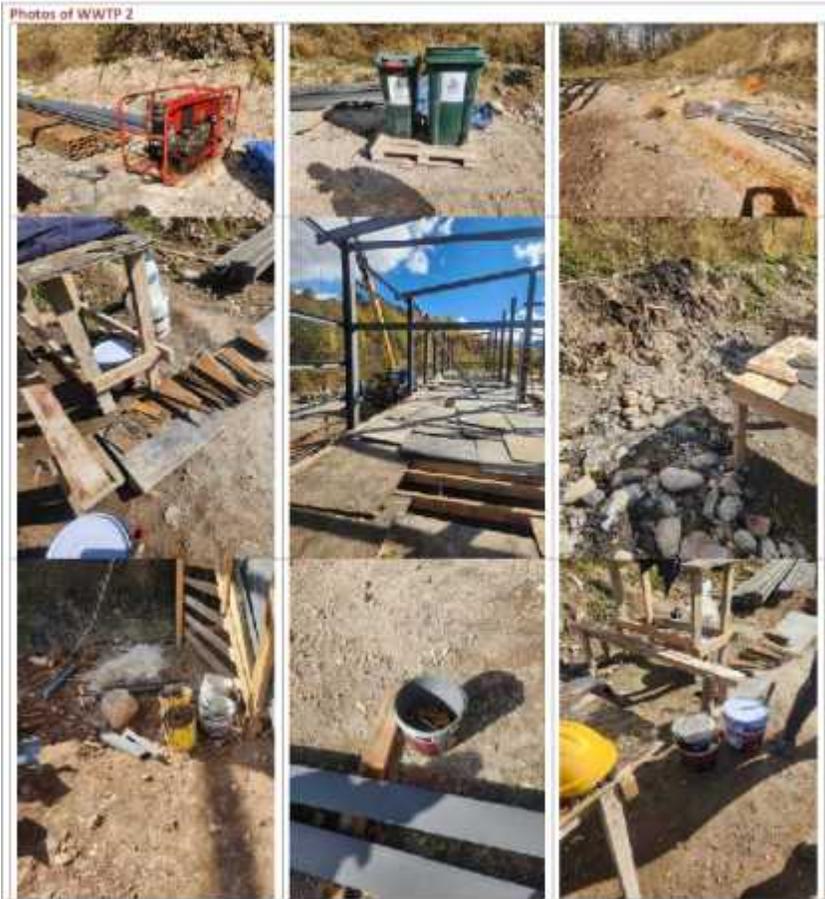
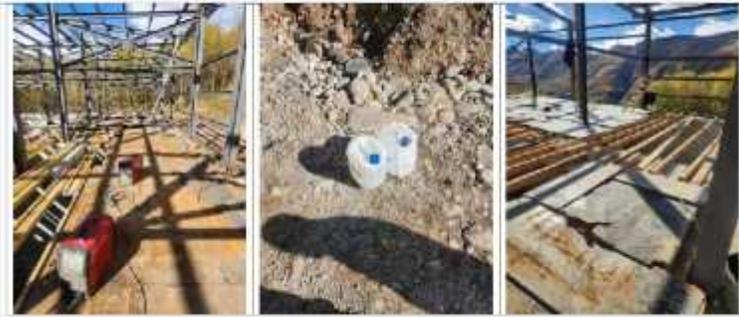
Photos of WWTP 1

- Workers always should use complete PPE
- Construction territory should be regularly cleaned

All these conditions have to be remedied within five days (by the 08.11.2022) by the prime Contractor (China Nuclear Industry 21 Construction Co., Ltd)

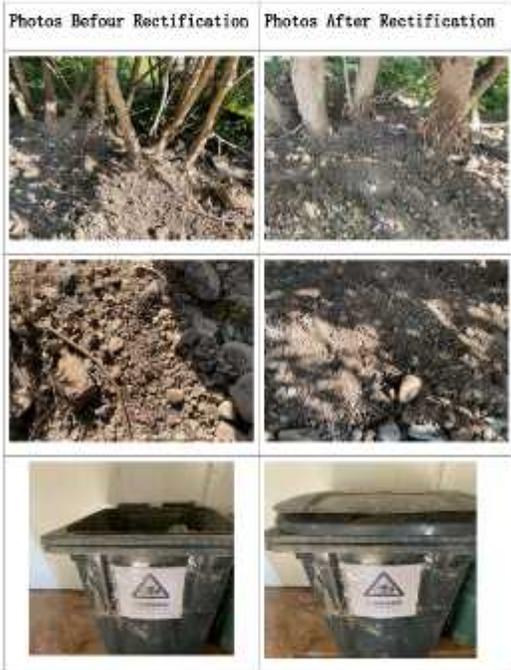
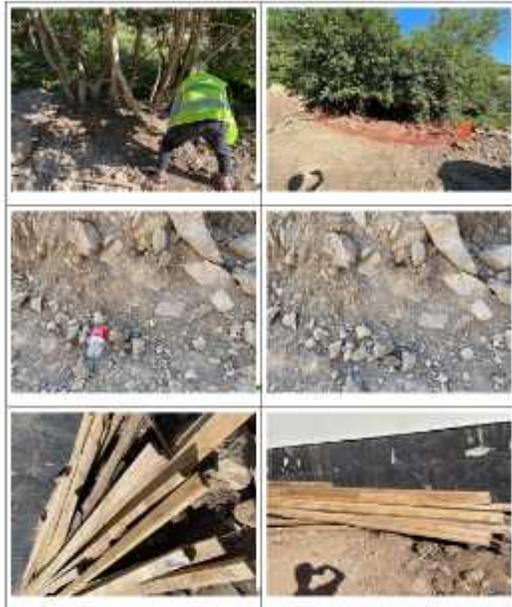
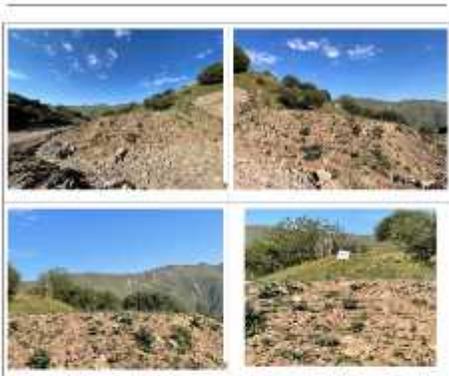
Rectification photos of WWTP1:

After receiving the Non-Compliance EPT/USHP/TL/2786 Gudaori WWTPs 29-AUG-2022, the Contractor immediately rectified the violations on site. At the same time, special training was carried out for site managers and workers to avoid recurring similar problems. Please refer to the attachment for details of the rectification.
