Semi-Annual Environmental Monitoring Report

(Reporting Period: July-December 2023)

Project Number: 43405-025

**GEORGIA: URBAN SERVICES IMPROVEMENT INVESTMENT PROGRAM
(TRANCHE 3)**

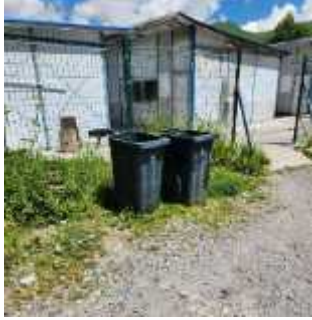
Date of visit	Name of Company Name of Contract	Auditors name	Purpose of audit	Summary of any significant findings	Cross reference to Audit report	Implementation progress
				<p>Hazardous Waste container with proper sign "Hazardous Waste" should be installed at the proper organized place with concrete floor and roofing</p> <p>Waste containers should be labeled, Photo N3</p>

<p>Waste should be placed only the proper waste container and discharged timely, Photo N4</p>		<p>Completed by the end of June 2023, Please see Photo N3</p>

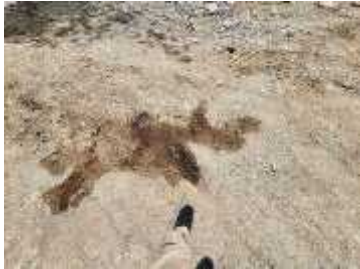
Date of visit	Name of Company Name of Contract	Auditors name	Purpose of audit	Summary of any significant findings	Cross reference to Audit report	Implementation progress
				<p>There are detected spill spots of fuel/lubricant at the construction territory. These contaminated places should be remediated, Photo N1</p>

<p>Entrance gate should not be left open for long time</p> <p>Fuel and lubricants spill elimination items (sand, sawdust, special containers)</p>	<p>are presented in Annex B, non-compliance note,)</p> <p>Corrective Action Plan has been developed by contractor and sent to SC and UWSCG</p>	<p>Completed, end of August 2023, Photo N2</p>

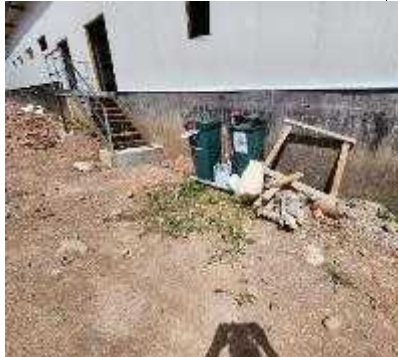
Date of visit	Name of Company Name of Contract	Auditors name	Purpose of audit	Summary of any significant findings	Cross reference to Audit report	Implementation progress
				<p>should be provided at the construction site</p> <p>Waste should be placed only at the proper waste container and discharged timely</p> <p>Hazardous Waste container with label should be installed at the proper organized place with concrete floor and roofing, Photo N2</p>

<p>Electric Generator should be placed at the concrete surface to avoid soil contamination by fuel or lubricants</p>		<p>Completed, end of August 2023</p> <p>Completed, end of August 2023, the hazardous waste containers has been removed from the site due to the completion of construction work, photo N3</p>

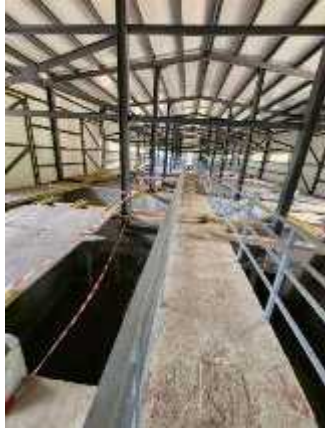
Date of visit	Name of Company Name of Contract	Auditors name	Purpose of audit	Summary of any significant findings	Cross reference to Audit report	Implementation progress
				<p>Safety norms during construction works at height should be respected. Safe walkways with handrail on open wells should be used to avoid workers falling and damage, Photo N3</p>

<p>Open holes and trenches should be fenced by high visible safety tapes and proper warning signs should be installed, Photo N5</p>		<p>Partially Completed, (Detailed information and recommendations for improvements are provided in para 41 and table 15) Photo N4</p>

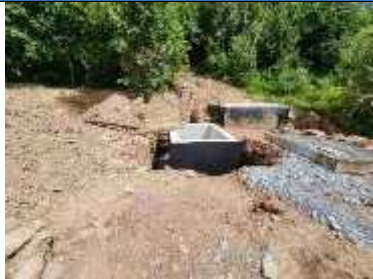
<p>WWTP 3</p> <p>Hazardous Waste container with should be installed at the proper organized place with concrete floor and roofing</p> <p>Waste should be placed only at the proper waste container and discharged timely, Photo N6</p>

<p>Completed, end of September 2023, the hazardous waste containers has been removed from the site due to the completion of construction work</p>

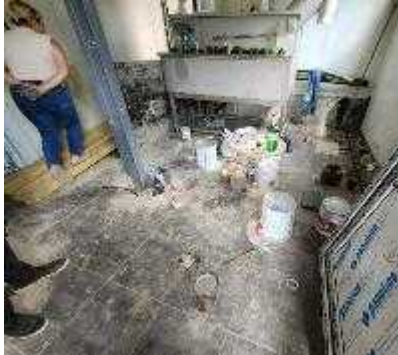
Date of visit	Name of Company Name of Contract	Auditors name	Purpose of audit	Summary of any significant findings	Cross reference to Audit report	Implementation progress
				<p>Entrance gate should not be left open for long time</p> <p>Sanitary norms at the workers rest/eating area should be respected, Photo N7</p>

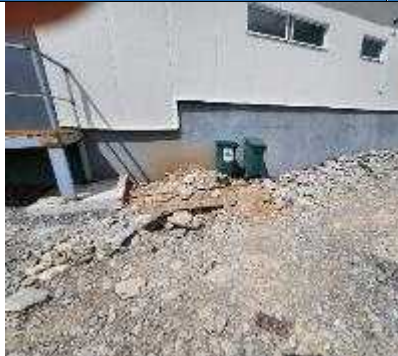
<p>Entrance gate should not be left open for long time.</p> <p>Construction waste materials should be fully removed from construction area and disposed according to agreement</p> <p>Hazardous Waste container with should be installed at the proper organized place with concrete floor and roofing</p> <p>Campsite Contractor's camp site plan should be provided and proper signs (in Georgian and English) for each</p>

<p>Completed, end of August 2023</p> <p>Completed, end of September 2023, the hazardous waste containers has been removed from the site due to the completion of construction work</p> <p>Completed, end of September 2023, Photo N7</p>

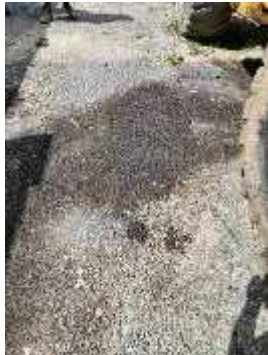
Date of visit	Name of Company Name of Contract	Auditors name	Purpose of audit	Summary of any significant findings	Cross reference to Audit report	Implementation progress
				<p>Photo N9</p>

<p>Waste management:</p> <p>Hazardous Waste container with proper sign “Hazardous Waste” should be installed at the proper organized place with concrete floor and roofing</p> <p>Hazardous waste temporary storage area should be arranged according to provided specifications (see below description and follow requirements of Ordinance N145 of the Government of Georgia should be followed)</p> <p>Waste should be placed only the proper waste container</p>		<p>Completed December 15, 2023, All containers were removed from the construction camp due to the limited presentation of the contractors on sites and a weather condition, Please see photo N8</p>

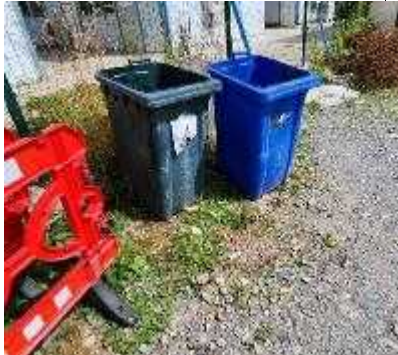
Date of visit	Name of Company Name of Contract	Auditors name	Purpose of audit	Summary of any significant findings	Cross reference to Audit report	Implementation progress
				<p>and discharged timely (waste containers should not be broken)</p> <p>Proper waste containers should be installed with cover and labeled</p> <p>Containers with hazardous substance should be stored at the proper organized place with concrete floor and roofing</p> <p>Accumulated waste materials should be removed from the campsite immediately</p> <p>Photo N10</p>

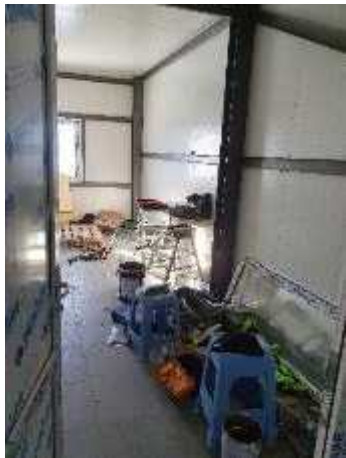
Date of visit	Name of Company Name of Contract	Auditors name	Purpose of audit	Summary of any significant findings	Cross reference to Audit report	Implementation progress
				<p>should be arranged, fenced and signed</p> <p>Construction materials should be segregated and placed at proper manner (area should be fenced and information sign should be installed)</p> <p>Safety norms during use electricity should be respected</p> <p>Construction territory should be regularly cleaned inside and outside, Photo N</p>

<p>Completed, Mid. Of December 2023</p> <p>Completed, Mid. Of December 2023</p> <p>Completed, Mid. Of December 2023</p> <p>Not Completed, (Detailed information and recommendations for improvements are provided in para 41 and table 15)</p>

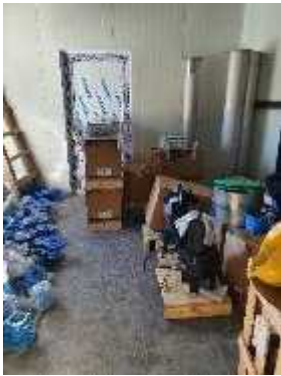
11 December 2023		<p>ADB's Environmental Safeguard Mission, Nino Nadashvili, Associate Safeguard Officer Georgia Resident Mission Asian Development Bank</p> <p>Environmental monitoring</p>	<p>ADB's Semi-annual Environmental Safeguard Mission</p>	<p>Keep construction area clean and organized, Photo N1</p>

<p>Verbal instructions have been given to the contractor to keep inside area clean and organized</p>	<p>Not completed Completed, (Detailed information and recommendations for improvements are provided in para 41 and table 15)</p>

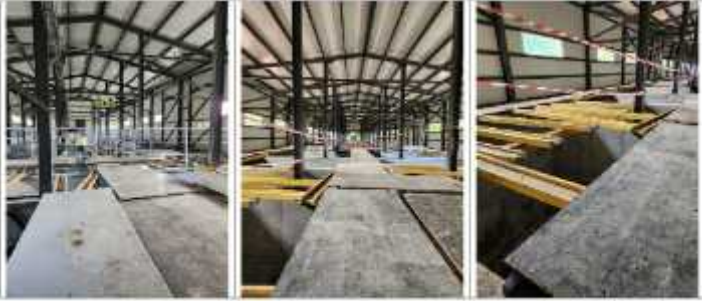
<p>Photos of WWTPs</p>

<p>Project: Urban Services Improvement Investment Program, Georgia</p> <p>Contract No: UWSIG-ICB-GUD-03</p> <p>Contractor: China Nuclear Industry 23 Construction Co., Ltd</p> <p>Reference: Construction of Wastewater Treatment Plants in Gudauri</p>	<p>Non-compliance Notice Gudauri</p>
<p>This notice is to advise you, the prime Contractor, on the referenced Contract, of the following notice on environmental measures to be implemented urgently.</p> <p>WWTP 1, WWTP 2, WWTP 3, WWTP 4</p> <ul style="list-style-type: none"> Safety rooms during construction works at height should be respected. Safe walkways with handrail on open wells should be used to avoid workers falling and damage. <p>Campsite</p> <ul style="list-style-type: none"> Fuel and lubricants spill elimination items (sand, sawdust, special containers) should be provided at the construction site. Hazardous Waste container with proper sign "Hazardous Waste" should be installed at the proper organized place with concrete floor and roofing. Waste should be placed only in the proper waste container and discharged timely. Containers with hazardous substance should be stored at the proper organized place with concrete floor and roofing. Waste containers should be labeled. Places contaminated by oil should be remediated and safely disposed. Oil should be removed from trench and properly disposed. Campsite territory should be regularly cleaned.

All these conditions have to be remedied within seven days (by the 17.07.2023) by the prime Contractor (China Nuclear Industry 23 Construction Co., Ltd)

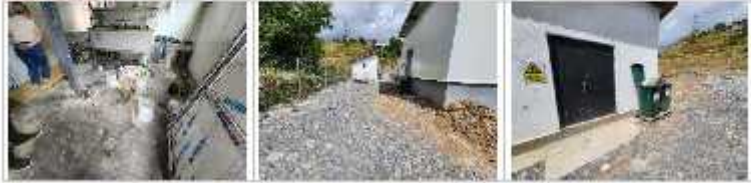
Photos of WWTP 3

- Fuel and lubricants spill elimination items (sand, sawdust, special containers) should be provided at the construction site
- All equipment and vehicles used for construction should be in good condition do not leakage

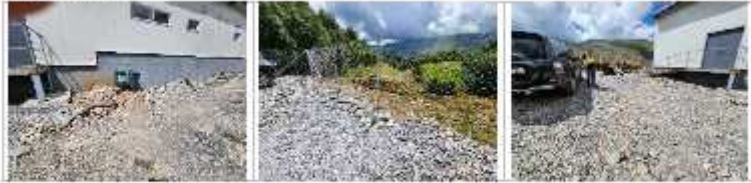
Photos of WWTP 4

- Hazardous Waste container with proper sign "Hazardous Waste" should be installed at the proper organized place with concrete floor and roofing
- Hazardous waste temporary storage area should be arranged according to provided specifications (see below description and follow requirements of Ordinance N145 of the Government of Georgia should be followed)

- Waste should be placed only the proper waste container and discharged timely (waste containers should not be broken)
- Containers with hazardous substance should be stored at the proper organized place with concrete floor and roofing

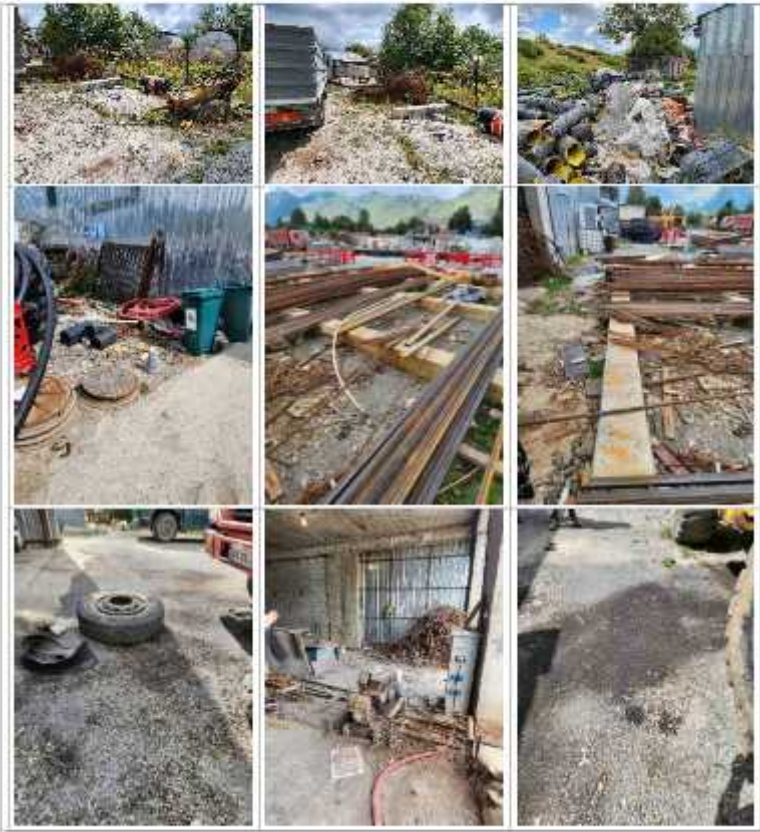
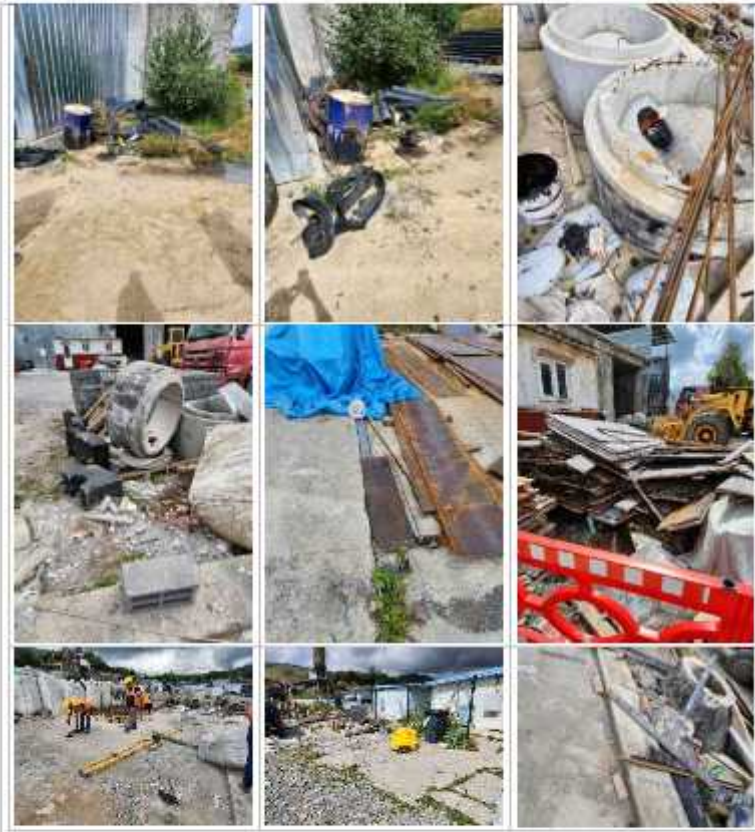
Photos of Campsite

- Safety norms during use electricity should be respected
- Campsite territory should be regularly cleaned

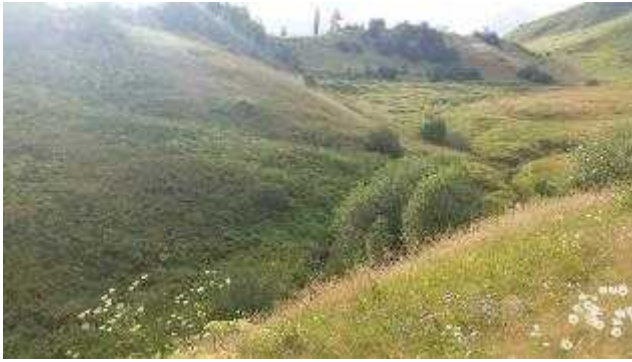
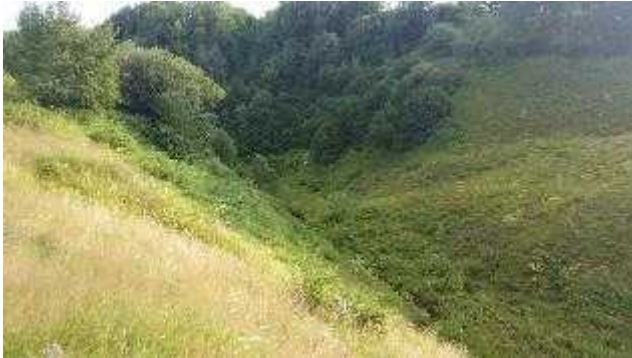
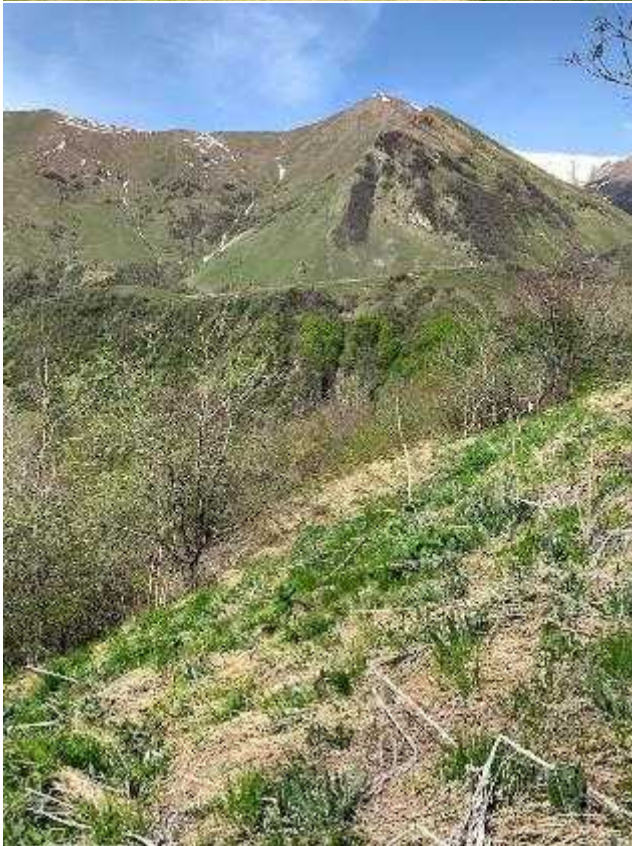
Figure 1. Photos of WWTP 5 Location

UWSCG has submitted change order N1 to cancel construction of WWTP 5. No works has been commenced on location of WWTP 5. As a result, no construction activities have begun at the planned site for WWTP 5, leaving the land in its original, undisturbed state. The photos of WWTPN5 is provided in the Fog.1 below.
