Semi-annual Environmental Monitoring Report

#15 Semiannual Report

(Reporting Period: July-December 2023)

**GEORGIA: URBAN SERVICES IMPROVEMENT INVESTMENT PROGRAM
(TRANCHE 4)**

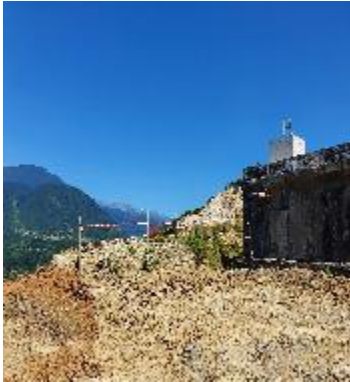
Date of Visit	Name of Company	Auditors Name	Purpose of audit	Summary of any Significant Findings	Cross Reference to Audit Report	Status of implementation
Continuously during reporting period (July-December 2023)	AS Inshaat-N LLC (Azerbaijan) JVA-01	EH&S Specialist of Contractor Mr. Nodar Usupishvili	Day to day monitoring of sites Compliance with Environmental and HES requirements	Poor housekeeping Safety issues on construction sites	Monthly Monitoring Reports	Completed on the monthly basis
5 July 2023		<p>ADB's Environmental Safeguard Mission, Nino Nadashvili, Associate Safeguard Officer Georgia Resident Mission Asian Development Bank</p> <p>Ms. Kate Chomakhidze UW SCG/USIIP/Environmental Specialist</p> <p>Environmental Specialist of SC Mr. Shalva Bosikashvili</p>	ADB's Semi-annual Environmental Safeguard Mission	<p>Proper safety fencing: Installing proper safety fencing around the trenches are missing, Photo N1</p>

Verbal instruction was given to contractor to immediately improve the situation.	<p>Completed</p> <p>All Construction activities on reservoir site were completed, therefore there are no open trenches on the site, see Photo n1</p>

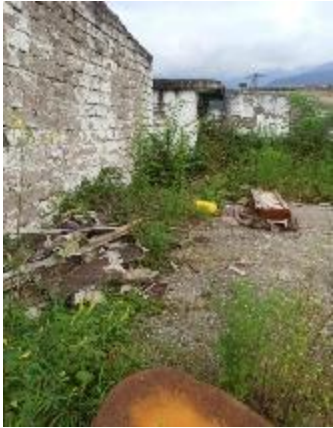
Date of Visit	Name of Company	Auditors Name	Purpose of audit	Summary of any Significant Findings	Cross Reference to Audit Report	Status of implementation
11 August 2023		Environmental Specialist of SC Mr. Shalva Bosikashvili	Regular Monitoring of Sites	<p>Unacceptable housekeeping, Photo N1</p>

<p>Non-compliance notice were issued to contractor and corrective actions were required to immediately improve the situation on sites under JVA-01 sub-project (Please see Annex C)</p>	<p>Completed Mid.of September 2023, all waste are removed from the construction territory</p> <p>Completed end of August 2023, please see, Photo N2</p>

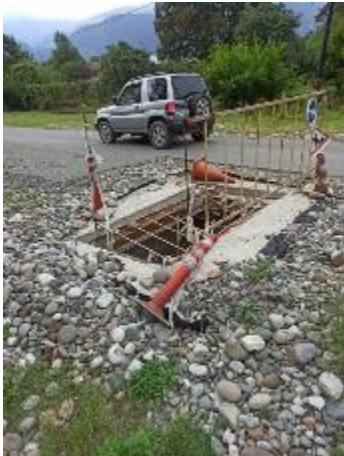
<p>Manhole improper cover, Photo N2</p>

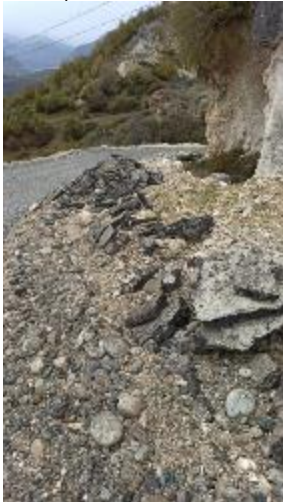
Date of Visit	Name of Company	Auditors Name	Purpose of audit	Summary of any Significant Findings	Cross Reference to Audit Report	Status of implementation
16 November 2023		Environmental Specialist of SC Mr. Shalva Bosikashvili	Regular Monitoring of Sites	<p>Reinstatement of the construction sites</p> <p>Solid waste beside the road, Photo N1</p>

Non-compliance notices were issued to the contractor and corrective actions were required to immediately improve the situation on sites under JVA-01 sub-project (Please see Annex C)	<p>Reinstatement of the construction sites</p> <p>Partially Completed, all reinstatement works will be completed by February 2023</p> <p>Partially Completed, all reinstatement works will be completed by February 2023</p>

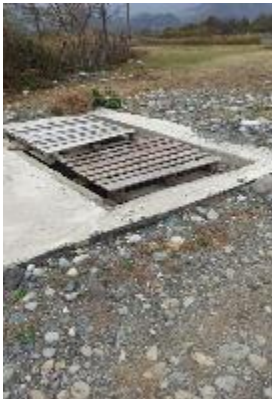
<p>Manhole improper cover, Photo N2</p>

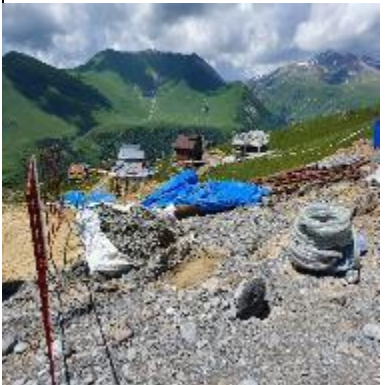
Date of Visit	Name of Company	Auditors Name	Purpose of audit	Summary of any Significant Findings	Cross Reference to Audit Report	Status of implementation
Continuously during reporting period (July-December 2023)	China Nuclear Industry 23 Construction Co., Ltd GUD-02	Environmental H&S Specialist of Contractor Mr.Aleksandre Mchedlishvili	Day to day monitoring of sites Compliance with Environmental and H&S issues Monthly Monitoring of construction sites	Site internally should be arranged properly and cleaned regularly. Minimize tree cutting on construction site, due to construction purposes	Prepare monthly monitoring reports	Completed
4 July 2023		ADB's Environmental Safeguard Mission, Nino Nadashvili, Associate Safeguard Officer Georgia Resident Mission Asian Development Bank Ms. Kate Chomakhidze UW SCG/USIIP/Environmental Specialist Environmental Specialist of SC Mr.Shalva Bosikashvili	ADB's Semi-annual Environmental Safeguard Mission	Unacceptable housekeeping (Boring Well 3), Photo N1

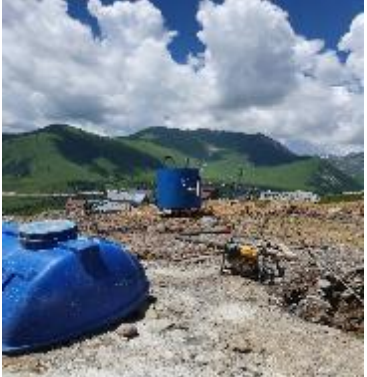
Generators without drip tray (Boring Well 3), Photo N2	Non-compliance notice were issued to contractor and corrective actions were required to immediately improve the situation on sites under GUD-02 sub-project (Please see Annex C)	Completed Major construction activities are completed in Boring Well N3, therefore all waste and construction materials are removed from the construction territory Completed

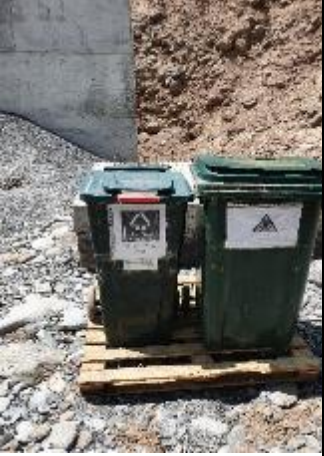
<p data-bbox="1136 592 1520 657">Waste containers without lid and label, Photo N3</p>

<p data-bbox="1774 609 2053 803">Completed, due to the completion of construction activities no waste is generated on construction site.</p>

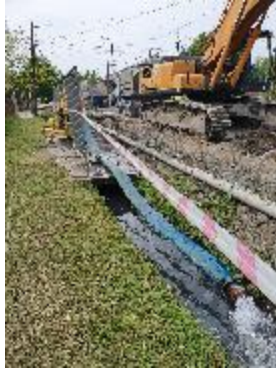
Date of Visit	Name of Company	Auditors Name	Purpose of audit	Summary of any Significant Findings	Cross Reference to Audit Report	Status of implementation
Continuously during reporting period (July-December 2023)	"MBD Inssat" (Turkey). POT-01/LOT-01/LOT-02/LOT-03	Environmental Specialist of SC Mr. Shalva Bosikashvili	Day to day monitoring of sites Compliance with Environmental and HES requirements	Poor housekeeping Safety issues on construction sites	Monthly Monitoring Reports	Completed on the monthly basis
25 September 2023	POT-01/LOT-02	Environmental Specialist of SC Mr. Shalva Bosikashvili Ms. Kate Chomakhidze UW SCG/USIIP/Environmental Specialist	Monthly Monitoring of Sites	<p>Gabunia Street Drainage channel maintenance: The drainage channel on the site is filled with excavated material and needs to be cleaned, also drainage channel is damaged and needs reinstatement. Photo N1</p>

<p>Arsena Street Informational Banner:</p>	<p>Non-compliance notice were issued to contractor and corrective actions were required from contractor to immediately improve the situation, under POT-01 sub-project (Please see Annex C)</p> <p>Corrective Action Plans were developed by</p>	<p>Completed. End September 2023, Photo N1</p>

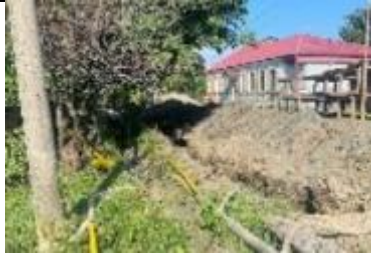
<p data-bbox="1150 488 1518 646">Proper safety fencing: Installing proper safety fencing around the trenches are missing.</p>		Completed, end of September
3 November 2023	POT-01/LOT-01	Environmental Specialist of Contractor Mr. Shalva Bosikashvili	<p data-bbox="890 683 1121 776">Monthly Monitoring of Sites</p> <p data-bbox="890 821 1083 984">Compliance with Environmental and HES requirements</p>	<p data-bbox="1150 683 1497 808">POT-01/LOT-01 Construction of Sewerage System in Poti, LOT-01 - CAMP</p> <p data-bbox="1150 846 1497 1068">Site internally should be arranged properly and cleaned regularly, All construction materials should be properly segregated and stored adequately, Photo N1</p>

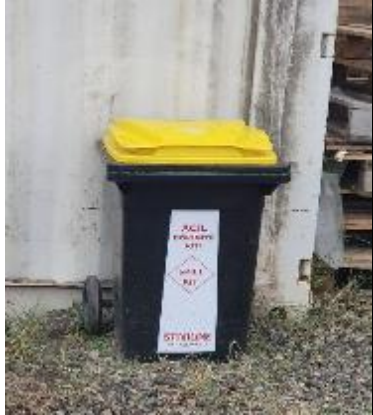
Date of Visit	Name of Company	Auditors Name	Purpose of audit	Summary of any Significant Findings	Cross Reference to Audit Report	Status of implementation
				<p>Waste should be placed only at the proper waste containers, containers should be labeled (Household waste and Hazardous waste), the signs should be in the local language and understandable by the workers, Photo N2</p>

<p>Electric cables must be arranged in accordance with standards, so that they do not pose any danger to the workers</p> <p>Empty cylinders must be removed from the construction site, Photo N3</p>		<p>Completed, Mid. November 2023, Photo N2</p>

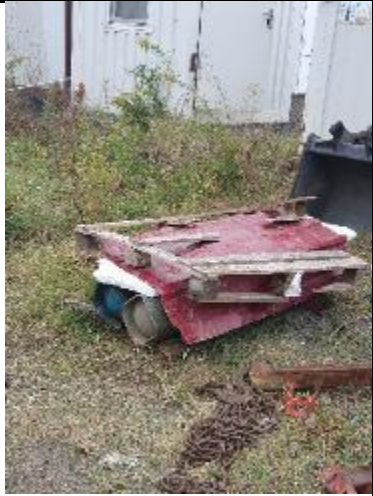
<p>Equipment that may cause oil leakage should be stored adequately on concrete floors and under a roof</p> <p>Construction of sewerage system in POTI, LOT-01</p> <p>Adequate and sufficient quantity of Safety/warning signs/tapes and trench side barriers around of deep open trenches should be installed to avoid accident, Photo N4</p>

<p>Completed, Mid. November 2023</p> <p>Completed, Mid. November 2023 Photo N4</p>

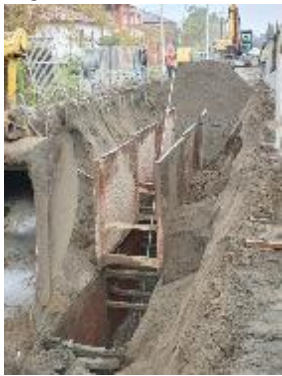
<p>Walls of the deep trenches (>1.5m) should be strengthened by adequate and sufficient quantity of boards to avoid landfall of the soil and accidents (workers damage) Photo N5</p>

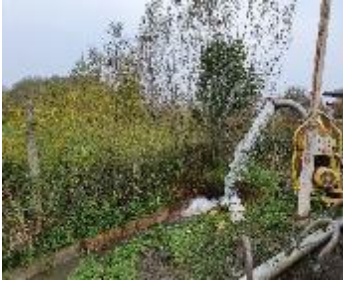
Date of Visit	Name of Company	Auditors Name	Purpose of audit	Summary of any Significant Findings	Cross Reference to Audit Report	Status of implementation
				<p>All construction materials has to be adequately stored during the construction not to cause the disturbance of the local population</p> <p>Due to the uncleanliness of the canal, the pumped water cannot flow into the canal and causes flooding of private lands, Photo N4</p>

<p>General Notes: Trench construction shall be taken up in small segments, so that work (excavation, pipe laying and refilling) in each segment is completed in a day. No trenches shall be kept open in the night/after work hours;</p>		<p>Completed, Mid. November 2023</p> <p>Completed, Mid. November 2023, Photo N6</p>

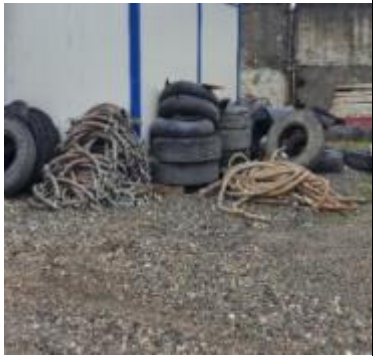
Date of Visit	Name of Company	Auditors Name	Purpose of audit	Summary of any Significant Findings	Cross Reference to Audit Report	Status of implementation
3 November 2023	POT-01/LOT-02 CAMP	<p>Ms. Kate Chomakhidze UW SCG/USIIP/Environmental Specialist</p> <p>Environmental Specialist of SC Mr. Shalva Bosikashvili</p>	Monthly monitoring of Sites	<p>Construction of Sewerage System in Poti, LOT-02 - CAMP</p> <p>General Notes :</p> <p>Site internally should be arranged properly and cleaned regularly, All construction materials should be properly segregated and stored adequately, Photo N1</p>

<p>Waste should be placed only at the proper waste containers, containers should be labeled (Household waste and Hazardous waste), the signs should be in the local language and understandable by the workers</p>	<p>Non-compliance notice were issued to contractor and corrective actions were required to immediately improve the situation on sites under POT-01 sub-project (Please see Annex C)</p>	<p>Completed, Mid. November 2023, Photo N1</p>

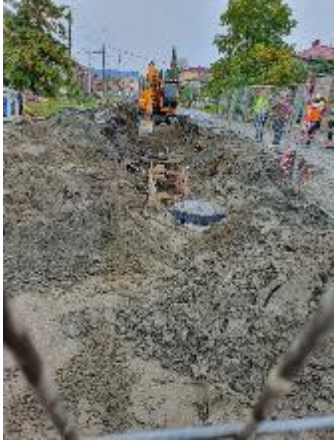
Date of Visit	Name of Company	Auditors Name	Purpose of audit	Summary of any Significant Findings	Cross Reference to Audit Report	Status of implementation
				<p>Construction of sewerage system in POTI, LOT-02</p> <p>HS requirements on construction of trenches (Photos N1, N2, N3)</p> <p>Walls of the deep trenches (>1.5m) should be strengthened by adequate and sufficient quantity of boards to avoid landfall of the soil and accidents (workers damage), Photo N1</p>

<p>Adequate and sufficient quantity of Safety/warning signs/tapes and</p>		<p>Partially Completed, despite regular site instructions on ESHS, issuance of notices of non-compliance, meetings and discussions with SC and CC representatives on HS safety issues, some construction sites, including trenches, require improvements from the contractor to comply with safety requirements</p> <p>Completed, Photo N2</p>

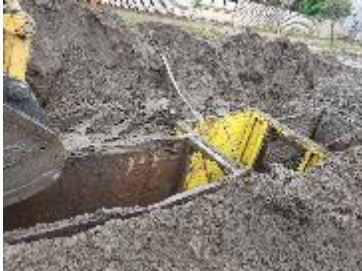
Date of Visit	Name of Company	Auditors Name	Purpose of audit	Summary of any Significant Findings	Cross Reference to Audit Report	Status of implementation
				<p>trench side barriers around of deep open trenches should be installed to avoid accident, Photo N2</p>

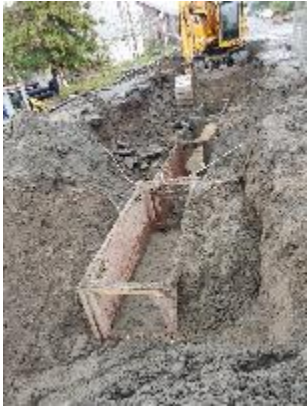
<p>All construction site/segment must have adequate access in order not to endanger the workers , Photo N3</p>

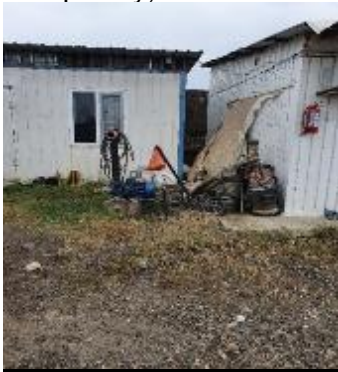
<p>3 November 2023</p>	<p>POT-01/LOT-03 - CAMP</p>	<p>Ms. Kate Chomakhidze UW SCG/USIIP/Environmental Specialist</p> <p>Environmental Specialist of SC Mr. Shalva Bosikashvili</p>	<p>Monthly monitoring of Sites</p>	<p>Construction of Sewerage System in Poti, LOT-03 - CAMP</p> <p>Site internally should be arranged properly and cleaned regularly, All construction materials should be properly segregated and stored adequately, Photo N1</p>

<p>Waste should be</p>	<p>Non-compliance notice were issued to contractor and corrective actions were required to immediately improve the situation on sites under POT-01 sub-project (Please see Annex C)</p>	<p>Completed, Mid. November 2023, Photo N1</p>

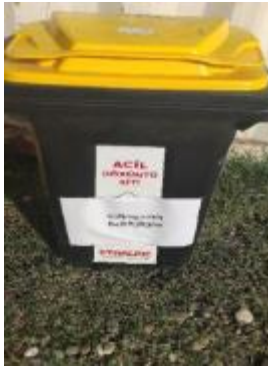
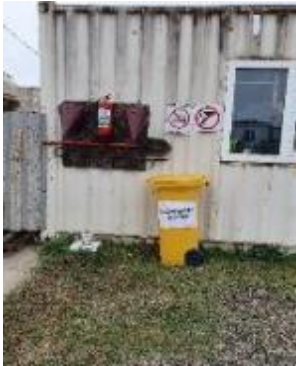
Date of Visit	Name of Company	Auditors Name	Purpose of audit	Summary of any Significant Findings	Cross Reference to Audit Report	Status of implementation
				<p>placed only at the proper waste containers, containers should be labeled (Household waste and Hazardous waste), the signs should be in the local language and understandable by the workers, Photo N2</p>

<p>Electric cables must be arranged in accordance with standards, so that they do not pose any danger to the workers, Photo N3</p>		<p>Photo N2</p> <p>Completed, Mid. November 2023, Photo N3</p>

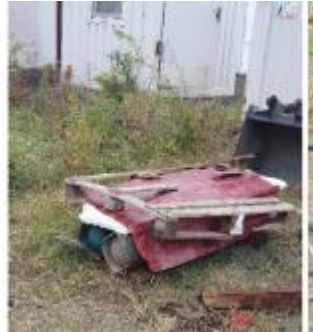
<p data-bbox="1150 1149 1461 1339">Equipment that may cause oil leakage should be stored adequately on concrete floors and under a roof, Photo N5</p>

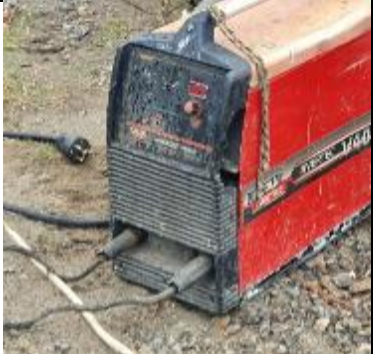
<p>Construction of Pumping Stations in POTI, LOT-03</p> <p>Working of height, HS requirements</p> <p>Adequate and sufficient quantity of Safety/warning signs/tapes, protective equipment for working at height, side barriers around of deep open excavations should be installed to avoid accident, Photo N6</p>

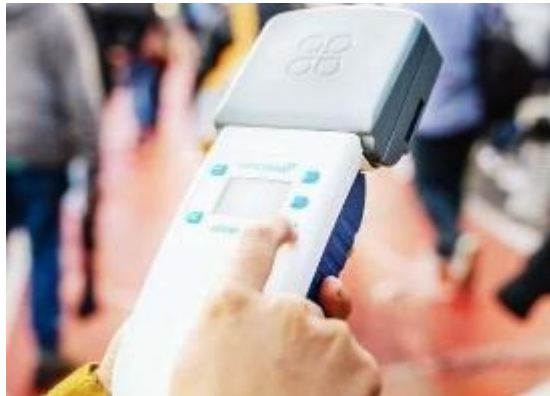
Figure 1: Air Quality Measuring Instrument Aeroqual Series 500

- 94. For air monitoring, BBE team used 4 different sensors of Aeroqual Series 500 (PM10/PM2.5, CO, NOx, SOx).
- 95. The Series 500 Portable Air Quality Monitor is a handheld portable monitor used to measure up to 30 pollutants using the unique sensor head format. Sensors are housed within an interchangeable cartridge (“head”) that attaches to the monitor base. The head can be removed and replaced in seconds, allowing users to measure as many gases as they wish. Sensor heads feature active fan sampling which ensures a representative sample is taken, increasing measurement accuracy.

- 96. A long-life lithium battery and in-field zero and span calibration make this an easy-to-use device. Monitor ID identifies the monitor uniquely and ensures that all data from it are tied to that monitor. Location ID can be used to tag measurements to a specific location – helpful when sampling at multiple sites over the course of a day or week.

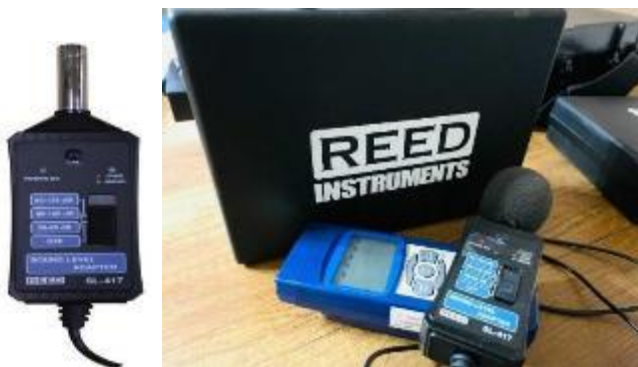
Figure 2: Noise level is determined by the REED INSTRUMENTS 9300 model adapter

97. The noise monitoring spot was chosen so it could fully show the impact of construction processes on the population. Noise was monitored for an hour. BBE team used REED instruments 9300 to determine the noise level.
98. The sound level meter consists of a calibrated microphone, electronic circuits, and a display. The microphone detects small air pressure variations associated with sound and converts them into electrical signals. The aforementioned signals are then processed using the instrument's electronic circuitry. The display shows the sound level in decibels.
99. The sound level meter acquires the sound pressure level at a particular location. A sound level meter is used for acoustic measurements. It is a hand-held instrument with a microphone.

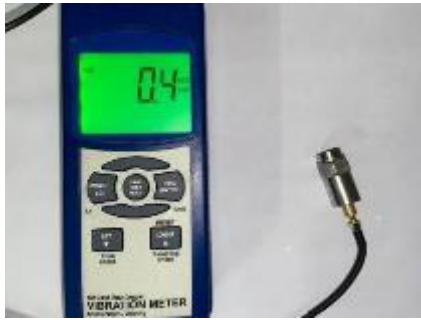
Figure 3: REED instruments SD-8205 model adapter

100. Vibration level is determined by the REED instruments SD-8205 model adapter.
101. Vibration analysis is a process that monitors vibration levels and investigates the patterns in vibration signals. It is commonly conducted both on the time waveforms of the vibration signal directly, as well as on the frequency spectrum, which is obtained by applying Fourier Transform on the time waveform.

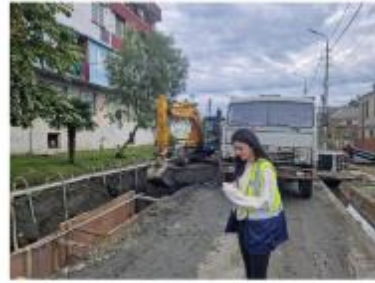
Figure 3.1 Noise (NM61) Monitoring Point

Table 3.1.1 Noise (NM61) Monitoring Results access road to the second camp

Different Parameters of NoiseLevel	Result (dB)
LAF _{max}	79.4
LAF _{min}	58.5
LAF _{av}	68.5

During the noise level monitoring conducted on October 10th 2023, the exceeding of the allowed limit values was not observed at the mentioned location.

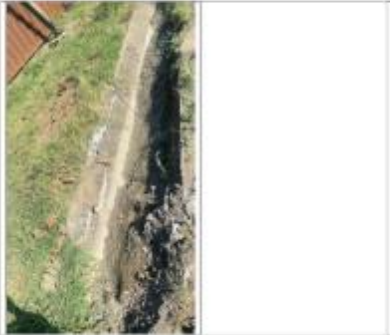
Photos of Gabunia street

Project/Unit/Drawings/Improvement/Itemization/Project/Site/Stage	Non-compliance Marker
Contract No. USHP/T&C/2011.13/POT-01 CONTRACTING: Sliver Banka Improvement (New) Lot 2 Project Reference: Construction of Sewerage System in Pot, LOT 2	Full
<p>The notice is about your failure to comply with the terms and conditions of the following sections of the original agreement to be implemented on site:</p> <p>General Street Drainage channel (see attached). The channel channel on the site is filled with excavated material and needs to be blocked after drainage channel is completed and before reclamation.</p> <p>Access Street Informational Barrier Closure, there is no informational barrier on the site. Please ensure that a barrier is installed as soon as possible to provide necessary information and ensure awareness of the ongoing construction work.</p> <p>Site Excavation and Material Storage It is important to ensure that materials are stored in a safe and orderly manner and that they are well secured in a manner on the public. This includes ensuring that hazardous materials are properly stored and secured, and that there is adequate space for workers to move around the site safely. Additionally, all material on the site should be properly fenced and clearly marked to avoid any confusion. Proper fencing and warning will ensure the safety of workers and prevent any unauthorized access to the site.</p> <p>Excavation and Material Storage This refers to the practice of using construction materials or equipment to block entrances to private properties, roads, or public areas. Make sure that all entrances and closures are properly marked and secured.</p> <p>Excavation Safety Installing proper safety fencing around the excavation is missing. Drainage channel reclamation: The drainage channel on the site is filled with excavated material and needs to be blocked after drainage channel is completed and before reclamation.</p> <p>Public Area and Informational Barrier Closure Informational Barrier Closure, there is no informational barrier on the site. Please ensure that a barrier is installed as soon as possible to provide necessary information and ensure awareness of the ongoing construction work.</p> <p>Site Excavation and Material Storage It is important to ensure that materials are stored in a safe and orderly manner and that they are well secured in a manner on the public. This includes ensuring that hazardous materials are properly stored and secured, and that there is adequate space for workers to move around the site safely. Additionally, all material on the site should be properly fenced and clearly marked to avoid any confusion. Proper fencing and warning will ensure the safety of workers and prevent any unauthorized access to the site.</p> <p>Excavation and Material Storage This refers to the practice of using construction materials or equipment to block entrances to private properties, roads, or public areas. Make sure that all entrances and closures are properly marked and secured.</p> <p>Excavation Safety Installing proper safety fencing around the excavation is missing.</p>

All these conditions have to be remedied within 30 days (by the 05.10.2023) by the MBO (most Samoyl ve tkant) s.s. (Turkey)

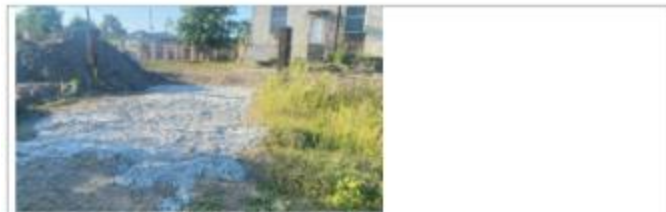
Concrete spill

All these conditions have to be remedied within 10 days by the prime Contractor **CM23**

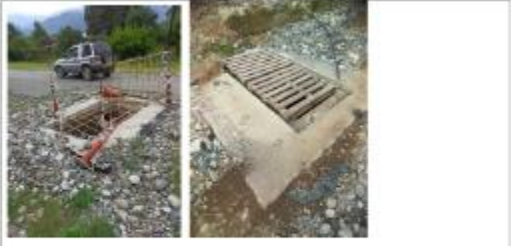
Unacceptable housekeeping

Mixhole improper cover

All these conditions have to be achieved within 14 days by the contractor <u>AZ-Jahat-S</u>	
Date of site visit: 18.08.2023	
State: Rheinland - Administrative operation: "LAG09"	
Kommun: Rheinbach - Environmental subcategory: "DWS02"

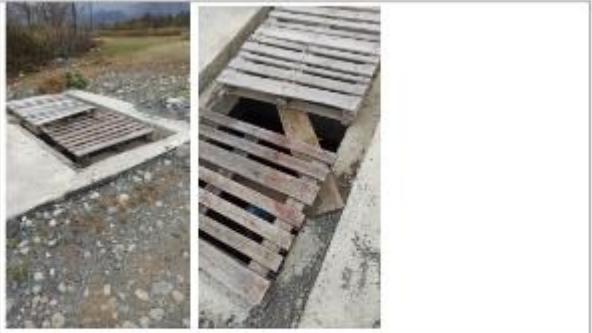
Solid waste beside the road	
Manhole improper cover

All these conditions have to be remedied within 14 days by the prime Contractor <u>AZ-Instaat-N</u>	
Date of site visit: 16.11.2024	
Shahin Bostkashvili - Environmental specialist - "SA/EGE"	
Ketevan Chomakhidze - Environmental specialist "UWSCG"

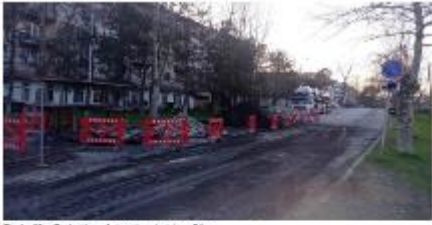
Photo #1 and Photo #2 – Site fence to protect the trenches installed

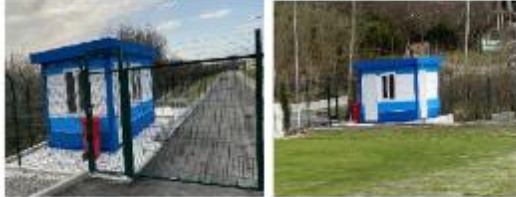
Figures 5 and 6: Ingiri PS

23. The territories were restored in a timely manner, the removed topsoil was used for the rehabilitation works. The local roads of all objects are improved.
24. Soil piles with already planted grass was laid on the territory of the Bashi reservoir and PS Ingiri. Small sections of the ground access roads to the facilities were also restored.
25. Both, the hazardous and household waste was totally disposed from the project zone. Besides, the construction techniques and construction materials were removed as well, and lighting poles were installed all over the area.
