SEMI-ANNUAL ENVIRONMENTAL MONITORING REPORT

(Reporting Period: July-December 2023)

**GEORGIA: URBAN SERVICES IMPROVEMENT INVESTMENT PROGRAM
(TRANCHE 5)**

Post - Construction Environmental Audit Report

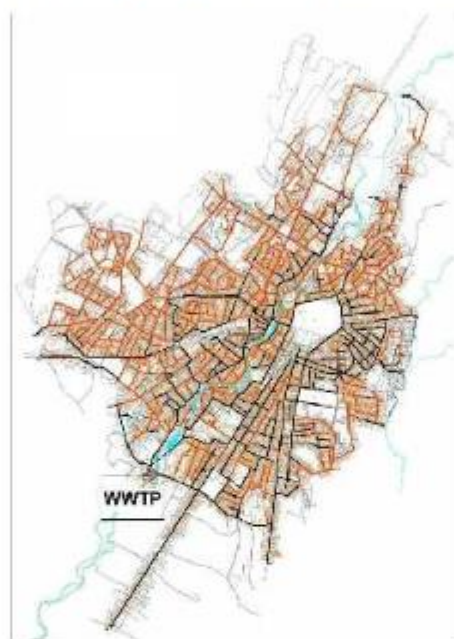
MAP 2: Design of Zugdidi Sewerage System

14. The design of the Zugdidi sewage collection system is presented in the map below.

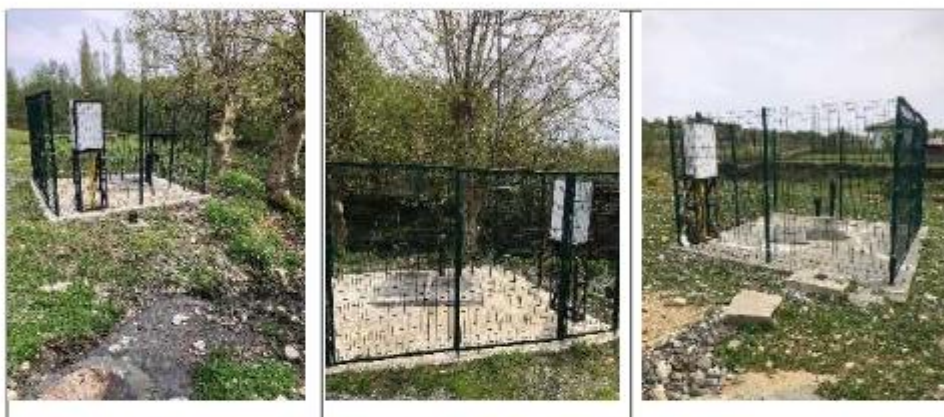
- In general, no signs, information and Specification plate, warnings and numbering are available on manholes and stations. (see Pic 1-3).

N	Non – Compliances	Problem Cause	Corrective actions	Related Photos	Terms of accomplishment
					Responsibility
1	Signs, information and Specification plate, warnings and numbering	Locations cannot be identified Dangers is not warned. Stations cannot be identified	Information plates to be installed

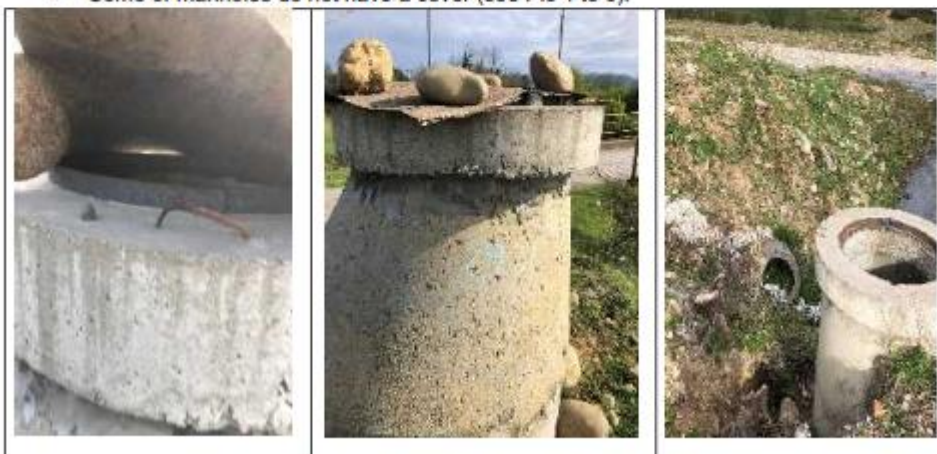
- Some of manholes do not have a cover (see Pic 4 to 6).

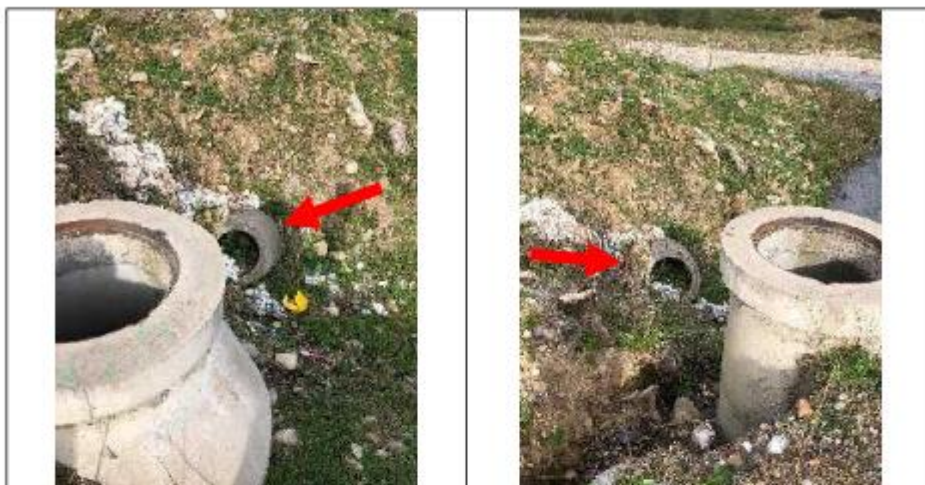
- Previous piping system of old plant has not been removed or blocked (see Pic 7 -8).

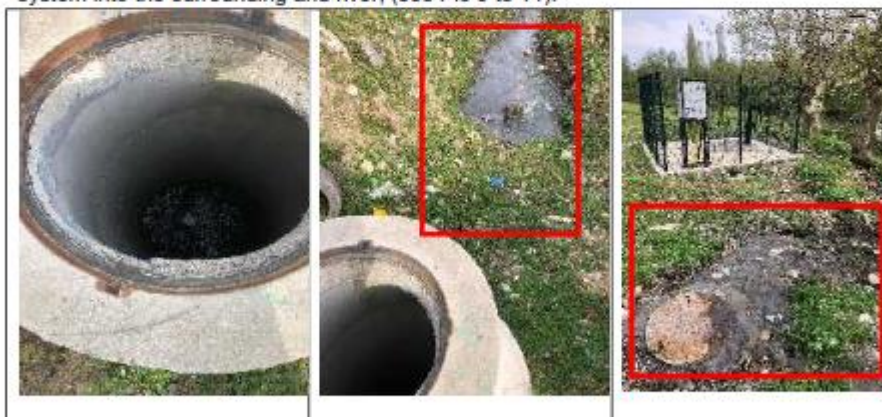
- A few constructed manholes are blocked therefore sewage water is flowing out of the system into the surrounding and river; (see Pic 9 to 11).

End of March UWSCG Included in defect remediation works
4	Blocked pipes	Some parts of the pipes are blocked by foreign objects and causes untreated sewage water to overflow into the	Blocked pipes to be cleared and provide proper covers for manhole s to prevent it from happening again. Daily check and maintenance of the pipelines and <u>manholes</u>

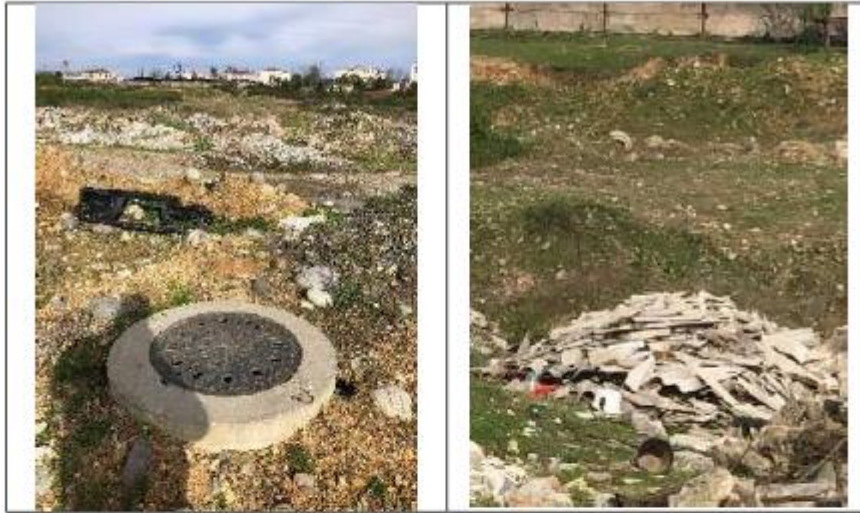
- Surplus waste soil and debris were piled up at different areas (see Pic 12 - 13).

N	Non – Compliances	Problem Cause	Corrective actions	Related Photos	Terms of accomplishment
					Responsibility
7	Surplus soil and debris	Visual pollution “Law on Soil Protection” provides the policy requirements and principles of the protection and preservation of fertility soil resources against negative impacts.	All garbage and debris to be collected, separated and disposed according to Georgian Law

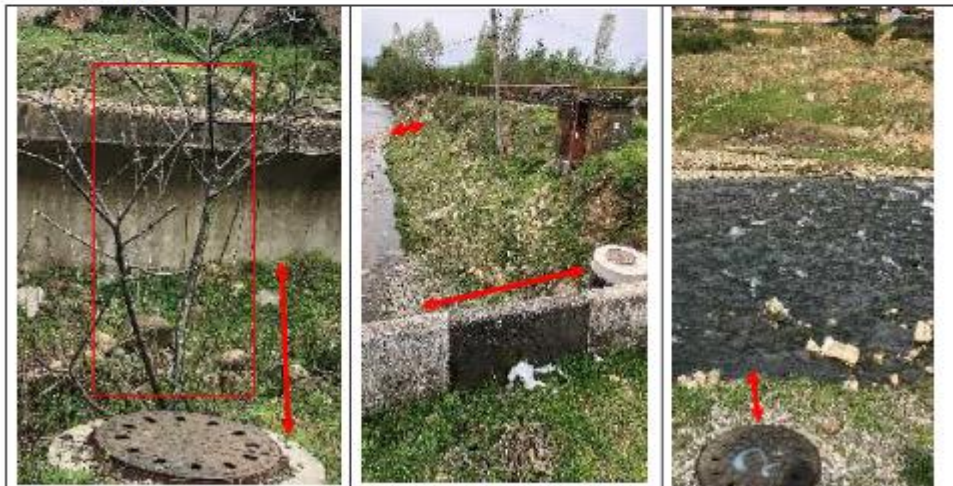
- Due to abundant atmospheric precipitation and intense snow melting since the construction of the project, the width of the Mestiachala River has increased therefore distance of a few manholes decrease below required standard. (see Pic 14 to 16).

N	Non – Compliances	Problem Cause	Corrective actions	Related Photos	Terms of accomplishment
					Responsibility
		surrounding environment	training		
5	Reduction, of distance between sewage pipe manholes and river	<p>Article 20 (Law Of Georgia On Water - River water protection zone) of Protection of natural resources of the Black Sea, defines protection zone of a river shall be its adjacent territory, where a special regime is established to protect water resources from pollution, littering, fouling, and depletion.</p> <p>This zone may include its dry bed, adjacent terraces, natural elevated and steep riversides, as well as gullies directly adjacent to riversides.</p> <p>The width of a river water protection</p>	<p>As per mentioned article, minimum distance shall be 10 m, therefore one of the following actions should be confirmed and executed;</p> <p>Relocate manholes to a distance more or equal to the standard;</p> <p>Block manhole and install new one at another place.</p> <p>(Suggestion: A team of design engineers investigate the problem and find the best solution according to the process requirement).</p>

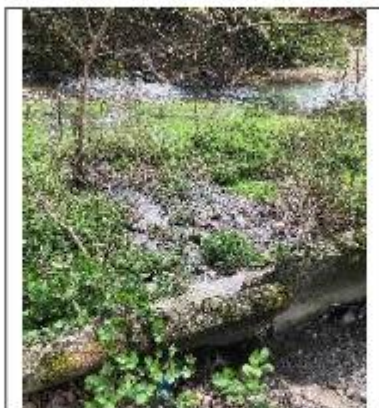
- Cement blocks near river acting as a barrier are damaged (see Pic. 17)

N	Non – Compliances	Problem Cause	Corrective actions	Related Photos	Terms of accomplishment
					Responsibility
		<p>zone shall be measured in meters from the edge of a riverbed to both sides under the following procedure:</p> <p>10 meters - in the case of a river up to 25 kilometer s long,</p> <p>20 meters - in the case of a river up to 50 kilometer s long,</p> <p>30 meters - in the case of a river up to 75 kilometer s long,</p> <p>50 meters - in the case of a river over 75 kilometer s long.</p>			
6	Damaged and broken cement blocks	These cement blocks were installed for the purpose of creating a barrier between river and land	All damaged ocks to be repaired or replaced

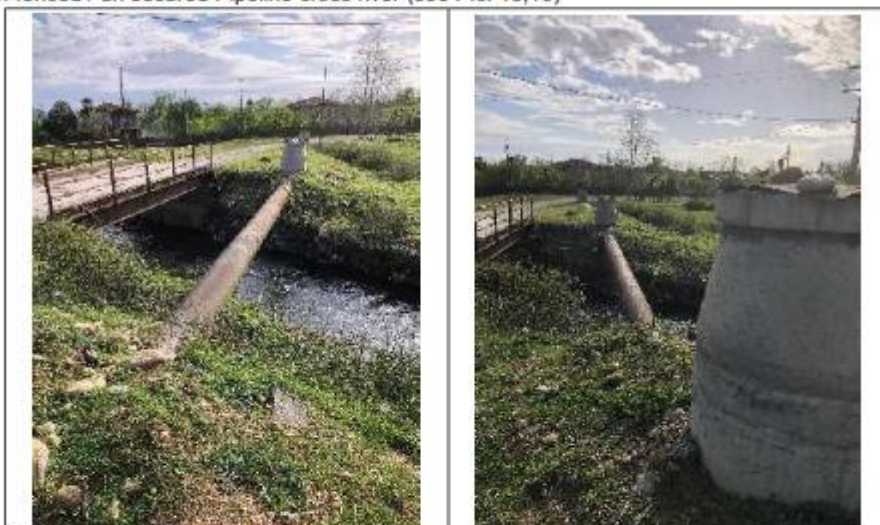
- Un-fenced / un secured Pipeline cross river (see Pic. 18,19)

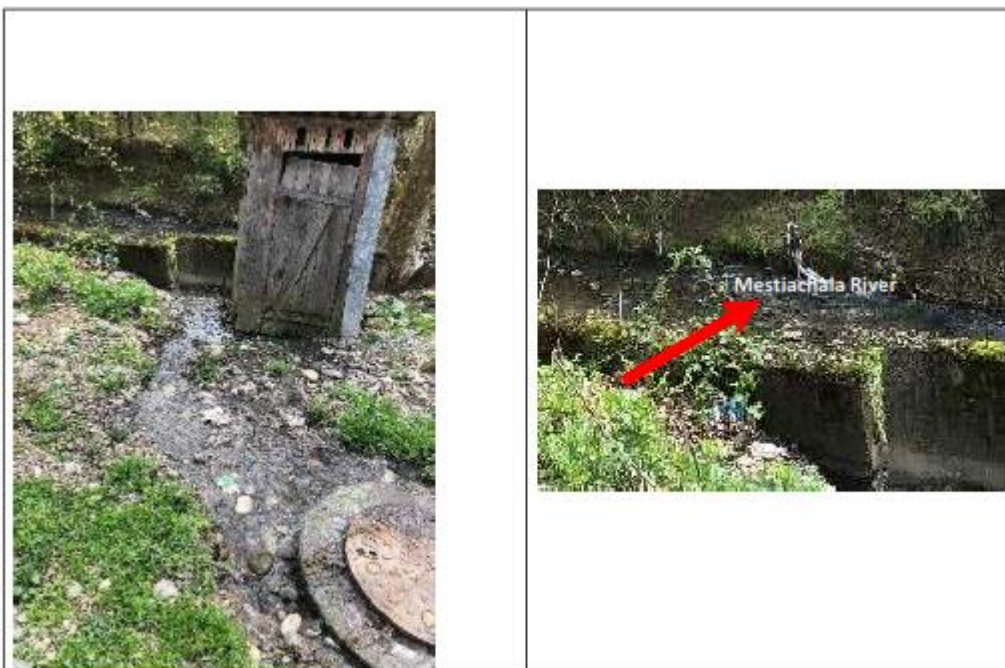
- An old ruined toilet used by students of the nearby school (see pic. 20,21)

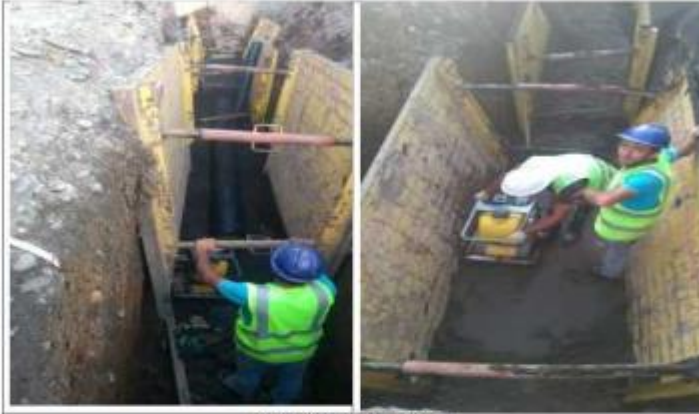
Walls of the deep trenches

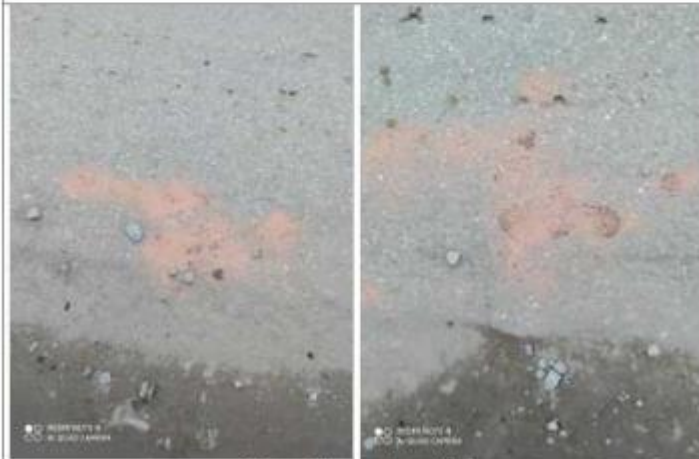
Manage oil-contaminated soil

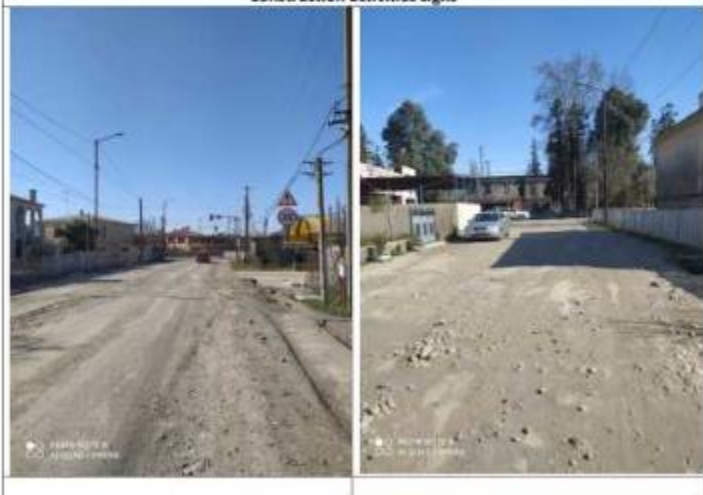
Construction activities signs

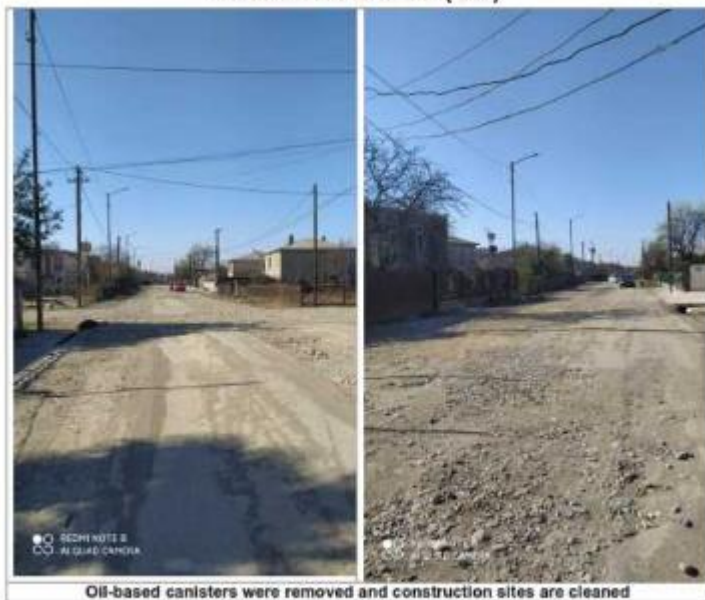
Oil-based canisters were removed and construction sites are cleaned

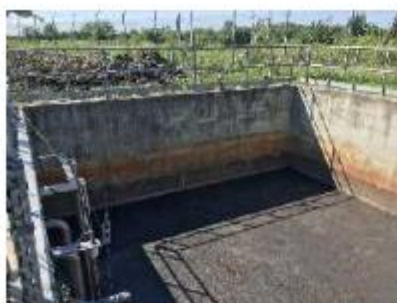
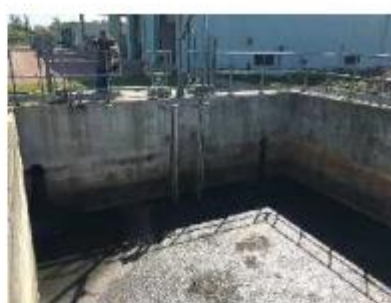
27. Since August 2022 one out of two fine screens is not operative anymore. It is mechanically damaged and there is no contractor to repair or exchange them.
- 28.
29. However, the screens have been investigated and it is clear which parts would be needed that so that UWSCG can repair them. It is proposed to directly order these part from the supplier until the end of December 2023.
30. In the absence of the digester and the sludge centrifuges a temporary sludge removal is established by UWSCG. Sludge is removed as follows: Primary sludge is thickened in the thickener and overflows from the thickener into the drainage pump sump, as no Primary Sludge (PS) can be withdrawn from the thickener. From hat drainage sump the scum layer is removed (by excavator!) to the emergency sludge storage hall for drying.

Drainage pump sum with scum layer after excavation end September 2023

32. In order to address the above-mentioned non-compliances, including the completion of the centrifuge, the gas line, the heating system for digester and the gas holder, as well as ensuring smooth operation of the fine screen, UWSCG and SC/Posch have decided to go for local contract of all works and services, which will take max. 4-6 months. To achieve this goal, at the end of January 2024, the Supervision Consultant/ Posch prepared and submitted to the UWSCG tender documents for the emergency procurement of all the above services and works, which will ensure that all defects are eliminated, including sludge dewatering and that all problems identified during the preliminary commissioning of the WWTP will be finally improved (for more details please see Annex B – Post-construction Audit Report for REG-03a sub-project).

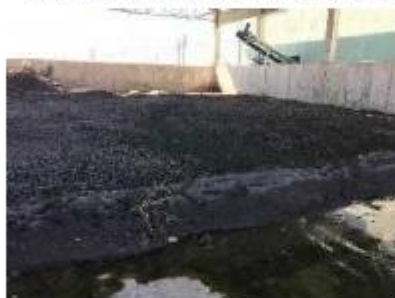
- Sludge from drain sump is stored in the sludge storage area (about 100m³), and some sludge was buried in the trench next to the drainage sump (about 50m³):

Sludge storage area

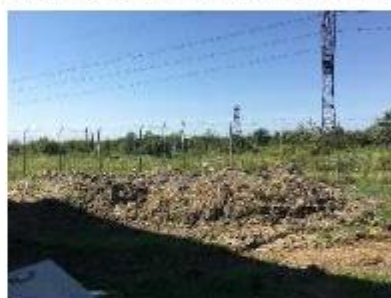
Sludge dump next to storage hall

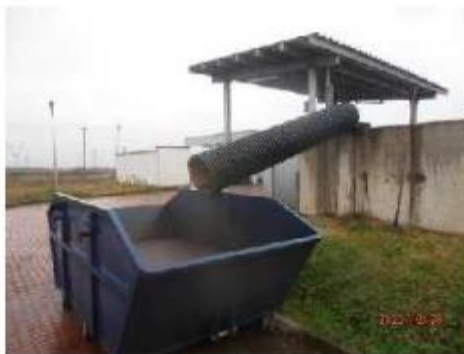
31. Excess sludge (secondary sludge) is pumped from the Return Sludge into the sludge storage sump. From time to time a small volume is withdrawn via a hose connected to the socket for the manometer and pumped to the emergency sludge storage hall where it is dried and disposed at the dump site as above.
32. Another portion of excess sludge (mainly floating sludge and scum) is manually removed from the open outlet/collection channel of the aeration tanks.

Dried sludge at emergency storage hall
