# Semi-Annual Environmental Monitoring Report

(Reporting Period: January-June 2024)

Loan Number: 3238 - GEO Project Number: 43405-025

GEORGIA: URBAN SERVICES IMPROVEMENT INVESTMENT PROGRAM

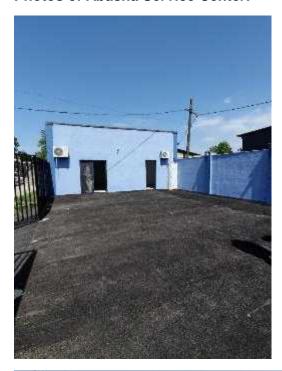
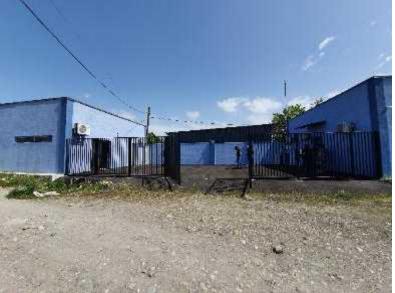
# **Photos of Abasha Service Center:**

- 26. Details regarding the observed non-compliances are presented in Table N1 below. These non-compliances primarily pertain to the storage and management of hazardous and non-hazardous waste, which were mixed and uncontrollably disposed of within the service center's premises. All identified non-compliances have been rectified within the stipulated deadlines and are documented in the table below, accompanied by corresponding improved photographs. There are no more any pending issues remained and all non-compliances have been resolved and closed.

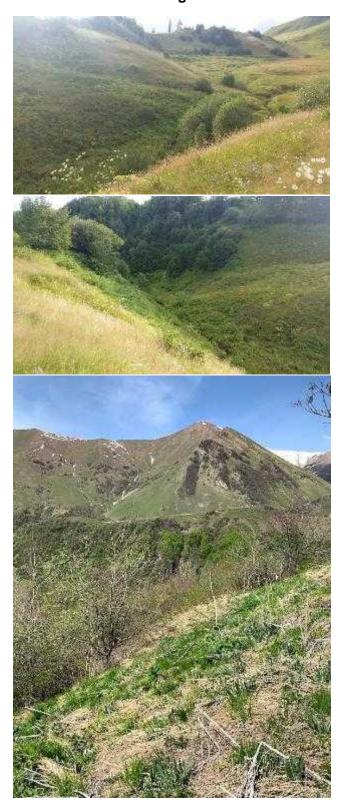
Figure 1. Photos of WWTP 5 Location

UWSCG has submitted change order N1 to cancel construction of WWTP 5. No works has been commenced on location of WWTP 5. As a result, no construction activities have begun at the planned site for WWTP 5, leaving the land in its original, undisturbed state. The photos of WWTPN5 is provided in the Fog.1 below.

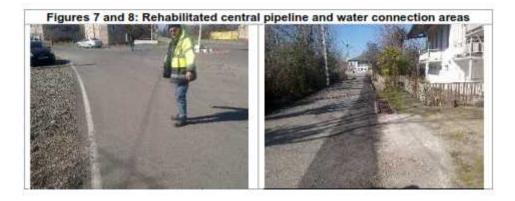
- 42. The project considered both the laying of a 15 km central water pipe and the connecting of subscribers to the central water pipeline.
- After project completion, both the central pipeline buffer and water connection areas were fully restored by the construction contractor (Figures 7 and 8).

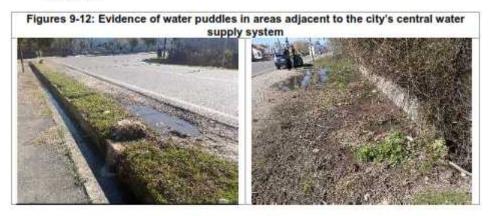
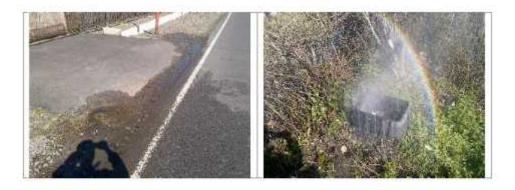
44. On the other hand, as seen in Figures 9-12, possible water leakage was observed in several locations along the newly installed pipeline. There is a possibility that the puddles of water shown in the Figures are caused by a damaged water pipe. However, without appropriate evidence, it is not possible to establish the said fact as non-compliance. On the other hand, the said fact cannot be ignored, because maybe not very high, but there is still a risk that the said puddles were caused by drinking water leaking from the central water pipe.

- 55. Depending on the level of non-compliance there is no need to hire a contractor. Rather, UWSCG can develop and implement corrective actions with its own personnel.
- 56. Instrumental studies should be conducted as soon as possible to determine the source of water puddles near the central water main.
- 57. If the studies confirm that the source of the existing puddles is due to damage to the central water main, an appropriate procedure should be developed and the cause of the puddles should be eliminated.

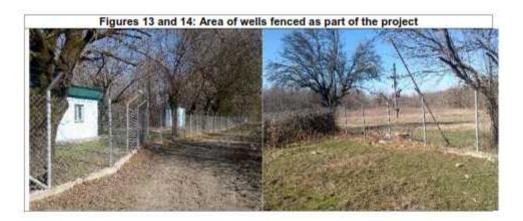
45. The well area is fenced and access by unauthorized persons and pets is restricted (Figures 13-14).
