Semi-annual Environmental Monitoring Report

#17 Semiannual Report

(Reporting Period: January-June 2024)

**GEORGIA: URBAN SERVICES IMPROVEMENT INVESTMENT PROGRAM
(TRANCHE 4)
(FINANCED BY THE ASIAN DEVELOPMENT BANK)**

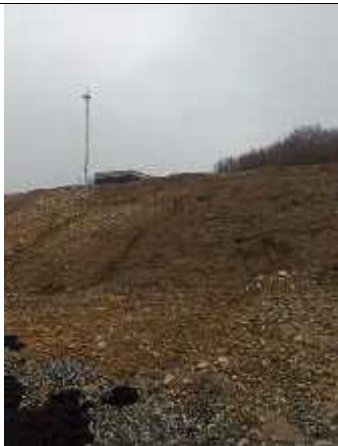
#	Non-compliance	Corrective action	Construction Site	Terms of accomplishment	Responsibility	Status
Jvari Reservoir						
1	Prevent access of public to the reservoir site - the fence of the reservoir should be completed and equipped with signs, information and warnings	Reservoirs sites should be equipped with proper fence

End of June 2024	UWSCG	Completed in June 2024

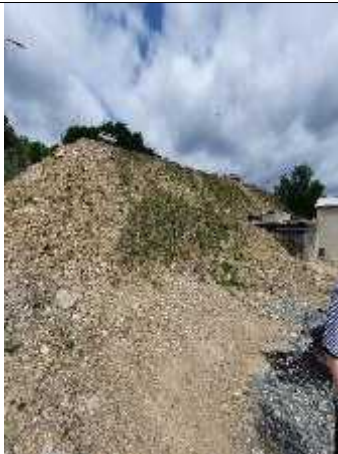
Reservoirs sites should be equipped with proper warning and information signs

End of June 2024	UWSCG	Not yet Completed will be implemented in July 2024
2.	Waste	nstruction		End of	UWSCG	Completed, end of

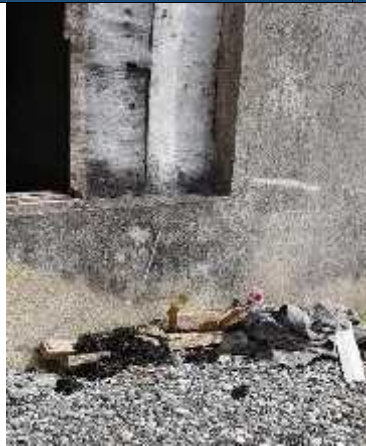
#	Non-compliance	Corrective action	Construction Site	Terms of accomplishment	Responsibility	Status
	management at the reservoir site: Remains of construction waste are not removed and not properly disposed	waste should be removed completely and disposed properly

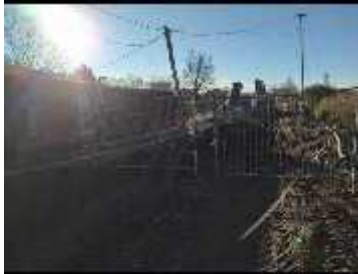
Date of Visit	Name of Company	Auditors Name	Purpose of audit	Summary of any Significant Findings	Cross Reference to Audit Report	Status of implementation
Continuously during reporting period (January-June 2024)	POT-01/LOT-01/LOT-02/LOT-03	Environmental Specialist of SC Mr. Shalva Bosikashvili	Day to day monitoring of sites Compliance with Environmental and HES requirements	Poor housekeeping Safety issues on construction sites	Monthly Monitoring Reports	Completed on the monthly basis
16 January 2024	Contractor: "MBD Inssat" (Turkey). POT-01/LOT-02	Environmental Specialist of SC Mr. Shalva Bosikashvili Ms. Kate Chomakhidze USIIP/Environmental Specialist	Monthly Monitoring of Sites	Open pit without warning signs and barriers, Photo N1

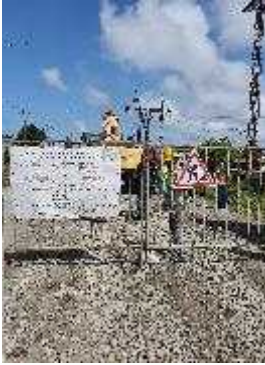
Worker without PPE in the trench, Photo N2	Non-compliance notice were issued to contractor and corrective actions were required from contractor to immediately improve the situation, under POT-01/LOT-02 sub-project (Please see Annex C)	Completed. February 2024, Photo N1

Completed, end September 2023, Photo N2

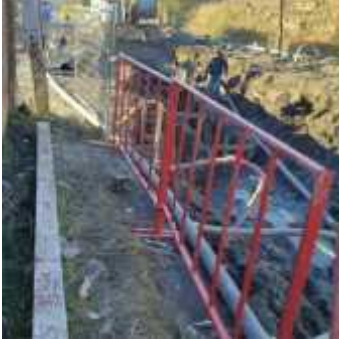
16 February 2024	<p>Contractor: "ECETAS Insaat" (Turkey)</p> <p>POT-01/LOT-01</p>	Environmental Specialist of SC Mr. Shalva Bosikashvili	Regular Monitoring of sites	<p>Open pit without hard barrier and warning signs, Photo N1</p>

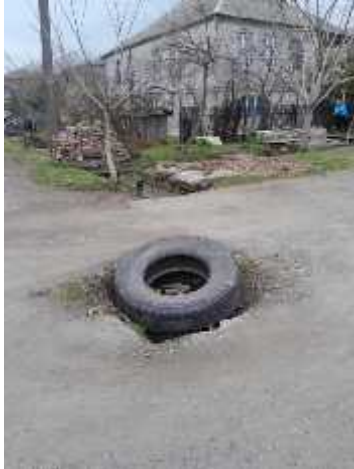
15 February 2024	<p>Contractor: "MBD Inssat" (Turkey).</p> <p>POT-01/LOT-02</p>	<p>Environmental Specialist of SC Mr. Shalva Bosikashvili</p> <p>Ms. Kate Chomakhidze UW SCG/USIIP/Environmental Specialist</p>	Regular Monitoring of Sites	<p>Open pit without warning signs and barriers, Photo N1</p>

<p>Worker without PPE in the trench</p> <p>Construction waste was dumped on the construction area</p>	<p>Non-compliance notice were issued to contractor and corrective actions were required from contractor to immediately improve the situation, under POT-01/LOT-02 sub-project (Please see Annex C)</p>	<p>Completed, February 2024, Photo N1</p>

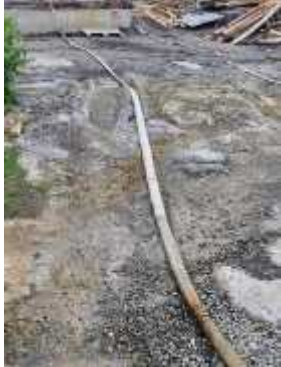
Date of Visit	Name of Company	Auditors Name	Purpose of audit	Summary of any Significant Findings	Cross Reference to Audit Report	Status of implementation
17 May 2024	Contractor: CHINA NUCLEAR INDUSTRY 23 CONSTRUCTION CO” Ltd (China)	Environmental Specialist of SC Mr. Shalva Bosikashvili	Regular Monitoring of sites	<p>WWTP Poti 01 LOT3</p> <p>Concrete spill and unacceptable housekeeping PS12, Photo N1</p>

Completed end of May 2024
17 May 2024	Contractor: “ECETAS Insaat” (Turkey) POT-01/LOT-01	Environmental Specialist of SC Mr. Shalva Bosikashvili	Regular Monitoring of sites	<p>Trench without proper hard barrier and warning sign, deformed shoring Photo N1</p>

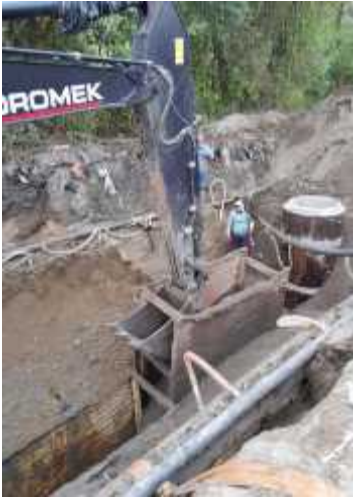
17 May 2024	Contractor: "MBD Inssat" (Turkey). POT-01/LOT-02	Environmental Specialist of SC Mr. Shalva Bosikashvili	Regular Monitoring of sites	<p>WWTP Poti 01 LOT2</p> <p>Worker without PPE in the trench</p>

Non-compliance notice were issued to contractor and corrective actions were required from contractor to immediately improve the situation, under POT-01/LOT-02 sub-project (Please see Annex C)	Completed. End September 2023, Photo N1

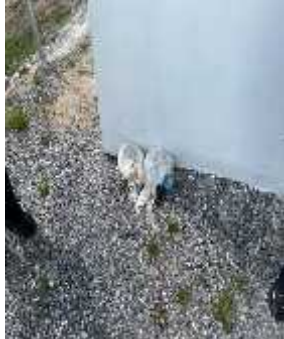
Waste scattered on the reservoir are should be removed and disposed accordingly, Photo N2

Completed, June 2024, Photo N2

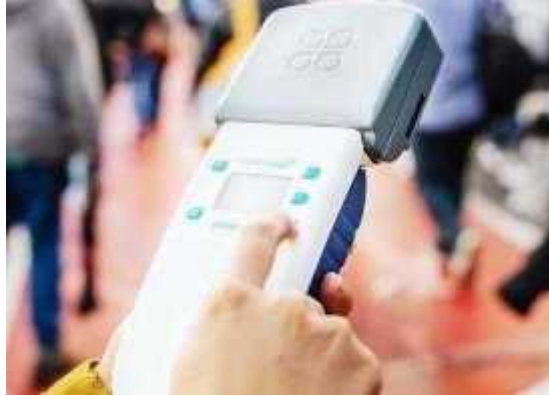
Figure 1: Air Quality Measuring Instrument Aeroqual Series 500

92. For air monitoring, BBE team used 4 different sensors of Aeroqual Series 500 (PM10/PM2.5, CO, NO_x, SO_x).
93. The Series 500 Portable Air Quality Monitor is a handheld portable monitor used to measure up to 30 pollutants using the unique sensor head format. Sensors are housed within an interchangeable cartridge ("head") that attaches to the monitor base. The head can be removed and replaced in seconds, allowing users to measure as many gases as they wish. Sensor heads feature active fan sampling which ensures a representative sample is taken, increasing measurement accuracy.

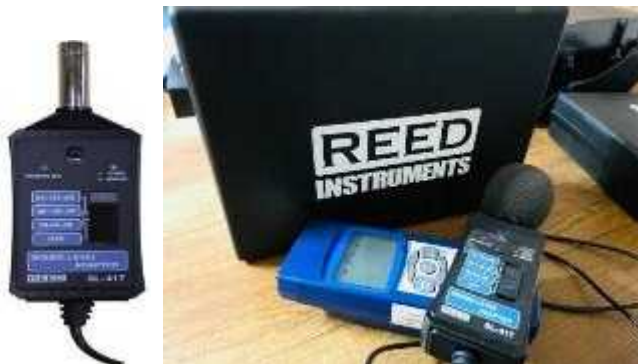
Figure 2: Noise level is determined by the REED INSTRUMENTS 9300 model adapter

- 95. The noise monitoring spot was chosen so it could fully show the impact of construction processes on the population. Noise was monitored for an hour. BBE team used REED instruments 9300 to determine the noise level.
- 96. The sound level meter consists of a calibrated microphone, electronic circuits, and a display. The microphone detects small air pressure variations associated with sound and converts them into electrical signals. The aforementioned signals are then processed using the instrument's electronic circuitry. The display shows the sound level in decibels.
- 97. The sound level meter acquires the sound pressure level at a particular location. A sound level meter is used for acoustic measurements. It is a hand-held instrument with a microphone.

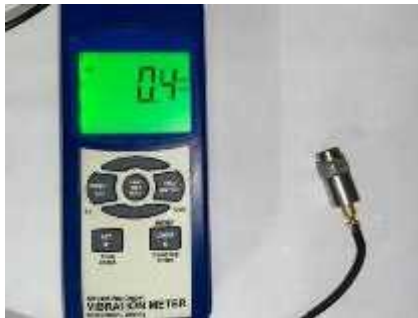
Figure 3: REED instruments SD-8205 model adapter

- 98. Vibration level is determined by the REED instruments SD-8205 model adapter.
- 99. Vibration analysis is a process that monitors vibration levels and investigates the patterns in vibration signals. It is commonly conducted both on the time waveforms of the vibration signal directly, as well as on the frequency spectrum, which is obtained by applying Fourier Transform on the time waveform.

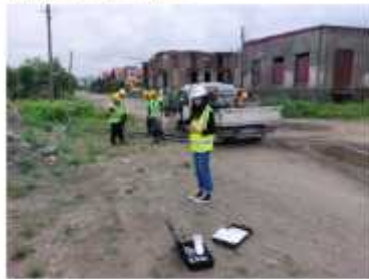
Figure 3.1 Noise (DMM) Monitoring Point

During the monitoring process, all devices were included and the work process was running as full scale.

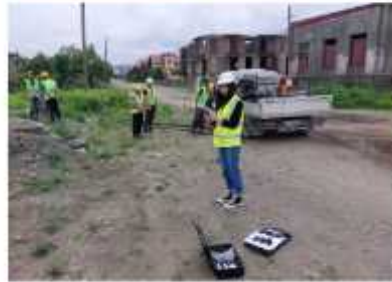
Figure 1.1 Air Quality Monitoring point (AIA #1)

During the monitoring process, all devices were included and the work process was running as full scale.

Parameter	Minimum	Maximum	Average value of measurements	Maximum limit
PM ₁₀	0.000	0.000	0.007	Average: 0.000-0.000 (PM Sensor)
PM _{2.5}	0.000	0.007	0.006	Average: 0.000-0.000 (PM Sensor)
CO	1.0	2.0	2.0	Average: 1.0-2.0 (CO Sensor)
NO _x	0.000	0.000	0.000	Average: 0.000-0.000 (NO _x Sensor)
SO ₂	0.00	0.00	0.00	Average: 0.000-0.00 (SO ₂ Sensor)

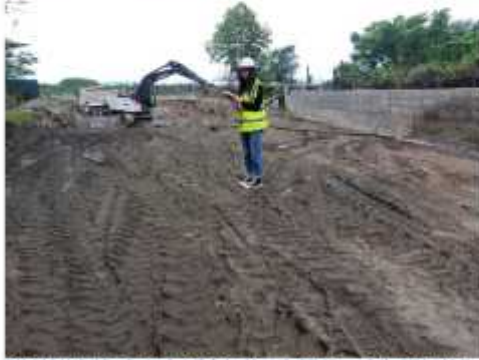
Figure 3.1 Air Quality Monitoring point (AA#- #1)

During the monitoring process, all activities were included and the work process was running at full load.

Parameter	Minimum	Maximum	Average value of measurement	Method used
PM 10	0.025	0.127	0.077	Aerograph 1410/1410B PPM Sensor
PM 2.5	0.005	0.019	0.013	Aerograph 1410/1410B PPM Sensor
CO	0.0	0.0	0.0	Aerograph 1410/1410B CO Sensor
NOx	0.174	0.148	0.134	Aerograph 1410/1410B NOx Sensor
SOx	1.94	2.01	1.90	Aerograph 1410/1410B SOx Sensor

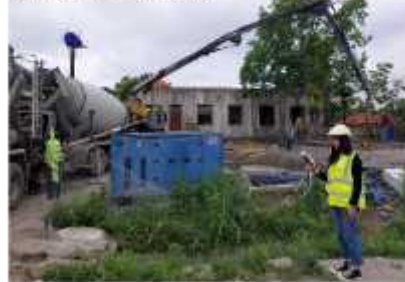
Figure 3.1: Air Quality Monitoring prior AAQ-#1

During the monitoring process, all data were collected and the work process was running as per usual.

Parameter	Maximum	Minimum	Average value of measurement	Method used
PM10	0.07	0.11	0.09	Aerqual 500 Series PM Sensor
PM2.5	0.02	0.03	0.02	Aerqual 500 Series PM Sensor
CO	0.2	0.0	0.0	Aerqual 500 Series CO Sensor
NO ₂	0.06	0.15	0.09	Aerqual 500 Series NO ₂ Sensor
SO ₂	0.04	0.04	0.04	Aerqual 500 Series SO ₂ Sensor

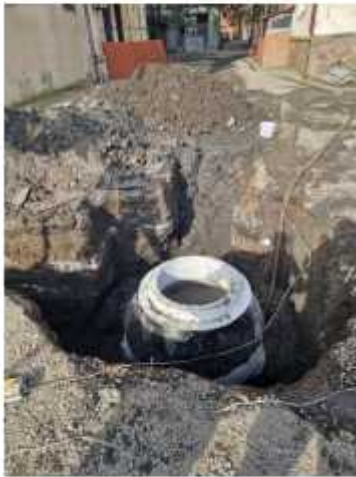
Open pit without hard barrier and warning sign

All these conditions have to be remedied within 10 days by the prime Contractor **ECETAS**.

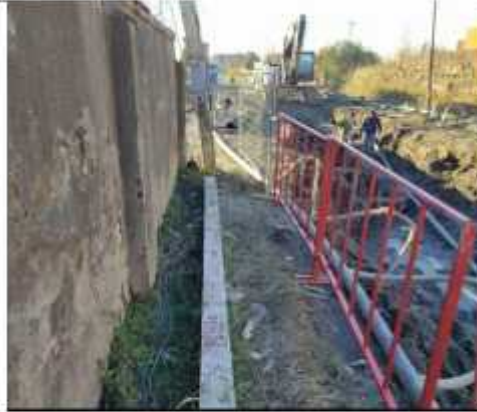
<p style="text-align: center;"><i>Worker without PPE in the trench</i></p>

All these conditions have to be remedied within 10 days by the prime Contractor **MBD**.

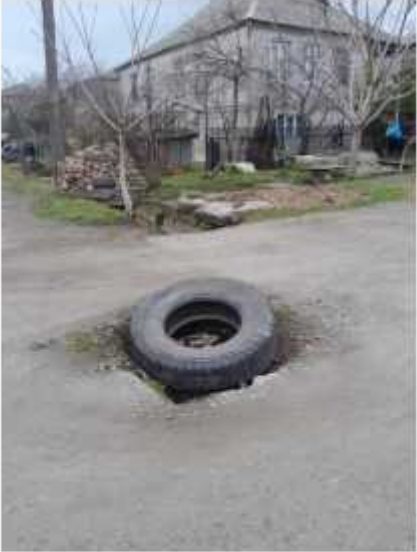
WWTP Poti 01 LOT2	
<ul style="list-style-type: none">• Open pit without warning signs and barriers• Worker without PPE in the trench• Construction waste	
Open pit without warning signs and barriers

All these conditions have to be remedied within 10 days by the prime Contractor **MBD**.

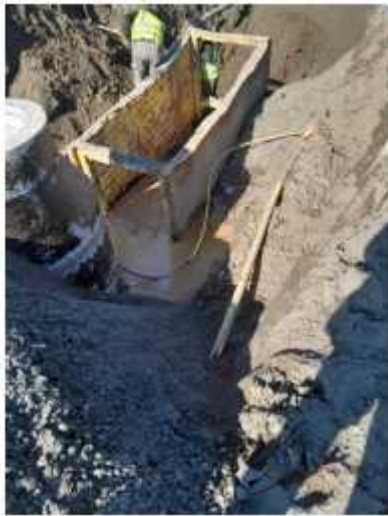
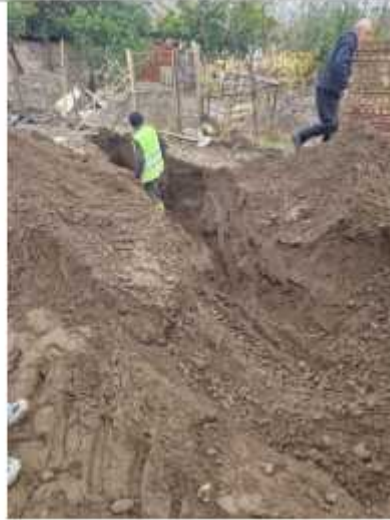
Worker without PPE in the trench

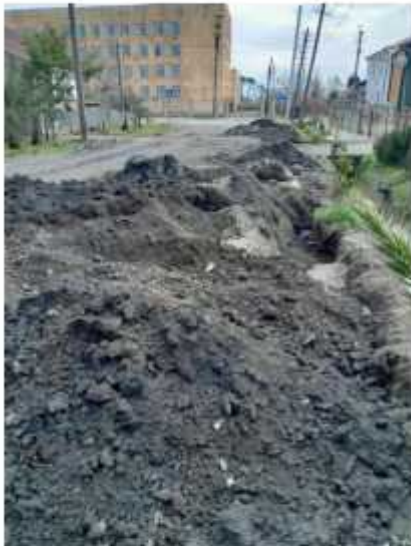
Construction waste

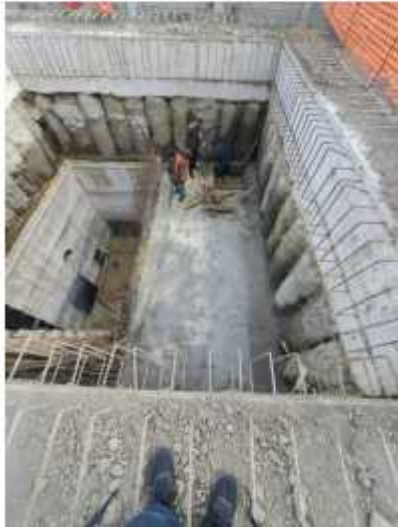
Project: Construction Supervision (under USIIP, Tranche 4 Projects), UWSCG/USIIP/QCBS/02-2014	Non-compliance Notice Poti 01
Contract No: P43405-ICB-POT-01	
Contractor: CNI23	
Reference:	
<p>This notice is to advise the prime Contractor, on the referenced Contract, of the following notice on health, safety and environmental measures to be implemented urgently.</p> <p>GENERAL COMMENT FOR ALL SITES: Site internally should be arranged properly and cleaned regularly. All construction materials and wastes should be properly segregated and stored adequately, Oil spill response kits should be placed at the appropriate locations. Refuelling station should be equipped with the spill kit and fire relevant fighting equipment; drip tray should be used for fuel spillage prevention. Relevant traffic signs and flagmen should control traffic movement properly. PPE wearing is obligatory at the construction site.</p> <p>NON-COMPLIANCE IN POTI 01</p> <p>WWTP Poti 01 LOT3</p> <ul style="list-style-type: none">• Workers without PPE in the pit• Fuel jerry cans without drip tray <p>Unacceptable housekeeping</p>

All these conditions have to be remedied within 10 days by the prime Contractor **CNI23**

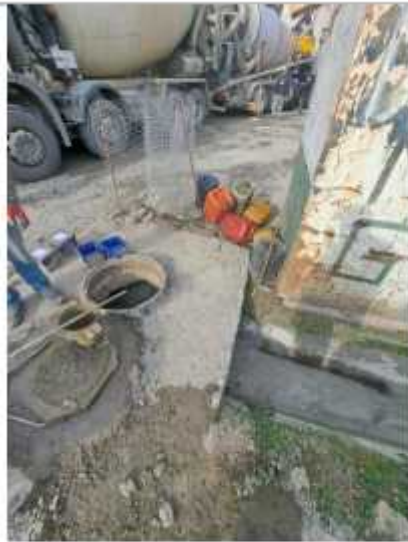
<p>Fuel jerry cans without drip tray</p>

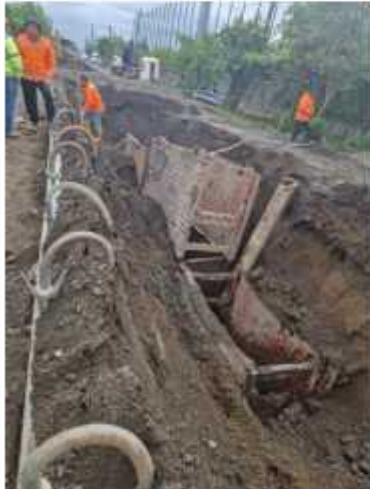
Project: Construction Supervision (under USIIP, Tranche 4 Projects), UWSCG/USIIP/QCBS/02-2014	Non-compliance Notice Poti 01
Contract No: P43405-ICB-POT-01	
Contractor: ECETAS	
Reference:	
<p>This notice is to advise the prime Contractor, on the referenced Contract, of the following notice on health, safety and environmental measures to be implemented urgently.</p> <p>GENERAL COMMENT FOR ALL SITES: Site internally should be arranged properly and cleaned regularly. All construction materials and wastes should be properly segregated and stored adequately. Oil spill response kits should be placed at the appropriate locations. Refuelling station should be equipped with the spill kit and fire relevant fighting equipment; drip tray should be used for fuel spillage prevention. Relevant traffic signs and flagmen should control traffic movement properly. PPE wearing is obligatory at the construction site.</p> <p>NON-COMPLIANCE IN POTI 01</p> <p>WWTP Poti 01 LOT1</p> <ul style="list-style-type: none">• Trench without proper hard barrier and warning sign, deformed shoring, worker without helmet• Worker without PPE in the trench <p><i>Trench without proper hard barrier and warning sign, deformed shoring, worker without helmet</i></p>

All these conditions have to be remedied within 10 days by the prime Contractor **ECETAS**

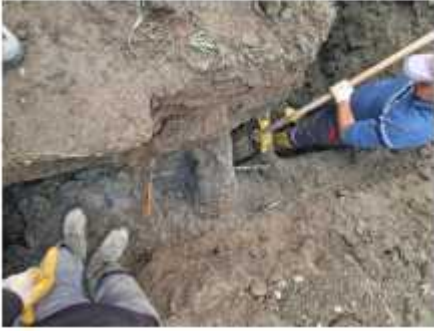
<p><i>Worker without PPE in the trench</i></p>

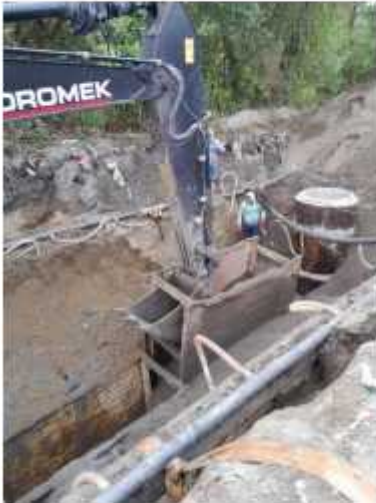
Worker without PPE in the trench

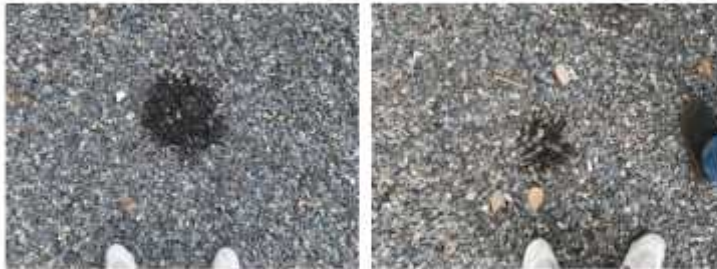
Oil spills at the Reservoir area

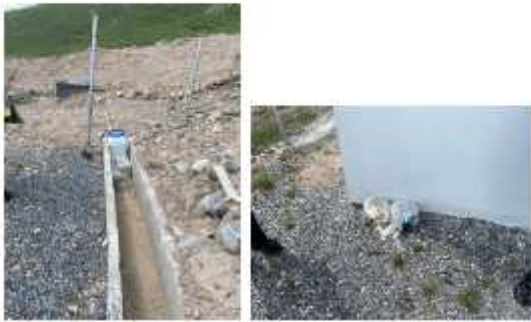
Waste scattered on the reservoir site should be removed and disposed accordingly

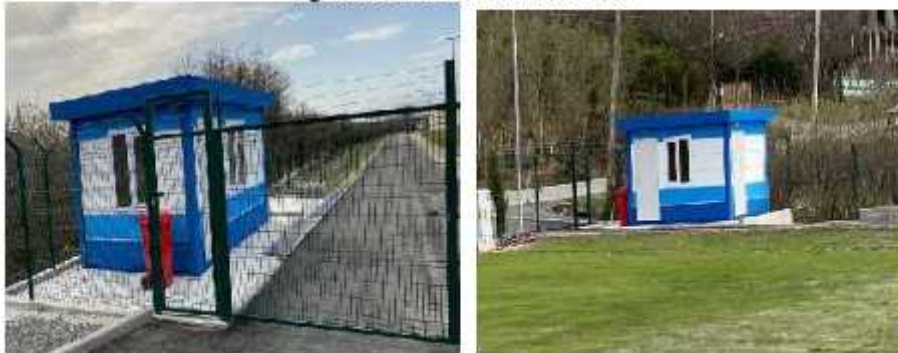
Figures 3 and 4: Bashi Reservoir

22. Reservoir (Bashi), PS (Ingiri) and water wells (Ingiri) were fenced and it was impossible for strangers as well as domestic animals to enter the site (see Figure 3, 4, 5, 6, 7, 8).

23. The territories were restored in a timely manner; the removed topsoil was used for the rehabilitation works. The local roads of all objects are improved.
24. Soil piles with already planted grass was laid on the territory of the Bashi reservoir and PS Ingiri. Small sections of the ground access roads to the facilities were also restored.
25. Both, the hazardous and household waste was totally disposed from the project zone. Besides, the construction techniques and construction materials were removed as well, and lighting poles were installed all over the area.

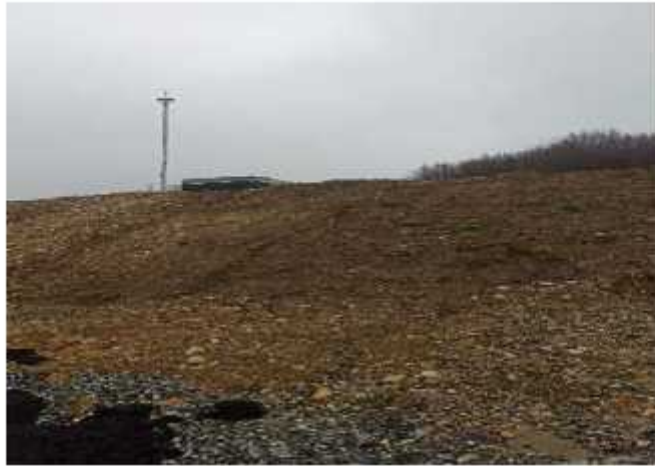
Figure 2: Reservoirs

Reservoirs, PS and water wells (Lia) were fenced and it was impossible for strangers as well as domestic animals to enter the site (**See Figure 2,3,4,5**). The access roads to the mentioned facilities are restored (**See Figure 3**).

The territories of all construction sites were restored in a timely manner; the removed topsoil was used for the rehabilitation works. The local roads of all objects are improved.

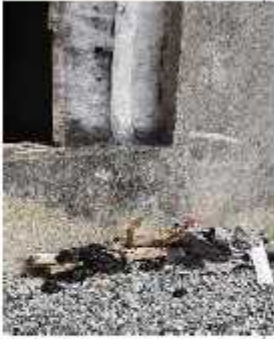
End of June 2024	UWSCG	Not yet Completed will be implemented in July 2024
	Waste management at the reservoir site: Remains of construction waste are not removed and not properly disposed	Construction waste should be removed completely and disposed properly

End of June 2024	UWSCG	Completed end of May 2024 Construction waste removed completely and disposed properly
