SEMI-ANNUAL ENVIRONMENTAL MONITORING REPORT

Project Number: 43405-027

**GEORGIA: URBAN SERVICES IMPROVEMENT INVESTMENT PROGRAM
(TRANCHE 5)**

Post - Construction Environmental Audit Report

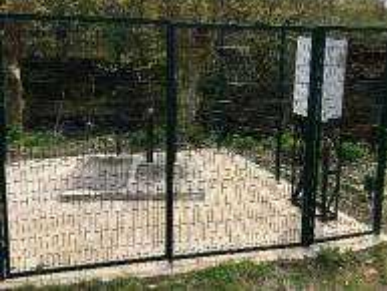
#	Non-compliance / non-conformance	Problem Cause	Corrective action	Documentation	Progress in corrective action I Status June 2024
1	Signs, information and Specification plate, warnings and numbering	<ul style="list-style-type: none"> Locations cannot be identified Dangers is not warned. Stations cannot be identified 	Information plates to be installed

Local service center instructed to install information and warning signs at PS3 and PS5
2	Manhole's cover	<p>Objects and children may fall and drop into manholes.</p> <ul style="list-style-type: none"> Dropped objects may block the pipe Fatality 	New covers to be prepared and placed

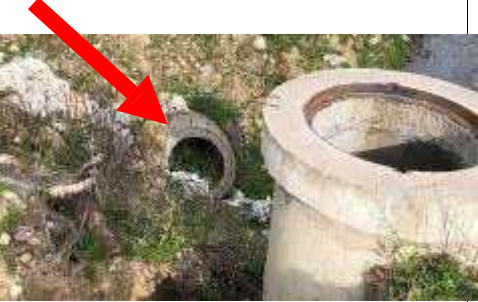
50pcs of MH covers Is included in tender documents for defect remediation
3	Old plant materials	Some of the old plant pipelines are disconnected from the system, but left unattended and remain in the area	All old pipelines to be removed and disposed.

Shall be included in defect remediation works

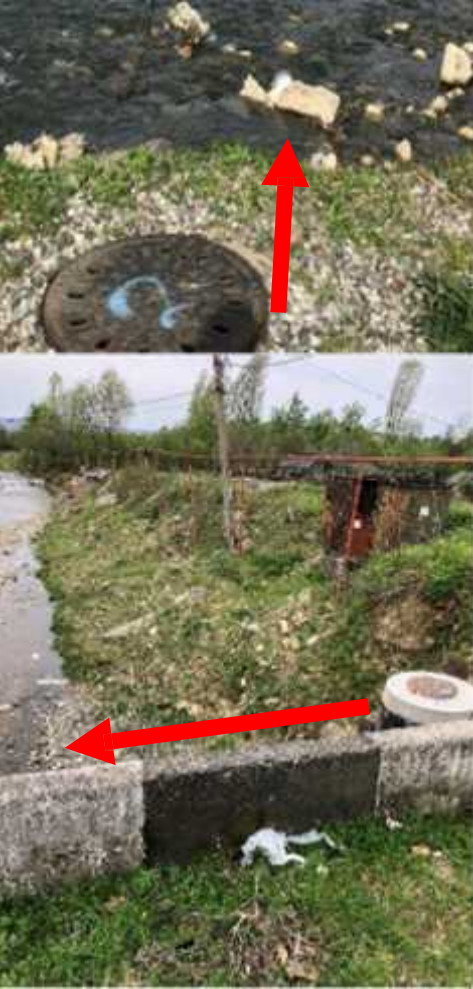
#	Non-compliance / non-conformance	Problem Cause	Corrective action	Documentation	Progress in corrective action Status June 2024
6	Reduction of distance between sewage pipe manholes and river	<p>Article 20 (Law Of Georgia On Water - River water protection zone) of Protection of natural resources of the Black Sea, defines protection zone of a river shall be its adjacent territory, where a special regime is established to protect water resources from pollution, littering, fouling, and depletion. This zone may include its dry bed, adjacent terraces, natural elevated and steep riversides, as well as gullies directly adjacent to riversides. The width of</p>	<p>As per mentioned article, minimum distance shall be 10 m, therefore one of the following actions should be confirmed and executed;</p> <ul style="list-style-type: none"> • Relocate manholes to a distance more or equal to the standard ; • Block manhole and install new one at another place.

<p>Resolving of this problem can not be done at local service center or municipal level, this needs enrolment of Minister of Infrastructure.</p> <p>Additional letter to UWSCG was sent by Supervision/Posch, with best solutions, such as block manhole and install new one at another place.</p> <p>Will be implemented by the end of October 2024.</p>

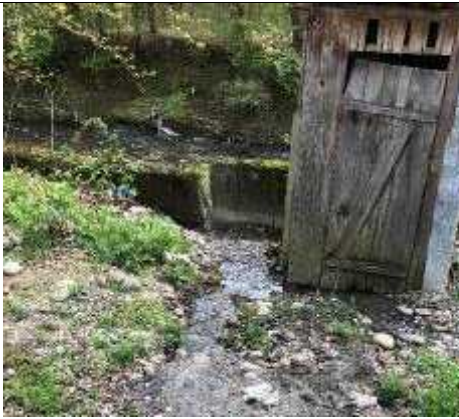
River crossing should be protected from access. Local municipality will resolve the problem by the end of December 2024
9	Old Toilet	Pollutant	This toilet was part of the nearby school and a new one is constructed inside school; therefore, it shall be removed completely.

DONE Old toilet at PS5 (Vajha Phshavela Street) is removed by local municipality in June 2024

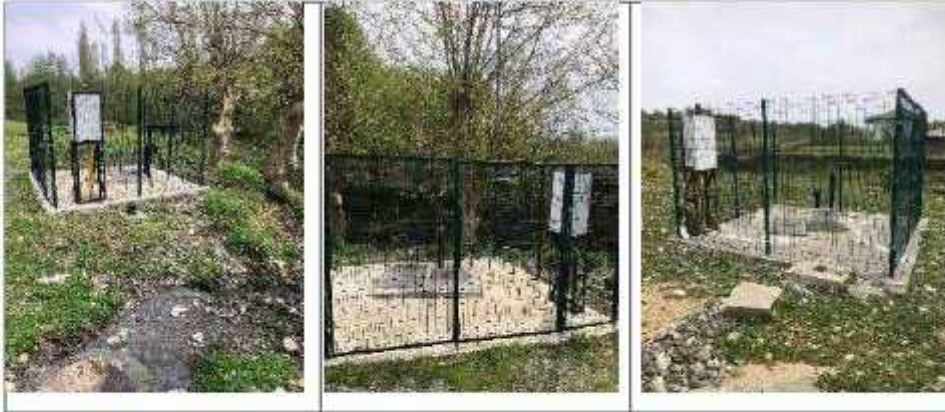
- In general, no signs, information and Specification plate, warnings and numbering are available on manholes and stations. (see Pic 1-3).

#	Non-compliance / non-conformance	Problem Cause	Corrective action	Documentation	Progress in corrective action I
					Status June 2024
1	Signs, information and Specification plate, warnings and numbering	<ul style="list-style-type: none"> Locations cannot be identified Dangers is not warned. Stations cannot be identified 	Information plates to be installed

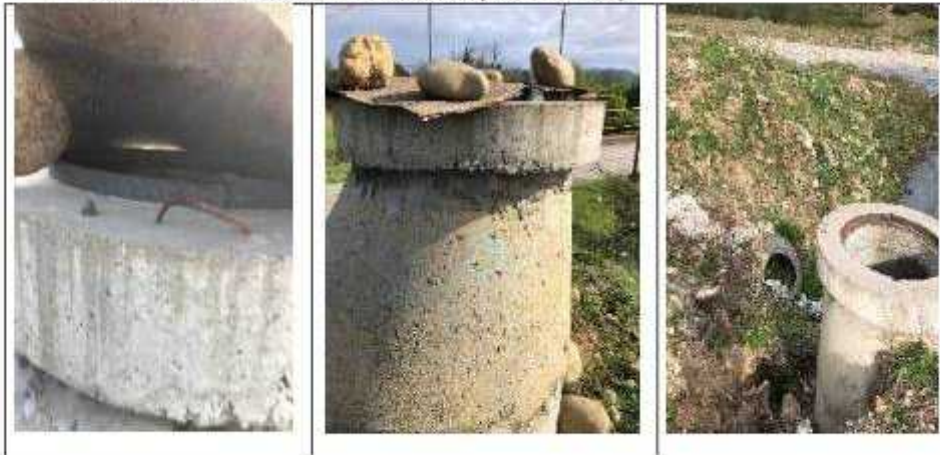
- Some of manholes do not have a cover (see Pic 4 to 6).

50pcs of MH covers is included in tender documents for defect remediation
3	Old plant materials	Some of the old plant pipelines are disconnected from the system, but left unattended and remain in the area	All old pipelines to be removed and disposed.

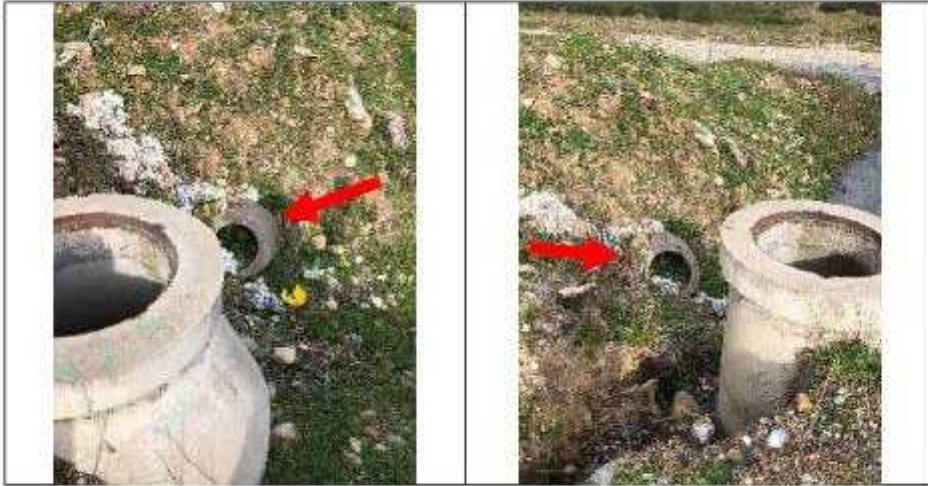
- Previous piping system of old plant has not been removed or blocked (see Pic 7 -8).

Shall be included in defect remediation works

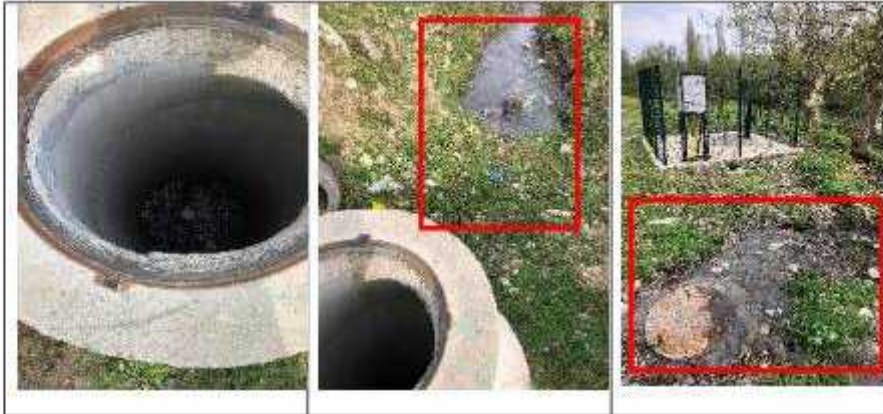
- A few constructed manholes are blocked therefore sewage water is flowing out of the system into the surrounding and river; (see Pic 9 to 11).

#	Non-compliance / non-conformance	Problem Cause	Corrective action	Documentation	Progress in corrective action I
					Status June 2024
4	Blocked pipes	Some parts of the pipes are blocked by foreign objects and causes untreated sewage water to overflow into the surrounding environment	<ul style="list-style-type: none"> Blocked pipes to be cleared and provide proper covers for manholes to prevent it from happening again. Daily check and maintenance of the pipelines and manholes, Training

<p>50% is completed.</p> <p>(problem was solved after putting in operation PS5) Remaining is blocked section of R1 collector, which is included in defect remediation list</p>

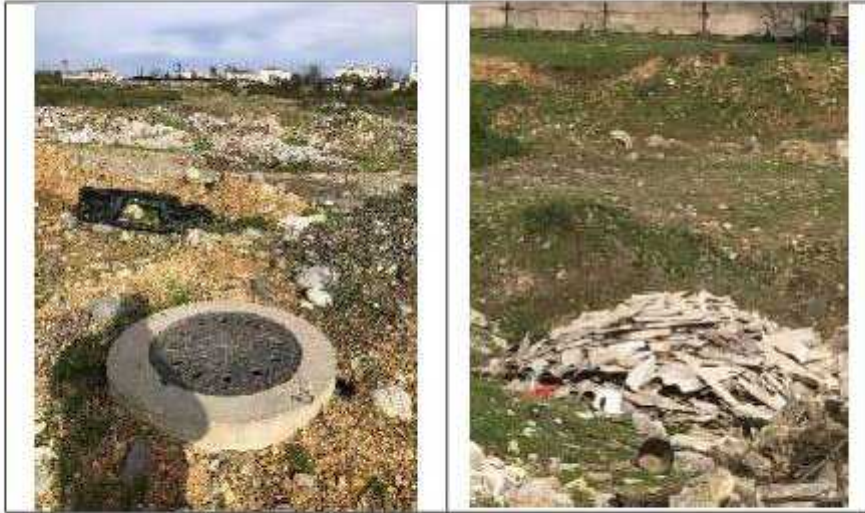
- Surplus waste soil and debris were piled up at different areas (see Pic 12 - 13).

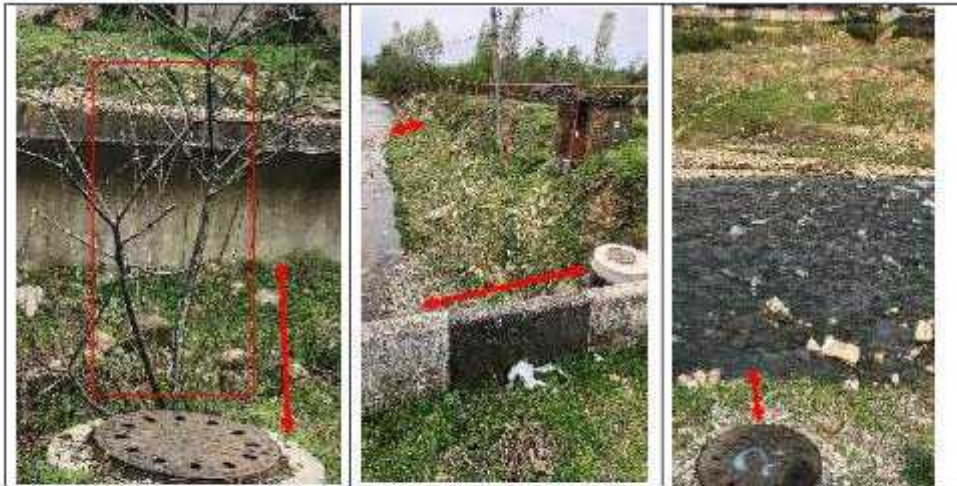
- Due to abundant atmospheric precipitation and intense snow melting since the construction of the project, the width of the Mestiachala River has increased therefore distance of a few manholes decrease below required standard. (see Pic 14 to 16).

#	Non-compliance / non-conformance	Problem Cause	Corrective action	Documentation	Progress in corrective action I Status June 2024
6	Reduction of distance between sewage pipe manholes and river	Article 20 (Law Of Georgia On Water - River water protection zone) of Protection of natural resources of the Black Sea, defines protection zone of a river shall be its adjacent territory, where a special regime is established to protect water resources from pollution, littering, fouling, and depletion. This zone may include its dry bed, adjacent terraces, natural elevated and steep riversides, as well as gullies directly adjacent to	<p>As per mentioned article, minimum distance shall be 10 m, therefore one of the following actions should be confirmed and executed;</p> <ul style="list-style-type: none"> Relocate manholes to a distance more or equal to the standard; Block manhole and install new one at another place. <p>(Suggestion: A team of design engineers investigate the problem and find the best solution</p>

<p>Resolving of this problem can not be done at local service center or municipal level, this needs involvement of Minister of Infrastructure.</p> <p>Supervision/Posch, with best solutions, such as block manhole and install new one at another place.</p> <p>Will be Implemented by the end of October 2024.</p>

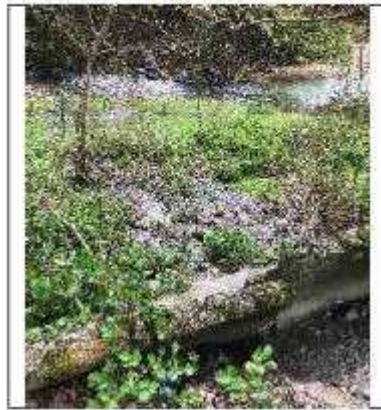
- Cement blocks near river acting as a barrier are damaged (see Pic. 17)

#	Non-compliance / non-conformance	Problem Cause	Corrective action	Documentation	Progress in corrective action I
					Status June 2024
		75 kilometers long.			
7	Damaged and broken cement blocks	These cement blocks were installed for the purpose of creating a barrier between river and land	All damaged blocks to be repaired or replaced

All damaged blocks will be repaired by the end of December 2024
8	Un-fenced pipe	Since pipeline is located near resident areas, children may use it as playground	Fences to be installed at both sides of the pipe

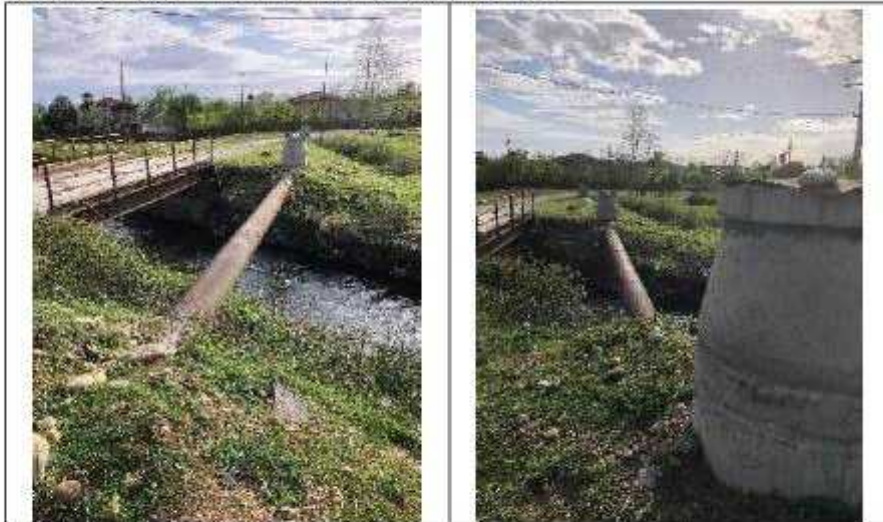
- Un-fenced / un secured Pipeline cross river (see Pic. 18,19)

Bar crossing should be protected to ensure access. Local municipality will solve the problem by the end of December 2024
9	Old Toilet	Pollutant	This toilet was part of the nearby school and a new one is constructed inside school; therefore, it shall be removed completely.

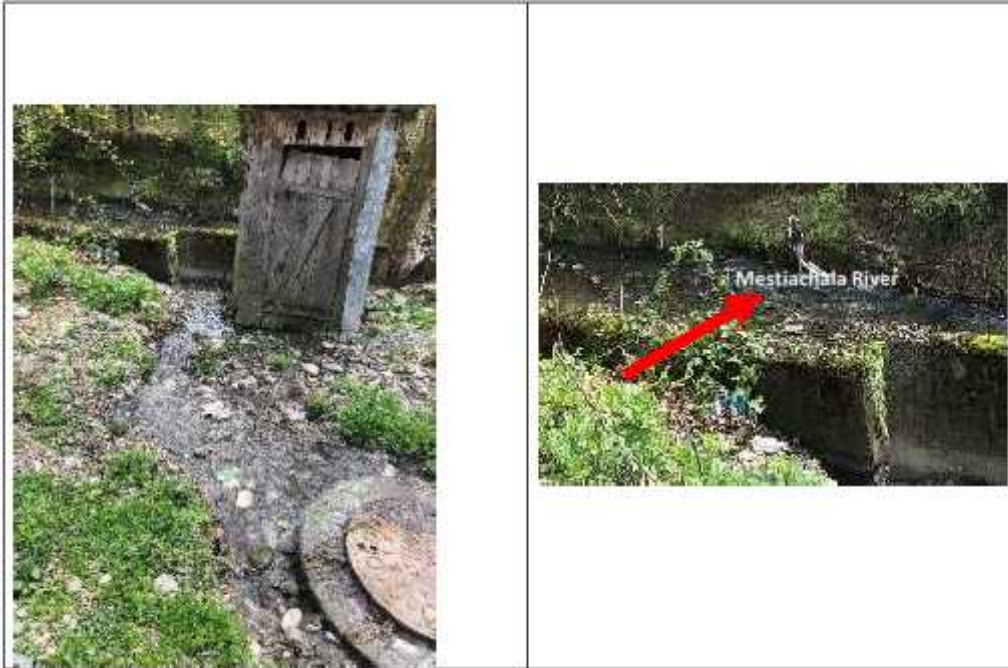
- An old ruined toilet used by students of the nearby school (see pic. 20,21)

DONE Old toilet at PS5 (Vajha Phshavele Street) is removed by local municipality in June 2024

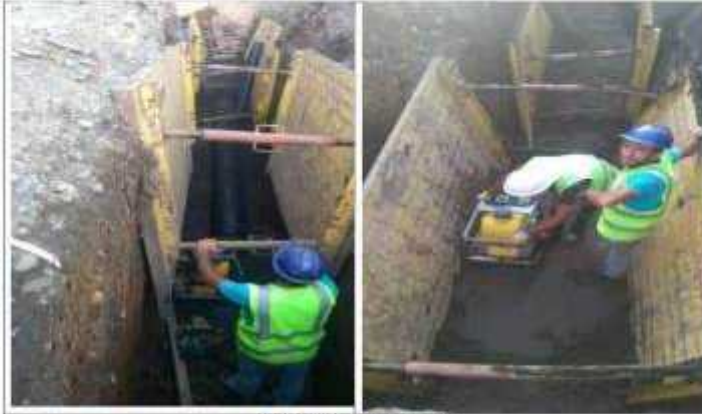
Walls of the deep trenches

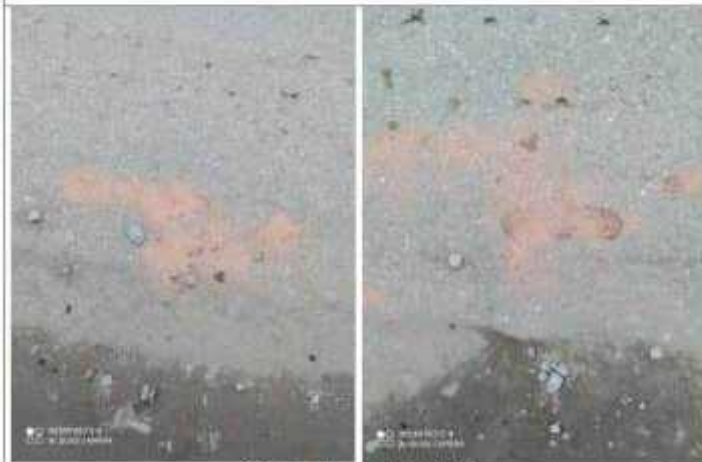
Manage oil-contaminated soil

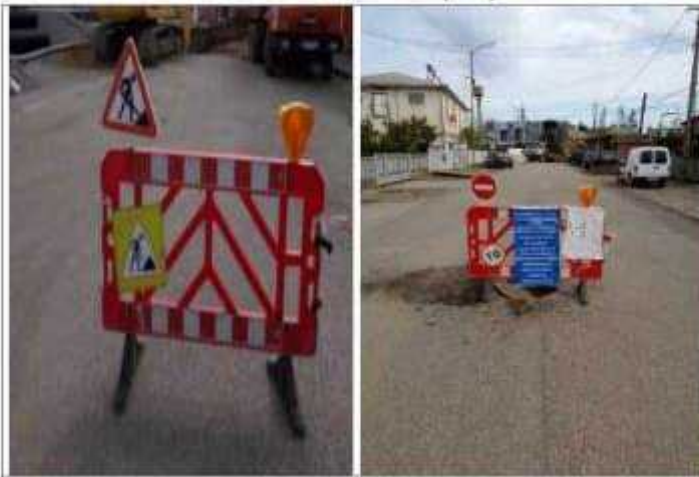
Construction activities signs

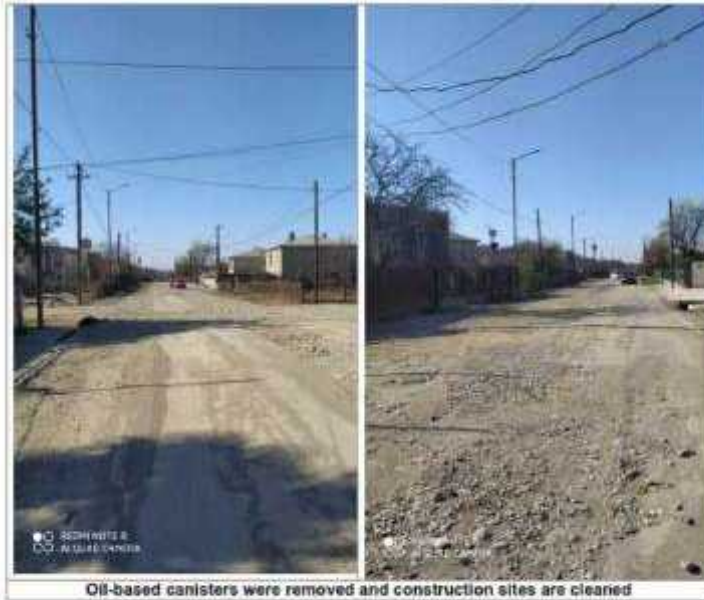
Oil-based canisters were removed and construction sites are cleaned

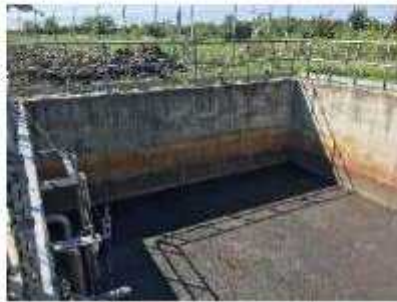
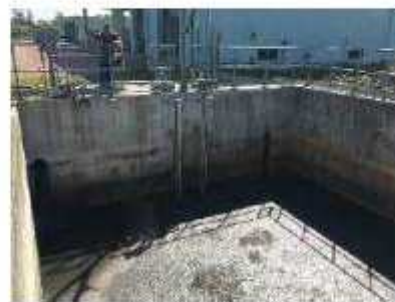
27. Since August 2022 one out of two fine screens is not operative anymore. It is mechanically damaged and there is no contractor to repair or exchange them.
- 28.
29. However, the screens have been investigated and it is clear which parts would be needed that so that UWSCG can repair them. It is proposed to directly order these part from the supplier until the end of December 2023.
30. In the absence of the digester and the sludge centrifuges a temporary sludge removal is established by UWSCG. Sludge is removed as follows: Primary sludge is thickened in the thickener and overflows from the thickener into the drainage pump sump, as no Primary Sludge (PS) can be withdrawn from the thickener. From hat drainage sump the scum layer is removed (by excavator!) to the emergency sludge storage hall for drying.

Drainage pump sump with scum layer after excavation end September 2023

32. In order to address the above-mentioned non-compliances, including the completion of the centrifuge, the gas line, the heating system for digester and the gas holder, as well as ensuring smooth operation of the fine screen, UWSCG and SC/Posch have decided to go for local contract of all works and services, which will take max. 4-6 months. To achieve this goal, at the end of January 2024, the Supervision Consultant/ Posch prepared and submitted to the UWSCG tender documents for the emergency procurement of all the above services and works, which will ensure that all defects are eliminated, including sludge dewatering and that all problems identified during the preliminary commissioning of the WWTP will be finally improved (for more details please see Annex B – Post-construction Audit Report for REG-03a sub-project).

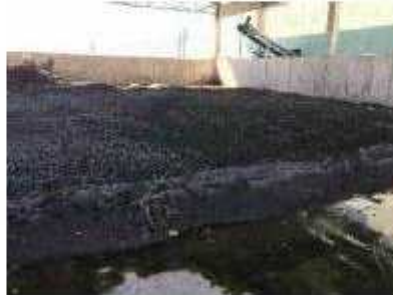
- Sludge from drain sump is stored in the sludge storage area (about 100m³), and some sludge was buried in the trench next to the drainage sump (about 50m³):

Sludge storage area

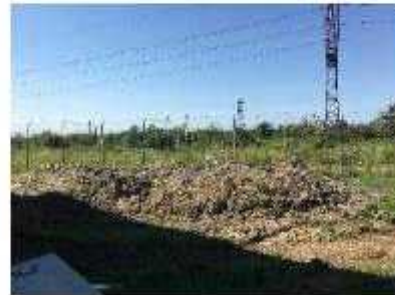
Sludge dump next to storage hall

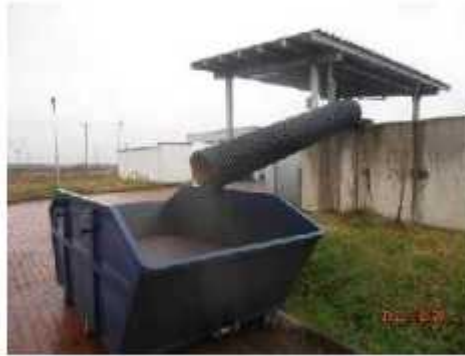
- Excess sludge (secondary sludge) is pumped from the Return Sludge into the sludge storage sump. From time to time a small volume is withdrawn via a hose connected to the socket for the manometer and pumped to the emergency sludge storage hall where it is dried and disposed at the dump site as above.
- Another portion of excess sludge (mainly floating sludge and scum) is manually removed from the open outlet/collection channel of the aeration tanks.

Dried sludge at emergency storage hall
