SEMI-ANNUAL ENVIRONMENTAL MONITORING REPORT

#13 Semi-annual Report

(Reporting Period: January-June 2024)

**GEORGIA: URBAN SERVICES IMPROVEMENT INVESTMENT PROGRAM
(TRANCHE 6)**

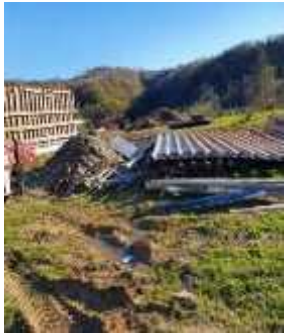
#	Non-compliance	Corrective action	Construction Site	Terms of accomplishment Responsibility	Progress of Corrective Actions
Avarioni Reservoir					
1	Avarioni Reservoir, uncontrolled disposal of construction waste were fixed.	Construction Waste must be collected and disposed from the project area.

UWSCG End of June 2024	Completed June 2024

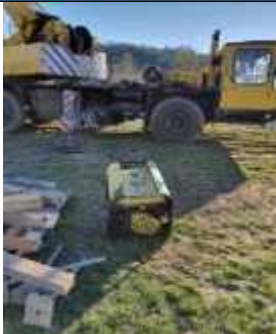
2	Avrioni Reservoir Oil spill Fuels and lubricants spills to be eliminated	Containers with fuel/lubricant should be managed properly (stored at the proper organized		UWSCG End of June 2024	Completed June 2024 No traces of leakage were identified in the project area.

#	Non-compliance	Corrective action	Construction Site	Terms of accomplishment Responsibility	Progress of Corrective Actions
		place with concrete floor and roofing) to avoid leakage and ground contamination.

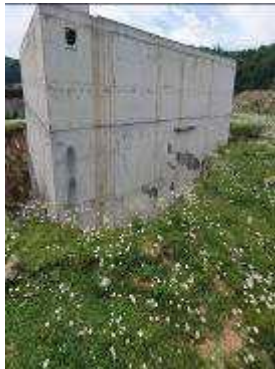
3	Avarioni Reservoir surplus waste soil soil were piled up on the construction area	Avarioni Reservoir surplus waste soil should be removed completely removed from the disposed area

UWSCG End of June 2024	Completed June 2024

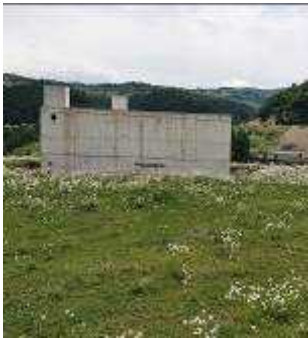
4	Prevent access of public to the reservoir site - The fence of the reservoir should be done properly and equipped with Signs, information and warnings	Reservoirs sites should be properly fenced equipped with proper warning signs

UWSCG UWSCG	Not yet completed ² A new tender will be issued to complete these remaining tasks, with funding provided through the central government budget. UWSCG is responsible for ensuring the completion of the CHI-01 sub-project.

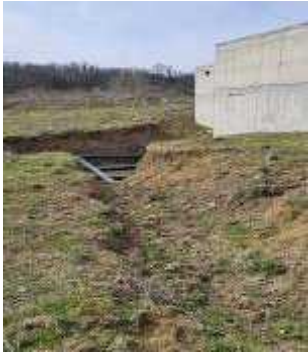
#	Non-compliance	Corrective action	Construction Site	Terms of accomplishment Responsibility	Progress of Corrective Actions
5	There are deep Trenches around the Avarioni Reservoir without Protection	Trenches on the Avarioni Reservoir should be filled or fenced off their borders.

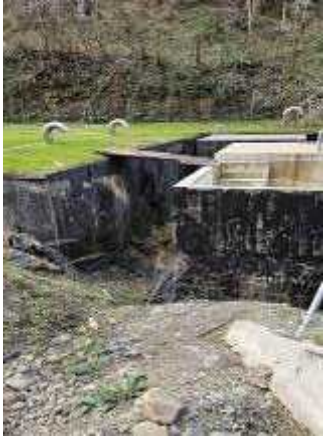
BISI Reservoir and Pumping Station					
6	Open trenches of the BISI Pumping Station are observed	Trenches on the BISI reservoir should be filled or fenced off their borders.

UWSCG	Not yet completed A new tender will be issued to complete these remaining tasks, with funding provided through the central government budget. UWSCG is responsible for ensuring the completion of the CHI-01 sub-project.
7	Uncontrolled disposal of construction waste were outside the BISI reservoir was fixed.	Construction Waste must be collected and disposed from the project area.

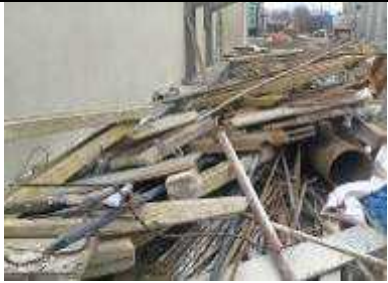
<p>Various Waste stored on soil and contacted directly with soil</p>	<p>(Photo-documentations are presented in Annex C, non-compliance note,)</p>

<p>Completed, end of January 2024</p>
15 March 2024		<p>Environmental Specialist of UWSCG/USIIP Ms.Kate Chomakhidze</p> <p>Environmental Specialist of Supervision Consultant HILL Mr.Nikoloz Neparidze</p>	<p>Regular monitoring of construction sites</p>	<p>Waste Water Treatment Plant</p> <p>An appropriate fence must be installed along the entire perimeter of the WWTP site to prevent unauthorized persons from entering the construction site (Photo No. 1)</p>

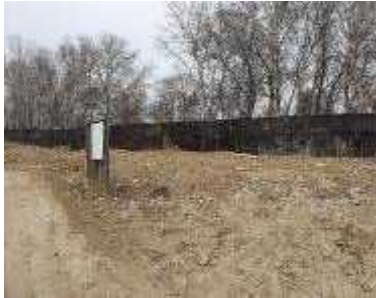
- An appropriate fence must be installed along the entire perimeter of the WWTP site to prevent unauthorized persons from entering the construction site (Photo No. 1);
- Clearly visible signs/safety tapes and trench side fences should be installed around deep open pits to avoid accidents with workers and visitors of the site (Photo No. 2);
- The internal area should be regularly cleaned and organized, construction materials should be placed separately and stored properly (Photo No. 3);
- Safety electric cables should be arraigned at construction site not to create danger for workers (Photo No. 4);
- Workers at height must be protected with appropriate personal protective equipment (Photo No. 5);
- Burning waste on the construction site is prohibited (Photo No. 6).

<p>Verbal instruction was given to contractor to immediately improve the situation.</p> <p>Non-Compliance Notice was issued and is presented in Annex C of this report.</p> <p>(Photo-documentations are presented in Annex C, non-compliance note,)</p>	<p>Will completed after finalization of the Construction Works in December 2024</p>

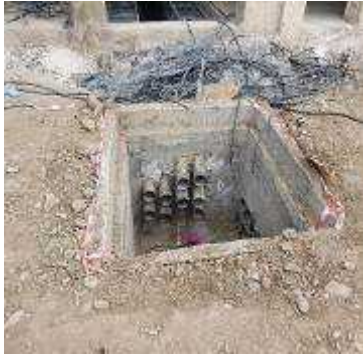
Date of Visit	Name of Company Name of Contract	Auditors Name	Purpose of audit	Summary of any Significant Findings	Implemented Actions	³ Implementation Status
				<p>Clearly visible signs/safety tapes and trench side fences should be installed around deep open pits to avoid accidents with workers and visitors of the site (Photo No. 2)</p>

<p>The internal area should be regularly cleaned and organized, construction materials should be placed separately and stored properly (Photo No. 3)</p>	<p>Corrective Action Plan has been developed by contractor and sent to SC and UWSCG</p>	<p>Completed, 1 April 2024</p>

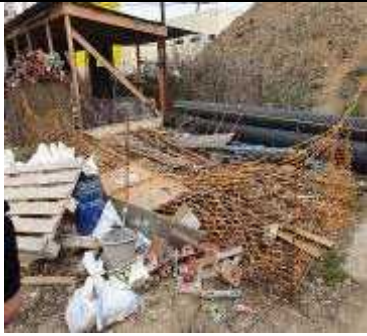
<p>Safety electric cables should be arraigned at construction site not to create danger for workers (Photo No. 4)</p>

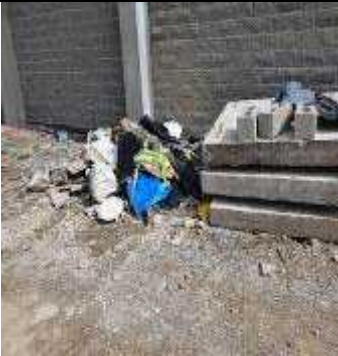
Burning waste on a construction site is strictly prohibited, Photo N2

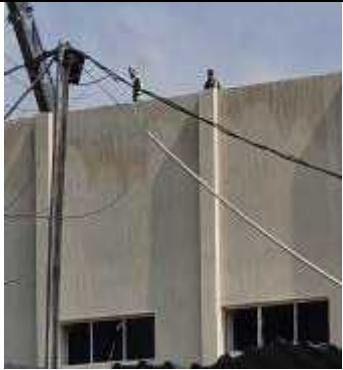
<p>There are open, unprotected trenches on the construction sites that impede the movement of personnel and pose a particular danger at night time, Photo N4</p>

<p>Completed April 2024, Photo N3</p>

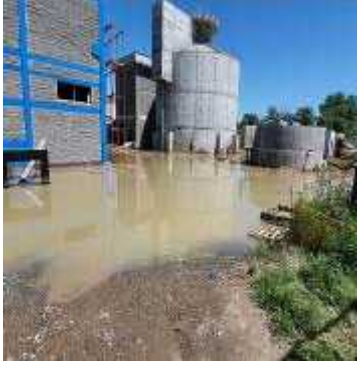
5 June, 2024		ADB's Environmental	Semi-annual Environmental Safeguard	Due to the Flooding in River Algety which was observed on 26 May 2024, the territory	Verbal instruction was given to contractor to	Partially Completed, the site should be properly cleaned and the waste

Date of Visit	Name of Company Name of Contract	Auditors Name	Purpose of audit	Summary of any Significant Findings	Implemented Actions	³ Implementation Status
		Safeguard Mission, led by Mrs. Ninette R. Pajarillaga, Country Environmental Focal and Ms. Nino Nadashvili, Associate Safeguards Officer Georgia Resident Mission Asian Development Bank Environmental Specialist of UWSCG/USIIP Ms.Kate Chomakhidze	Mission	of the WWTP was over flooded, Photo N1

immediately improve the situation and clean the site	removed from the territory
Continuously during reporting period (January-June 2024)	POLAT Yol Yapi Sanayi ve Ticaret Anonim Sirkei (Turkey).	Environmental, H&S Specialist of Contractor Mr. Sandro Abzianidze	Day to day monitoring of sites Compliance with Environmental and HES	Day to day monitoring of sites Compliance with Environmental requirements and HES	Prepare Monthly Environmental Monitoring Reports and send to SC	Performed monthly during the reporting period

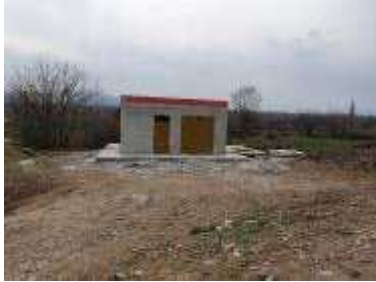
Date of Visit	Name of Company Name of Contract	Auditors Name	Purpose of audit	Summary of any Significant Findings	Implemented Actions	³ Implementation Status
15 March 2024	MAR-01 LOT-04, LOT-05	Environmental Specialist of UWSCG/USIIP Ms.Kate Chomakhidze Environmental Specialist of Supervision Consultant HILL Mr.Nikoloz Neparidze	requirements	<p>An appropriate fence must be installed along the entire perimeter of the Pumping Station to prevent unauthorized persons from entering the territory, Photo N1</p>

<p>Un-fenced/un secured pipeline cross river near resident areas, where children may use it as a playground make threats to local population and should be adequately fenced and protected, Photo N2</p>	<p>Verbal instruction was given to contractor to immediately improve the situation.</p> <p>Non-Compliance Notice was issued and is presented in Annex C of this report.</p> <p>(Photo-documentations are presented in Annex C, non-compliance note,)</p> <p>Corrective Action Plan has been developed by contractor and sent to SC and UWSCG</p>	<p>Will be completed after finalization of the construction works, by the September 2024</p> <p>Will be completed after finalization of the construction works, by the September 2024</p>

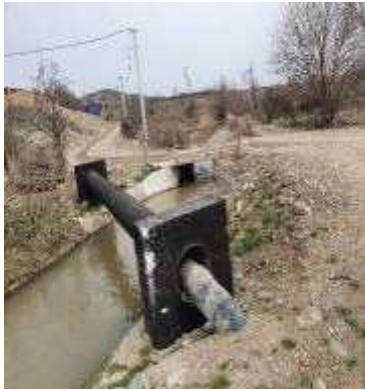
<p>Clearly visible signs/safety tapes, trench side fences or proper cover should be installed around deep open pits to avoid accidents with local residents</p>		<p>Will be completed after finalization of the construction works, by the September 2024</p> <p>Completed, March 2024 Please see Photo N1</p>

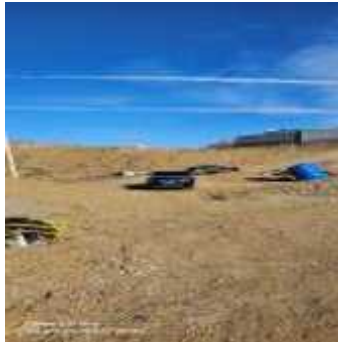
Date of Visit	Name of Company Name of Contract	Auditors Name	Purpose of audit	Summary of any Significant Findings	Implemented Actions	³ Implementation Status
20 January 2024	MAR-01 LOT-01, LOT-02, LOT-03 and LOT-06	Environmental Specialist of Supervision Consultant HILL Mr.Nikoloz Neparidze	Regular Environmental monitoring of sites	<p>MAR-01/LOT-06, Jandari Reservoir</p> <p>The part of fence and main gate are temporary removed, Photo N1</p>

<p>The information signs are not installed</p> <p>Trash cans are not installed</p> <p>Deep tranches are not protected, Photo N2</p>	<p>Verbal instruction was given to contractor to immediately improve the situation.</p> <p>Non-Compliance Notice was issued and is presented in Annex C of this report.</p> <p>(Photo-documentations are presented in Annex C, non-compliance note,)</p> <p>Corrective Action Plan has been developed by contractor and sent to SC and UWSCG</p>	<p>Will be completed after finalization of the construction works, by the September 2024</p> <p>Will be completed after finalization of the construction works, by the September 2024</p> <p>Completed, end of January 2024</p> <p>Completed, February 2024, Please see Photo N1</p>

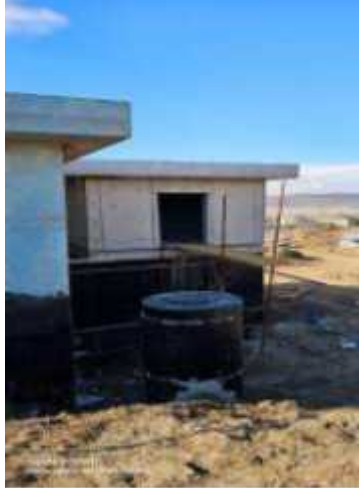
<p data-bbox="1099 799 1487 911">There is no warehouse for building materials on the territory</p> <p data-bbox="1099 1011 1487 1078">The ladder to the roof does not have handles, Photo N3</p>

<p data-bbox="1823 759 2159 895">Completed, all building materials are removed from the territory February 2024</p> <p data-bbox="1823 1011 2159 1147">Completed, ladder is removed from the territory, February 2024, Please see Photo N2</p>

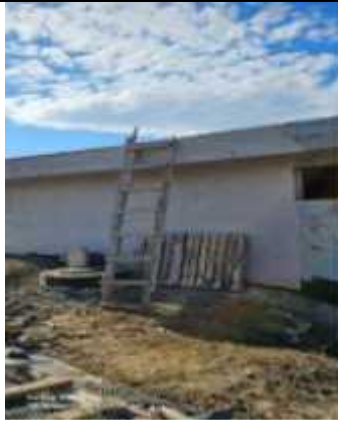
<p data-bbox="1099 724 1485 874">When the work is not in progress, the gas cylinders should be placed in a special protected place.</p>

<p data-bbox="1821 718 2159 778">Completed, January 2024</p>
26 January 2024		<p data-bbox="633 962 837 1123">Environmental Specialist of UWSCG/USIIP Ms.Kate Chomakhidze</p> <p data-bbox="633 1166 860 1362">Environmental Specialist of Supervision Consultant HILL Mr.Nikoloz Neparidze</p>	Regular monitoring of construction sites	<p data-bbox="1099 962 1485 1023">MAR-01/LOT-06 – Kolagiri Pumping Station</p> <p data-bbox="1099 1062 1485 1326">The trench, the depth of which is several meters, is bounded only by a protective tape, which cannot protect the personnel from falling into the trench and resulting from severe injuries, Photo N1</p>	<p data-bbox="1507 962 1809 1106">Verbal instruction was given to contractor to immediately improve the situation.</p> <p data-bbox="1507 1203 1809 1337">Non-Compliance Notice was issued and is presented in Annex C of this report.</p>	<p data-bbox="1821 1062 2159 1262">Partially Completed, the adequate fence will be installed after the completion of Construction activities in February 2024, Photo N1</p>

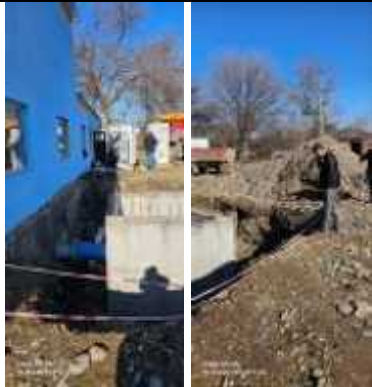
<p>Waste containers are not located on site</p> <p>There is no hazardous waste container located on site</p>	<p>(Photo-documentations are presented in Annex C, non-compliance note,)</p> <p>Corrective Action Plan has been developed by contractor and sent to SC and UWSCG</p>

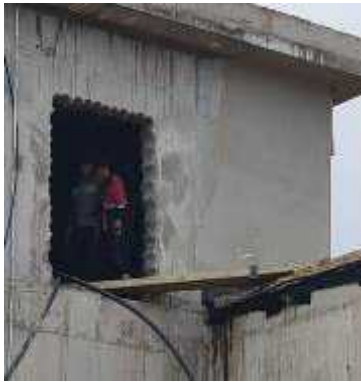
<p>Proper access across the deep and open pits should be provided for workers to avoid accident.</p>	<p>Notice was issued and is presented in Annex C of this report.</p> <p>(Photo-documentations are presented in Annex C, non-compliance note)</p>	<p>Photo N1</p>

<p>Completed, March 2024</p>
5 June, 2024	MAR-01, City Reservoir, Jandari Reservoir	ADB's Environmental Safeguard Mission, led by Mrs. Ninette R. Pajarillaga, Country Environmental Focal and Ms. Nino Nadashvili, Associate Safeguards Officer	Semi-annual Environmental Safeguard Mission	<p>Some minor waste management issues were observed during the site visit</p> <p>Jandari Reservoir</p> <p>Fencing of Jandary Reservoir, Photo N1</p>	Verbal instruction was given to contractor to immediately improve the situation.	Will be completed after finalization of the MAR-01/LOT-01 in September 2024

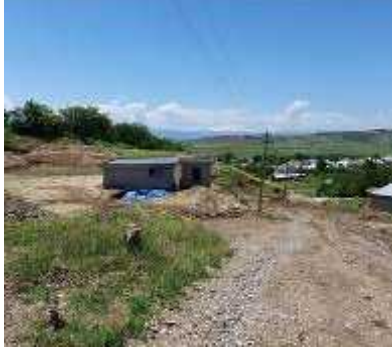
<p>City Reservoir</p> <p>Site internally should be cleaned regularly and construction waste should be removed from the site, Photo N2</p>

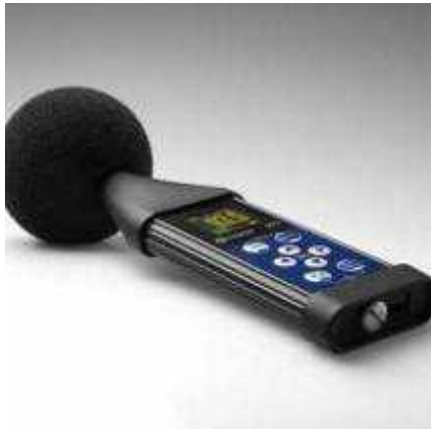
Figure 2: Organization-owned noise meter

- 110. Noise meter configurations during the study were:
 - Noise measurement range: 30-130 dB;
 - Noise meter response speed: Slow (1 second);
 - Frequency weight: A.
 - Type of microphone: 0.5" (12.7 mm.) el. Condensator.

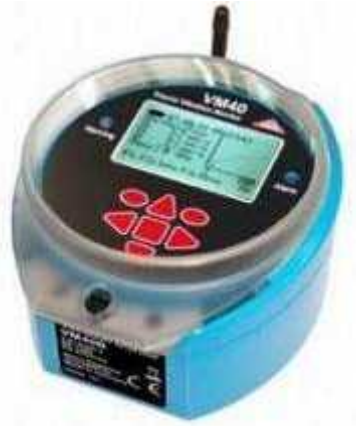
Figure 3: Triaxial Vibration Monitor VM40A/B

111. The VM40 is designed for measuring vibration in buildings, bridges, towers, pipelines and various other large structures. The measurements serve to prevent possible structural damage or disturbance to people. The VM40 contains a sensor, recording and evaluation electronics and an accumulator in its robust casing. It is especially suitable for autonomous operation over longer periods of time e.g. on construction sites.

112. The instrument contains three highly sensitive piezoelectric systems for vibration measurement of all three special dimensions. The signal processing is controlled by a microprocessor. The VM40 is operated via its seven keypad buttons and illuminated LCD display. The measurement data can be transferred to a PC via the USB interface. The instrument also has a port for connecting a charger and a relay output for the external signaling of vibration occurrences.

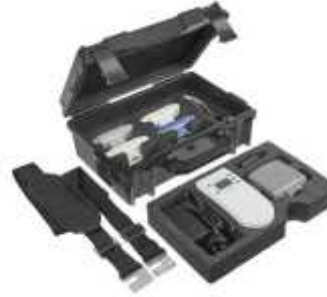
Figure 5.: “Aeroqual Series 500 Portable Air Quality Monitor”

- 115.** The device has different sensors for each type of harmful substance. The device has the following types of sensors:
- Gas sensitive semi-conductor sensor (GSS);
 - Gas sensitive electrochemical sensor (GSE);
 - Laser Particle Counter (LPC);
 - Photo Ionization Detector (PID).
- 116.** During performing the measurement, the device records the average minute data of the obtained samples. Measurements was made within 20 minutes.
- 117.** Figure 6 and Figure 7 below show the measurement points, project zone and measurement location.

114. The Figure 4 and Figure 5 - below shows the “Aeroqual Series 500 Portable Air Quality Monitor”.

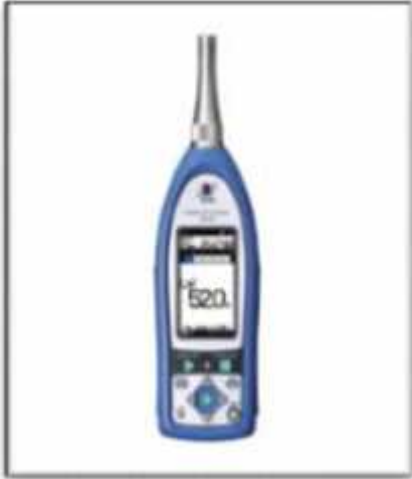
Noise measuring device

- Rion NL-52, First class noise measurement device;
- Windscreen, WS-16;
- Tripod;
- SD Card;

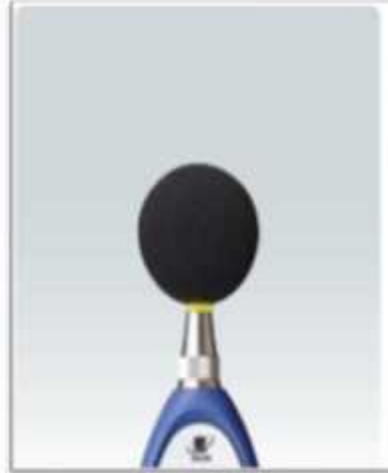
Windscreen WS-16

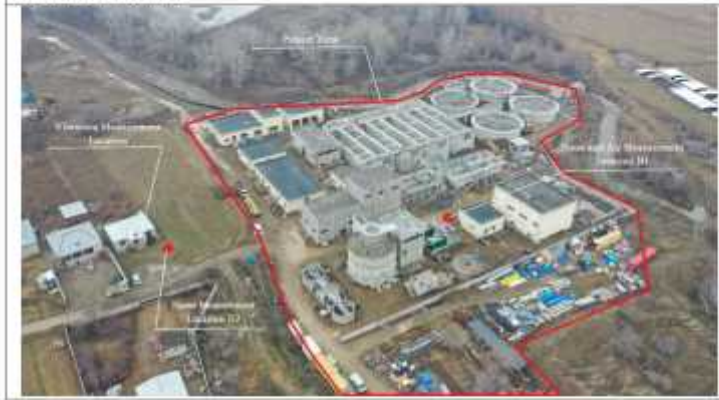
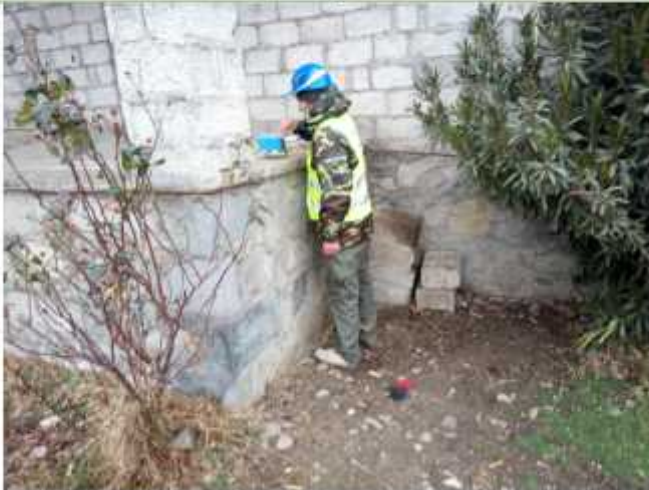
Measurement protocol N1	
1. General	
1.1 Person in charge	Archil Revazishvili - Head of the Examination Lab
1.2 Measurement period	25.01.2024 11:33:37 - 25.01.2024 13:46:11
2. Kind of vibration	
2.1 Excitation	Construction Works
2.2 Operating conditions	High intensity work
3. Structure	
3.1 Name and address	City Marneuli
3.2 Classification	Balcony of a residential house. Open space from three sides
3.3 Description	Residential building. According to DIN 4150-3, N2 categories of buildings (residential and similar buildings)
4. Location and position	
4.1 Source of vibration

5. Environmental conditions	open space from three sides; Smooth floor surface
6. Subjective observations	The vibration of the working specifics doesn't affect on the general condition
7. Measuring chain	Triaxial Vibration Meter VM40B Serial number: 180665 Calibration Date: May 2023 Measurement method: DIN 4150-3 Settings: short res. found.: Frequency range: 1-80 Hz Trigger mode: 060s + events Measurement processing and report generation done with VM40MDB software.
8. Measurement result	
8.1 Event chart

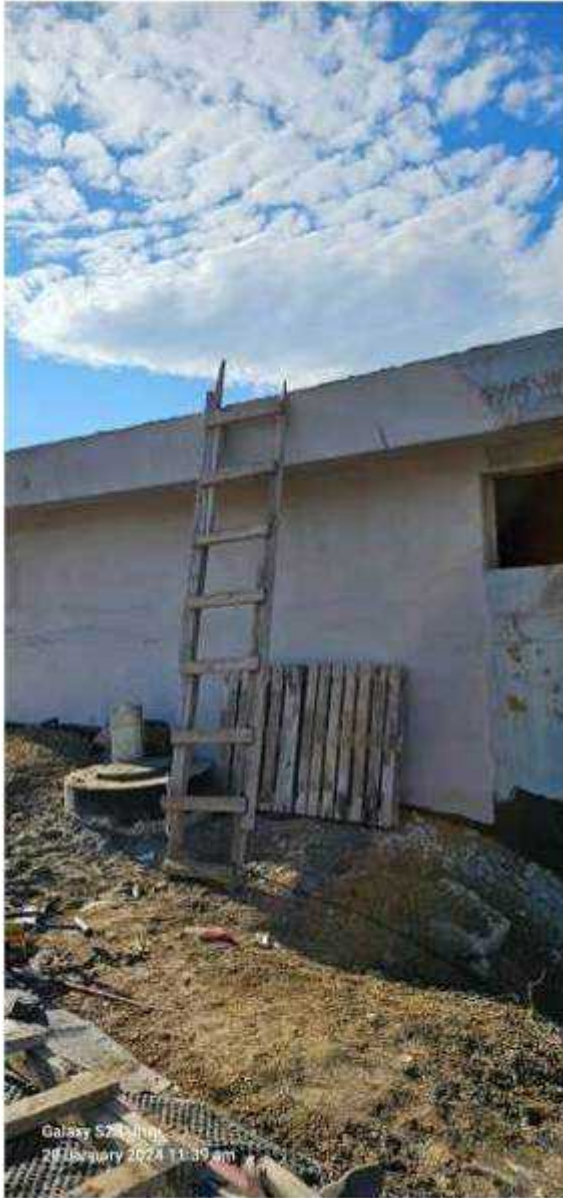
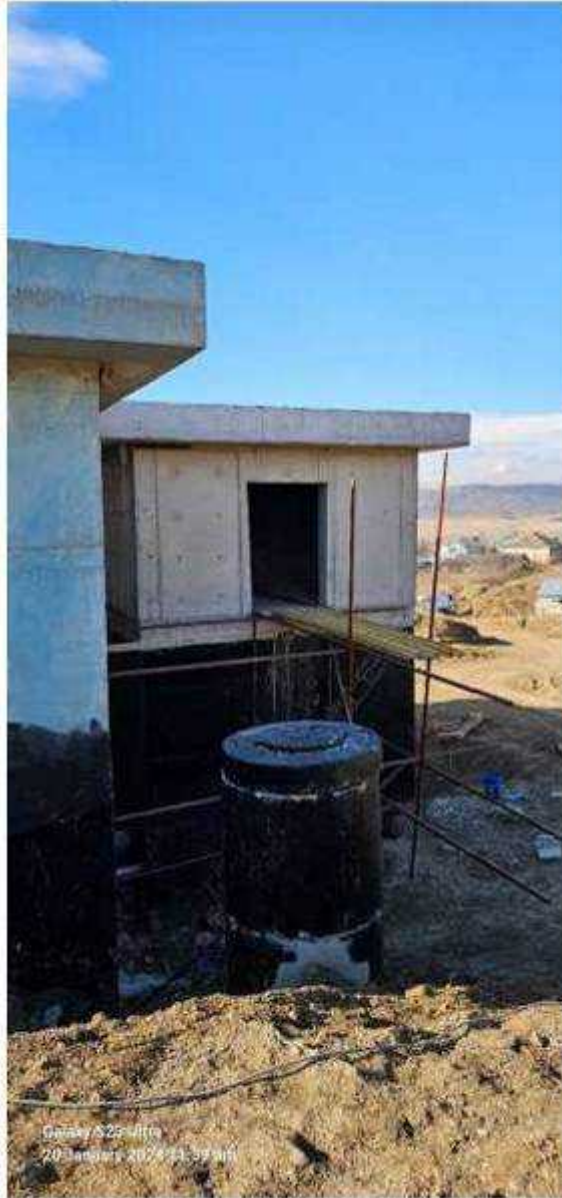
Stairs and Caffolding

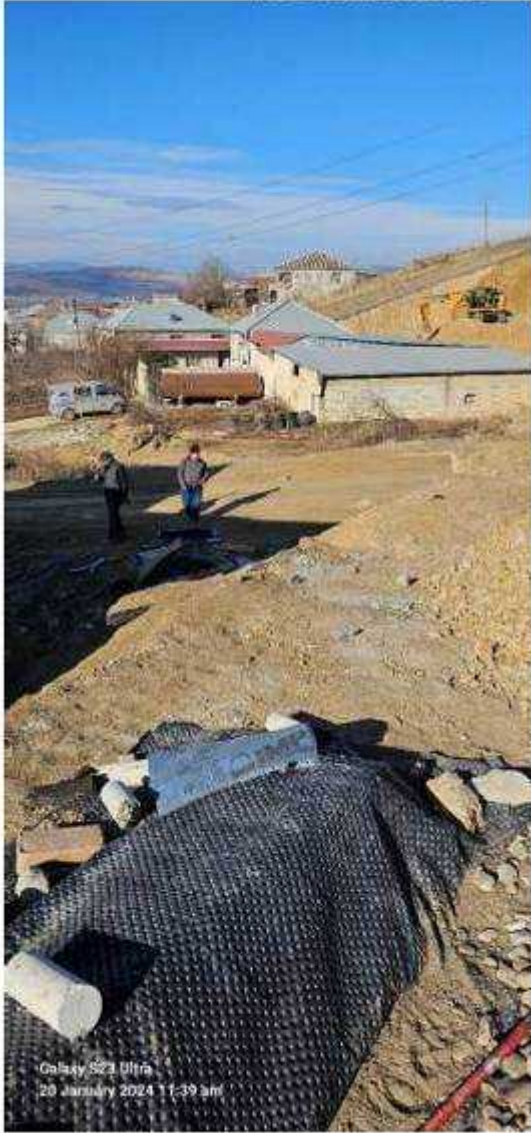
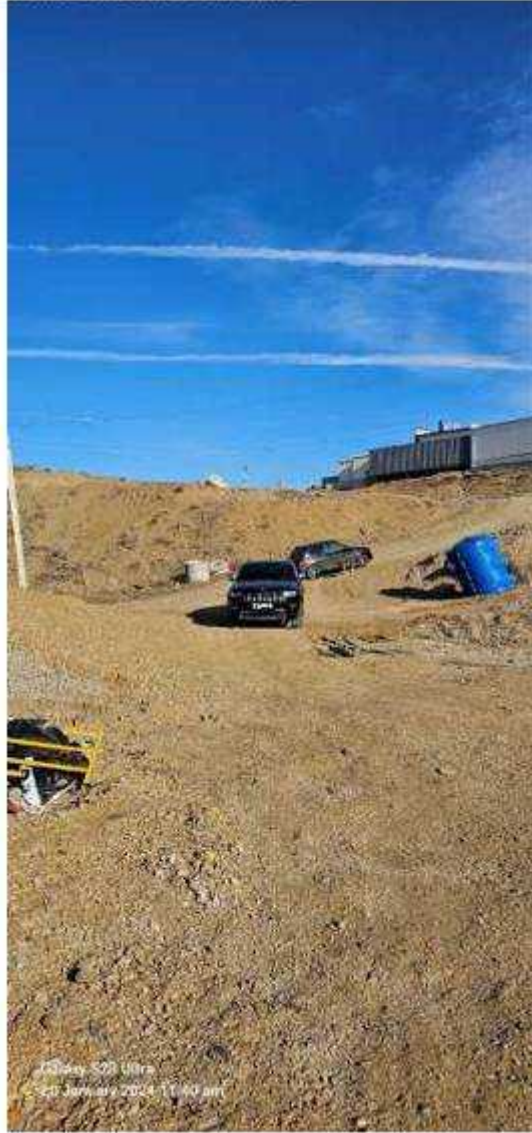
The construction site - The main Gate is not installed

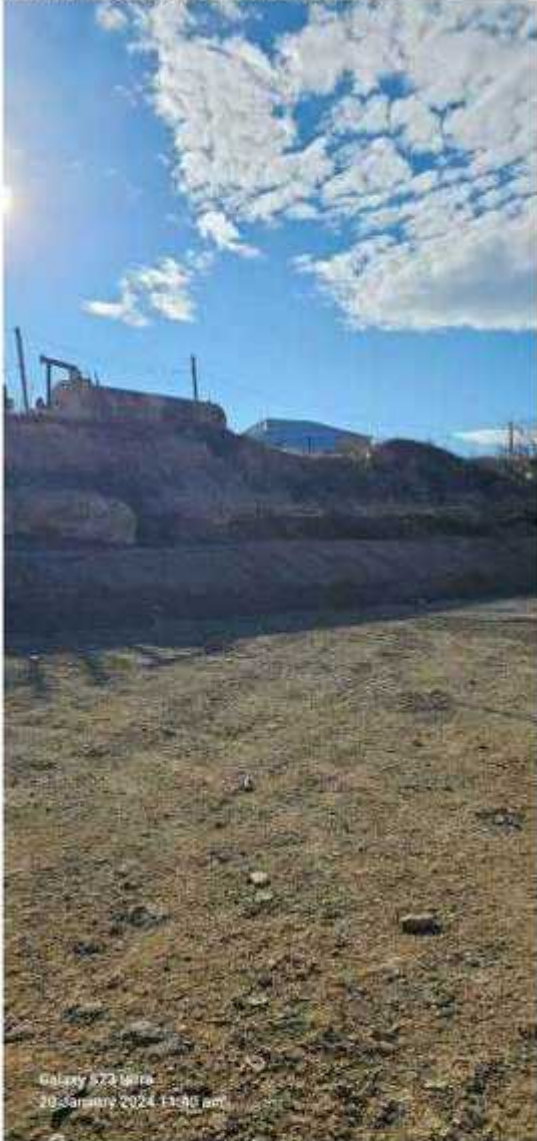
The part of fence are removed.

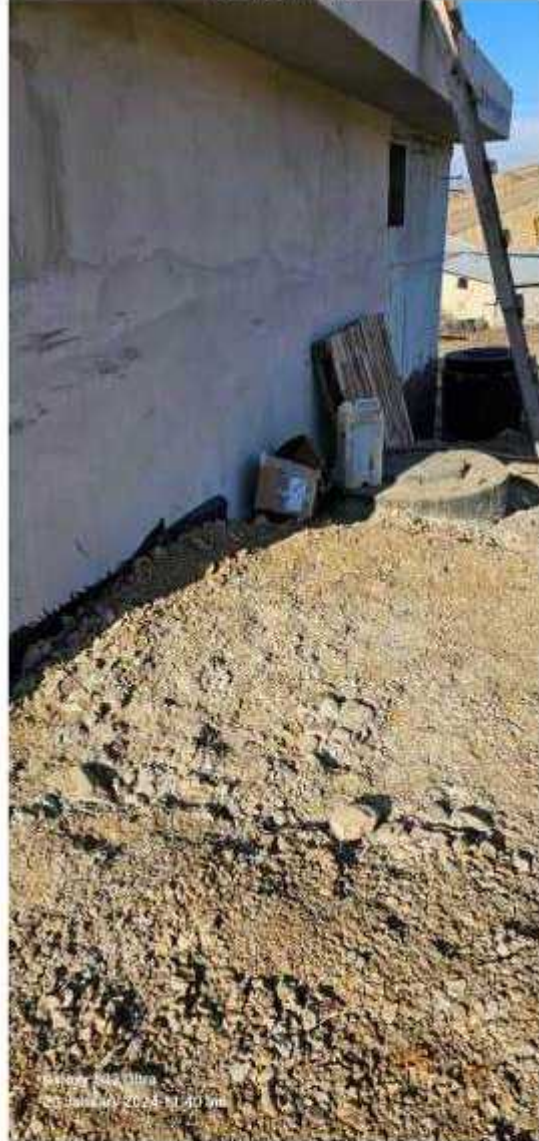
No trash cans

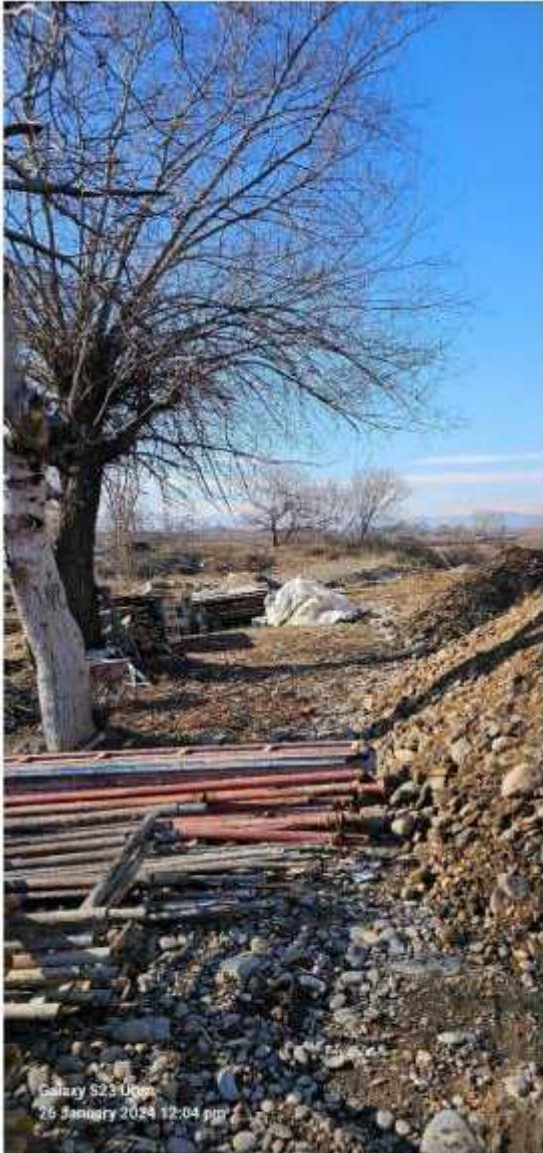
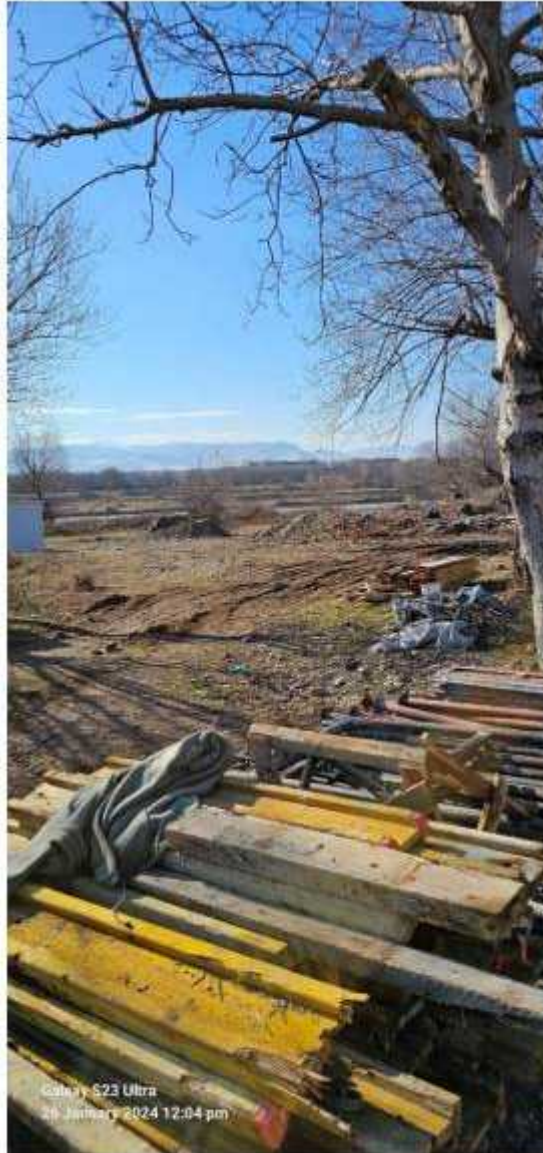
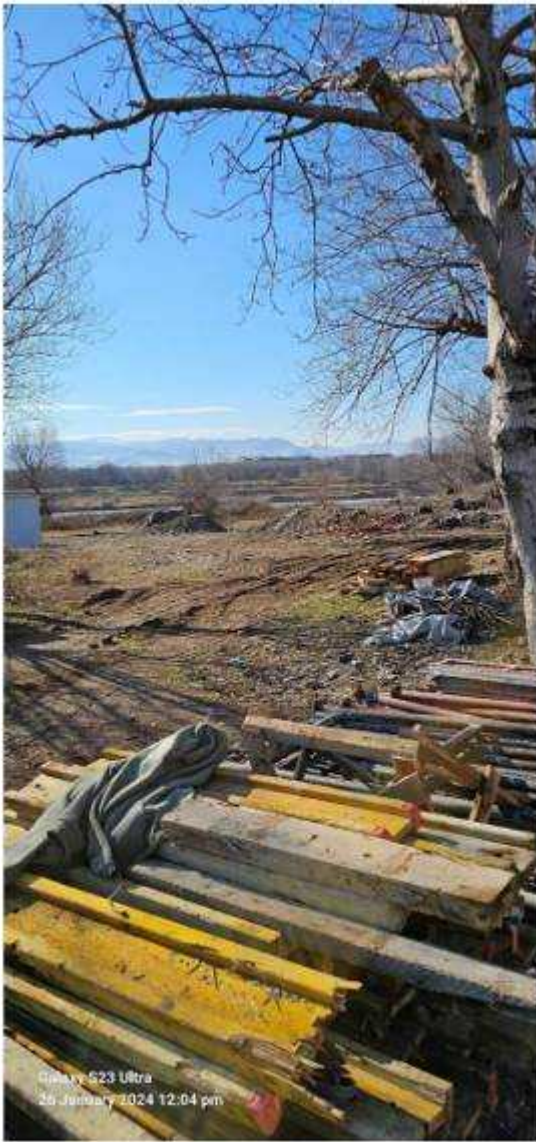
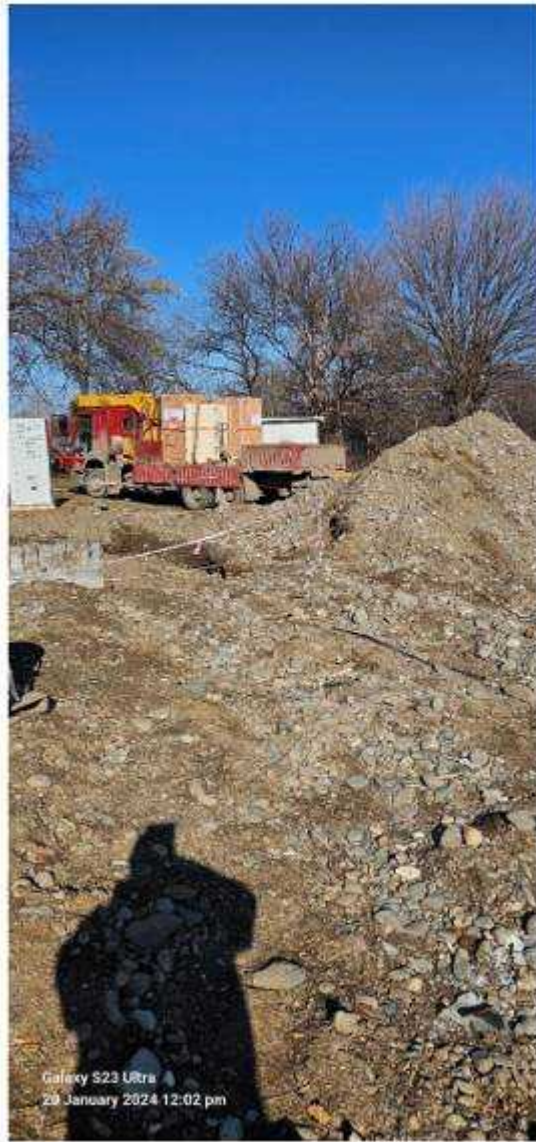
The Site

<i>The contractor must eliminate the specified discrepancies within a maximum of 7 working days.</i>	
See photos below

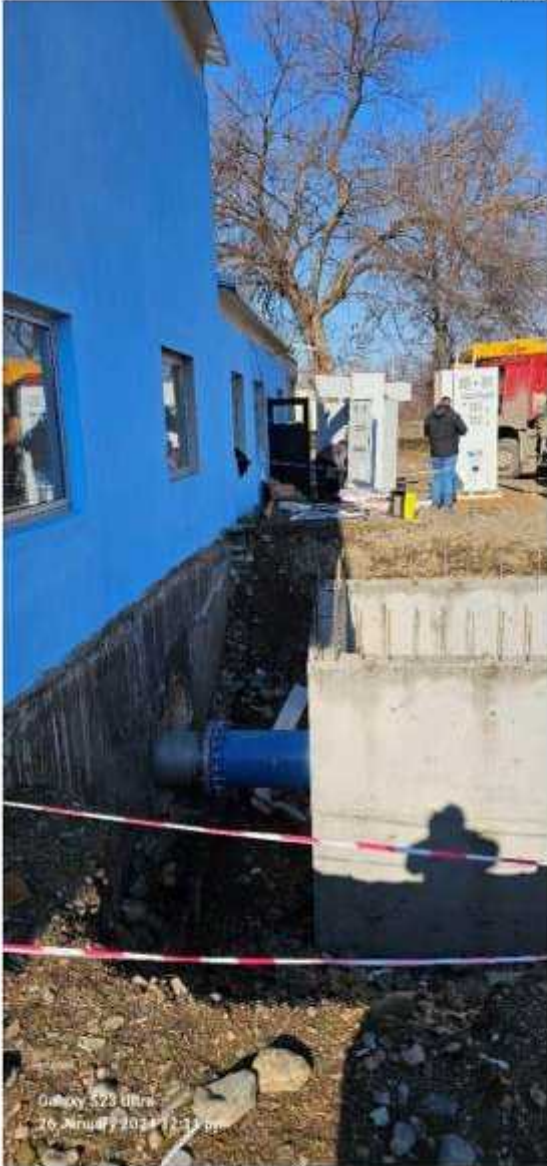
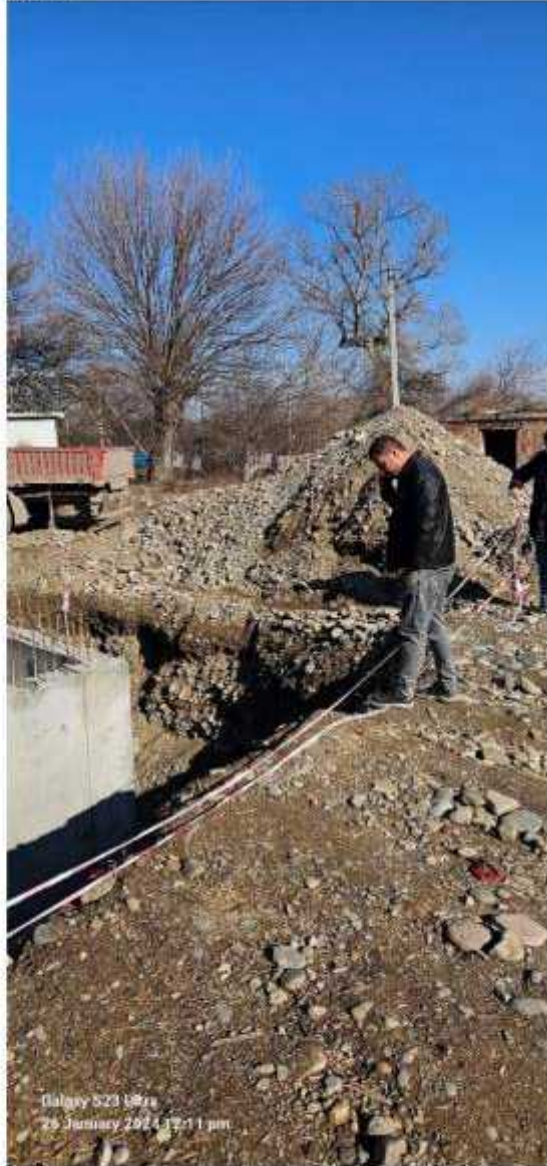
Deep trench

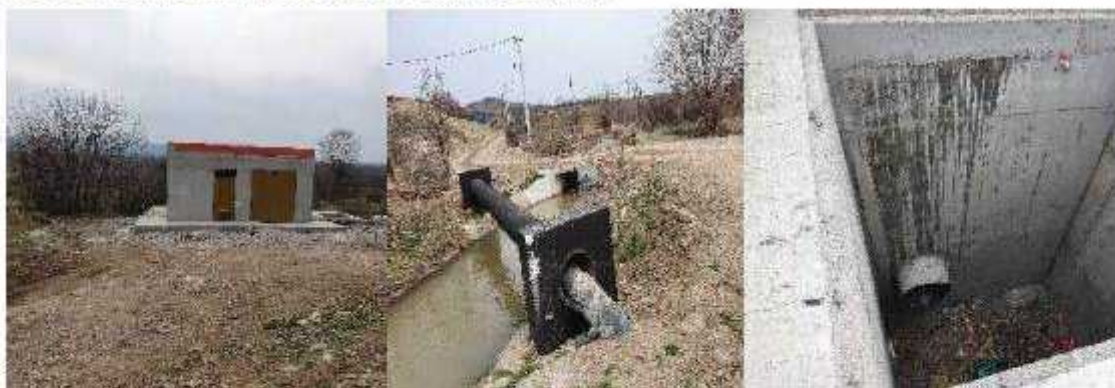
Photos of Bolnisi WW Network and Pumping Stations

- An appropriate fence must be installed along the entire perimeter of the Pumping Station to prevent unauthorized persons from entering the territory (Photo No. 1);
- Un-fenced/un secured pipeline cross river near resident areas, where children may use it as a playground make threats to local population and should be adequately fenced and protected (Photo No. 2);
- Clearly visible signs/safety tapes, trench side fences or proper cover should be installed around deep open pits to avoid accidents with local residents (Photo No. 3) **(should be improved immediately)**.

All these conditions have to be remedied by the end of this week, 22 March 2024

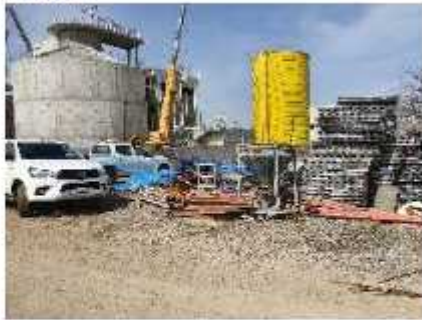
Photo #1

- Site internally should be arranged properly and cleaned regularly, including construction materials segregation (Photo #1, Photo #2)

All these conditions have to be remedied within 5 calendar days by the prime Contractor (Toshiba Water Solutions Pvt. Ltd)

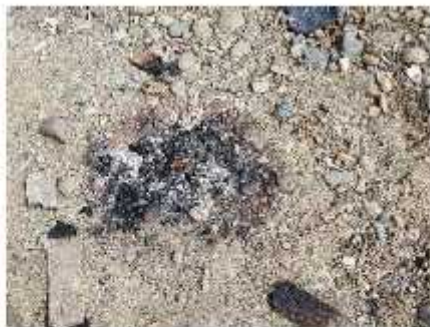
Photo #3

- Burning waste on a construction site is strictly prohibited (Photo #3)
- Workers on height are working without safety and health regulations, without life belts and safety equipment (Photo #4)

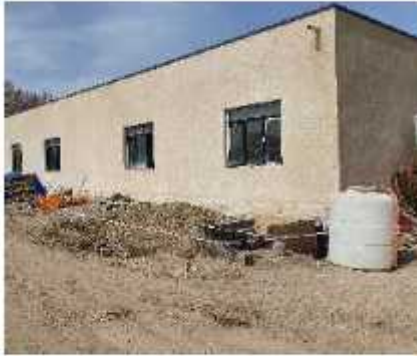
Photo #5

- There are open, unprotected trenches on the construction sites that impede the movement of personnel and pose a particular danger at night time

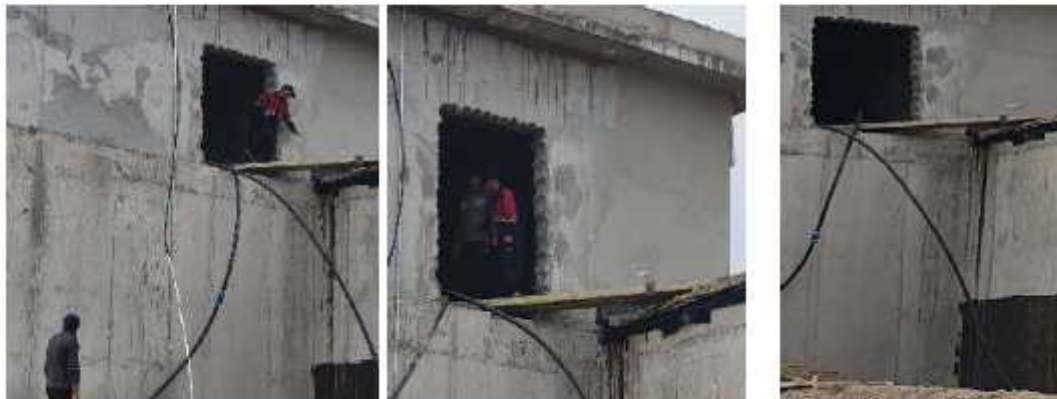
Photos of Marneuli City Reservoir

- Workers should be equipped with PPE on construction site (Photo No.1);
- When working at height workers must be equipped with specialised equipment and personal protective gear (Photo No.2);
- Proper access across the deep and open pits should be provided for workers to avoid accident (Photo No.3).

All these conditions have to be remedied immediately by contractor and Supervisor

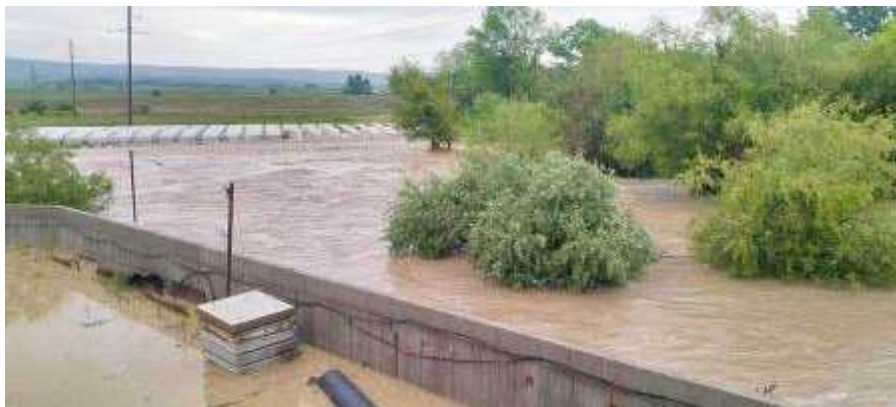
Fig. N1

About 10% of the water to WWTP came from the rain in WWTP area as the drainage system is not yet constructed. Photos are provided in Figure 1 and Figure 2 below:
