Semi-Annual Environmental Monitoring Report

#18 Semiannual Report

GEORGIA: URBAN SERVICES IMPROVEMENT INVESTMENT PROGRAM (TRANCHE 3)

During the reporting period, only minor civil works were carried out within the GUD-03 sub-project: “Construction of Four Wastewater Treatment Plants in Gudauri,” which included preparations for the subsequent testing and commissioning phases of the WWTPs. Key activities involved inspecting the air compressors, conducting joint inspections of equipment installations and performing paint repairs.

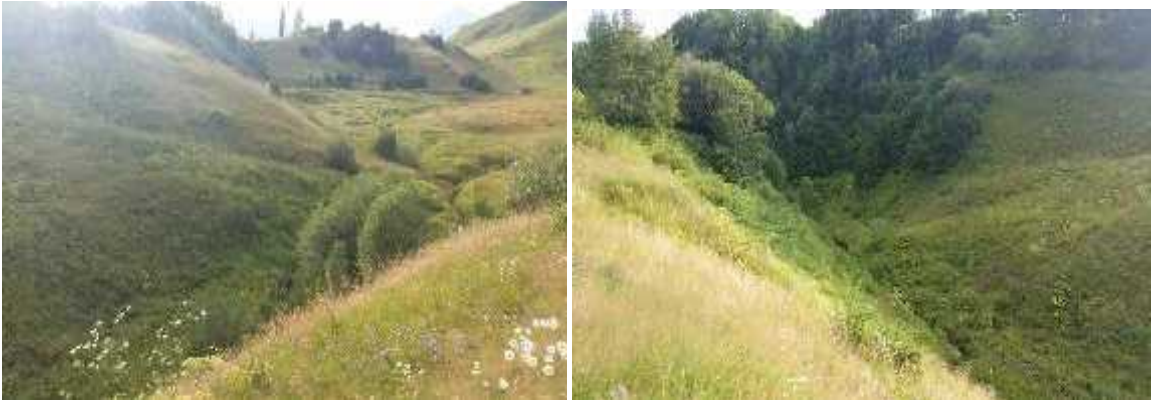
Figure 1. Photos of WWTP 5 Location

was not feasible due to project timelines and legal constraints. To prevent potential misuse of complaints, certain work areas were excluded from the project scope, and the decision was made to cancel the construction of WWTP No. 5, leaving the site undisturbed. Please refer to Figure N1 below for location of WWTP#5.

19. In December 2023, based on Change Order No. 1 sent to ADB WWTP #5 was excluded from GUD-03 sub-project.

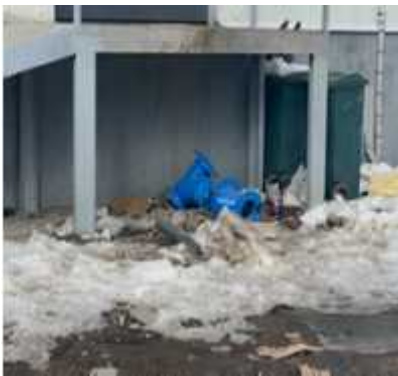
Non-compliance/Observation	Required action and term	Responsible person	Note
2	Non-compliance 2: Hazardous and non-hazardous construction waste mixed together are uncontrollably placed on the territory of the WWTP 3	<p>"Waste Management Code" - Chapter 19 (1) "It is prohibited to mix hazardous waste with other hazardous waste or other wastes, substances or materials". Besides, other requirement of the same law are violated, namely "Requirements for Hazardous Waste Temporary Storage Facilities", Photo N1</p>

<p>Term: 31 January 2025 (After post construction audit will be adopted)</p>	UWSCG	
3	Observation 1: The quadricycle rental company uses several containers as office space. One of these containers is located on a sewage pipe. The container does not have direct contact with the sewage pipe, however, there is a risk of damage to the pipe.	<p>It is necessary in collaboration with the rental company and the local authorities to find an area where the mentioned container will be moved, please see Photo N1</p>

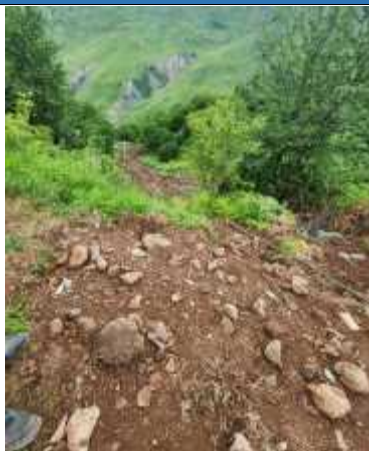
Date of visit	Name of Contractor	Auditors name	Purpose of audit	Summary of any significant findings	Cross reference to Audit report	Implementation progress
Continuously during reporting period (July-December 2024)	"China Nuclear Industry 23 Construction Co." LTD (CNI23)	Mr. Aleksandre (Sasha) Mchedlishvili Environmental Specialist of contractor	Day to day monitoring of sites Compliance with Environmental and HES requirements	Environmental, Health and Safety issues on construction sites Regular cleaning of the construction site All photo-documentations are presented in Annex A and Annex B of this report.	Weekly Monitoring Checklists	Completed
10 July 2024		Environmental monitoring specialists of SC/EPTISA Mr.Irakli Legashvili	Regular monitoring of construction sites	Discharge Pipeline construction area should be fenced by high visible safety grids and proper warning signs should be installed, please see Photo N1	Non-compliance notice were issued to contractor and corrective actions were required from contractor to immediately improve the situation, under GUD-03 sub-project (Please see Annex B)	Completed end of July 2024, please see Photo N1

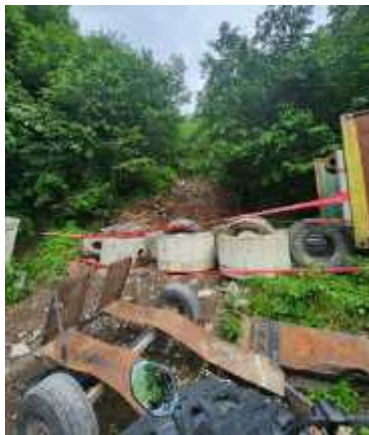
<p>Organize and clean the site to remove debris and materials that could pose tripping hazards, please see Photo N2</p>

<p>Completed, end of July 2024, all construction activities are already finished and all debris and construction materials were removed from the site</p>

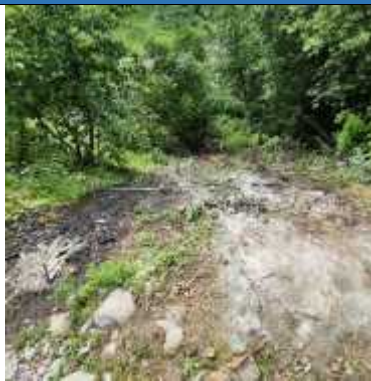
<p>Proper barriers and grids for preventing of rock falling should be installed at the bottom on the passing road to avoid damage of transport means and people</p> <p>Proper waste container for household waste should be installed with cover and label</p>		<p>Completed, end of July 2024</p> <p>Completed, end of July 2024</p>
18 October 2024		<p>Environmental monitoring specialists of SC/EPTISA Mr.Irakli Legashvili</p> <p>Ms. Kate Chomakhidze</p>	Regular Monitoring of Sites	<p>WWTP 1</p> <p>Vegetation should be restored at the slopes (as per requirement of site reinstatement)</p>	<p>Non-compliance notice were issued to contractor and corrective actions were required from contractor to</p>	<p>Reinstatement of the WWTP #1 area is Partially completed, backfilling is finalized and the sowing of green grass in on-going The vegetation</p>

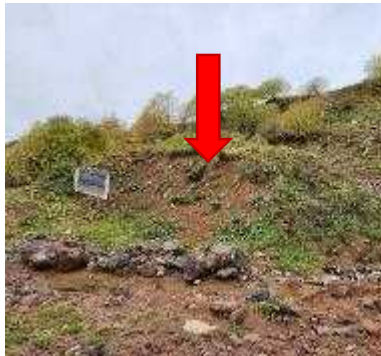
Date of visit	Name of Contractor	Auditors name	Purpose of audit	Summary of any significant findings	Cross reference to Audit report	Implementation progress
		UWSCG/USIIP /Environmental Specialist		<p>Topsoil should be backfilled at the site, please see Photo N1</p>

<p>immediately improve the situation, under GUD-03 sub-project (Please see Annex B)</p>	<p>restoration process has begun. Please see the attached photos of sowing at WWTP N1.</p> <p>The reinstatement of the WWTP No. 1 territory is partially completed, with backfilling of Topsoil finished. The process of planting vegetation for filling the territory has begun also, starting with the sowing of grass. Please see Photo No. 1 below.</p>

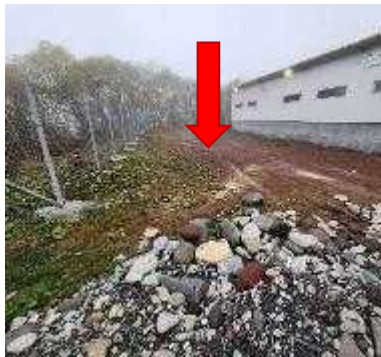
Date of visit	Name of Contractor	Auditors name	Purpose of audit	Summary of any significant findings	Cross reference to Audit report	Implementation progress
				<p>WWTP 2</p> <p>Vegetation should be restored at the site and slopes (as per requirement of construction site reinstatement), Please see Photo N2</p>

<p>WWTP 3</p> <p>Vegetation should be restored at the site and slopes (as per requirement of construction site reinstatement)</p> <p>Topsoil should be backfilled at the site, please see Photo N3</p>		<p>The reinstatement of the WWTP No. 2 territory is partially completed, with backfilling finished. The process of planting vegetation for filling the territory has begun also, starting with the sowing of grass. Please see Photo No. 2 below.</p>

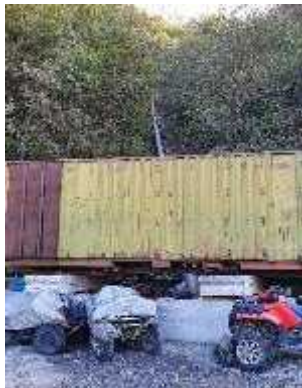
Date of visit	Name of Contractor	Auditors name	Purpose of audit	Summary of any significant findings	Cross reference to Audit report	Implementation progress
24 October 2024		ADB's Environmental Safeguard Mission, Nino Nadashvili, Safeguard Officer, OSFG, Ms. Kate Chomakhidze UWSCG/USIIP /Environmental Specialist	ADB's Environmental Safeguard Mission	<p>Quadricycle's mobile office (located in a container) is positioned too close to the WWTP discharge pipe and should be relocated from the area to prevent potential damage to the facility, please see Photo N1 below</p>

Verbal instruction was given to contractor to immediately improve the situation.	Not yet completed. Please see also Table N3 above Deadline for improvement is until the end of February 2025

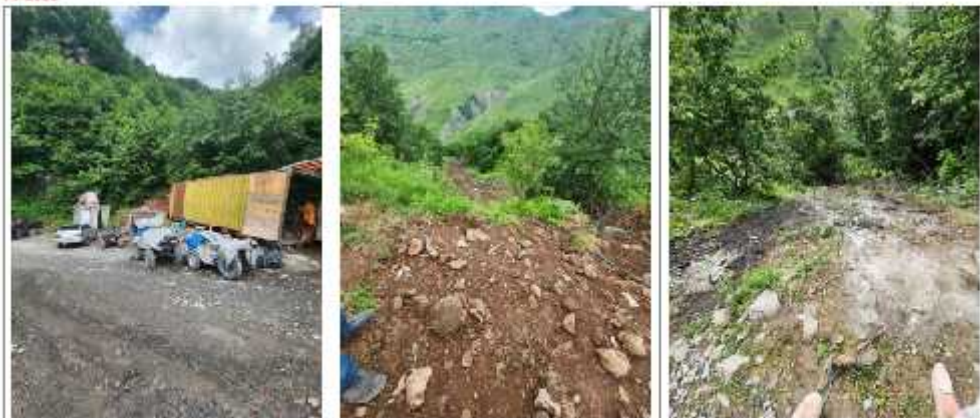
Photos

- Discharge Pipeline construction area should be fenced by high visible safety grids and proper warning signs should be installed
- Organize and clean the site to remove debris and materials that could pose tripping hazards.

- Manage vegetation around the work area to reduce hazards and interference with construction activities.
- Safety norms during pipeline construction work (works at height) should be respected.

- Personnel should use complete PPE (including safety belts) to avoid falling and damage
- Proper information and warning signs should be installed at the bottom on the passing road to avoid damage (e.g. falling rocks) of transport means and people

- Proper barriers and grids for preventing of rock falling should be installed at the bottom on the passing road to avoid damage of transport means and people

- Proper waste container for household waste should be installed with cover and label

All these conditions have to be remedied within seven days (by the 23.07.2024) by the prime Contractor (China Nuclear Industry 23 Construction Co., Ltd)		
Date of site visits 10.07.2024		
Irakli Legashvili EPTISA - Environment

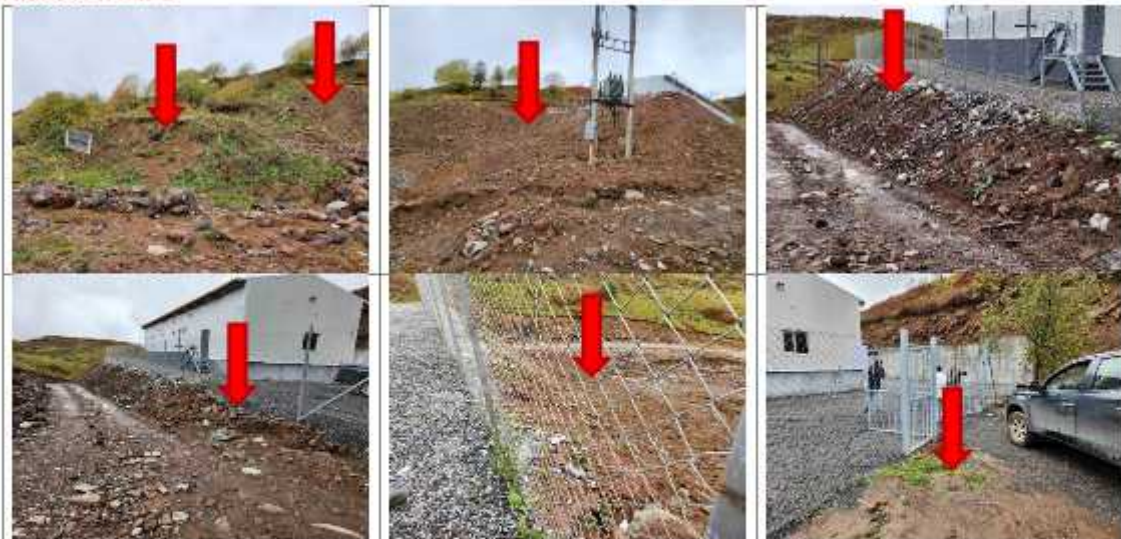
WWTP 4 <ul style="list-style-type: none">- Vegetation should be restored at the slopes (as per requirement of construction site reinstatement) and respective planting activities- Topsoil should be backfilled at the site	
Photos of WWTP 1

Project: Urban Services Improvement Investment Program, Georgia	Non-compliance Notice Gudauri
Contract No: UWSCG-ICB-GUD-03	
Contractor: China Nuclear Industry 23 Construction Co., Ltd	
Reference: Construction of Wastewater Treatment Plants in Gudauri	
This notice is to advise you, the prime Contractor, on the referenced Contract, of the following notice on environmental measures to be implemented urgently .	
WWTP 1 <ul style="list-style-type: none">- Vegetation should be restored at the slopes (as per requirement of construction site reinstatement)- Topsoil should be backfilled at the site	
WWTP 2 <ul style="list-style-type: none">- Vegetation should be restored at the site and slopes (as per requirement of construction site reinstatement)	
WWTP 3 <ul style="list-style-type: none">- Vegetation should be restored at the site and slopes (as per requirement of construction site reinstatement)- Topsoil should be backfilled at the site

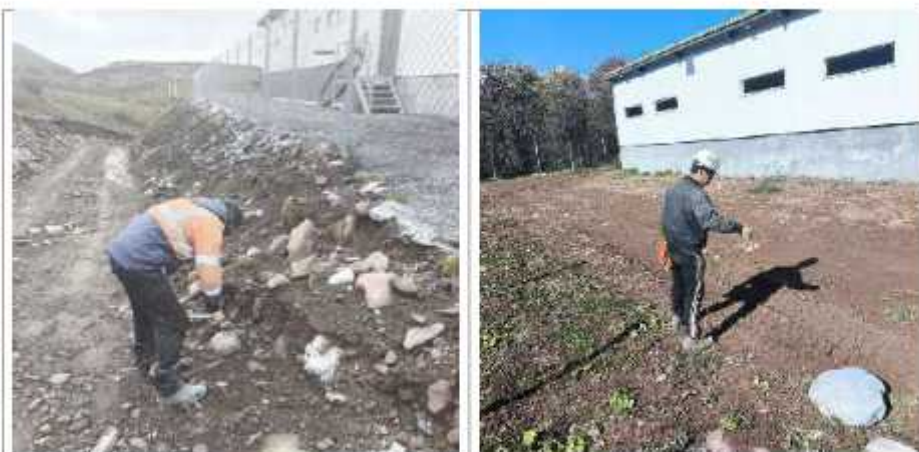
Rectification photos of WWTP1:

WWTP1sowing, Restore vegetation
Rectification photos of WWTP2:

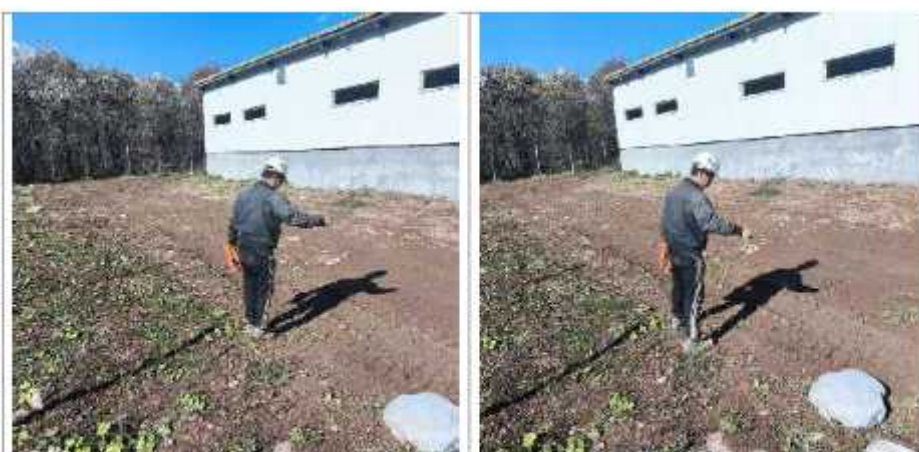
WWTP2sowing, Restore vegetation

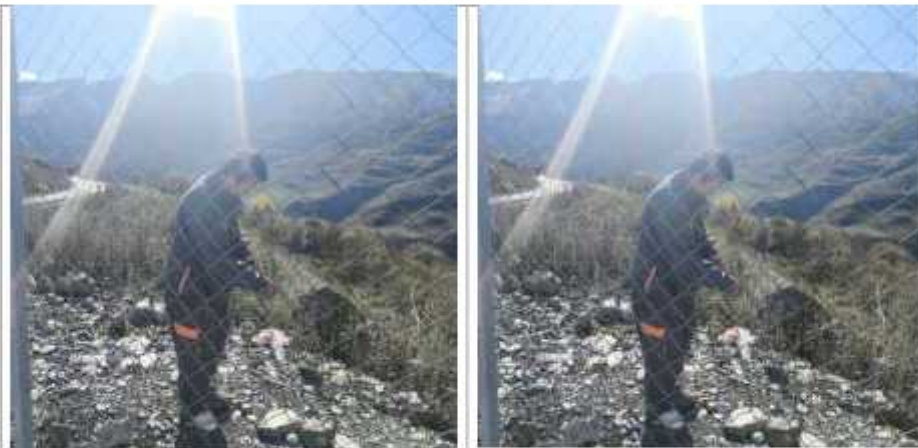
WWTP3sowing, Restore vegetation
Rectification photos of WWTP4:

WWTP4sowing, Restore vegetation

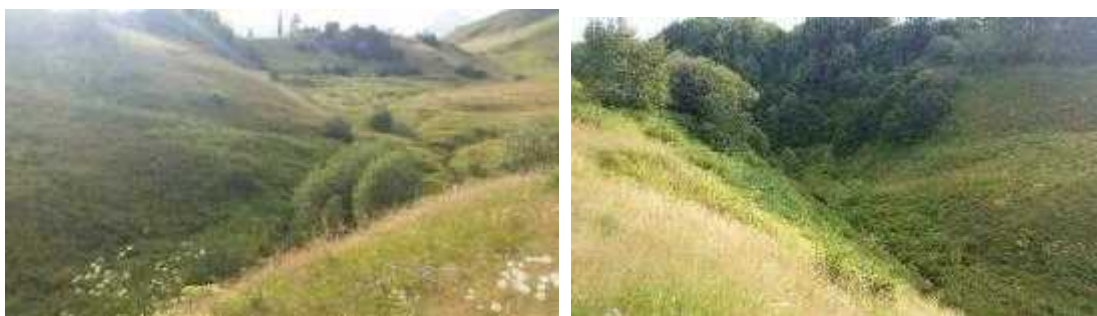
Figure 1. Photos of WWTP 5 Location

UWSCG has submitted change order N1 to cancel construction of WWTP 5. No works has been commenced on location of WWTP 5. As a result, no construction activities have begun at the planned site for WWTP 5, leaving the land in its original, undisturbed state. The photos of WWTPN5 is provided in the Fog.1 below.
