SEMI-ANNUAL ENVIRONMENTAL MONITORING REPORT

**GEORGIA: URBAN SERVICES IMPROVEMENT INVESTMENT PROGRAM
(TRANCHE 5)**

ANNEX A: POST CONSTRUCTION ENVIRONMENTAL AUDIT REPORT, REG-03a

Post - Construction Environmental Audit Report

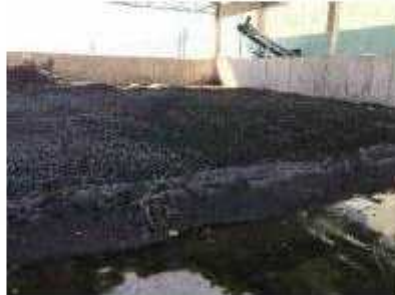
- Sludge from drain sump is stored in the sludge storage area (about 100m³), and some sludge was buried in the trench next to the drainage sump (about 50m³):

Sludge storage area

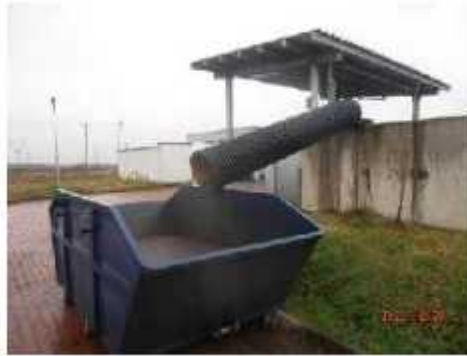
- Excess sludge (secondary sludge) is pumped from the Return Sludge into the sludge storage sump. From time to time a small volume is withdrawn via a hose connected to the socket for the manometer and pumped to the emergency sludge storage hall where it is dried and disposed at the dump site as above.
- Another portion of excess sludge (mainly floating sludge and scum) is manually removed from the open outlet/collection channel of the aeration tanks.

Dried sludge at emergency storage hall

32. In order to address the above-mentioned non-compliances, including the completion of the centrifuge, the gas line, the heating system for digester and the gas holder, as well as ensuring smooth operation of the fine screen, UWSCG and SC/Posch have decided to go for local contract of all works and services, which will take max. 4-6 months. To achieve this goal, at the end of January 2024, the Supervision Consultant/ Posch prepared and submitted to the UWSCG tender documents for the emergency procurement of all the above services and works, which will ensure that all defects are eliminated, including sludge dewatering and that all problems identified during the preliminary commissioning of the WWTP will be finally improved (for more details please see Annex B – Post-construction Audit Report for REG-03a sub-project).
