# Semi-annual Environmental Monitoring Report

## **#19 Semiannual Report**

*(Reporting Period: January-June 2025)*

**GEORGIA: URBAN SERVICES IMPROVEMENT INVESTMENT PROGRAM  
(TRANCHE 4)  
(FINANCED BY THE ASIAN DEVELOPMENT BANK)**

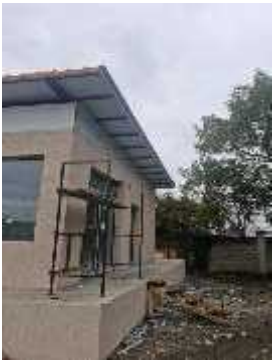
| Date of Visit | Name of Company | Auditors Name | Purpose of audit | Summary of any Significant Findings | Cross Reference to Audit Report | Status of implementation |
|---|---|---|---|---|---|---|
| 17 January 2025 | Contractor: CHINA NUCLEAR INDUSTRY 23 CONSTRUCTION CO” Ltd (China)<br><br>POT-01/LOT-03 | Environmental Specialist of SC Mr.Shalva Bosikashvili | Regular Monitoring of Sites | Unsafe scaffold (PS17), Photo N1<br><br>Unsafe ladder (PS9), Photo N2 | Non-compliance notice were issued to contractor and corrective actions were required from contractor to immediately improve the situation, under POT-01/LOT-03 sub-project (Please see Annex B) | Completed, end of January 2025<br><br>Completed, end of January 2025, ladder is removed, Photo N2 |

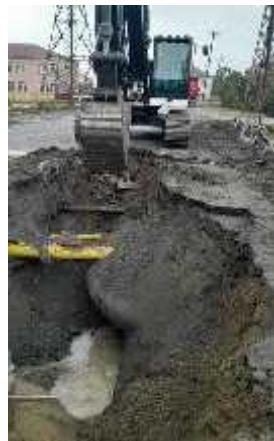
| Date of Visit | Name of Company | Auditors Name | Purpose of audit | Summary of any Significant Findings | Cross Reference to Audit Report | Status of implementation |
|---|---|---|---|---|---|---|
| | | | | <p>flagman, Photo N2</p> | | January 2025, all construction activities under the LOT-02 is completed. |

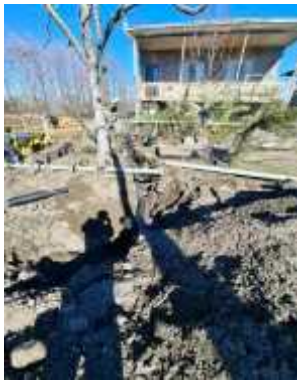
| Date of Visit | Name of Company | Auditors Name | Purpose of audit | Summary of any Significant Findings | Cross Reference to Audit Report | Status of implementation |
|---|---|---|---|---|---|---|
| 12 March 2025 | <p>Contractor: "MBD Inssat" (Turkey).</p> <p>POT-01/LOT-02</p> | Environmental Specialist of SC Mr.Shalva Bosikashvili | Regular Monitoring of Sites | <p>Trenches without barrier and warning sign; entrance and gate blocked, Photo N1</p> <p>Workers without relevant PPE, helmets and gloves Photo N2</p> | <p>Non-compliance notice were issued to contractor and corrective actions were required from contractor to immediately improve the situation, under POT-01/LOT-02 sub-project (Please see Annex B)</p> | <p>Completed. End of March 2025, all construction activities under the LOT-02 is completed.</p> <p>Completed. End of March 2025, all construction activities under</p> |

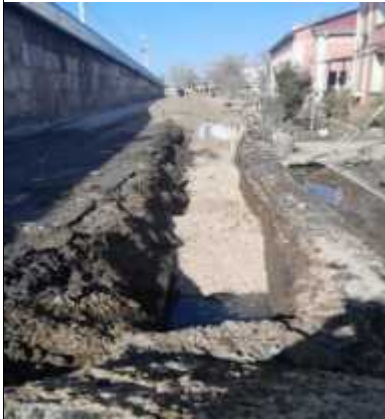
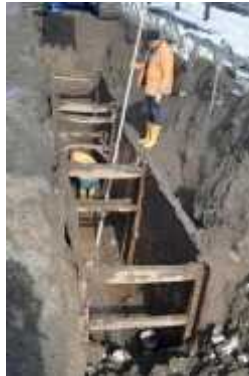
| Date of Visit | Name of Company | Auditors Name | Purpose of audit | Summary of any Significant Findings | Cross Reference to Audit Report | Status of implementation |
|---|---|---|---|---|---|---|
| 12 February 2025 | Contractor: "MBD Inssat" (Turkey).<br><br>POT-01/LOT-02 | Environmental Specialist of SC<br>Mr. Shalva Bosikashvili | Regular Monitoring of Sites | <p>Deep trenches without barrier and warning sign, see Photo N1</p> <p>Workers without full PPE in the trench, see Photo N2</p> | Non-compliance notice were issued to contractor and corrective actions were required from contractor to immediately improve the situation, under POT-01/LOT-02 sub-project (Please see Annex B) | <p>Completed. End of February 2025, all construction activities under the LOT-02 is completed, photo N1</p> <p>Completed. End of February 2025, all construction activities under</p> |

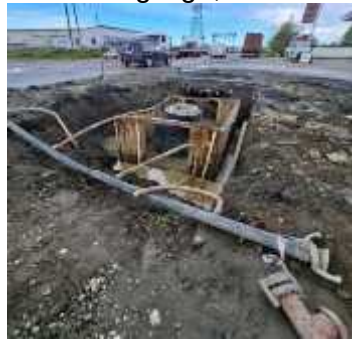
| Date of Visit | Name of Company | Auditors Name | Purpose of audit | Summary of any Significant Findings | Cross Reference to Audit Report | Status of implementation |
|---|---|---|---|---|---|---|
| 14 April 2025 | <p>Contractor: "MBD Inssat" (Turkey).</p> <p>POT-01/LOT-02</p> | Environmental Specialist of SC Mr. Shalva Bosikashvili | Regular Monitoring of Sites | <p>Manhole pit without barrier and warning sign, Photo N1</p> <p>Workers without relevant PPE, generator without drip tray, Photo N2</p> | <p>Non-compliance notice were issued to contractor and corrective actions were required from contractor to immediately improve the situation, under POT-01/LOT-02 sub-project (Please see Annex B)</p> | <p>Completed. End of April 2025, all construction activities under the LOT-02 is completed.</p> <p>Completed. End of February 2025, all construction activities under the LOT-02 is completed, Photo N1</p> |

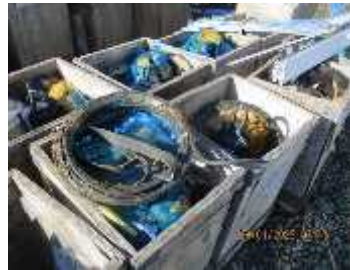
| Date of Visit | Name of Company | Auditors Name | Purpose of audit | Summary of any Significant Findings | Cross Reference to Audit Report | Status of implementation |
|---|---|---|---|---|---|---|
| 6 February 2025 | Contractor:<br>CHINA<br>NUCLEAR<br>INDUSTRY 23<br>CONSTRUCTI<br>ON CO” Ltd<br>(China)<br><br>POT-01/LOT-03 | Environmental Specialist of SC<br>Mr.Shalva Bosikashvili | Regular Monitoring of Sites | <p>Expensive equipment and goods should be adequate stored and protected, Photo N1, Photo N2</p> <p>The rules for working at</p> | Non-compliance notice were issued to contractor and corrective actions were required from contractor to immediately improve the situation, under POT-01/LOT-03 sub-project (Please see Annex B) | Completed, all equipment is stored appropriately March 2025 |

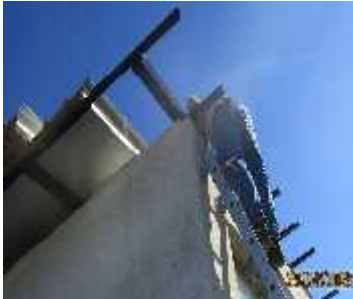
| Date of Visit | Name of Company | Auditors Name | Purpose of audit | Summary of any Significant Findings | Cross Reference to Audit Report | Status of implementation |
|---|---|---|---|---|---|---|
| | | | | <p>height are violated, the worker is without protective equipment and PPE, Photo N3</p> <p>Also, the access ladder is inadequate and does not meet standards, Photo N3</p> | | Completed immediately |

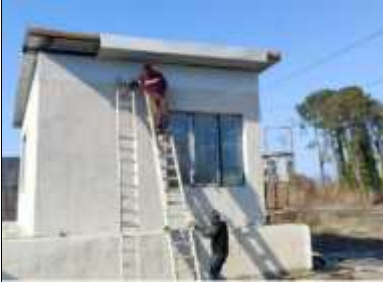
| Date of Visit | Name of Company | Auditors Name | Purpose of audit | Summary of any Significant Findings | Cross Reference to Audit Report | Status of implementation |
|---|---|---|---|---|---|---|
| 13 February 2025 | <p>Contractor: CHINA NUCLEAR INDUSTRY 23 CONSTRUCTION CO” Ltd (China)</p> <p>POT-01/LOT-03</p> | Environmental Specialist of SC<br>Mr.Shalva Bosikashvili | Regular Monitoring of Sites | <p>Unsafe work on height without PPE, see Photo N1</p> | Non-compliance notice were issued to contractor and corrective actions were required from contractor to immediately improve the situation, under POT- | Completed immediately |

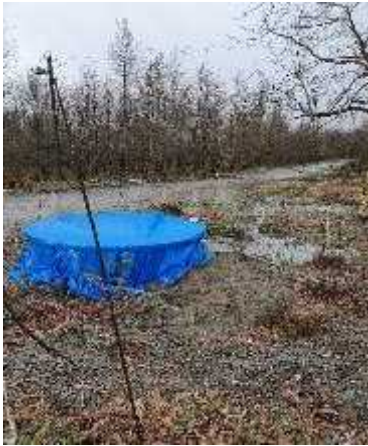
| Date of Visit | Name of Company | Auditors Name | Purpose of audit | Summary of any Significant Findings | Cross Reference to Audit Report | Status of implementation |
|---|---|---|---|---|---|---|
| 20 February 2025 | Contractor: CHINA NUCLEAR INDUSTRY 23 CONSTRUCTION CO” Ltd (China)<br><br>POT-01/LOT-03 | Environmental Specialist of USIIP<br>Ms.Kate Chomakhidze | Monthly Monitoring of Sites | <p>Adequate and proper fencing, along with side barriers, should be installed around deep open excavations to prevent accidents at the construction site (see Photo #1)</p> <p>Plastic and wooden covers</p> | <p>Non-compliance notice were issued to contractor and corrective actions were required from contractor to immediately improve the situation, under POT-01/LOT-03 sub-project (Please see Annex B)</p> | <p>Completed immediately, Photo N1</p> <p>Completed , end</p> |

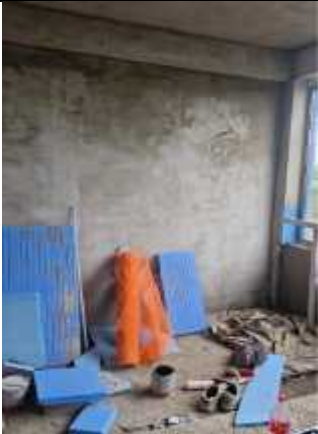
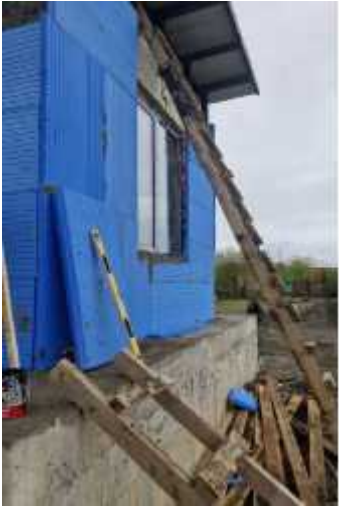
| Date of Visit | Name of Company | Auditors Name | Purpose of audit | Summary of any Significant Findings | Cross Reference to Audit Report | Status of implementation |
|---|---|---|---|---|---|---|
| | | | | <div><br/>Unsafe handmade ladders<br/>PS13, Photo N2</div> <div></div> | immediately improve the situation, under POT-01/LOT-03 sub-project (Please see Annex B) | Completed immediately |

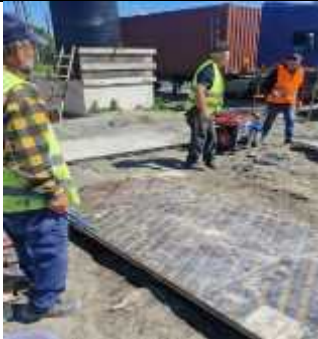
| Date of Visit | Name of Company | Auditors Name | Purpose of audit | Summary of any Significant Findings | Cross Reference to Audit Report | Status of implementation |
|---|---|---|---|---|---|---|
| | ON CO" Ltd (China)<br><br>POT-01/LOT-03 | Environmental Specialist of USIIP<br>Ms.Kate Chomakhidze | | <br>Welder without relevant PPE, Photo N2<br> | and corrective actions were required from contractor to immediately improve the situation, under POT-01/LOT-03 sub-project (Please see Annex B) | Completed, 21 May 2025 |

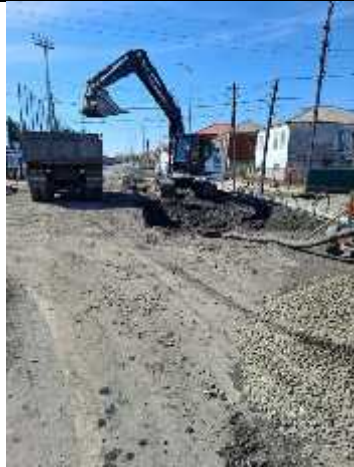
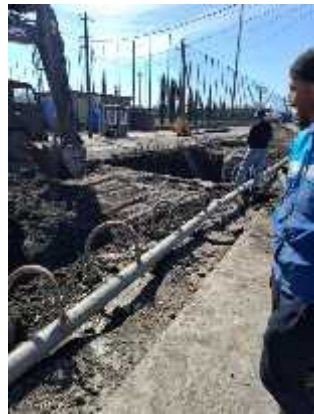
| Date of Visit | Name of Company | Auditors Name | Purpose of audit | Summary of any Significant Findings | Cross Reference to Audit Report | Status of implementation |
|---|---|---|---|---|---|---|
| | | | | <p>Open trench without barrier/warning tape, Workers without PPE at the construction site, Photo N2</p> | improve the situation, under POT-01/LOT-03 sub-project (Please see Annex B) | Completed, March 2025 |

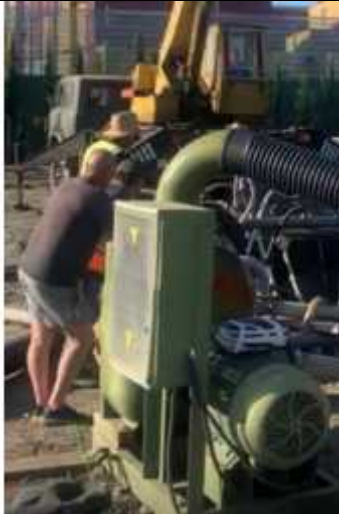
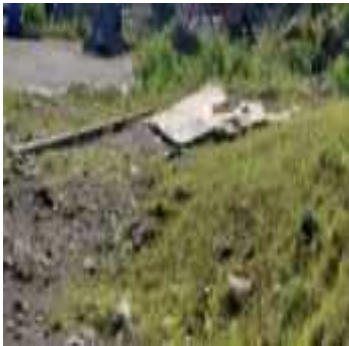
| Date of Visit | Name of Company | Auditors Name | Purpose of audit | Summary of any Significant Findings | Cross Reference to Audit Report | Status of implementation |
|---|---|---|---|---|---|---|
| | CONSTRUCTION CO” Ltd (China)<br><br>POT-01/LOT-03 | Environmental Specialist of USIIP<br>Ms.Kate Chomakhidze | | <br>Housekeeping problems (PS12), Photo N2<br> | contractor and corrective actions were required from contractor to immediately improve the situation, under POT-01/LOT-02 sub-project (Please see Annex B) | Completed 20 June 2025, the dumped construction materials have been removed from the site., Photo N1<br> |

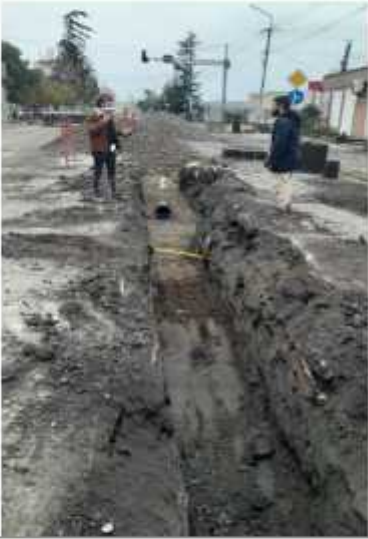
| <ul style="list-style-type: none"> <li>• Deep trenches without barrier and warning sign; equipment works without flagman</li> <li>• <i>Deep pit without barrier and warning sign; equipment works without flagman(Samegrelo Street)</i></li> </ul> | |

All these conditions have to be remedied within 10 days by the prime Contractor **MBD**

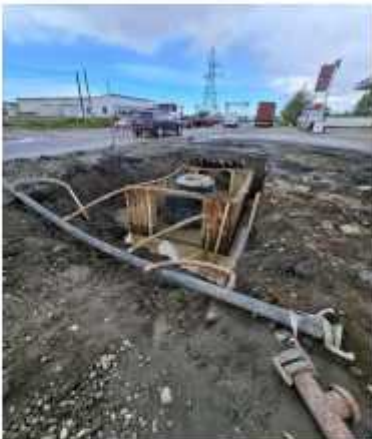
**Manhole poit without barrier and warning sign; (Larnaka st)**

All these conditions have to be remedied within 10 days by the prime Contractor **MBD**

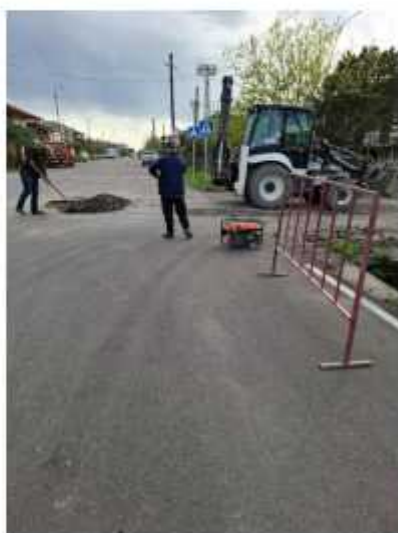
**Workers without relevant PPE, generator without drip tray (Larnaka st)**

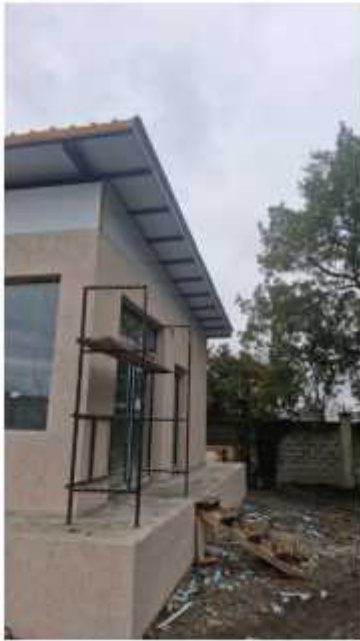
- Unsafe scaffold (PS17)
- Unsafe ladder (PS9)
- *Unsafe scaffold (PS17)*

| All these conditions have to be remedied within 10 days by the prime Contractor <b>CNI23</b> | |

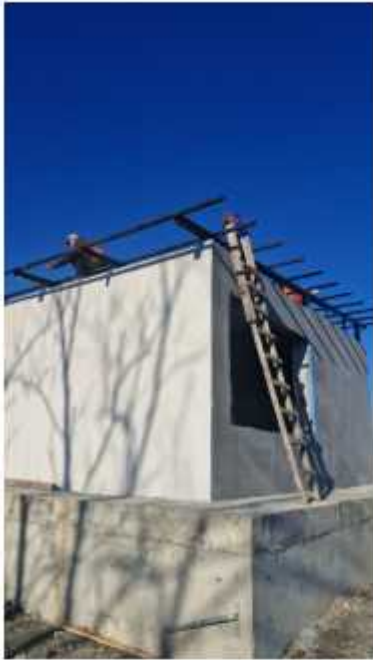
- *Unsafe ladder (PS9)*

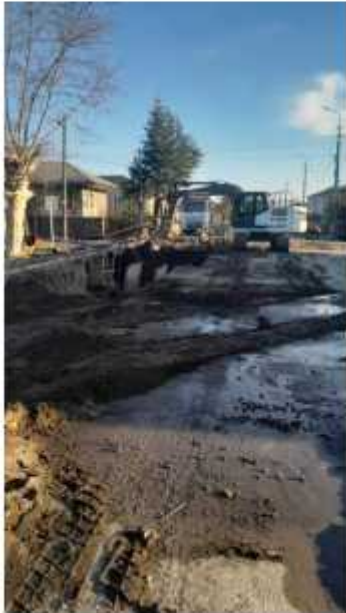
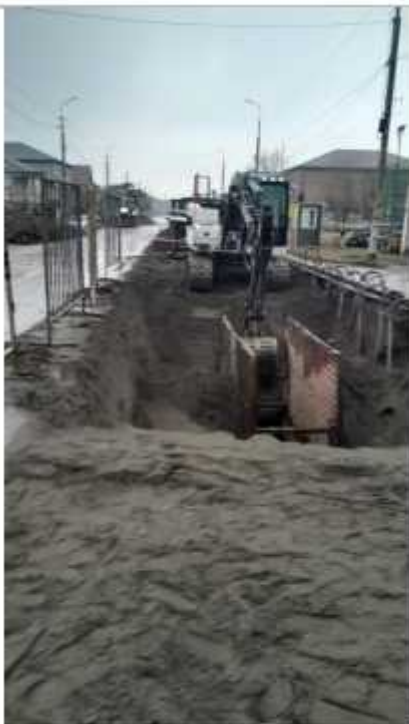
| <b><i>Open trench without barrier/warning tape, warning sign and heavy equipment works without flagman (Guria street)</i></b> | |

All these conditions have to be remedied within 10 days by the prime Contractor **ECETAS**

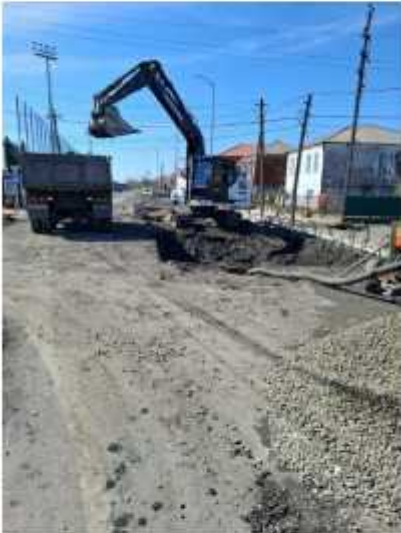
***Open trench without barrier/warning tape, backhoe works without flagman (8 March and Kikalishvili st crossing)***

All these conditions have to be remedied within 10 days by the prime Contractor **ECETAS**

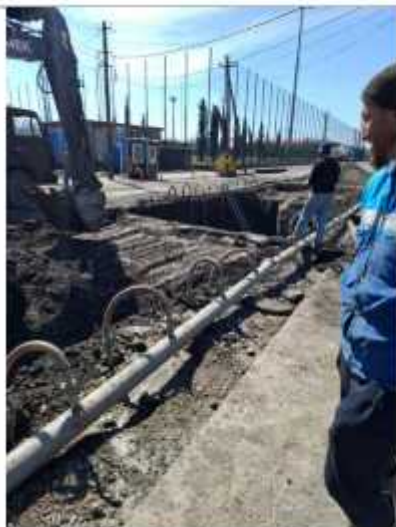
***Open trench without barrier/warning tape, Workers without PPE at the construction site  
(Kikalishvili st)***

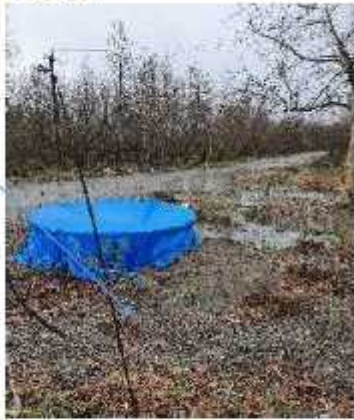
**Photo N1**

| <b>Construction of Pumping Stations in POTI, LOT-03 (PS 26, PS 12, PS 11, PS 2, PS 7, PS 3, PS 27)</b> <ul style="list-style-type: none"> <li>- Adequate and proper fencing, along with side barriers, should be installed around deep open excavations to prevent accidents at the construction site (see Photo #1).</li> <li>- Plastic and wooden covers should be placed over the Pumping Station to prevent accidents at the construction site (see Photo #2);</li> <li>- All construction sites/segments must have proper access, ladders, or other necessary facilities. A secure cover should be installed around deep open pits/reservoirs inside the pumping station to prevent accidents involving workers (see Photo #3);</li> <li>- A safety ladder should be installed at the construction site to prevent worker injuries (see Photo #4);</li> <li>- All construction sites should be properly graveled, and open trenches should be backfilled promptly (see Photo N5);</li> <li>- An appropriate fence must be installed around the entire perimeter of the Pumping Station (see Photo N6);</li> <li>- Clear, visible signs, safety tapes, trench side fences, and barriers with warning signs should be installed around deep pits/trenches to prevent accidents involving the local population. The site should be kept clean, with mud removed promptly and the area properly graveled (please see Photo N7 and Photo #8);</li> <li>- The local population living near the construction area should be informed about the potential risks associated with the construction and the expected duration of the project (PS #27).</li> </ul> | |

All these conditions have to be remedied immediately by Contractor and Supervision Company and send improved photos of sites

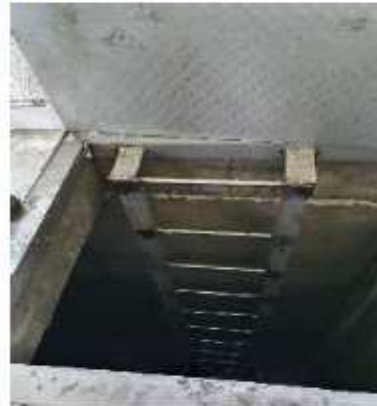
**Photo N4**

| Date of Visit | Name of Company | Auditors Name | Purpose of audit | Summary of any Significant Findings | Cross Reference to Audit Report | Status of implementation |
|---|---|---|---|---|---|---|
| | | | | <div></div> <p>All construction sites should be properly graveled, and open trenches should be backfilled promptly (see Photo N4)</p> <div></div> <p>An appropriate fence must be installed around the entire perimeter of the Pumping Station (see</p> | | <p>all pumping stations</p> <p>Partially completed, Graveling is underway in areas where the construction of PS has been completed.</p> |

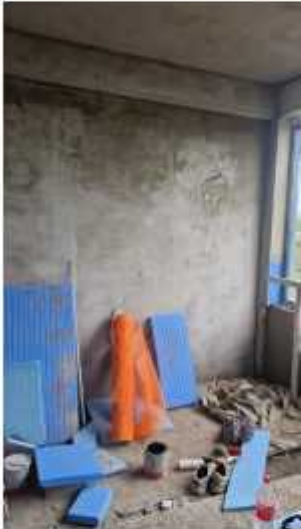
| <b><i>Unacceptable housekeeping (tripping/slipping hazard)</i></b> | |

All these conditions have to be remedied within 10 days by the prime Contractor **CNI23**

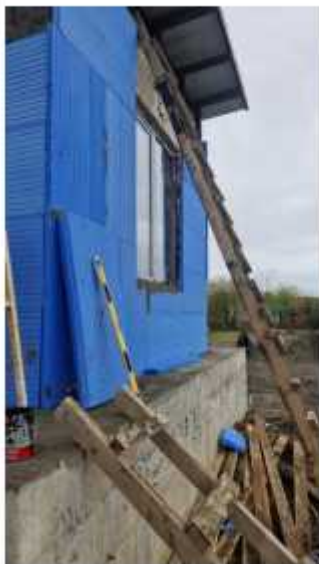
*Unsafe handmade ladder*

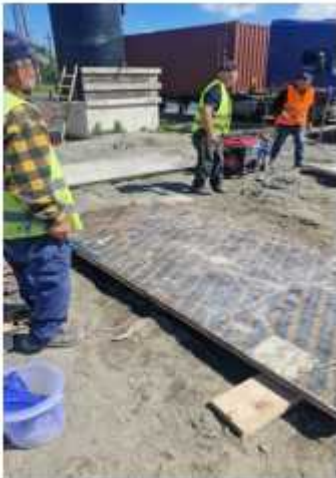
| <b><u>GENERAL COMMENT FOR ALL SITES:</u></b><br><br>Site internally should be arranged properly and cleaned regularly. All construction materials and wastes should be properly segregated and stored adequately. Oil spill response kits should be placed at the appropriate locations. Refuelling station should be equipped with the spill kit and fire relevant fighting equipment; drip tray should be used for fuel spillage prevention. Relevant traffic signs and flagmen should control traffic movement properly. PPE wearing is obligatory at the construction site.<br><br><b><u>NON-COMPLIANCE IN POTI 01</u></b><br><br><b>WWTP Poti 01 LOT3</b><br><br><ul style="list-style-type: none"><li>• Workers without relevant PPE; Generator without drip tray ( PS27)</li><li>• Welder without relevant PPE (PS27)</li><li>•</li></ul><br><b><i>Workers without relevant PPE; Generator without drip tray )</i></b> | |

All these conditions have to be remedied within 10 days by the prime Contractor **CNI23**

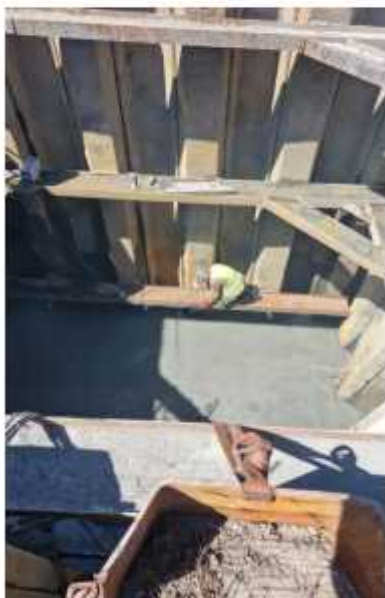
**Welder without relevant PPE**
