# SEMI-ANNUAL ENVIRONMENTAL MONITORING REPORT

## # 16 Semi-annual Report

**GEORGIA: URBAN SERVICES IMPROVEMENT INVESTMENT PROGRAM  
(TRANCHE 5)**

## **Urban Services Improvement Investment Program Tranche 5 Project: Construction of Waste Water Treatment Plant in Zugdidi (REG-03a)**

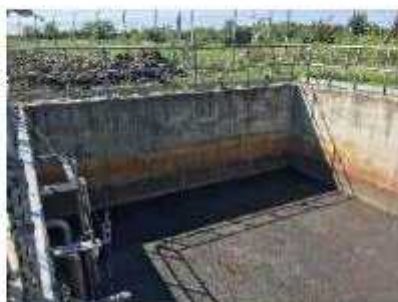
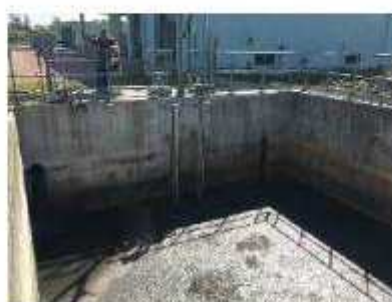
27. Since August 2022 one out of two fine screens is not operative anymore. It is mechanically damaged and there is no contractor to repair or exchange them.
- 28.
29. However, the screens have been investigated and it is clear which parts would be needed that so that UWSCG can repair them. It is proposed to directly order these part from the supplier until the end of December 2023.
30. In the absence of the digester and the sludge centrifuges a temporary sludge removal is established by UWSCG. Sludge is removed as follows: Primary sludge is thickened in the thickener and overflows from the thickener into the drainage pump sump, as no Primary Sludge (PS) can be withdrawn from the thickener. From hat drainage sump the scum layer is removed (by excavator!) to the emergency sludge storage hall for drying.

Drainage pump sum with scum layer after excavation end September 2023

32. In order to address the above-mentioned non-compliances, including the completion of the centrifuge, the gas line, the heating system for digester and the gas holder, as well as ensuring smooth operation of the fine screen, UWSCG and SC/Posch have decided to go for local contract of all works and services, which will take max. 4-6 months. To achieve this goal, at the end of January 2024, the Supervision Consultant/ Posch prepared and submitted to the UWSCG tender documents for the emergency procurement of all the above services and works, which will ensure that all defects are eliminated, including sludge dewatering and that all problems identified during the preliminary commissioning of the WWTP will be finally improved (for more details please see Annex B – Post-construction Audit Report for REG-03a sub-project).

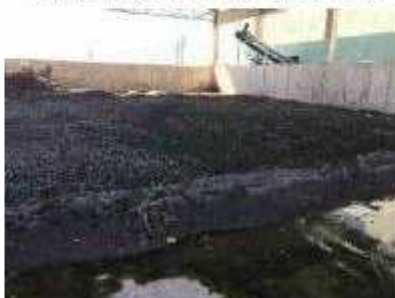
- Sludge from drain sump is stored in the sludge storage area (about 100m<sup>3</sup>), and some sludge was buried in the trench next to the drainage sump (about 50m<sup>3</sup>):

Sludge storage area

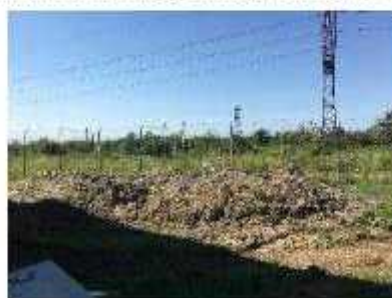
Sludge dump next to storage hall

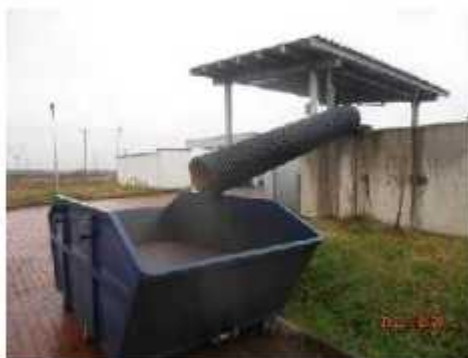
31. Excess sludge (secondary sludge) is pumped from the Return Sludge into the sludge storage sump. From time to time a small volume is withdrawn via a hose connected to the socket for the manometer and pumped to the emergency sludge storage hall where it is dried and disposed at the dump site as above.
32. Another portion of excess sludge (mainly floating sludge and scum) is manually removed from the open outlet/collection channel of the aeration tanks.

Dried sludge at emergency storage hall
