# SEMI-ANNUAL ENVIRONMENTAL MONITORING REPORT

## #15 Semi-annual Report

(Reporting Period: January-June 2025)

**GEORGIA: URBAN SERVICES IMPROVEMENT INVESTMENT PROGRAM  
(TRANCHE 6)**

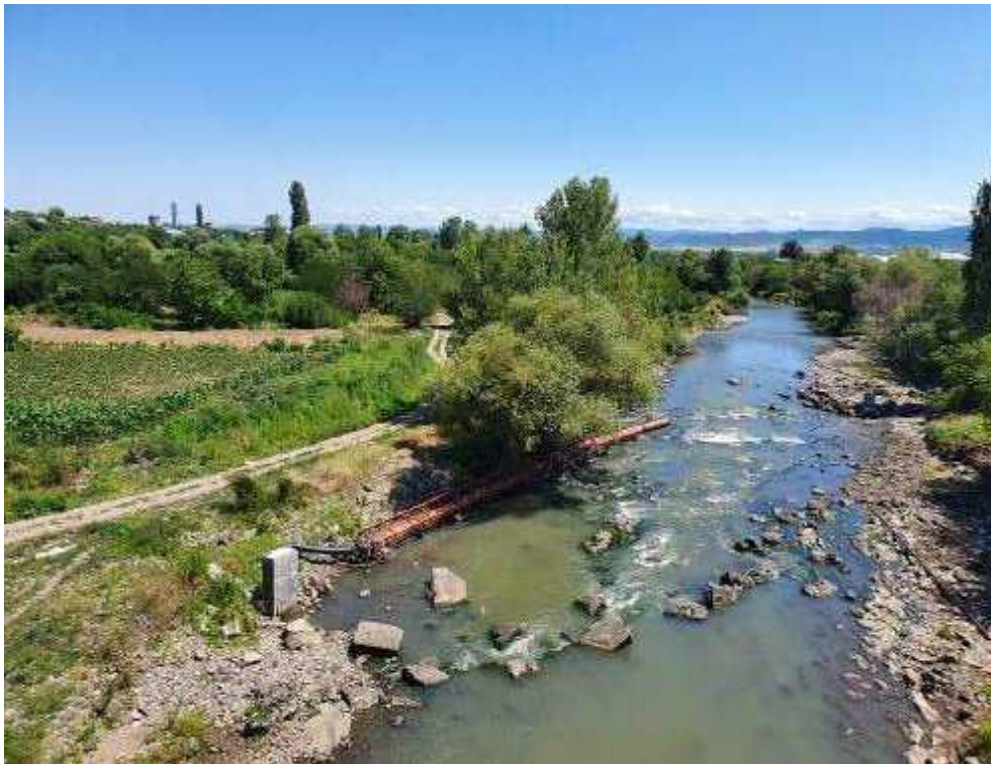
**Photo N2: Damaged Sewerage Collector**

9. During the night of 25 to 26 May 2024, severe flooding caused by prolonged and intense rainfall led to an abnormal rise in the water level of the Mashavera River. As a result, damage occurred to the newly installed sewerage collector, under the ongoing MAR-01/ LOT-05 sub-contract (Construction of sewerage collector in Bolnisi), which was partially rectified by the contractor to the extent possible.

11. The primary cause of the damage in both cases was the abnormal rise in river levels, driven by prolonged heavy rainfall, extensive sand and gravel extraction from the riverbed, and the resulting erosion of the riverbanks.

12. The United Water Supply Company of Georgia (UWSCG) is currently evaluating new alignment options to relocate the sewerage collector further from the river to minimize the risk of future flood-related damage. Three alternative routes are being developed and assessed by the UWSCG design department. A new tender will be announced after approval of new DD, and these changes will be incorporated into the scope. Consequently, the existing Supplementary Initial Environmental Examination (IEE) for MAR-01/LOT-04 and LOT-05 sub-projects will be revised accordingly. The document is scheduled to be updated by the end of December 2025.

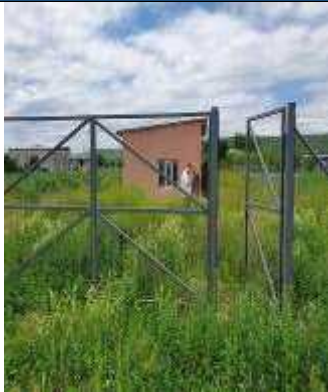
| # | Non-compliance | Corrective action | Construction Site | Terms of accomplishment | Responsibility | Status |
|---|---|---|---|---|---|---|
| 1 | There are no warning and information signs on entrance gates of the Pumping Stations (Photo N1) | Proper Warning and information signs should be installed on entrance gate | Photo N1 | End of August 2025 | UWSCG | Not completed by the end of June 2025 |

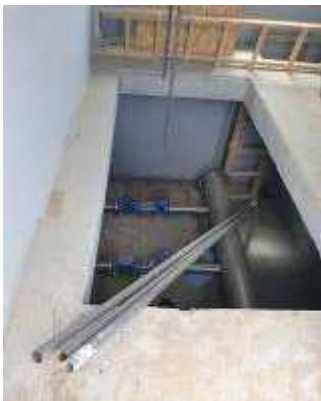
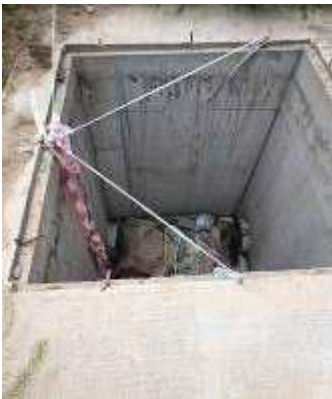
| # | Non-compliance | Corrective action | Construction Site | Terms of accomplishment | Responsibility | Status<br>By the June 2025 |
|---|---|---|---|---|---|---|
| 2 | Deep and unprotected pits, both inside (Photo N2) and outside (Photo N3) the pumping station building | Clearly visible signs/safety tapes, trench side fences or proper cover should be installed around deep open pits/reservoirs (3-7m) to avoid accidents with working personal indoor and outdoor of the Pumping Stations | <p><b>Photo N2</b></p> <p><b>Photo N3</b></p> | <b>End of August 2025</b> | CC | <b>Not completed by the end of June 2025</b> |

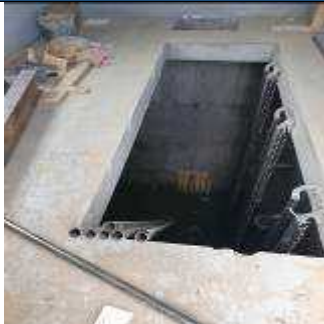
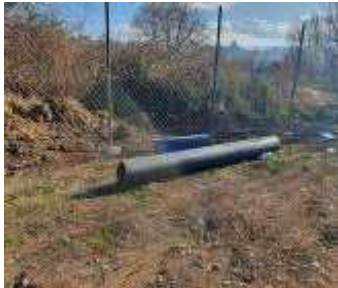
| # | Non-compliance | Corrective action | Construction Site | Terms of accomplishment | Responsibility | Status<br>By the June 2025 |
|---|---|---|---|---|---|---|
| 3 | A small amount of construction waste remains on the site, both inside (Photo N5) and outside (Photo N5) the pumping | Construction waste should be removed from the territory and disposed adequately | <b>Photo N4</b> | <b>End of December 2024</b> | CC | <b>Completed, removed from inside and outside of Pumping Station, May 2025, please see Photo N1</b> |

| # | Non-compliance | Corrective action | Construction Site | Terms of accomplishment | Responsibility | Status<br>By the June 2025 |
|---|---|---|---|---|---|---|
| | station building. | | <p>Photo N5</p> | | | <p>and N2 below</p> <p>Photo N1</p> <p>Photo N2</p> |

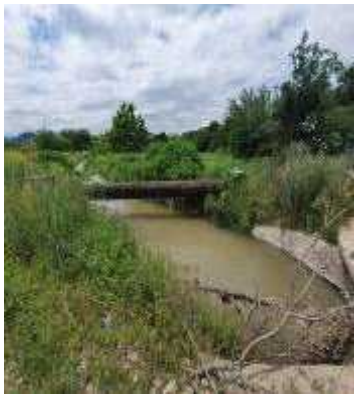
| # | Non-compliance | Corrective action | Construction Site | Terms of accomplishment | Responsibility | Status<br>By the June 2025 |
|---|---|---|---|---|---|---|
| | Un-fenced /unsecured pipeline cross river near resident areas (next to PS #2), Photo N6 | The sewage collector across the river should be properly fenced off, as children may use the pipeline as a playground or bridge, posing a potential health risk | <p>Photo N6</p> | End of August 2025 | CC | Not completed by the end of June 2025 |

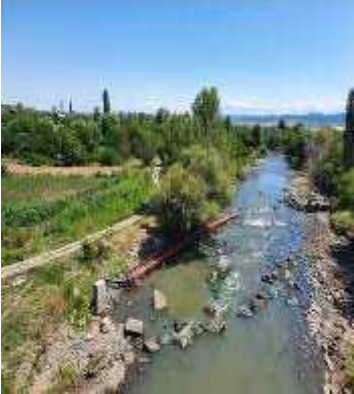
**22.** However, as noted above, an additional circumstance arose in January 2025, when flooding of the Mashavera Riv. In Bolnisi, caused significant damage: approximately 300 meters of the sewerage collector, previously installed within a protective metal casing, was washed away. This incident has been included in the PCEAR and reflected in the corresponding summary table (see Table No. 1 below).

| # | Non-compliance | Corrective action | Construction Site | Terms of accomplishment | Responsibility | Status<br>By the June 2025 |
|---|---|---|---|---|---|---|
| | Approximately 300 meters of the sewerage collector, which had been installed within a protective metal casing, was washed away by the river Mashavera, as a result of the abnormal increase in river levels, triggered by prolonged heavy rainfall, intensified sand and gravel extraction from the riverbed. | UWSCG should evaluate new alignment options to relocate the sewerage collector further from the river. Three alternative routes should be developed and assessed by the UWSCG design department. A new tender will be announced, and these changes will be incorporated into the scope. | | End of December 2025 | UWSCG | Not completed |

37. Between May 25-26 2024, and again in January 2025, severe flooding caused by prolonged heavy rainfall led to significant damage to the newly installed sewerage collector under the MAR-01/LOT-05 sub-contract. Around 300 meters of the pipe, previously laid within a protective casing behind a gabion wall, was washed away. The primary causes were abnormal river level rises, excessive sand and gravel extraction, and resulting riverbank erosion. The United Water Supply Company of Georgia (UWSCG) is currently evaluating three alternative alignment options to relocate the pipeline further from the river to reduce future flood risk. A new tender will be announced, and the Supplementary Initial Environmental Examination (IEE) will be updated to reflect the final design and environmental considerations.

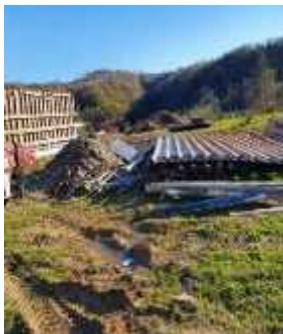
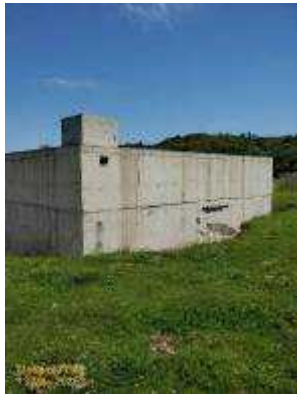
| # | Non-compliance | Corrective action | Construction Site | Terms of accomplishment<br><br>Responsibility | Progress of Corrective Actions |
|---|---|---|---|---|---|
| <b>1</b> | Avarioni Reservoir, uncontrolled disposal of construction waste were fixed. | Construction Waste must be collected and disposed from the project area. | Photo N1<br> | <b>UWSCG</b><br><br><b>End of June 2024</b> | <b>Completed June 2024, Photo N1</b><br> |

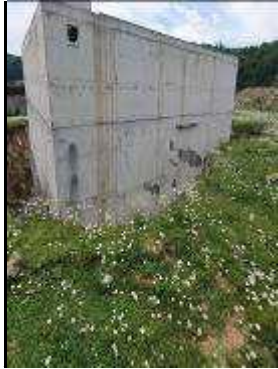
| # | Non-compliance | Corrective action | Construction Site | Terms of accomplishment<br>Responsibility | Progress of Corrective Actions |
|---|---|---|---|---|---|
| 3 | Avarioni Reservoir surplus waste soil<br><br>soil were piled up on the construction area | Avarioni Reservoir surplus waste soil should be removed completely from the disposed area | Photo N3<br> | UWSCG<br><br>End of June 2024 | Completed June 2024, Photo N3<br> |

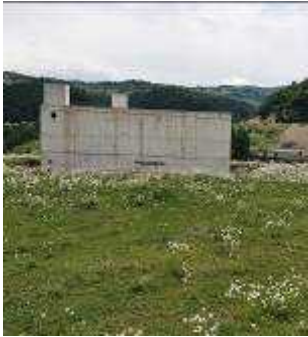
| # | Non-compliance | Corrective action | Construction Site | Terms of accomplishment<br>Responsibility | Progress of Corrective Actions |
|---|---|---|---|---|---|
| 4 | Prevent access of public to the reservoir site - The fence of the reservoir should be done properly and equipped with<br><br>Signs, information and warnings | Reservoirs sites should be properly fenced equipped with proper warning signs | Photo N4<br> | UWSCG<br><br>UWSCG | Not yet completed<br><br><sup>2</sup> A new tender will be issued to complete these remaining tasks, with funding provided through the central government budget. UWSCG is responsible for ensuring the completion of the CHI-01 sub-project. |

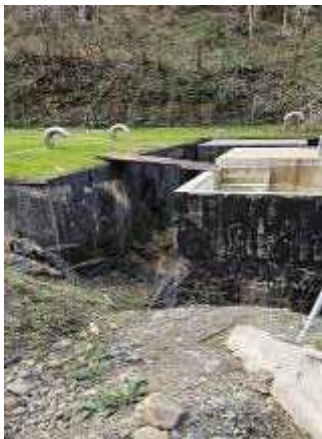
| # | Non-compliance | Corrective action | Construction Site | Terms of accomplishment<br>Responsibility | Progress of Corrective Actions |
|---|---|---|---|---|---|
| <b>6</b> | Open trenches of the BISI Pumping Station are observed | Trenches on the BISI reservoir should be filled or fenced off their borders. | <b>Photo N6</b><br> | <b>UWSCG</b> | <b>Not yet completed</b><br><br>A new tender will be issued to complete these remaining tasks, with funding provided through the central government budget. UWSCG is responsible for ensuring the completion of the CHI-01 sub-project. |

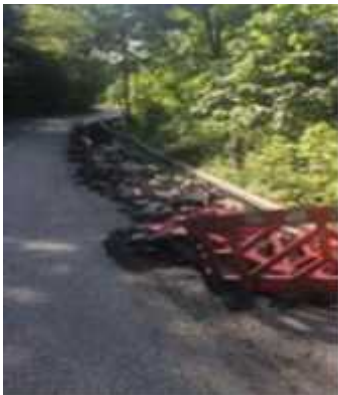
| # | Non-compliance | Corrective action | Construction Site | Terms of accomplishment<br>Responsibility | Progress of Corrective Actions |
|---|---|---|---|---|---|
| <b>7</b> | Uncontrolled disposal of construction waste were outside the BISI reservoir was fixed. | Construction Waste must be collected and disposed from the project area. | <b>Photo N7</b><br> | <b>UWSCG</b><br><br><b>End of May 2024</b> | <b>Completed May 2024, Photo N4</b><br> |

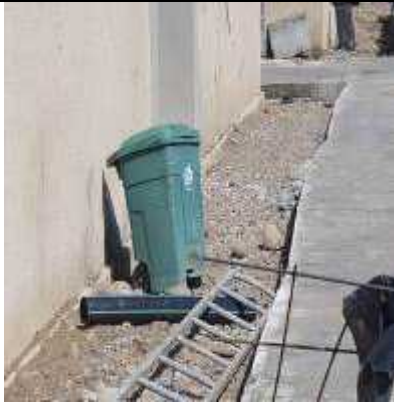
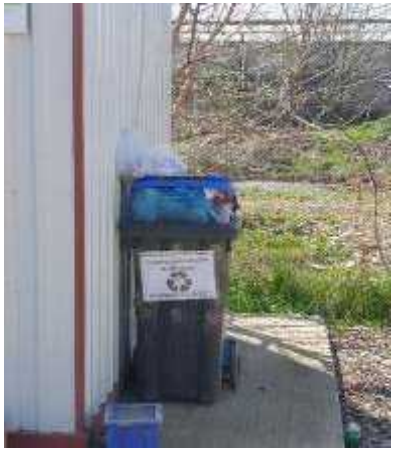
| Date of Visit | Name of Company<br><br>Name of Contract | Auditors Name | Purpose of audit | Summary of any Significant Findings | Implemented Actions | <sup>3</sup> Implementation Status |
|---|---|---|---|---|---|---|
| | | | | <p>Construction waste should be timely removed from the construction site and disposed properly (Photo N2)</p> <p>Workers without PPE,</p> | <p>Non-Compliance Notice was issued and is presented in Annex C of this report.</p> <p>(Photo-documentations are presented in Annex C, non-compliance note)</p> | <p>Completed: Waste has been removed and waste bins have been cleaned (May 2025). Please see Photo N2.</p> <p>Completed, April 2025</p> |

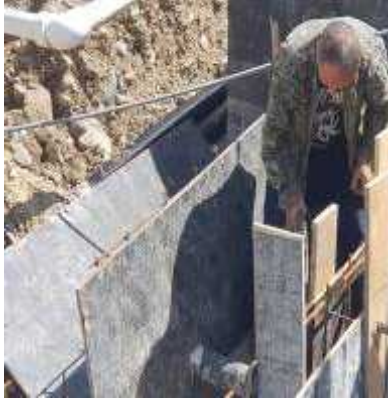
| Date of Visit | Name of Company<br><br>Name of Contract | Auditors Name | Purpose of audit | Summary of any Significant Findings | Implemented Actions | <sup>3</sup> Implementation Status |
|---|---|---|---|---|---|---|
| | | | | <p>helmets, gloves, and safety boots (Photo N3)</p> <p>Adequate and sufficient quantity of Safety/warning signs/tapes and trench side barriers around of deep open trenches should be installed to avoid accident of workers on construction site (Photo N4)</p> | | Completed, all tranches on the WWTP site is backfilled and closed, May 2025, Photo N3 |

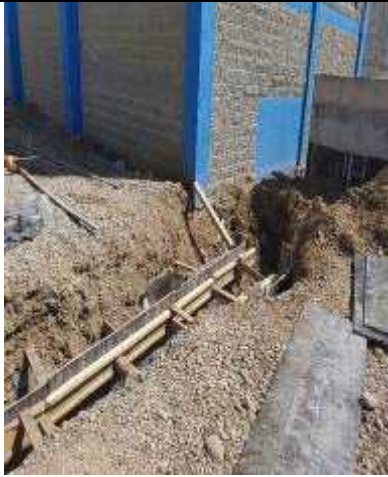
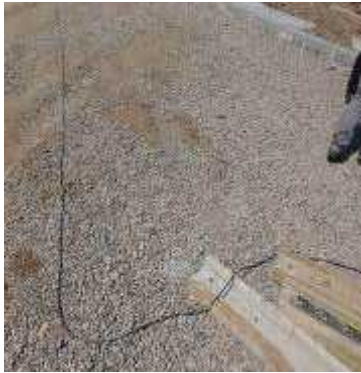
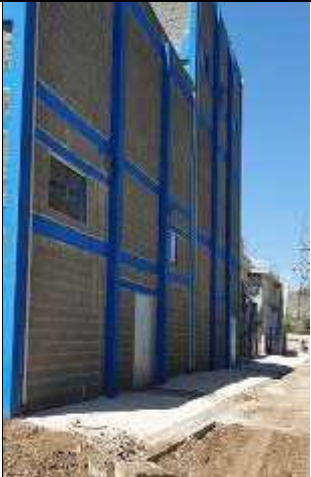
| Date of Visit | Name of Company<br><br>Name of Contract | Auditors Name | Purpose of audit | Summary of any Significant Findings | Implemented Actions | <sup>3</sup> Implementation Status |
|---|---|---|---|---|---|---|
| | | | | <p>Avoid having cables on the ground where they can be a tripping hazard or exposed to water, dirt, and debris (Photo N5)</p> | | <p>Completed, cables are removed from the construction territory, May 2025</p> |

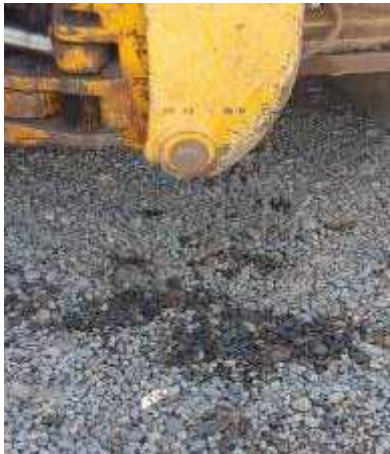
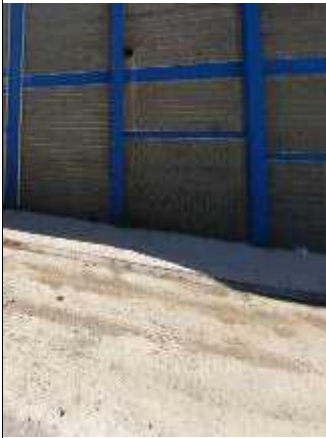
| Date of Visit | Name of Company<br><br>Name of Contract | Auditors Name | Purpose of audit | Summary of any Significant Findings | Implemented Actions | <sup>3</sup> Implementation Status |
|---|---|---|---|---|---|---|
| | | | | <p>Oil spills should be cleaned up immediately to avoid pollution of the land (Photo N6)</p> | | <p>Completed, The area has been cleaned of oil residues and covered with an asphalt layer, May 2025, Photo N4</p> |

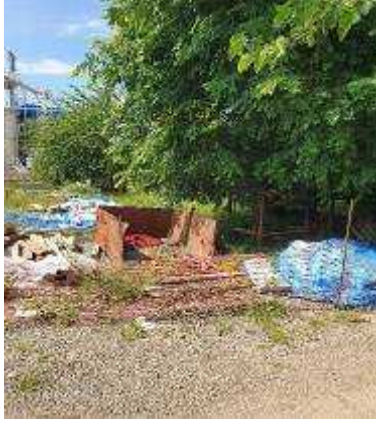
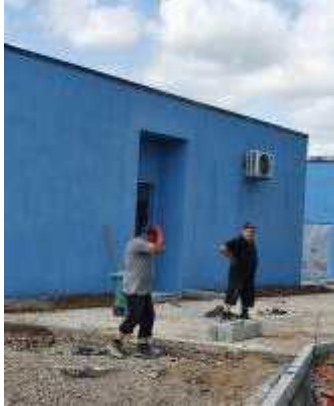
| Date of Visit | Name of Company<br><br>Name of Contract | Auditors Name | Purpose of audit | Summary of any Significant Findings | Implemented Actions | <sup>3</sup> Implementation Status |
|---|---|---|---|---|---|---|
| | | Neparidze | | <p>Workers without PPE, helmets, gloves, and safety boots, Photo No. 2</p> <p>Adequate and sufficient quantity of Safety/warning signs/tapes and trench side barriers around of deep open trenches should be installed to avoid accident</p> | <p>(Photo-documentations are presented in Annex C, non-compliance note)</p> | <p>Completed, May 2025, Photo N2</p> <p>Completed, May 2025, there are no open trenches on the construction site</p> |

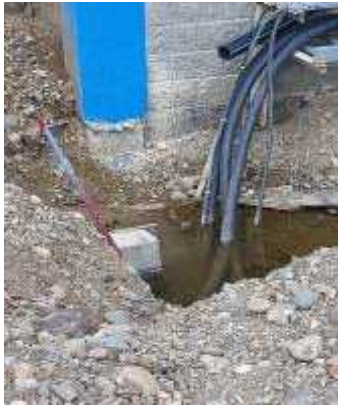
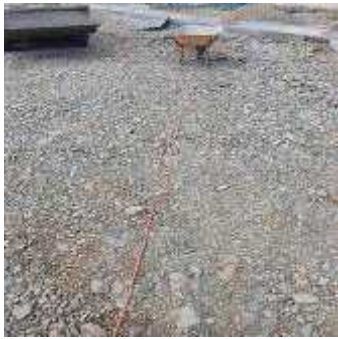
| Date of Visit | Name of Company<br><br>Name of Contract | Auditors Name | Purpose of audit | Summary of any Significant Findings | Implemented Actions | <sup>3</sup> Implementation Status |
|---|---|---|---|---|---|---|
| | | | | <p>of workers on construction site, Photo No. 3</p> <p>Avoid having cables on the ground where they can be a tripping hazard or exposed to water, dirt, and debris, Photo No. 4</p> <p>Hazardous waste should be timely removed from construction site and</p> | | <p>Completed, cables are removed from the site, May 2025</p> <p>Completed all hazardous waste is removed from the territory and adequately stored, Photo N3</p> |

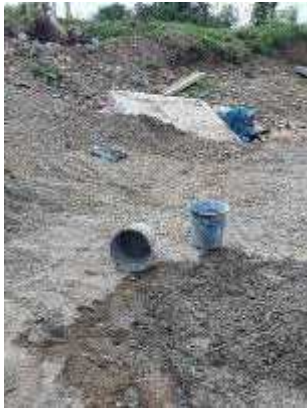
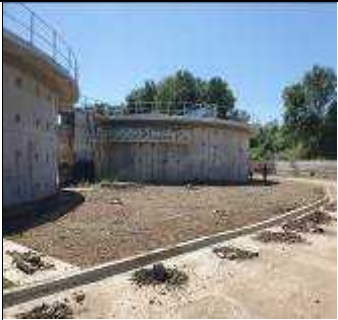
| Date of Visit | Name of Company<br><br>Name of Contract | Auditors Name | Purpose of audit | Summary of any Significant Findings | Implemented Actions | <sup>3</sup> Implementation Status |
|---|---|---|---|---|---|---|
| | | | | disposed properly, Photo No. 5<br> | | |

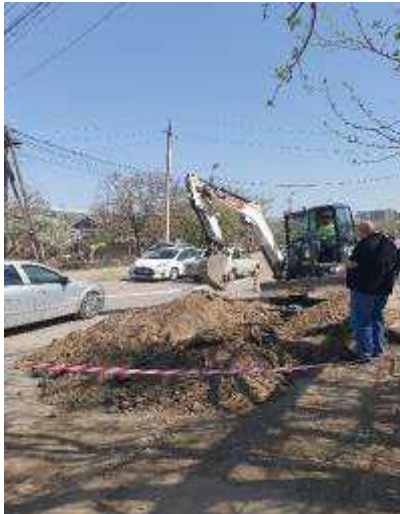
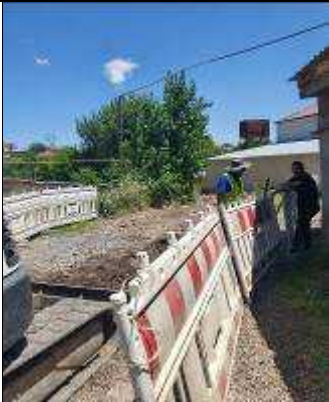
| Date of Visit | Name of Company<br><br>Name of Contract | Auditors Name | Purpose of audit | Summary of any Significant Findings | Implemented Actions | <sup>3</sup> Implementation Status |
|---|---|---|---|---|---|---|
| | | Environmental Specialist | | <p>N1)</p> <p>Walls of the deep trenches (&gt;1.5m) should be strengthened by adequate and sufficient quantity of boards to avoid landfall of the soil and accidents (workers damage) (Photo N2)</p> | <p>Notice was issued and is presented in Annex C of this report.</p> <p>(Photo-documentations are presented in Annex C non-compliance note)</p> <p>Corrective Action Plan has been developed by contractor and sent to SC and UWSCG</p> | <p>Completed, April 2025</p> |

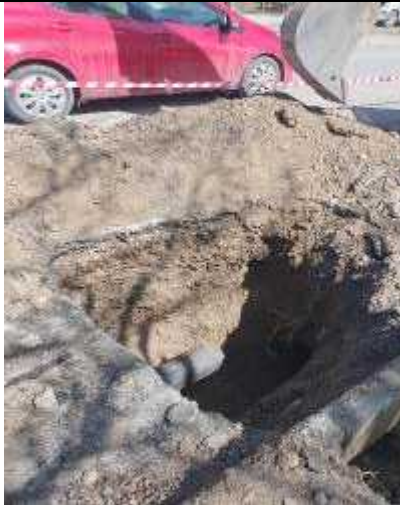
| Date of Visit | Name of Company | Auditors Name | Purpose of audit | Summary of any Significant Findings | Implemented Actions | <sup>3</sup> Implementation Status |
|---|---|---|---|---|---|---|
| | Name of Contract | | | <p>Proper reinstatement of the roads should be carried out after the completion of the construction works to avoid causing disturbance to the population (Photo N3)</p> | | Partially completed, In the area where construction work is underway, the road surface will be restored after the completion of the construction work. |

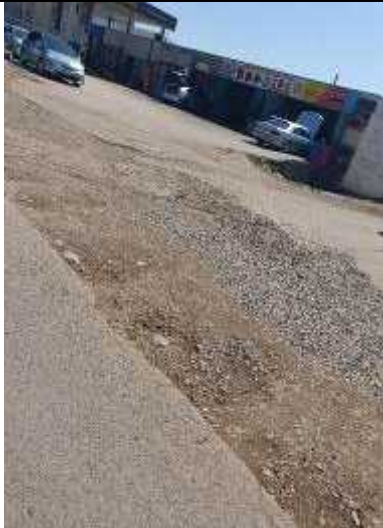
| Date of Visit | Name of Company | Auditors Name | Purpose of audit | Summary of any Significant Findings | Implemented Actions | <sup>3</sup> Implementation Status |
|---|---|---|---|---|---|---|
| | Name of Contract | | | <p>No trenches shall be kept open in the night/after work hours to avoid accidents (Photo N4)</p> | | Completed immediately. |

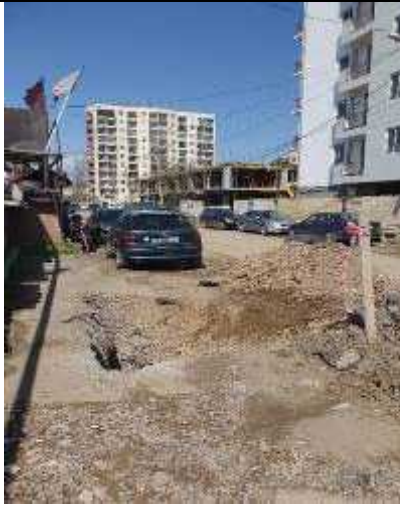
| Date of Visit | Name of Company<br><br>Name of Contract | Auditors Name | Purpose of audit | Summary of any Significant Findings | Implemented Actions | <sup>3</sup> Implementation Status |
|---|---|---|---|---|---|---|
| | | | | <p>No surplus soil should be left in public streets or spaces, it can cause traffic disruptions, pose safety risks to pedestrians. Surplus soil should be disposed of properly or stored in designated areas to minimize disruption (Photo N5)</p> | | Completed, April 2025 |

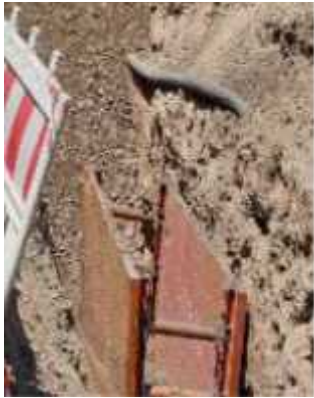
| Date of Visit | Name of Company<br><br>Name of Contract | Auditors Name | Purpose of audit | Summary of any Significant Findings | Implemented Actions | <sup>3</sup> Implementation Status |
|---|---|---|---|---|---|---|
| 10 June 2025 | | <p>Environmental Specialist of UWSCG/USIIP<br/>Ms.Kate Chomakhidze</p> <p>Environmental Specialist of Supervision Consultant HILL<br/>Mr.Nikoloz Neparidze</p> | Regular monitoring of construction sites | <p>Works are being carried out in a completely unprotected deep trench</p> <p>See Photo N1</p> | <p>Verbal instruction was given to contractor to immediately improve the situation.</p> <p>Non-Compliance Notice was issued and is presented in Annex C of this report.</p> <p>(Photo-documentations are presented in Annex C, non-compliance note)</p> | <p>Completed Immediately, Photo N1</p> |

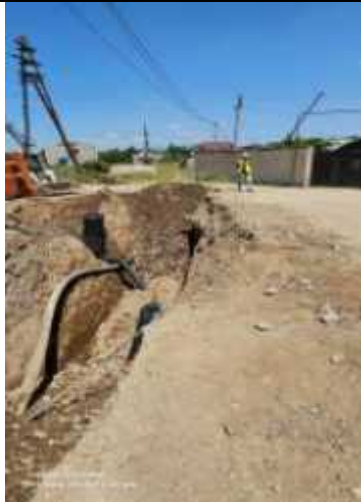
| Date of Visit | Name of Company | Auditors Name | Purpose of audit | Summary of any Significant Findings | Implemented Actions | <sup>3</sup> Implementation Status |
|---|---|---|---|---|---|---|
| | | | | <p>The work area is not demarcated by special barriers, their installation only began during the visit. There are no speed limit and warning signs installed on the adjacent highway, Photo N2</p> | <p>Corrective Action Plan has been developed by contractor and sent to SC and UWSCG</p> | <p>Completed immediately</p> |

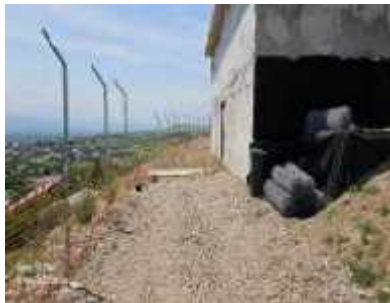
| Date of Visit | Name of Company<br><br>Name of Contract | Auditors Name | Purpose of audit | Summary of any Significant Findings | Implemented Actions | <sup>3</sup> Implementation Status |
|---|---|---|---|---|---|---|
| 19 June 2025 | | <p>Environmental Specialist of UWSCG/USIIP<br/>Ms.Kate Chomakhidze</p> <p>Environmental Specialist of Supervision Consultant HILL<br/>Mr.Nikoloz Neparidze</p> | Regular monitoring of construction sites | <p>City Reservoir (MAR-01/LOT-06)</p> <p>The fence of the facility is almost completed and it is fenced with temporary barriers, although the materials for the final fence have already been stored in the area, Photo N1, Photo N2</p> <p>Photo N2</p> | <p>Verbal instruction was given to contractor to immediately improve the situation.</p> <p>Non-Compliance Notice was issued and is presented in Annex C of this report.</p> <p>(Photo-documentations are presented in Annex C, non-compliance note)</p> <p>Corrective Action Plan has been developed by contractor and sent to SC and UWSCG</p> | Not completed, will be completed by the end of July 2025 |

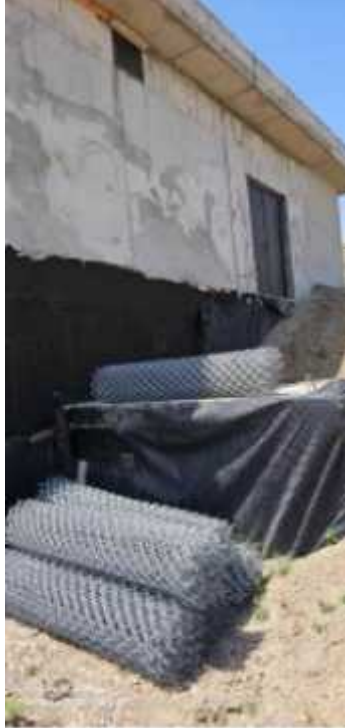
| Date of Visit | Name of Company<br><br>Name of Contract | Auditors Name | Purpose of audit | Summary of any Significant Findings | Implemented Actions | <sup>3</sup> Implementation Status |
|---|---|---|---|---|---|---|
| | | | | <p>The main entrance gate has not been installed</p> | | Not completed, will be completed by the end of July 2025 |

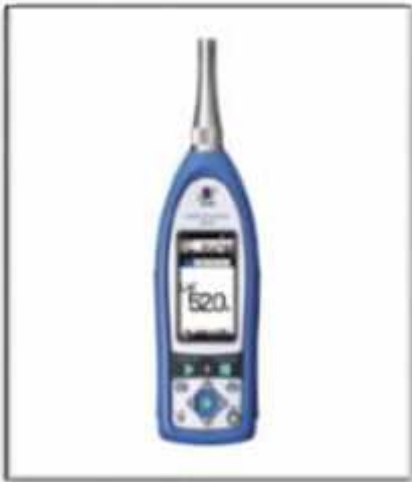
Noise measuring device

- Rion NL-52, First class noise measurement device;
- Windscreen, WS-16;
- Tripod;
- SD Card;

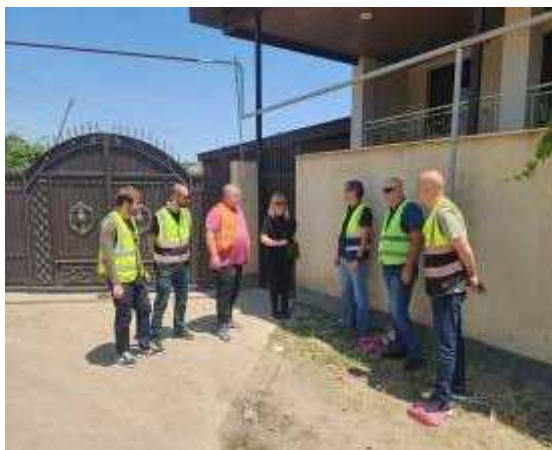
58. Representatives of UWSCG, the Supervision Consultant (SC), and the Construction Contractor (CC) held a preliminary discussion on the upcoming works, Photo No 1

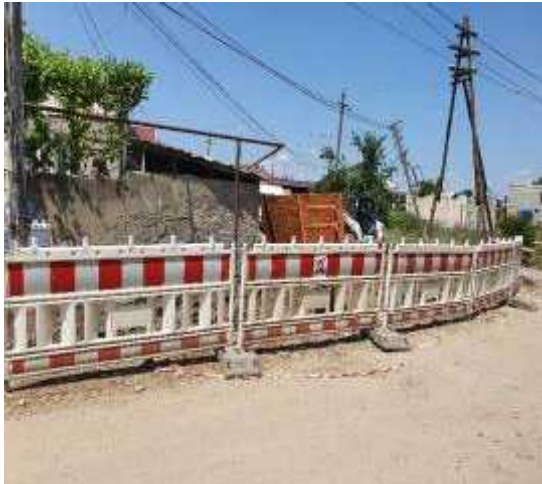
#### **Site Fencing**

59. The area was securely fenced prior to the commencement of civil works, Photo No 2

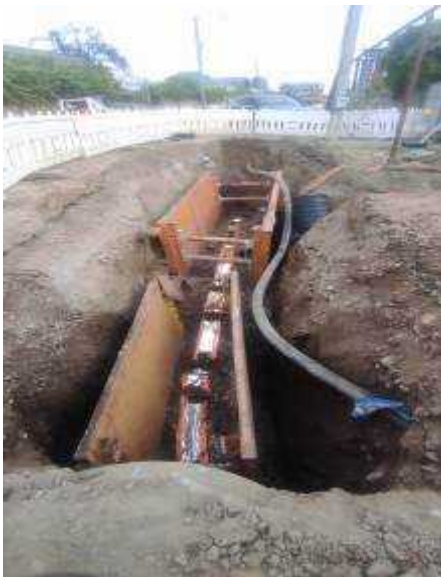
### **Installation of Trench Boxes/Shields**

60. Trench protection systems were delivered and prepared on site before excavation and pipe installation began, Photo No 3

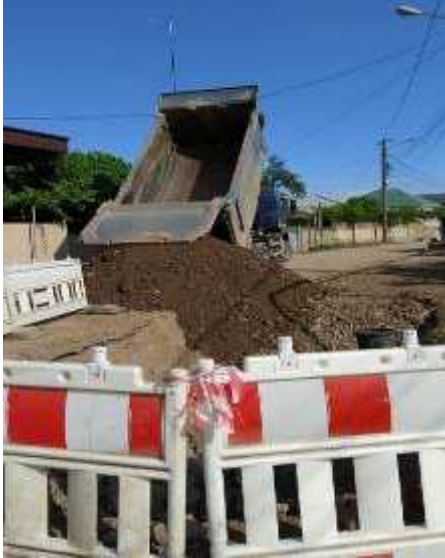
### **Backfilling Activities:**

61. Following the pipe connection, the trench was properly backfilled, Photo No 4

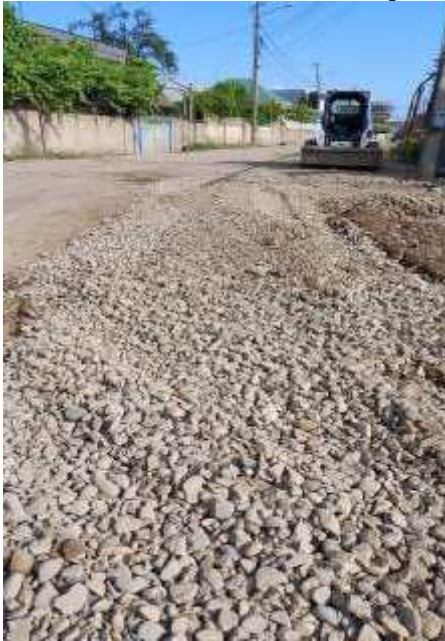
**Site Leveling:**

62. The surface was leveled and gravel was applied to stabilize the area, Photo No 5

63. After a certain period, the area will be leveled and graveled again, pending final road restoration works by the municipal authorities.

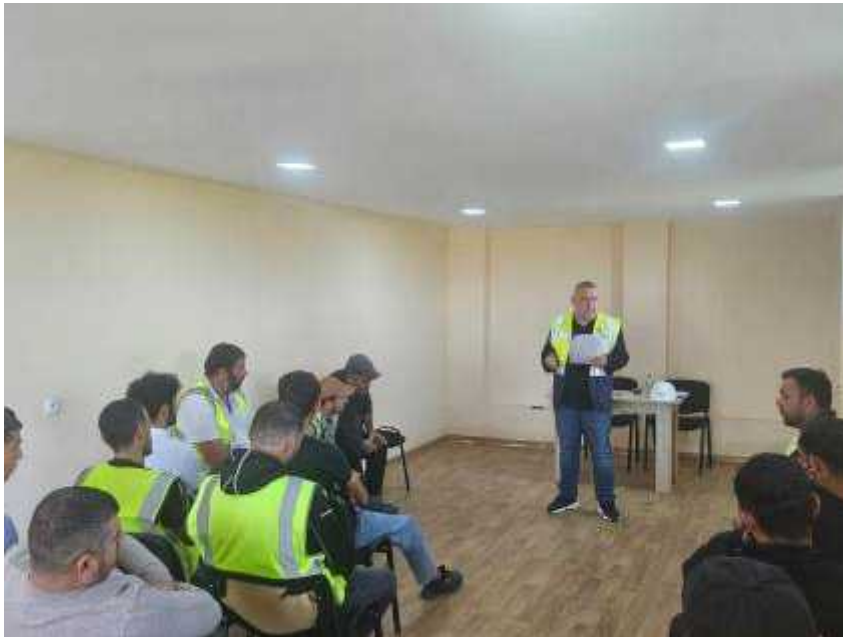
**Photo N1: training session under MAR-01 sub-project**

94. As part of the corrective actions and in response to the fatal incident that occurred on 9 May 2025 under the MAR-01/LOT-03 sub-project which resulted in the tragic death of a worker due to inadequate trench safety measures the Contractor engaged an external occupational safety consulting firm, Ltd. "Labor Safety Systems" (LSS). LSS conducted an intensive on-the-job training session for construction site personnel on 17 May 2025, covering requirements of Georgian labor safety legislation and project-specific H&S standards. The training was attended by both Contractor and Supervision Consultant staff (please see photo N1 below).

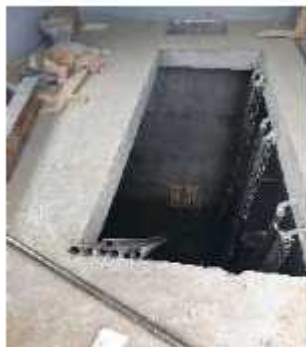
Photo No.1

1. **Secure covers, safety tapes, trench-side barriers** must be installed around deep open pits or reservoirs (ranging from 3 to 7 meters in depth) both inside the Pumping Station buildings and in the surrounding yard, to prevent accidents involving personnel. Immediate corrective action is required to address this serious safety hazard (Photo No. 1, Photo No. 2);

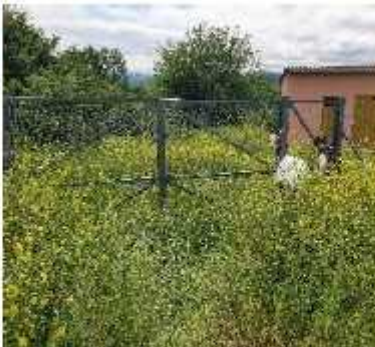
Photo No.3

2. The internal perimeter of the construction site must be cleaned, and all waste should be removed from the area (Photo No. 1) ;
3. The grass should be mowed from the entrance and the yard of the PS to allow personnel to move safely and protect from reptiles (Photo No. 3);

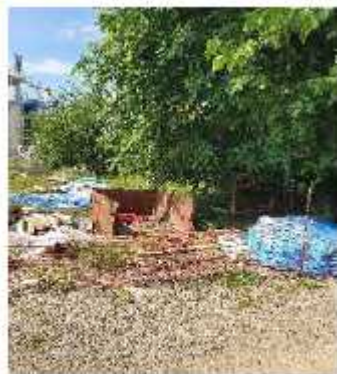
Photo No. 1

- Site internally should be arranged properly and cleaned regularly, construction waste should be timely removed from the construction site and disposed properly (Photo No. 1);
- Workers without PPE, helmets, gloves, and safety boots (Photo No. 2);
- Adequate and sufficient quantity of Safety/warning signs/tapes and trench side barriers around of deep open trenches should be installed to avoid accident of workers on construction site (Photo No. 3)
- Avoid having cables on the ground where they can be a tripping hazard or exposed to water, dirt, and debris (Photo No. 4)
- Hazardous waste should be timely removed from construction site and disposed properly (Photo No. 5 and No. 6)

All these conditions must be addressed by both the CC and SC within 5 working days, by Amy 26, 2025.
