SEMI-ANNUAL ENVIRONMENTAL MONITORING REPORT

#13 Semi-annual Report

(Reporting Period: July-December 2023)

**GEORGIA: URBAN SERVICES IMPROVEMENT INVESTMENT PROGRAM
(TRANCHE 6)**

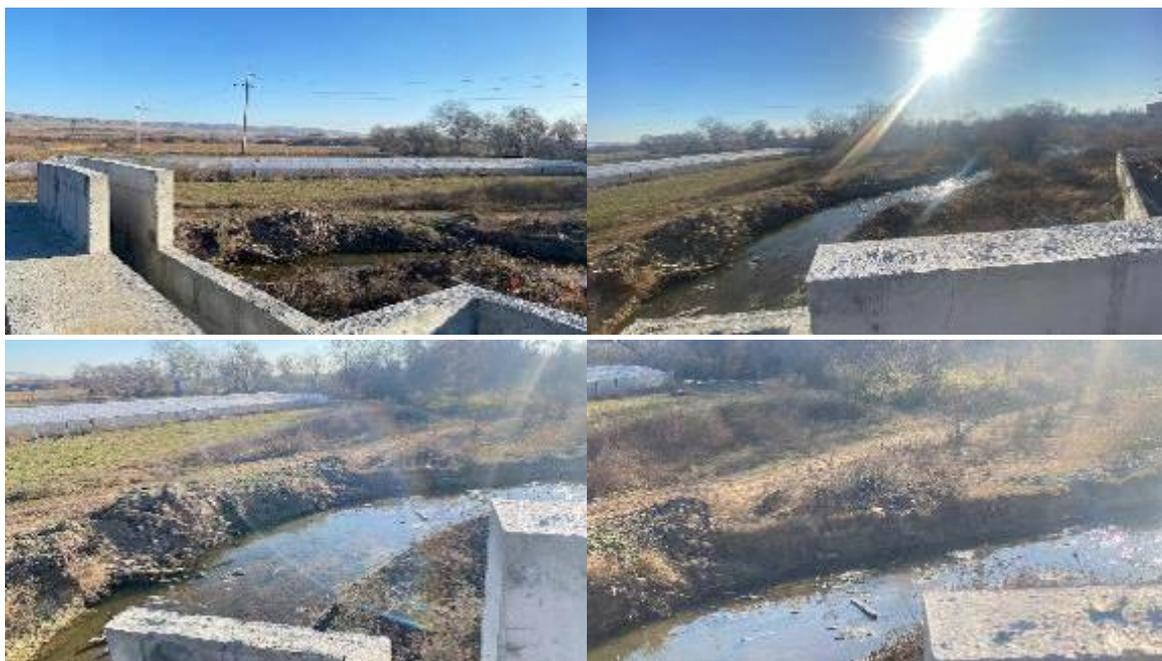
Photo N1: Photos of Site after the Construction of Wall

41. In response to these concerns, a social safeguards specialist Ms.Gvantsa Lukava visited the site to evaluate the situation. The specialist conducted a thorough review of the Initial Environmental Examination, related documents, and the existing hydrological study to assess the wall's impact on the lands across the river. However, it was determined that to accurately gauge the wall's influence on the river's flow levels, an additional hydrological study focusing on the wall and its potential effects on flooding is necessary in January 2024. Photos of the site of potential flooding is provided below. The results of the contractor's hydrological study and the status of the resolved complaint will be presented in the next environmental monitoring report in April 2024.

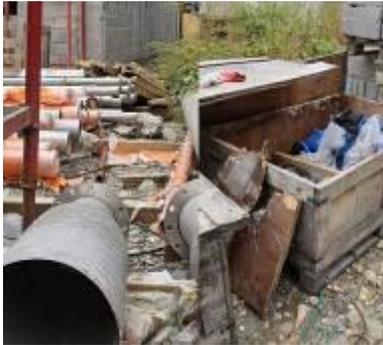
Date of Visit	Name of Company Name of Contract	Auditors Name	Purpose of audit	Summary of any Significant Findings	Implemented Actions	Implementation Status
		Specialist of UWSCG/USIIP Ms.Kate Chomakhidze Environmental Specialist of Supervision Consultant HILL Mr.Nikoloz Neparidze				
23 September 2023		Environmental Specialist of UWSCG/USIIP Ms.Kate Chomakhidze Environmental Specialist of Supervision Consultant HILL Mr.Nikoloz Neparidze	Regular monitoring of construction sites	The construction materials should be stored properly, Photo N1

The working tools & equipment should be stored properly The waste should be	Verbal instruction was given to contractor to immediately improve the situation. Non-Compliance Notice was issued and is presented in Annex C of this report. (Photo-documentations are presented in Annex C, non-compliance note,)	Completed, end September 2023, Photo N1

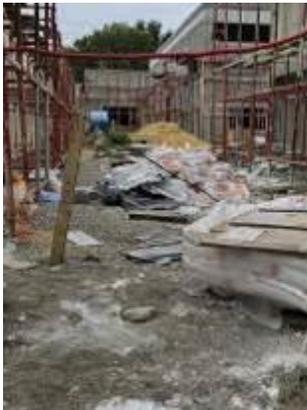
Date of Visit	Name of Company Name of Contract	Auditors Name	Purpose of audit	Summary of any Significant Findings	Implemented Actions	² Implementation Status
				<p>segregated, Photo N2</p>

<p>The waste bins and places should be labelled for identification</p> <p>The construction site should be cleaned regularly, Photo N3</p>		<p>from the construction territory in accordance with the required regulations end September 2023, Photo N2</p>

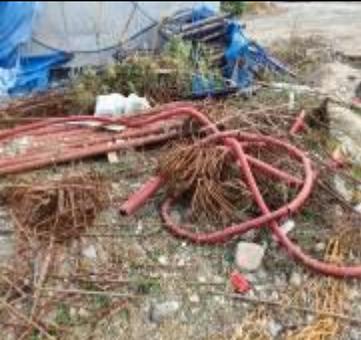
<p>Completed, end September 2023</p>
25 October 2023		<p>Environmental Specialist of UWSCG/USIIP Ms.Kate Chomakhidze</p> <p>Environmental Specialist of Supervision Consultant HILL Mr.Nikoloz Neparidze</p>	Regular monitoring of construction sites	<p>Waste Water Treatment Plant</p> <p>Site internally should be arranged properly and cleaned regularly, including construction materials segregation, Photo N1</p>	<p>Verbal instruction was given to contractor to immediately improve the situation.</p> <p>Non-Compliance Notice was issued and is presented in Annex C of this report.</p> <p>(Photo-documentations are presented in Annex C, non-compliance</p>	Completed by the mid of November 2023, all garbage is removed from the construction territory, Photo N1

<p>Construction chemicals should be managed properly</p> <p>The contractor is required to instruct and train their workforce in the storage and handling of materials and chemicals that can potentially cause soil contamination</p> <p>Storage of all hazardous material to be safe, under strict control and clearly labelling all dangerous products</p> <p>There should be a special designated area for municipal and hazardous</p>	<p>note,)</p> <p>Corrective Action Plan has been developed by contractor and sent to SC and UWSCG</p>

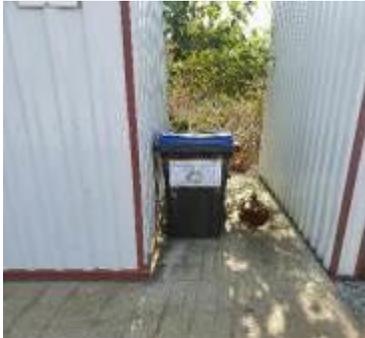
<p>No poultry are allowed on the construction site, Photo N3</p>

<p>Workers on height are working without safety and health regulations</p> <p>Without life belts and safety equipment</p> <p>The stair steps should also</p>

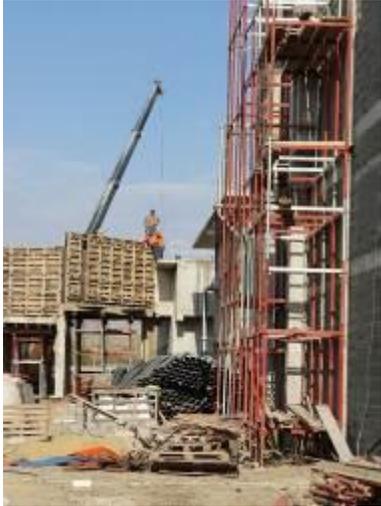
<p>There are open, deep, unprotected trenches on the construction sites that impede the movement of personnel and pose a particular danger at night time, Photo #4</p>		<p>meetings and discussions with SC and CC representatives on HS safety issues, some construction sites, including trenches, require improvements from the contractor to comply with safety requirements</p> <p>Completed Mid, October 2023, the open trench was immediately backfilled</p>

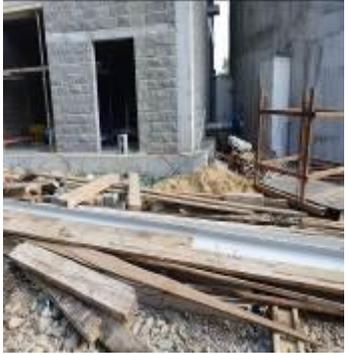
13 November 2023		<p>Environmental Specialist of UWSCG/USIIP Ms.Kate Chomakhidze</p> <p>Environmental Specialist of Supervision Consultant HILL Mr.Nikoloz Neparidze</p>	Regular monitoring of construction sites	<p>Construction materials should be stored adequately, Photo N1</p>

<p>Verbal instruction was given to contractor to immediately improve the situation.</p> <p>Non-Compliance Notice was issued and is presented in Annex C of this report.</p>	<p>Completed by the end of March 2023, Photo N1</p>

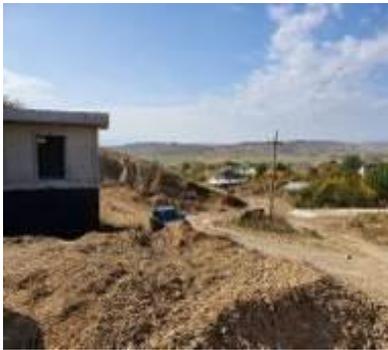
<p>The trenches are open and there is no shielding</p>		rules on a permanent basis.
25 October 2023		<p>Environmental Specialist of UWSCG/USIIP Ms.Kate Chomakhidze</p> <p>Environmental Specialist of Supervision Consultant HILL Mr.Nikoloz Neparidze</p>	Regular monitoring of construction sites	<p>Construction of Jandari Reservoir in Marneuli</p> <p>Construction site should be properly fenced from all sides and equipped with lockable gate, Photo N1</p>

<p>Proper warning and</p>	<p>Verbal instruction was given to contractor to immediately improve the situation.</p> <p>Non-Compliance Notice was issued and is presented in Annex C of this report.</p> <p>(Photo-documentations are presented in Annex C, non-compliance note,)</p>	<p>Partially Completed, the adequate fence will be installed after the completion of Construction activities in February 2024</p> <p>Completed,</p>

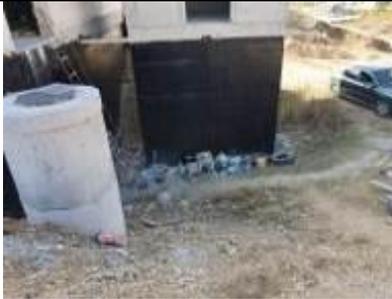
<p>Workers always should use complete PPE and Safety norms during working at height should be provided</p> <p>Construction waste should be timely removed from the construction site and disposed properly, Photo N3</p>	<p>Corrective Action Plan has been developed by contractor and sent to SC and UWSCG</p>	<p>December 2023</p> <p>Completed, December 2023</p> <p>Completed, December 2023, All construction waste is removed from the Jandari Reservoir site</p>

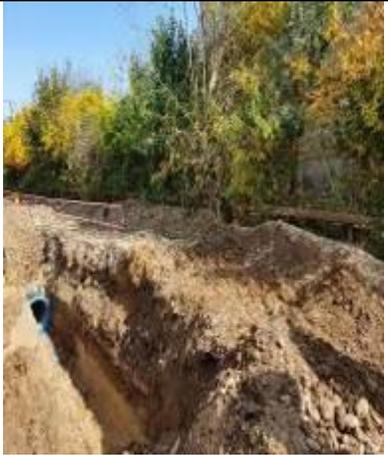
<p>Walls of the deep trenches (>1.5m) should be strengthened by adequate and sufficient quantity of boards to avoid landfall of the soil and accidents (workers damage), Photo N6</p>

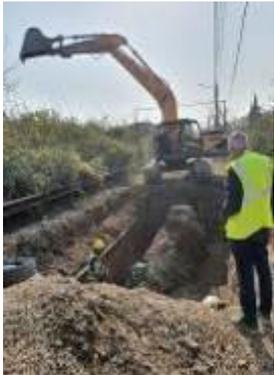
Date of Visit	Name of Company Name of Contract	Auditors Name	Purpose of audit	Summary of any Significant Findings	Implemented Actions	² Implementation Status
				<p>(>1.5m) should be strengthened by adequate and sufficient quantity of boards to avoid landfall of the soil and accidents (workers damage), Photo N1</p>

<p>Construction activities information signs should be installed at each construction segment</p> <p>Trench construction shall be taken up in small segments not more than 30m (please see relevant EMP and SEMP requirements), so that work (excavation, pipe laying and refilling) in each segment is completed in a day. No trenches shall be kept open</p>		<p>Completed by the end of November 2023, please see Photo N2 below</p>

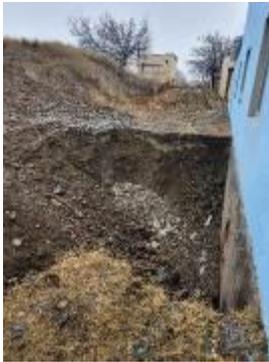
Date of Visit	Name of Company Name of Contract	Auditors Name	Purpose of audit	Summary of any Significant Findings	Implemented Actions	Implementation Status
		Development Bank Specialist of UWSCG/USIIP Ms.Kate Chomakhidze Environmental Specialist of Supervision Consultant HILL Mr.Nikoloz Neparidze	Program (USIIP)	to avoid accident of workers on construction site, Photo N1

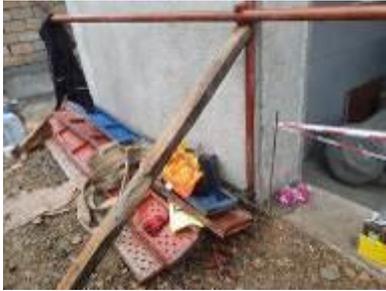
Site internally should be arranged properly and cleaned regularly, waste should be placed only at the proper waste container, Construction waste should be timely removed from the construction site and disposed properly, Photo N2

Non-Compliance Notice was issued and is presented in Annex C of this report. (Photo-documentations are presented in Annex C, non-compliance note,) Corrective Action Plan has been developed by contractor and sent to SC and UWSCG	Photo N1

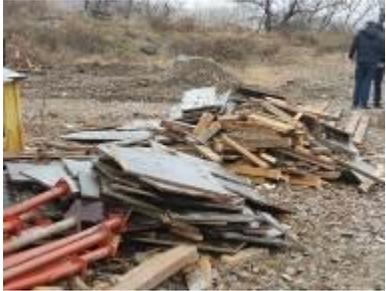
Date of Visit	Name of Company Name of Contract	Auditors Name	Purpose of audit	Summary of any Significant Findings	Implemented Actions	Implementation Status
				<p>All construction materials should be properly segregated and stored adequately, Photo N3</p>

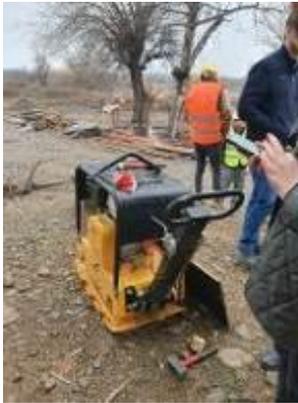
<p>The use of integral drip trays for generators and tanks is mandatory throughout the project for all construction sites, Photo N4</p>

<p>Electric cables must be</p>		<p>Completed by the end of December 2023, all construction materials are removed from the territory, Photo N3</p>

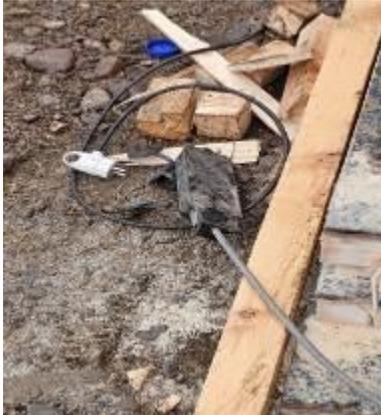
Date of Visit	Name of Company Name of Contract	Auditors Name	Purpose of audit	Summary of any Significant Findings	Implemented Actions	² Implementation Status
				<p>arranged in accordance with standards, so that they do not pose any danger to the workers, Photo N5</p>

<p>Completed, Mid-December 2023, Photo N4</p>

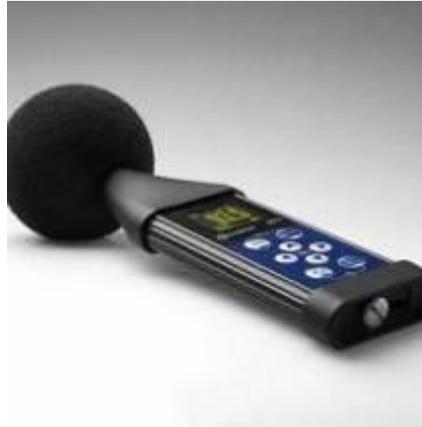
Figure 2: Organization-owned noise meter

- 93.** Noise meter configurations during the study were:
- Noise measurement range: 30-130 dB;
 - Noise meter response speed: Slow (1 second);
 - Frequency weight: A.
 - Type of microphone: 0.5" (12.7 mm.) el. Condensator.

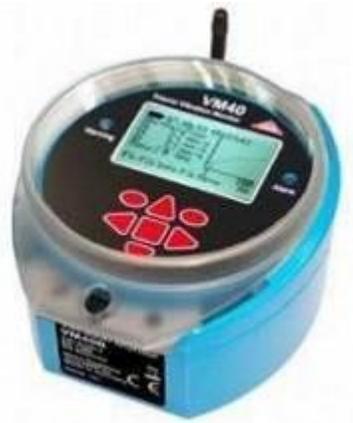
Figure 3: Triaxial Vibration Monitor VM40A/B

- 94.** The VM40 is designed for measuring vibration in buildings, bridges, towers, pipelines and various other large structures. The measurements serve to prevent possible structural damage or disturbance to people. The VM40 contains a sensor, recording and evaluation electronics and an accumulator in its robust casing. It is especially suitable for autonomous operation over longer periods of time e.g. on construction sites.

95. The instrument contains three highly sensitive piezoelectric systems for vibration measurement of all three special dimensions. The signal processing is controlled by a microprocessor. The VM40 is operated via its seven keypad buttons and illuminated LCD display. The measurement data can be transferred to a PC via the USB interface. The instrument also has a port for connecting a charger and a relay output for the external signaling of vibration occurrences.

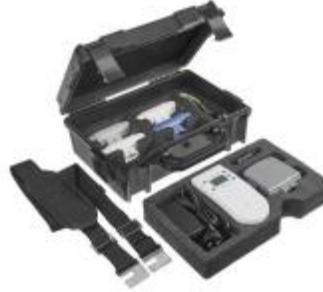
Figure 5.: “Aeroqual Series 500 Portable Air Quality Monitor”

96. The New Zealand based “Aeroqual Series 500 Portable Air Quality Monitor” is used to measure air. The air quality meter allows real-time monitoring of air pollutants. The device measures the concentrations of the following major pollutants in the air:
- Particulate Matters 10 μ m and 2.5 μ m (PM10, PM2.5);
 - Nitrogen Dioxide (NO₂);
 - Carbon Monoxide (CO);
 - Ozone (O₃);
 - Volatile Organic Compounds (VOC).
97. The Figure 4 and Figure 5 - below shows the “Aeroqual Series 500 Portable Air Quality Monitor”.

98. The device has different sensors for each type of harmful substance. The device has the following types of sensors:
- Gas sensitive semi-conductor sensor (GSS);
 - Gas sensitive electrochemical sensor (GSE);
 - Laser Particle Counter (LPC);
 - Photo Ionization Detector (PID).
99. During performing the measurement, the device records the average minute data of the obtained samples. Measurements was made within 20 minutes.
100. Figure 6 and Figure 7 below show the measurement points, project zone and measurement location.

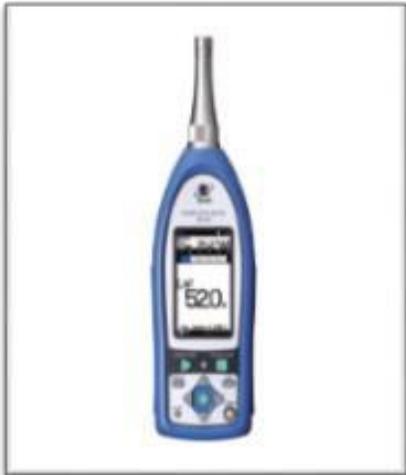
Noise measuring device

- 103.** According to the above-mentioned standard, the following equipment was used during the noise level measurement activities:
 - Rion NL-52, First class noise measurement device;
 - Windscreen, WS-16;
 - Tripod;
 - SD Card;

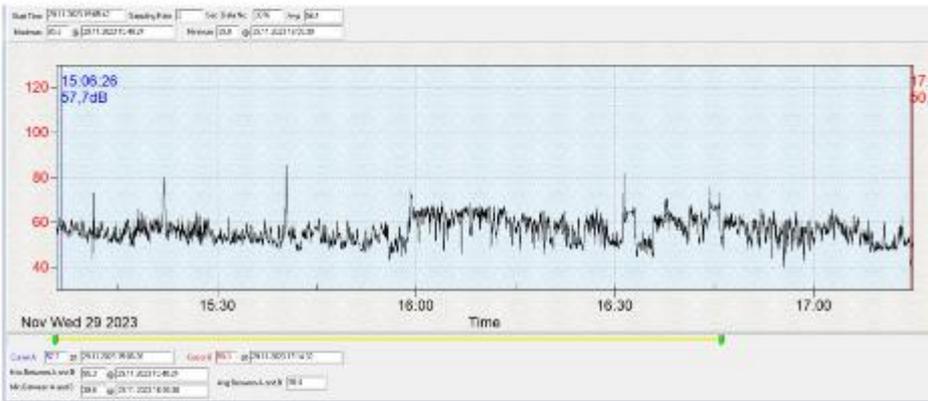
Graphical data for noise measurement- N2 point (At the residential House)

69. At point N2 (near the residential building), the peak noise level was recorded in the five-minute interval from 16:05 to 16:10, which was 62.7 dBA. The nearest residential house was located approximately 50m from the construction site and therefore appropriate noise abatement measures were immediately taken, resulting in noise levels returning to normal levels of 55 dBA. Mitigation measures to reduce noise propagation are presented in the table 48 below. IFC/WHO and national standards for Noise are presented in the Tables 25 above. It should also be noted that measurements carried out at construction sites, were temporary and conducted during the daytime and no complaints were received from the local population about the noise during the reporting period.

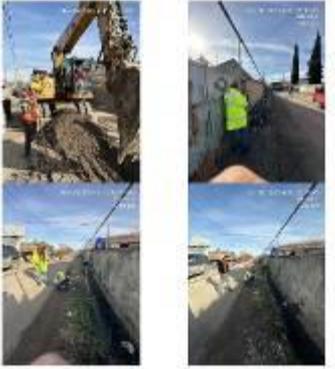
Figure 2.1.4 - WVO 2

Access to the section shown in (1). The works included the excavation, tracking, and installation of water
 supply pipe. The excavator and other heavy equipment were standing on the site, the access to the end
 of the local road was closed as the monitoring process.

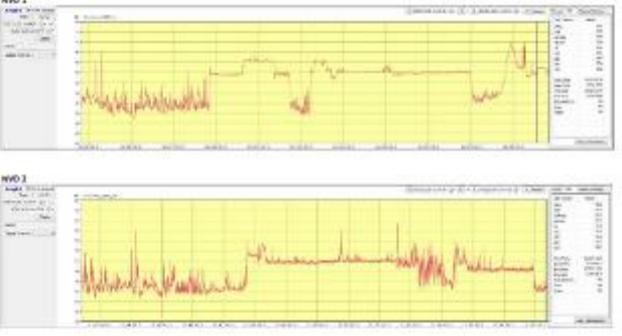
Figure 2.1.2 - The sound graphs of the noise monitoring sessions

The noise measurement results are provided in table 2.1.1 and graphs are given in figure 2.1.2.

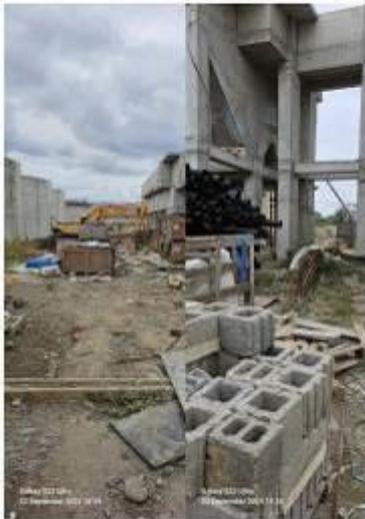
The construction site should be cleaned regularly

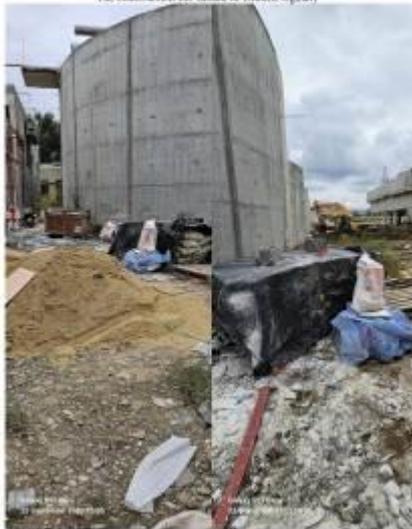
On 23 September I visited the Marneuli WWTP site. I checked the ongoing activities. As I mentioned previous visit report, I am satisfied of checking the site, but now there is serious problem about the storage of the construction materials and working tools, about the cleaning the site, about the segregation of the

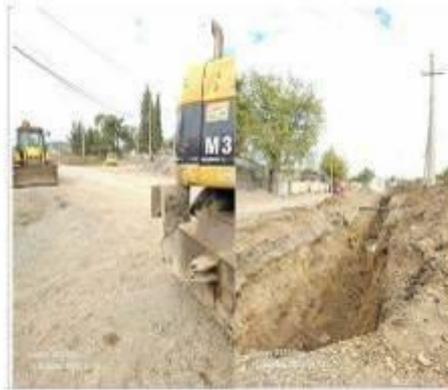
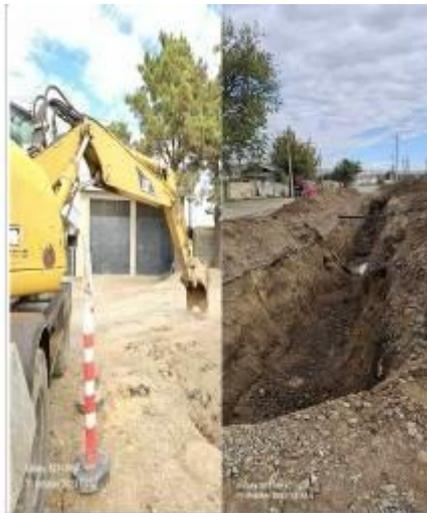
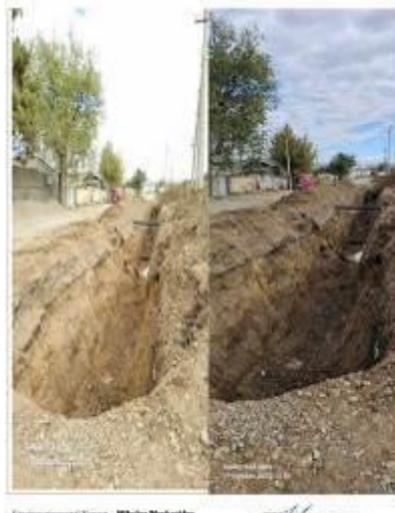
Photos

Checking activities

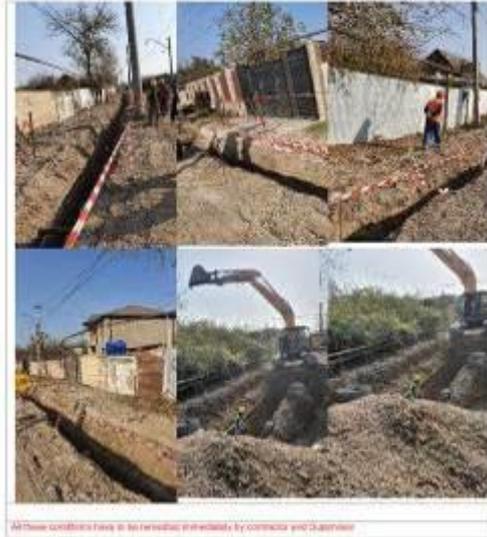
Photos of Marnuli WWS Network

Project: USIP	Non-Compliance Notice
Contract No: LOT-01, LOT-02, LOT-03 and LOT-06	CONSTRUCTION OF WATER SUPPLY AND SEWERAGE SYSTEMS IN MARNULI AND SEWERAGE SYSTEM AND COLLECTOR IN BOLNISI, USHUYI&UN2022MAR-01
Contractor: China Geo-engineering Corporation (CGC) (Peoples Republic of China)	
Supervisor Consultant: HILL	
Reference: "CONSTRUCTION OF WATER SUPPLY AND SEWERAGE SYSTEM IN MARNULI"	
This notice is to advise you, the Contractor, on the referenced Contract, of the following notice on environmental measures to be implemented urgently.	
Construction of Sewerage Network in Marnuli	
<ul style="list-style-type: none"> - Proper warning and information signs should be arranged at the entrance and perimeter of the sites; - High visible safety sign/tapes and trench side barriers around of deep open excavation should be installed from all sides to avoid accidents of local population; - Proper walkways/planks across the deep and open trenches should be provided for pedestrians to have access to their residential houses and businesses; - Adequate and sufficient quantity of trench side barriers around of deep open trenches should be installed to avoid accident; - Walls of the deep trenches (>1.5m) should be strengthened by adequate and sufficient quantity of boards to avoid landslide of the soil and accidents (workers damage); - Construction activities information signs should be installed at each construction segment; - Trench construction shall be taken up in small segments not more than 30m (please see relevant EMP and SEMR requirements), so that work (excavation, pipe laying and refilling) in each segment is completed in a day. No trenches shall be kept open in the night/after work hours; - Increasing workforce to complete the work in minimum time; - There is no Backwater Bucket Control on the construction sites this needs specific training of the workers or permanent control of the excavation movement at sites.
