# Semi-annual Environmental Monitoring Report

*Reporting Period: July-December 2019*

**GEORGIA: URBAN SERVICES IMPROVEMENT INVESTMENT PROGRAM  
(TRANCHE 4)**

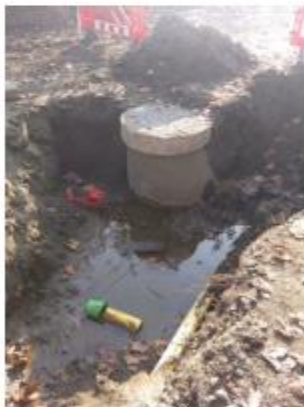
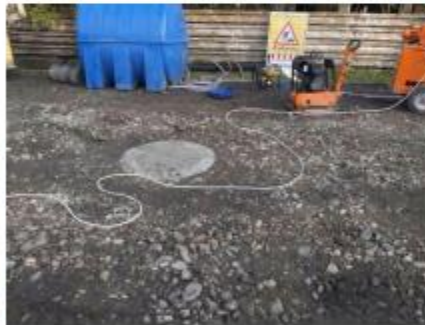
1. Open trench contaminated with solid waste
2. Generator without drip tray and power wire on the ground

- Only non hazardous waste wheelie bins are provided and placed where necessary.
- Drip trays should be provided and used at the vehicle and heavy equipment maintenance area/ Re-fuelling points
- No Spill Response Equipment on site; Spill kits should be placed at the vehicle and heavy equipment maintenance area, fuel and lubricant storage and refueling points.
- Waste storage and disposal should be improved.
- All vehicles and heavy equipment should be inspected on daily basis (use relevant checklists), in case of leakage finding, prohibit usage of the damaged Vehicles/Heavy equipment.
- General housekeeping is acceptable
- Power generator should be placed in the sufficient drip tray or concrete fuel/oil containment band should be arranged around.

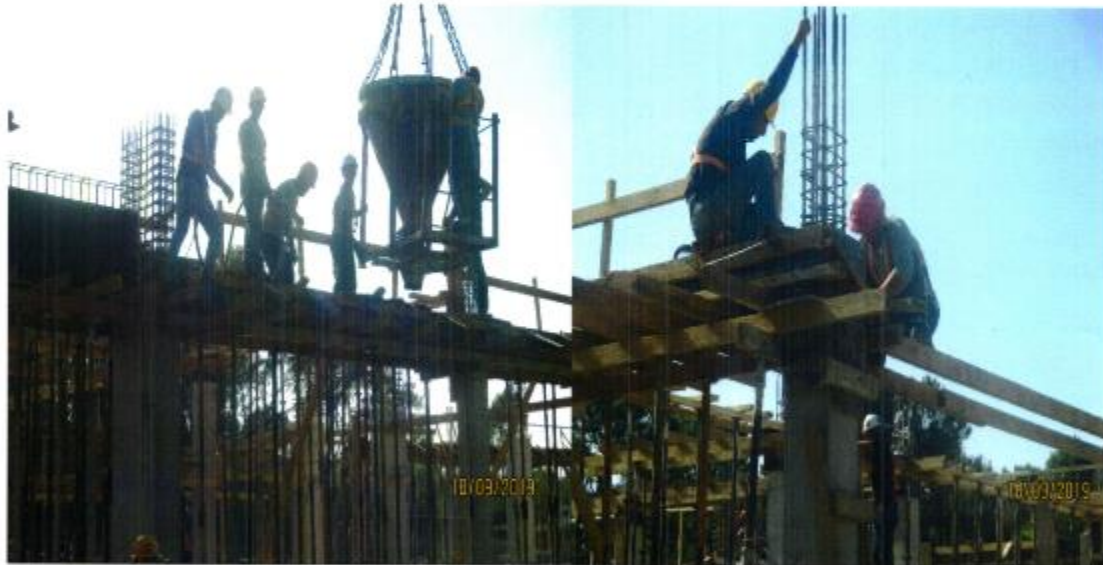
**PHOTO DOCUMENTATION / ფოტო დოკუმენტაცია:**

მუშათა პერსონალი არ იყენებს სიმაღლეზე მუშაობისთვის აუცილებელ დამცავ ღვედს.

All these conditions have to be remedied within immediatley / აღნიშნული ხარვეზი უნდა იქნას აღმოფხვრილი დაუყოვნებლივ.

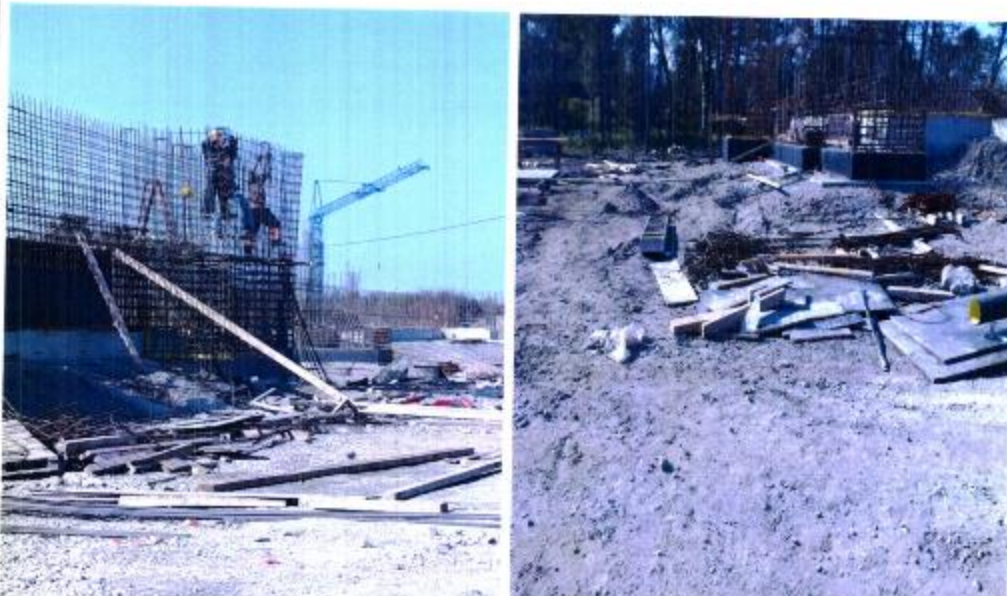
**PHOTO DOCUMENTATION / ფოტო დასაბუთება:**

Spilled soil should be removed

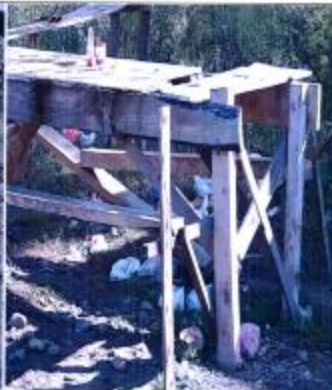
Household waste placed in containers

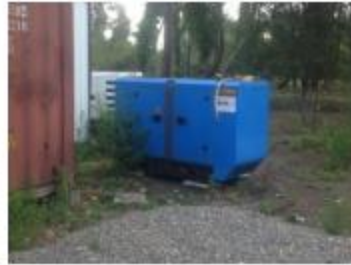
Running power generators outdoor without drip trays

<b>Environment</b>
<ul style="list-style-type: none"> <li>Vehicles and heavy equipment parking outside the defined parking should be prohibited. Hazardous and non hazardous waste wheelie bins are provided and placed where necessary.</li> <li>All vehicles and heavy equipment should be inspected on daily basis (use relevant checklists), in case of leakage finding, prohibit usage of the damaged Vehicles/Heavy equipment.</li> <li>General housekeeping is acceptable</li> <li><b>Fuel, lubricants and chemicals should be stored in the building with proper ventilation or under temporary shelters.</b></li> <li><b>During refueling drip trays and absorbent pads should be used to prevent environment contamination by hydrocarbons.</b></li> </ul>

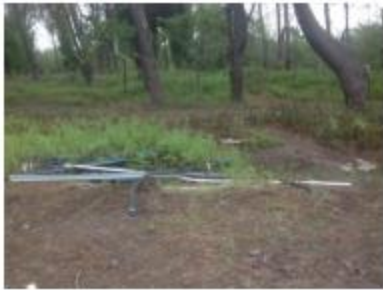
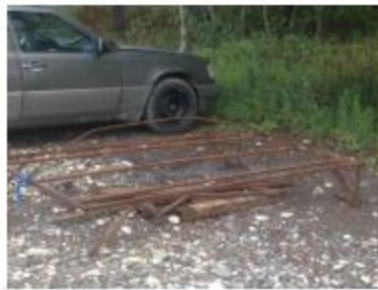
Unacceptable housekeeping

<b>General Housekeeping</b>
<ul style="list-style-type: none"> <li>Housekeeping is not satisfactory.</li> </ul>

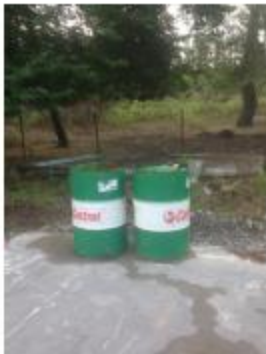
Oil drums stored outdoor.

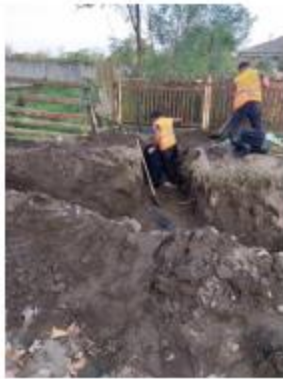
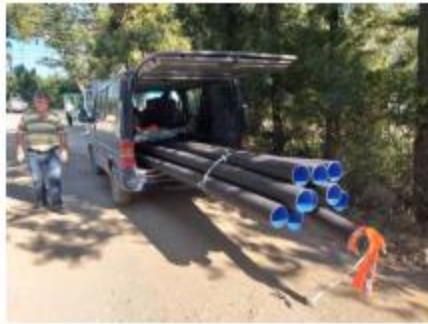
1. No shoring. Worker without PPE in the trench
2. Transportation with improper equipment.

- PPE in place. Some workers don't wear PPE.
- Refreshment training should be provided about specific PPE and PPE requirements in general
