SEMI-ANNUAL ENVIRONMENTAL MONITORING REPORT

#11 Semiannual Report

(Reporting Period: July-December 2022)

**GEORGIA: URBAN SERVICES IMPROVEMENT INVESTMENT PROGRAM
(TRANCHE 6)**

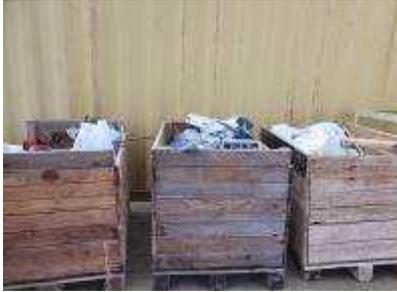
| Date of Visit | Name of Company Name of Contract | Auditors Name | Purpose of audit | Summary of any Significant Findings | Implemented Actions | ² Implementation Status |
|---|---|--|---|--|--|---|
| | | <p>Environmental Specialist of UWSCG/USIIP Ms.Kate Chomakhidze</p> <p>Environmental Specialist of Supervision Consultant HILL Mr.Nikoloz Neparidze</p> <p>Social Specialist of Supervision Consultant HILL Ms.Kety Chubabria</p> | | <p>Site internally should be properly arranged, construction materials and waste should be safely segregated/stored and construction site should be cleaned regularly, Please see Photo N1 below</p> <p>Insecure connection to the power socket should be immediately improved, all cables in the facility must be protected to avoid any damage to users/workers/visitors of the power supply, Please see</p> | <p>Non-Compliance Notice was issued and is presented in Annex C of this report.</p> <p>(Photo-documentations are presented in Annex C, non-compliance note, 20 October 2022)</p> <p>Corrective Action Plan has been developed by contractor on 26 October 2022 and sent to SC and UWSCG, Please see Annex D.</p> | <p>Completed in 26 October 2022, please see photo N1 below</p> <p>Completed, 26 October 2022, please see Photo N2</p> |

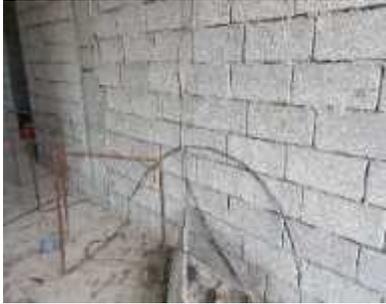
| Date of Visit | Name of Company Name of Contract | Auditors Name | Purpose of audit | Summary of any Significant Findings | Implemented Actions | ² Implementation Status |
|---|---|---|---|--|---|---|
| | | | | <p>Photo N2 below</p> <p>The construction site and access road should be graveled to minimize mud and dust generation, which also Impeding movement of workers on the construction site and interrupt the labor process, Please see Photo N3 below</p> | | <p>Completed 26 October 2022, please see Photo N3 and Photo N4 below</p> |

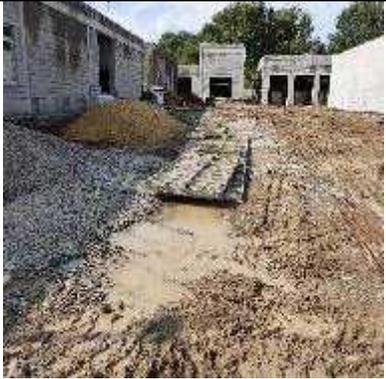
| Date of Visit | Name of Company Name of Contract | Auditors Name | Purpose of audit | Summary of any Significant Findings | Implemented Actions | ² Implementation Status |
|---|---|---|---|--|---|--|
| | | | | <p data-bbox="1099 683 1485 831">Safety issues on construction sites should be protected, workers always should use complete set of PPE</p> <p data-bbox="1099 863 1485 1050">Concrete wash out pit should be arranged at construction site, "Concrete Rivers" should be immediately removed from the soil</p> <p data-bbox="1099 1082 1485 1390">CC shall ensure that all materials that is stored on construction area or intended to be handing over to people are safe and do not pose any risk to people. CC shall remove nails from the construction waste, Please</p> | | <p data-bbox="1827 703 2063 767">Completed end of October 2022</p> <p data-bbox="1827 842 2063 906">Completed end of October 2022</p> <p data-bbox="1827 1114 2063 1177">Completed end of October 2022</p> |

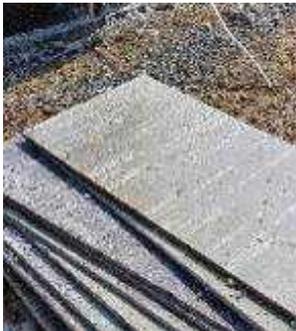
| Date of Visit | Name of Company Name of Contract | Auditors Name | Purpose of audit | Summary of any Significant Findings | Implemented Actions | ² Implementation Status |
|---|---|---|---|--|---|--|
| | | | | <p>see Photo N4 below</p> <p>Hazardous wastes are disposed all over the territory and are stored without proper regulations and pose a threat to the environment and the health of the workforce employed on site. Hazardous waste storage area shall be properly arranged, and workers shall be trained by CC on safe handling of hazardous waste and materials, Please see Photos N5, N6 below</p> | | <p>Completed 26 October 2022, please Photos N5 and N6 below.</p> |

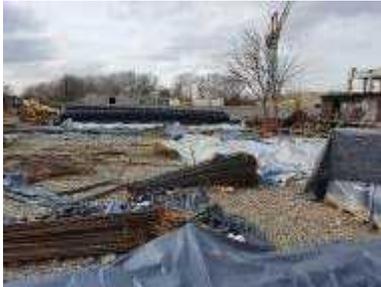
| Date of Visit | Name of Company Name of Contract | Auditors Name | Purpose of audit | Summary of any Significant Findings | Implemented Actions | ² Implementation Status |
|---|---|---|---|--|--|---|
| 29 October 2022 | | USIIP Environmental Specialist Ms. Kate Chomakhidze | Regular Environmental monitoring of sites | <p>Site internally should be better arranged, materials should be better segregated/stored and cleaned regularly, Photo N1</p> <p>Although the insecure connection to the power socket has been partially improved, all cables in the</p> | <p>Verbal instruction was given to contractor to immediately improve the situation.</p> <p>Non-Compliance Notice was issued and is presented in Annex C of this report.</p> <p>(Photo-documentations are presented in Annex C, non-compliance note, 17 March 2022)</p> | <p>Completed, November 2022, please see improved photo of site</p> <p>Photo N1</p> <p>Completed, November 2022</p> |

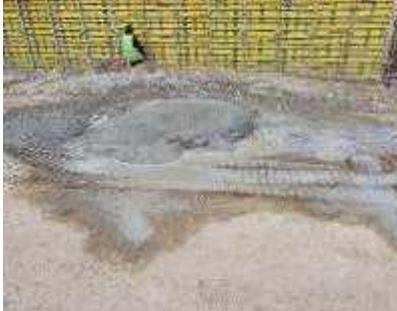
| Date of Visit | Name of Company Name of Contract | Auditors Name | Purpose of audit | Summary of any Significant Findings | Implemented Actions | ² Implementation Status |
|---|---|---|---|--|--|---|
| | | | | <p>facility must be protected to avoid any damage to users of the power supply</p> <p>Concrete wash out pit should be arranged at construction site, "Concrete Rivers" should be immediately removed from the soil, Photo N2</p> <p>In case planned to have some amount of fuel on the site – adequate protection of environment from spreading of accidentally spilled liquid (Precaution measures include – secondary containment capable to retain 110% of container volume should be arranged</p> <p>Top Soil should be stored</p> | <p>Corrective Action Plan was prepared by contractor and is presented in the Annex D to this report.</p> | <p>Existing concrete spots on WWTP site were removed, please see photo N3 below</p> <p>Completed in November 2022, additional improvements are required</p> <p>Partially Completed,</p> |

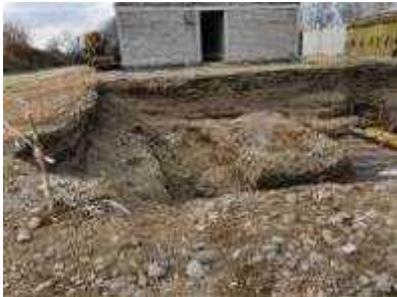
| Date of Visit | Name of Company Name of Contract | Auditors Name | Purpose of audit | Summary of any Significant Findings | Implemented Actions | ² Implementation Status |
|--|---|---|--|---|---|---|
| | | | | <p>properly and managed in accordance with the required regulations</p> <p>Proper waste containers with roof & and concrete basement should be installed at the storage area</p> <p>Provide warning signs or safety tapes around open tranches on the construction area for safety issues of workers, Photo N3</p> | | <p>November 2022</p> <p>Completed, November 2022</p> <p>Completed, November 2022</p> |

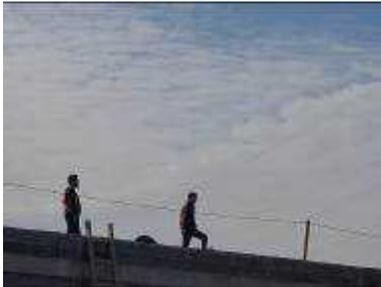
| Date of Visit | Name of Company Name of Contract | Auditors Name | Purpose of audit | Summary of any Significant Findings | Implemented Actions | ² Implementation Status |
|---|---|--|---|--|---|--|
| | | Georgia Resident Mission Asian Development Bank Ms. Kate Chomakhidze UWSCG/USIIP /Environmental consultants | | <p>Safety issues on construction sites, Workers always should use complete set of PPE, Safety norms during working at height should be respected, Special equipment during working at heights should be used, please see Photo N1 below.</p> <p>The following non – compliances which were revealed during the ADB's environmental safeguard mission on 24 May 2022 were monitored by the</p> | | <p>Will be completed in January 2023 and reflected in the next SAEMR of January-June 2023.</p> <p>Not completed. Strong instruction is given to contractor to maintain safety norms of workers. Will be completed in January 2023 and reflected in the next SAEMR of January-June 2023.</p> |

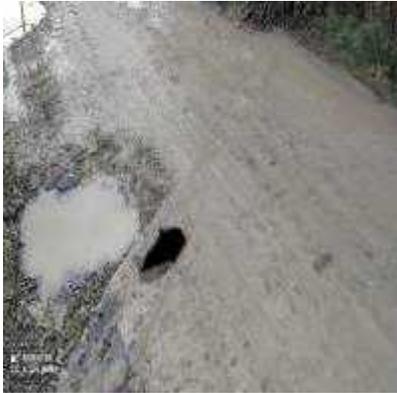
| Date of Visit | Name of Company Name of Contract | Auditors Name | Purpose of audit | Summary of any Significant Findings | Implemented Actions | ² Implementation Status |
|---|---|---|---|--|---|---|
| 8 December 2022 | | SC/HILL Environmental Specialist Mr. Nikoloz Neparidze Yakup Sezgun, SC/HILL Resident Engineer | Regular Environmental monitoring of sites | <p>The existing pipeline supplying water for agriculture on the main road to connect to construction site has been damaged due to intensive movement of concrete mixers during the construction period. The attached photograph shows damaged pipe, please see Photo N1</p> | <p>Verbal instruction was given to contractor to immediately improve the situation.</p> <p>Non-Compliance Notice was issued and is presented in Annex C of this report.</p> <p>(Photo-documentations are presented in Annex C, non-compliance note, 17 March 2022)</p> <p>Corrective Action Plan was prepared by contractor and is presented in the Annex D to this report.</p> | <p>Completed in 10 December 2022, please see Photo N1 below</p> |

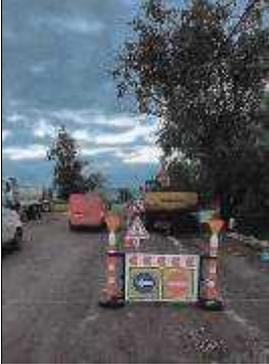
| Date of Visit | Name of Company Name of Contract | Auditors Name | Purpose of audit | Summary of any Significant Findings | Implemented Actions | ² Implementation Status |
|---|--|---|---|--|---|--|
| 9 November 2022 | LOT-04, LOT-05 | ADB's Review mission Ms. Nino Nadashvili, Associate Safeguards Officer Georgia Resident Mission Asian Development Bank; Ms. Kate Chomakhidze UWSCG/USIIP /Environmental consultants | Quarterly environmental Safeguard Mission | Safety/warning signs/tapes and trench side barriers around of deep open trenches should be installed to avoid accident, please see photo N1 below Walls of the deep trenches (>1.5m) should be strengthened by boards to avoid landfall of the soil and accidents (workers damage), please see photo N2 | Verbal instruction was given to contractor to immediately improve the situation. Non-Compliance Notice was issued and is presented in Annex C of this report. (Photo-documentations are presented in Annex C, non-compliance note, 17 March 2022) Corrective Action Plan was prepared by | Completed immediately, please see photo N1 Completed immediately, Please see photo N2 |

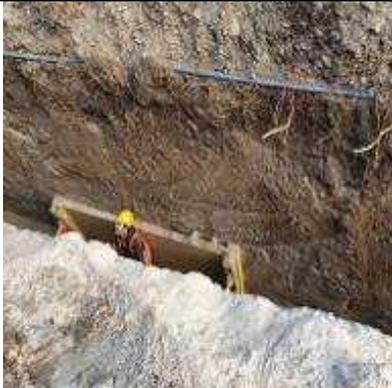
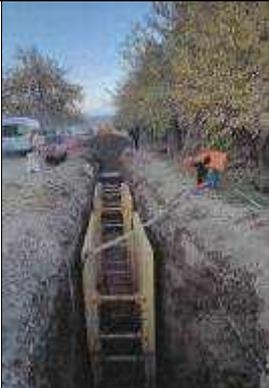
| Date of Visit | Name of Company Name of Contract | Auditors Name | Purpose of audit | Summary of any Significant Findings | Implemented Actions | ² Implementation Status |
|---|---|---|---|---|---|--|
| | | | | <p>Construction activities information signs should be installed at each construction segment;</p> <p>Trench construction shall be taken up in small segments, so that work (excavation, pipe laying and refilling) in each segment is completed in a day. No trenches shall be kept open in the night/after work hours, in case construction works are not completed during the day time provide adequate lighting to avoid accidents;</p> <p>Informing all residents and businesses about the nature and duration of any work well in advance so that they can make necessary</p> | <p>contractor and is presented in the Annex D to this report.</p> | <p>Completed in 12 November 2022</p> <p>Completed in 12 November 2022</p> <p>Completed in 12 November 2022</p> |

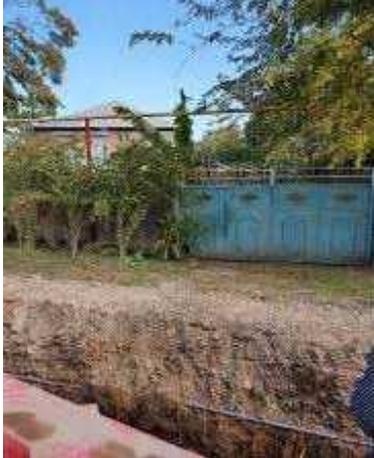
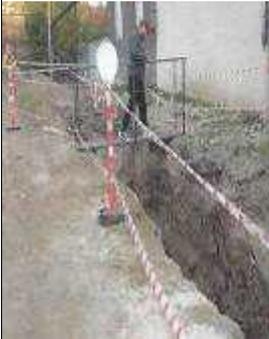
| Date of Visit | Name of Company Name of Contract | Auditors Name | Purpose of audit | Summary of any Significant Findings | Implemented Actions | ² Implementation Status |
|---|---|---|---|---|---|--|
| | | | | <p>preparations if needed;</p> <p>Providing wooden walkways/planks across trenches for pedestrians and metal sheets where vehicle access is required, Please see photo N4</p> <p>Increasing workforce to complete the work in minimum time;</p> <p>The construction area must be constantly watered to reduce dust generation, watering of the road should be carefully managed and maintained, so that the volume and timing of water used is correct and water</p> | | <p>Completed in 12 November 2022</p> <p>Completed in November 2022</p> <p>Completed in November 2022</p> |

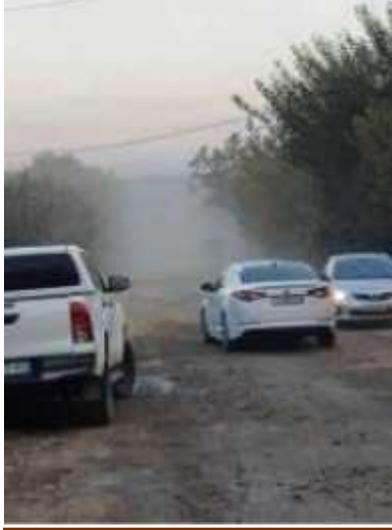
| Date of Visit | Name of Company Name of Contract | Auditors Name | Purpose of audit | Summary of any Significant Findings | Implemented Actions | ² Implementation Status |
|---|---|---|---|---|---|---|
| | | | | <p>run-off does not make its way into watercourses, please see Photo N5</p> <p>Surplus waste soils should be removed and disposed in a proper place during the construction activities and not to make threat to workers and local population;</p> <p>The contractor shall hire a traffic control person – flag man, whose main role is to:</p> <p>Stop, slow, and safely direct traffic through work or construction sites ;</p> | | <p>Completed in November 2022</p> <p>Completed in November 2022</p> |

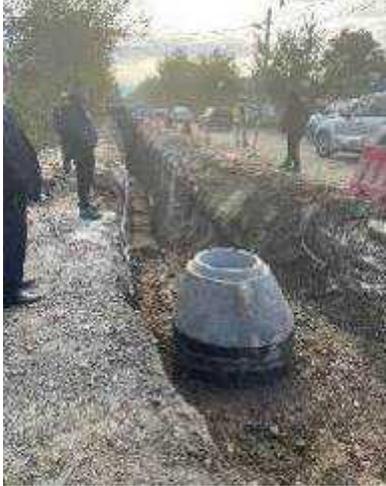
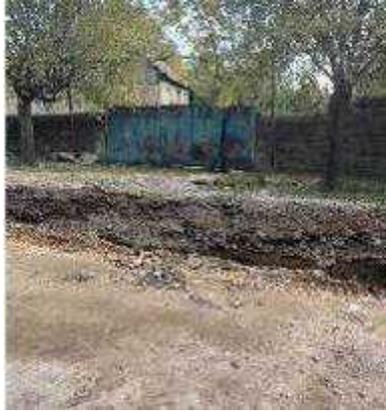
| Date of Visit | Name of Company Name of Contract | Auditors Name | Purpose of audit | Summary of any Significant Findings | Implemented Actions | ² Implementation Status |
|---|---|---|---|--|---|--|
| | | | | <p data-bbox="1099 778 1485 981">Tranches are excavated too close to private houses. No safety signs and measures area implemented. No barricades are provided. Risk of fall in is too high (Photo 3)</p> | | Completed Immediately in November 2022 |

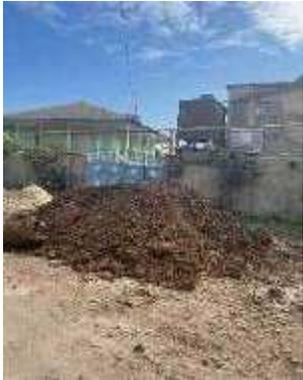
| Date of Visit | Name of Company Name of Contract | Auditors Name | Purpose of audit | Summary of any Significant Findings | Implemented Actions | ² Implementation Status |
|---|---|---|---|---|---|---|
| | | | | <p>No ramps are provided to the excavations and houses are blocked (Photo 4).</p> <p>Corrective Actions:</p> <p>Provide hard barricades around the excavated area</p> <p>Install shield (Scaffolding) in the excavated trench whenever working in trench</p> | | <p>Completed in 12 November 2022</p> <p>Completed in 12 November 2022</p> <p>Completed in 12 November 2022</p> |

| Date of Visit | Name of Company Name of Contract | Auditors Name | Purpose of audit | Summary of any Significant Findings | Implemented Actions | ² Implementation Status |
|---|---|---|---|---|---|--|
| | | | | <p>deeper than 1.5 m.</p> <p>Provide all safety signage and lights in the night and follow traffic management plan</p> <p>Provide ladders in the trench for workers to come out in case of emergency</p> <p>Provide bridges for crossing trenches if access of any household is prevented by trench</p> | | <p>Completed in 12 November 2022</p> <p>Completed in 12 November 2022</p> <p>Completed in 12 November 2022</p> |

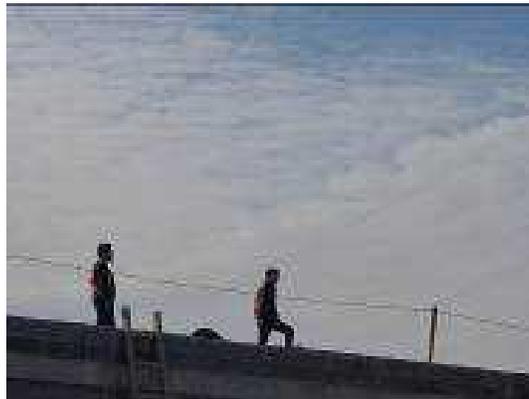
Photo N1: MAR-02, 9 November 2022

- Safety issues on construction sites, Workers always should use complete set of PPE, Safety norms during working at height should be respected, special equipment during working at heights should be used, please see Photo N1 below.

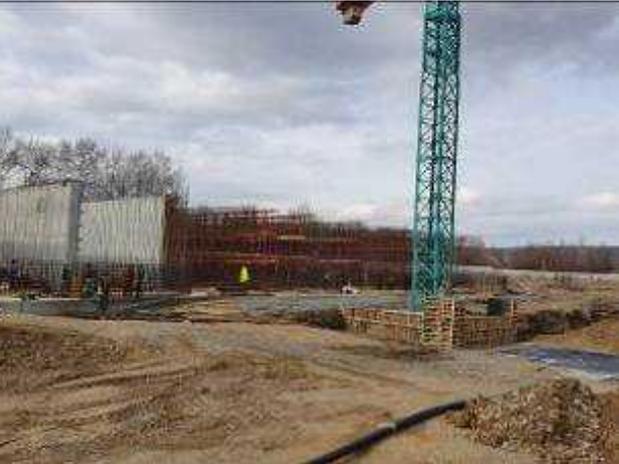
- Walls of the deep trenches (>1.5m) should be strengthened by boards to avoid landfall of the soil and accidents (workers damage), please see Photo N2 below

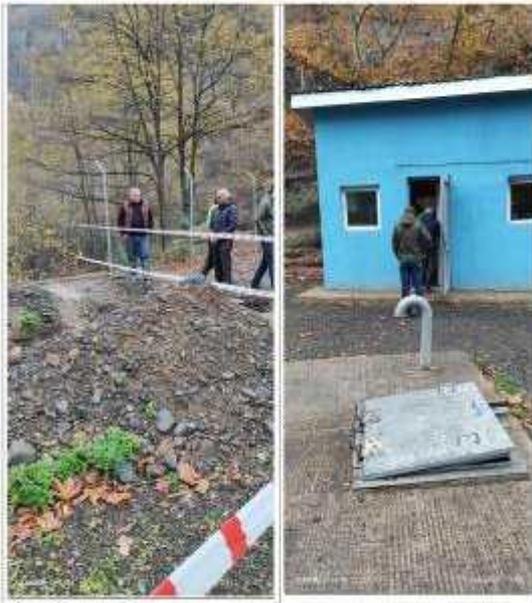
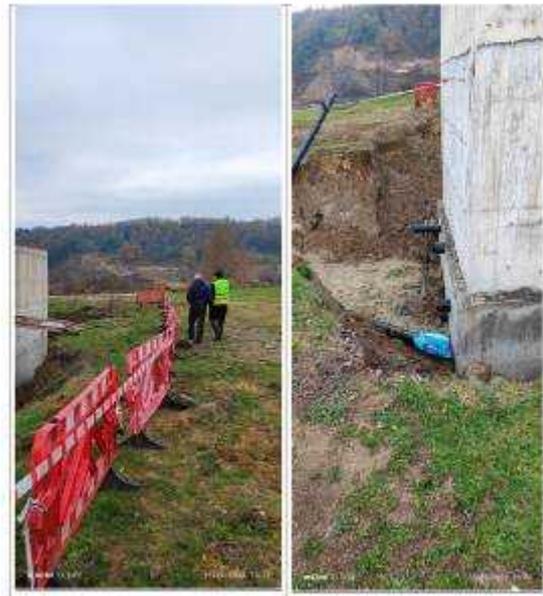
| <ul style="list-style-type: none">- Avarioni reservoir works have started but fencing is not provided all around the site and thus safety is compromised. Hard Fencing should be provided as soon as possible and at least by 15 Dec 2022. Other safety measures should be taken. Please keep complaint log register and complaint box. Safety & Environment pamphlets should be provided at site.- The project documents should be printed and available at the construction site. | |

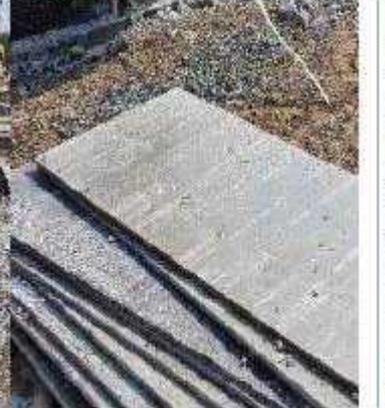
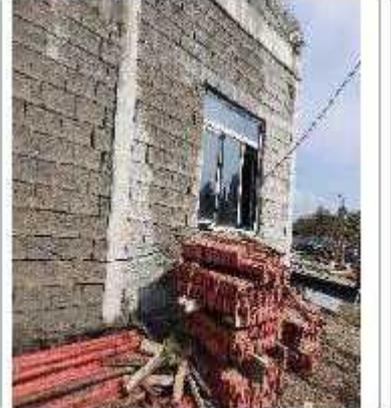
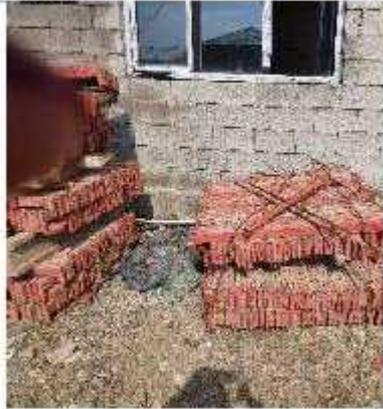
- **CC shall ensure that all materials that is stored on construction area or intended to be handing over to people are safe and do not pose any risk to people. CC shall remove nails from the construction waste (Photo #11,#12,#13);**

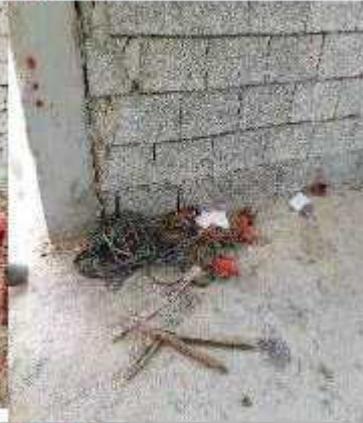
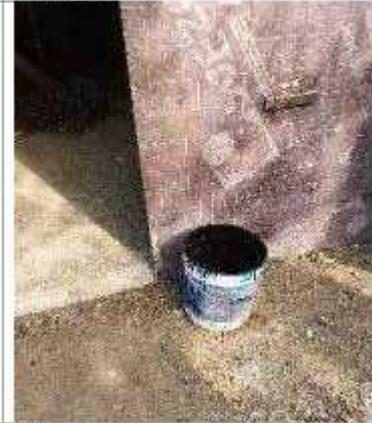
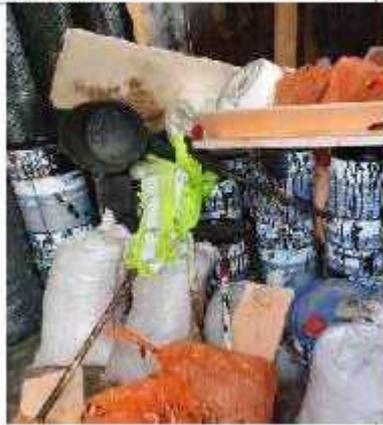
- **Hazardous wastes are disposed all over the territory and are stored without proper regulations and pose a threat to the environment and the health of the workforce employed on site. Hazardous waste storage area shall be properly arranged, and workers shall be trained by CC on safe handling of hazardous waste and materials (Photo #14,#15,#16);**

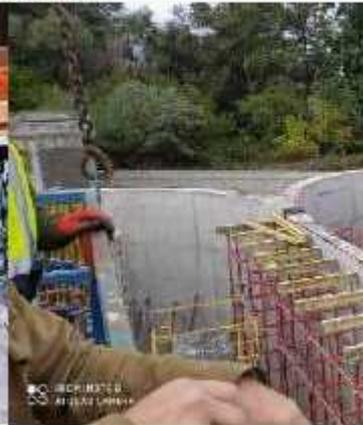
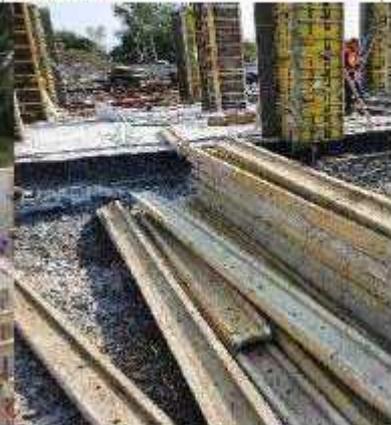
- **Safety norms identified by the Georgian regulations during works at the height should be respected to avoid workers damage (Photo #17, #18)**

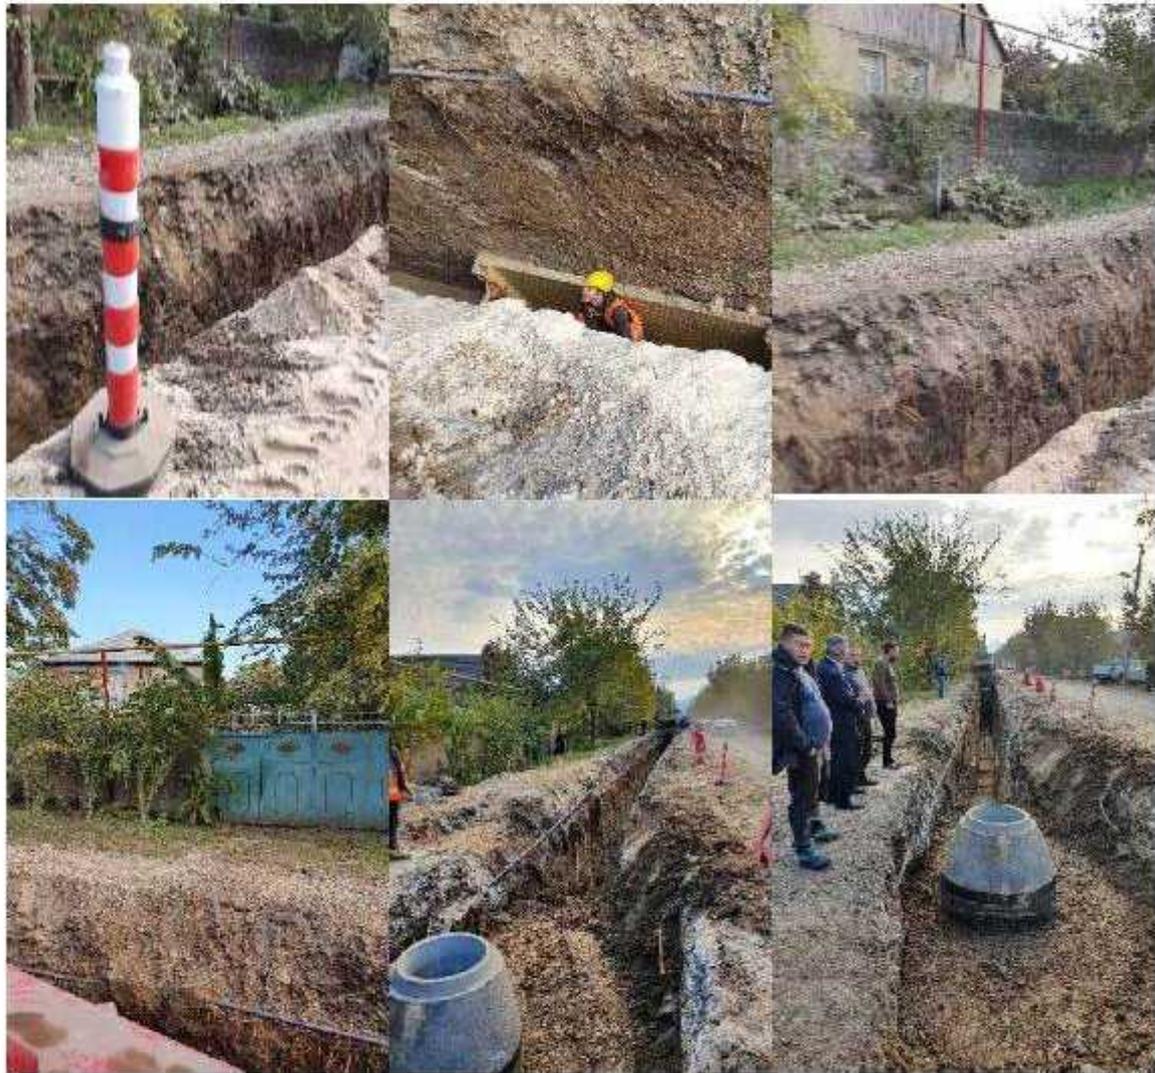
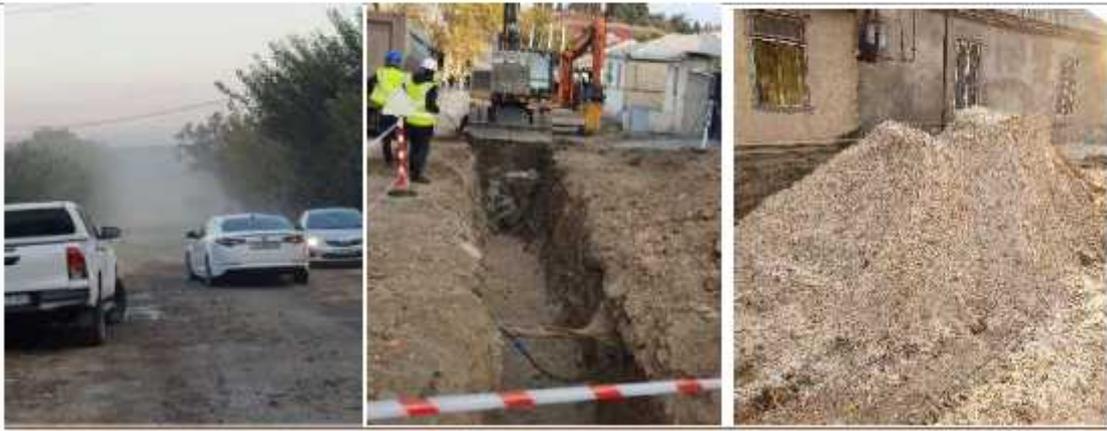
Photos of Bolnisi WW Network

| <p>NON-COMPLIANCE IN</p> <p>SEWERAGE NETWORK BOLNISI</p> <ul style="list-style-type: none"> - Safety/warning signs/tapes and trench side barriers around of deep open trenches should be installed to avoid accident; - Walls of the deep trenches (>1.5m) should be strengthened by boards to avoid landfall of the soil and accidents (workers damage); - Construction activities information signs should be installed at each construction segment; - Trench construction shall be taken up in small segments, so that work (excavation, pipe laying and refilling) in each segment is completed in a day. No trenches shall be kept open in the night/after work hours, in case construction works are not completed during the day time provide adequate lighting to avoid accidents; - Informing all residents and businesses about the nature and duration of any work well in advance so that they can make necessary preparations if needed; - Providing wooden walkways/planks across trenches for pedestrians and metal sheets where vehicle access is required; - Increasing workforce to complete the work in minimum time; - The construction area must be constantly watered to reduce dust generation, watering of the road should be carefully managed and maintained, so that the volume and timing of water used is correct and water run-off does not make its way into watercourses; - Surplus waste soils should be removed and disposed in a proper place during the construction activities and not to make threat to workers and local population; - The contractor shall hire a traffic control person – flag man, whose main role is to: <ul style="list-style-type: none"> • Stop, slow, and safely direct traffic through work or construction sites ; • Protect workers in the construction zone by regulating traffic flow ; • Give traffic control directions and signals clearly and precisely so that motorists understand their meaning ; • Keep the flow of traffic moving with as few delays as possible. | |

In addition contractor should always use barriers, barricades, lane control devices, traffic signal lights, sign trucks, and other methods as appropriate in addition to, traffic control persons to ensure the safety of all workers and local community.

All these conditions have to be remedied immediately by contractor and Supervisor

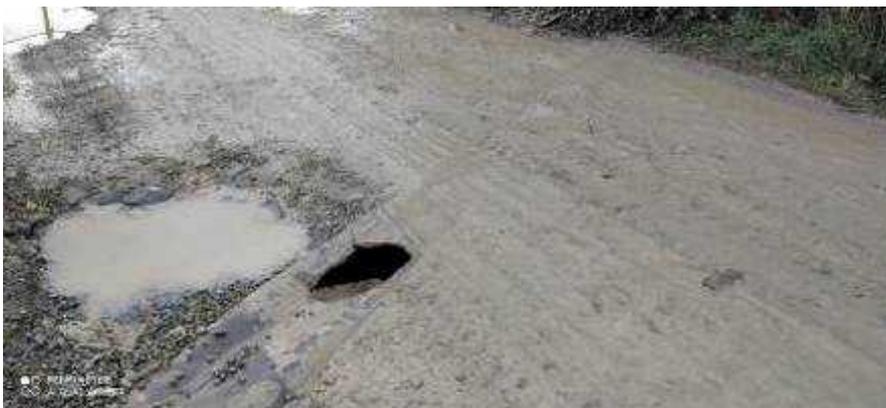
The existing pipeline supplying water for agriculture on the main road to connect to construction site has been damaged due to intensive movement of concrete mixers during the construction period. The attached photograph shows damaged pipe.

You are requested to act immediately for improvement of this pipe and road condition.

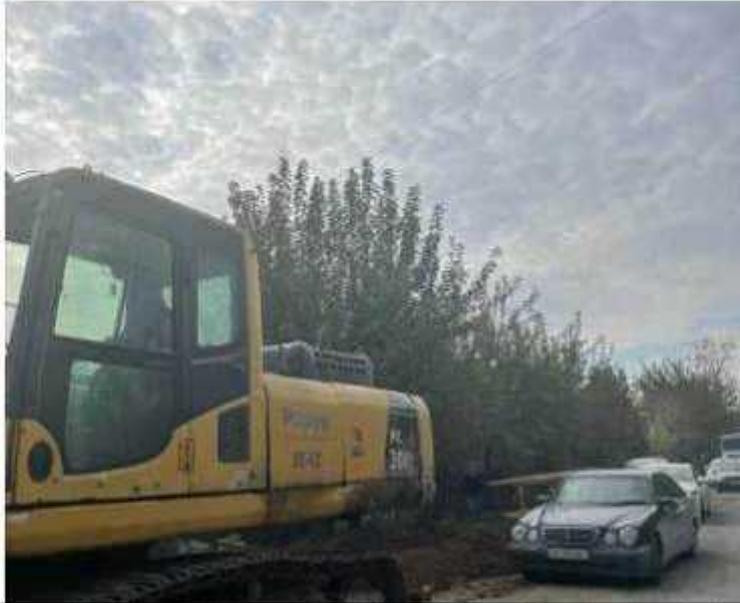
Photo #5

| Unsafe excavation on the main road connecting Marneuli to Bolnisi. Excavated area has no hard barricades around. Cars are moving very close to the construction sites and risk of the accidents is high. (Photo 5) | |

| <ol style="list-style-type: none">1. Provide hard barricades around the excavated area2. Install shield (Scaffolding) in the excavated trench whenever working in trench deeper than 1.5 m.3. Provide all safety signage and lights in the night and follow traffic management plan4. Provide ladders in the trench for workers to come out in case of emergency5. Provide bridges for crossing trenches if access of any household is prevented by trench5. Sprinkle water on road and refilling material so that dust generation is controlled and health hazard to population living around the area is controlled. | |

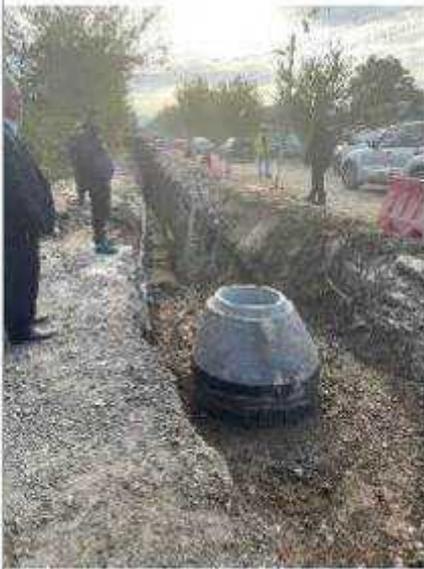
Photo #1

| Excavation is too deep, more than 4 meters, Sides of the excavation are too steep, and no shields are provided. Risk of the cave in is too high. (Photo 1) | |

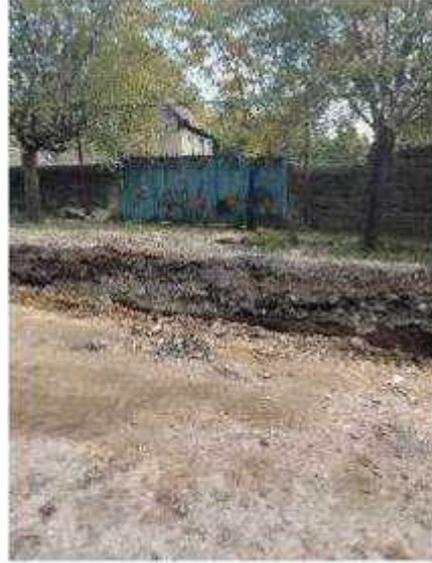
Photo #2

| Trenches are excavated too close to private houses. No safety signs and measures are implemented. No barricades are provided. Risk of fall in is too high. (Photo 2 and 4) | |
| No ramps are provided in the excavations and houses are blocked. (Photo 2, 3 and 4) | |

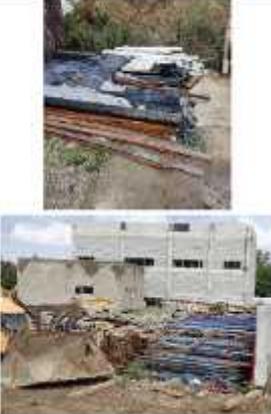
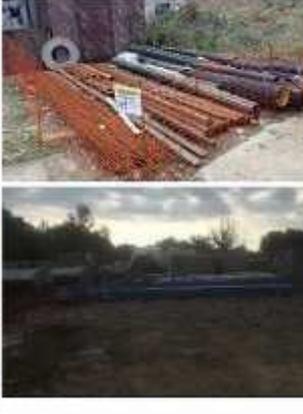
| Non-compliance point | Non-compliance photo | Corrective action photo |
|--|---|--|
| <p>1.Site materials should be properly arranged, construction materials and waste should be safely segregated/stored and construction site should be fenced regularly (photo #1, #2, #3)</p> | | |

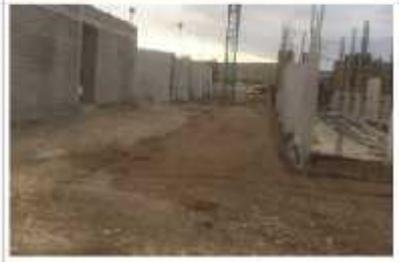
| Non-compliance point | Non-compliance photo | Corrective action photo |
|---|---|--|
| <p data-bbox="319 1541 478 1724">S.CC shall ensure that all materials that is stored on construction area or intended to be standing over to people are safe and do not pose any risk to people. CC shall remove nails from the construction waste (Photo #11.#12.#13);</p> | | |

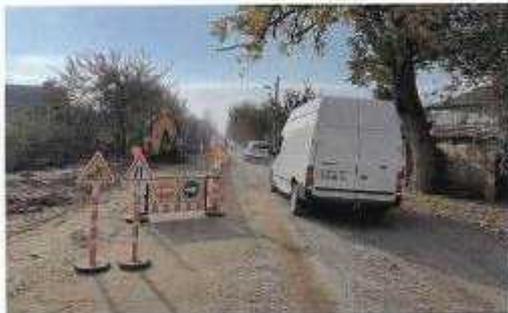
Photo no.9

| Non-compliance point | Non-compliance photo | Corrective action photo |
|---|---|---|
| <p>4. Safety issues on construction sites should be protected, workers always should use complete set of PPE (Photo #9).</p> | | <p>Workers use:</p> <ul style="list-style-type: none"> - Safety helmets - safety shoes - protective clothing/reflective vests - safety gloves |
