SEMI-ANNUAL ENVIRONMENTAL MONITORING REPORT

#14 Semi-annual Report

(Reporting Period: July-December 2024)

**GEORGIA: URBAN SERVICES IMPROVEMENT INVESTMENT PROGRAM
(TRANCHE 6)**

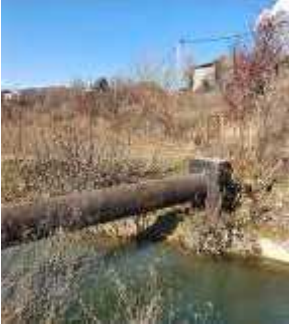
Construction of Waste Water Collector in Bolnisi						
4	Un-fenced /unsecured pipeline cross river near resident areas (next to PS #2), Photo N6	The sewage collector across the river should be properly fenced off, as children may use the pipeline as a playground or bridge, posing a potential health risk	<p>Photo N6</p>

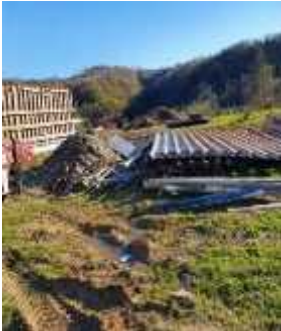
#	Non-compliance	Corrective action	Construction Site	Terms of accomplishment Responsibility	Progress of Corrective Actions
Avarioni Reservoir					
1	Avarioni Reservoir, uncontrolled disposal of construction waste were fixed.	Construction Waste must be collected and disposed from the project area.	Photo N1

UWSCG End of June 2024	Completed June 2024, Photo N1

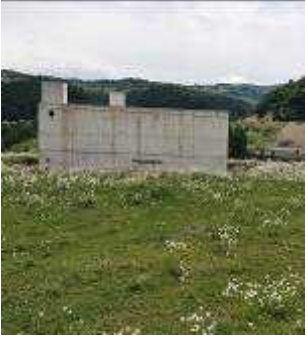
4	Prevent access of public to the reservoir site - The fence of the reservoir should be done properly and equipped with Signs, information and warnings	Reservoirs sites should be properly fenced equipped with proper warning signs	Photo N4

UWSCG UWSCG	Not yet completed ² A new tender will be issued to complete these remaining tasks, with funding provided through the central government budget. UWSCG is responsible for ensuring the completion of the CHI-01 sub-project.
5	There are deep Trenches around the Avarioni Reservoir without Protection	Trenches on the Avarioni Reservoir should be filled or fenced off their borders.	Photo N5

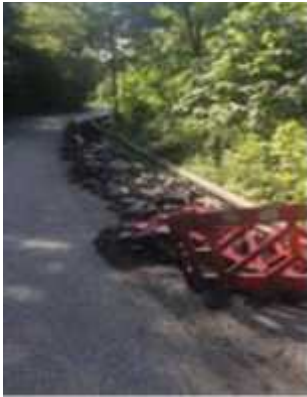
UWSCG	<p>Not yet completed</p> <p>A new tender will be issued to complete these remaining tasks, with funding provided through the central government budget. UWSCG is responsible for ensuring the completion of the CHI-01 sub-project.</p>
7	Uncontrolled disposal of construction waste were outside the BISI reservoir was fixed.	Construction Waste must be collected and disposed from the project area.	<p style="text-align: center;">Photo N7</p>

UWSCG End of May 2024	<p>Completed May 2024, Photo N4</p>

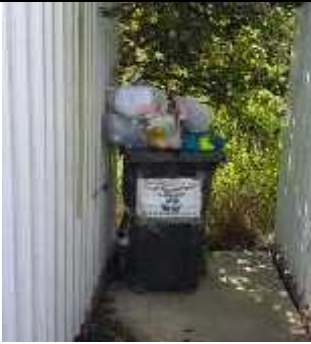
<p>All construction materials should be properly segregated and stored adequately, Photo N2</p>

<p>Construction waste should be timely removed from the construction site and disposed properly</p>	<p>Non-Compliance Notice was issued and is presented in Annex B of this report.</p> <p>(Photo-documentations are presented in Annex B, non-compliance note)</p>

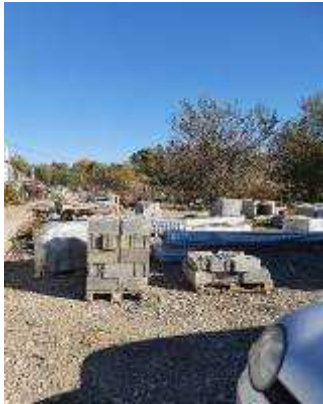
Date of Visit	Name of Company Name of Contract	Auditors Name	Purpose of audit	Summary of any Significant Findings	Implemented Actions	³ Implementation Status
		Specialist of UWSCG/USIIP Ms.Kate Chomakhidze Environmental Specialist of Supervision Consultant HILL Mr.Nikoloz Neparidze		All construction materials should be properly segregated and stored adequately, Photo N2

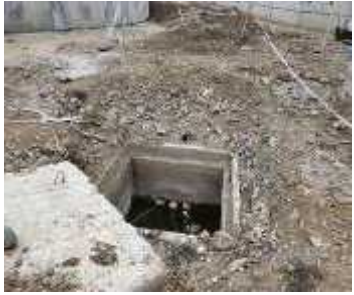
<p>Deep unprotected trenches</p> <p>Deep and unprotected open trenches pose a threat to workers and visitors to the construction site, Photo N2</p>

<p>Corrective Action Plan has been developed by contractor and sent to SC and UWSCG</p>	<p>Completed, Photo N1</p>

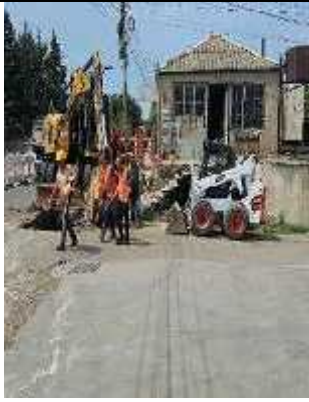
10 September 2024		Environmental Specialist of Supervision Consultant HILL Mr.Nikoloz Neparidze	Regular Environmental monitoring of sites	<p>The deep trench is not reinforced with protective shield, Photo N1</p>

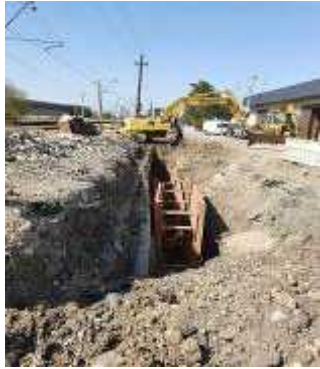
<p>All construction site/segment must have adequate access in order not to endanger the workers, Photo N2</p>

<p>The contractor shall hire a cable control person – flag man to avoid</p>	<p>Corrective Action Plan has been developed by contractor and sent to SC and UWSCG</p>	<p>Completed, September 2024</p> <p>Mid.</p>

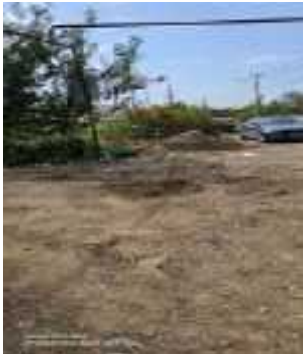
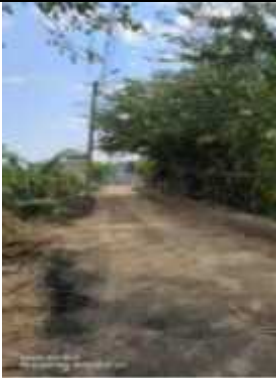
25 September, 2024		Environmental Specialist of Supervision Consultant HILL Mr.Nikoloz Neparidze	Permanent monitoring of Sites	<p>There is no speed limit sign along the trench The trench boundary is damaged or missing. Garbage is dumped in the trench, Photo N1</p>

1. 41.482758; 44.788674
There is no speed limit sign along the trench
The trench boundary is damaged or missing.
Garbage is dumped in the trench.
If the work is temporarily stopped, the trench should be covered with a special cover
2. 41.485188; 44.788857
Earthworks are underway
The deep trench is not surrounded with protective shields.
The vehicle passage on the trench is not surrounded by embankments
3. 41.475499; 44.808018
Traffic is blocked for cars.
There are no limit signs set at the head and end of the blocked section.
There is no crossing bridge at the entrance to the residents' houses
4. 41.485571; 44.808018
Earthworks are underway.
Traffic is blocked for cars.
There is no crossing bridge at the entrance to the residents' houses

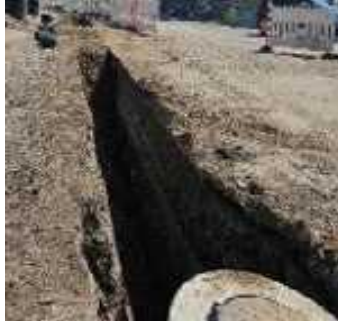
Date of Visit	Name of Company Name of Contract	Auditors Name	Purpose of audit	Summary of any Significant Findings	Implemented Actions	³ Implementation Status
				<p>cover</p> <p>Earthworks are underway. The deep trench is not reinforced with protective shields, Photo N2</p>

<p>The vehicle passage on the trench is not surrounded by embankments</p> <p>Traffic is blocked for cars.</p> <p>There is no crossing bridge at the entrances to the residents' houses, Photo N3</p>	<p>Corrective Action Plan has been developed by contractor and sent to SC and UWSCG</p>	<p>Completed, end of September 2024, Photo N2</p>

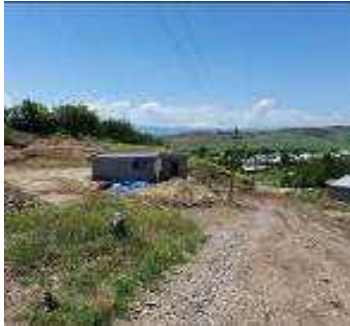
<p>The trench boundary is damaged or missing.</p>	<p>Corrective Action Plan has been developed by contractor and sent to SC and UWSCG</p>	<p>Completed, Mid. October 2024</p>
<p>7 November, 2024</p>	<p>MAR-01</p>	<p>ADB's Environmental Safeguard Mission, led by Mrs. Ninette R. Pajarillaga, Country Environmental Focal and Ms. Nino Nadashvili, Safeguards Officer Georgia Resident Mission Asian Development</p>	<p>Semi-annual Environmental Safeguard Mission</p>	<p>Jandari Reservoir Fencing of Jandary Reservoir, Photo N1</p>

Recommendations under MAR-01	
Recommendations MAR-01 (LOT-01/LOT-02/LOT-03/LOT-04/LOT-05/LOT-06)	Implementation Status and Date
MAR-01/LOT-06 Fencing of Jandari Reservoir, installation of the information signs	Instruction are given to contractor to conduct relevant mitigation measures by the end March 2025

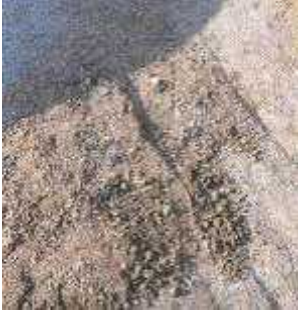
<p>Concrete must be removed from the area and the soil must be reclaimed, Photo N7</p>		<p>Completed, immediately, Photo N4</p>

<p>Completed, December 2024</p> <p>Mid.</p>

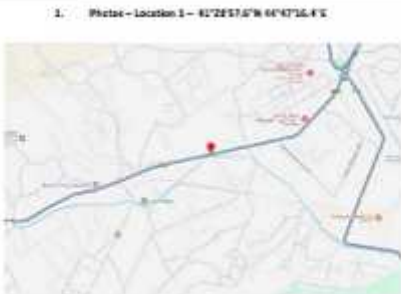
Visit report		09 September 2024
Project : Urban Services Improvement Investment Program (USIP), Georgia Contract: MAR 01 Contractor: China Geo Corporation		Site Visit Report
On 09 September 2024 I visited Manual ongoing activities (Street Works) on 2 locations at the coordinates: 1. 41°28'57.6"N 84°47'36.4"E Earthworks are underway. The deep trench is not reinforced with protective shields. The workers are not using the PPE.

- Walls of the deep trenches (1.5m) should be strengthened by adequate and sufficient quantity of boards to avoid landslide of the soil and accidents (workers damage) (Photo N2, Photo N3, Photo N4)

- All construction site/segment must have adequate access in order not to endanger the workers (Photo N4)
- The contractor shall hire a cable control person – flag man to avoid damage of cables (Photo N5)

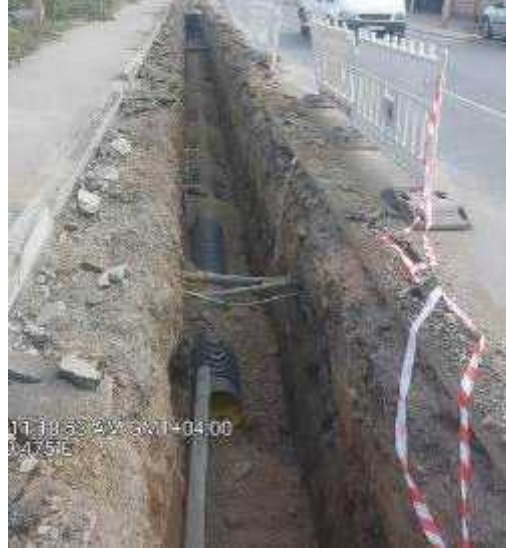
Encl.: Three photographs showing unsatisfactory situation

The engineer is noting that, despite several warnings, the current works on 36 May street in Bakula are continuously being carried out without adequate safety conditions. Among other items, shoring is not being used, there is a lack of adequate protection of the trench and the traffic signals are insufficient, this way putting at risk not only workers but the population that needs to use that road.

It should also be noted that the quality of the performed works is not in accordance with the requirements of the Contract, as the backfilling of the trenches is not being done in layers, nor is it properly compacted.

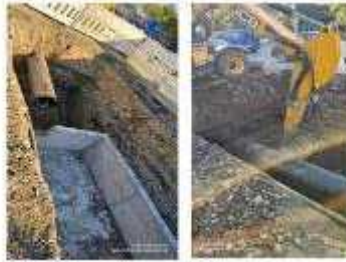
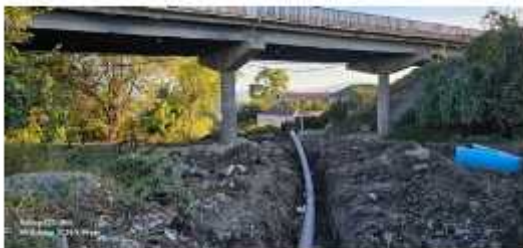
Photos - Location 2

Project: Urban Services Improvement Investment Program (USIP), Georgia	Site Visit Report
Contractor: M&A 01	
Contractor: China Geo Corporation	
On 9 October 2024 I visited:	
Marazuli ongoing activities (Street Works) on 4 locations at the coordinates:	
1. 41.491562; 44.892643 Earthworks are underway. The deep trench is not reinforced with protective shields. The workers are not using the PPE.	
2. 41.481673; 44.781936 Earthworks are underway. The trench boundary is damaged or missing.

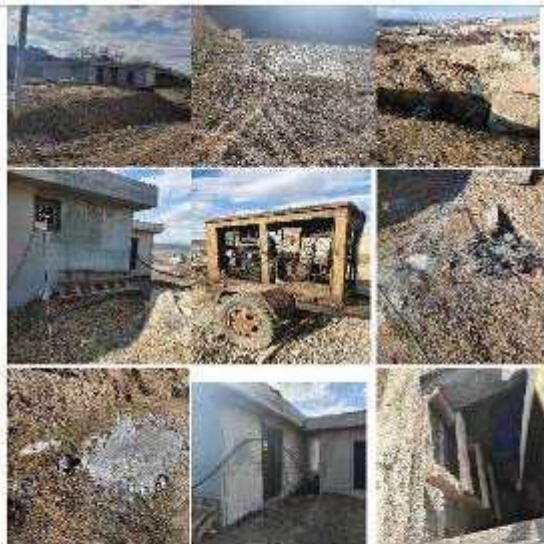
<p>Photos of Jandari Reservoir under MAR-01 sub-project (12 December, 2024)</p>

<p>Project: USIP Contract No.: No UWSOS-ICB-MAR-01/LOT-01/LOT-02/LOT-03/LOT-04 Contractor: China Geo-engineering Corporation (CGC) (People's Republic of China) Supervisor/Consultant: HLL Reference: 'CONSTRUCTION OF WATER SUPPLY AND SEWERAGE SYSTEM IN MARNEULI', LOT-01, LOT-02, LOT-03 and LOT-04</p>	<p>Non-compliance Notice: CONSTRUCTION OF WATER SUPPLY AND SEWERAGE SYSTEMS IN MARNEULI AND SEWERAGE SYSTEM AND COLLECTOR IN BOUNSI USIP/ITS/CW/2022/MAR-01</p>
<p>This notice is to advise you, the Contractor, on the referenced Contract, of the following notice on environmental measures to be implemented until 20 December 2024.</p>	
<p>Construction of Jandari Reservoir in Momeali:</p> <ul style="list-style-type: none"> - An appropriate fence must be installed along the entire perimeter of the Jandari Reservoir to prevent unauthorized persons from entering the construction site and equipped with lockable gate and proper warning and formation signs (Photo No. 1); - The construction site should be gravelled to ensure smooth and safe movement of workers and visitors (Photo No. 2); - High visible safety signboards and trench side barriers around of deep open excavation should be installed from all sides to avoid accidents of local population (Photo No. 3); - The construction internal area should be regularly cleaned and organized, construction materials should be placed separately and stored properly (Photo No. 4); - A power generator without a drip tray and/or concrete floor causes oil leaks and soil contamination (Photo No. 5); - Burning of waste on the construction site is prohibited (Photo No. 6); - Concrete must be removed from the area and the soil must be reclaimed (Photo No. 7); - Safety electric cables should be arranged at construction site not to create danger for workers (Photo No. 8); - Safety ladder should be installed on construction site to avoid workers damage (Photo No. 9).

<p>All these conditions have to be remedied within 7 working days: 20 December 2024</p>	
<p>Date of the visit: 12 December 2024 Site Monitoring was carried out by: Hava Chomachidze, Environmental Consultant of UWSOS/USIP</p>	<p>NCR is prepared by: Kato Chomachidze, Environmental Consultant, UWSOG/USIP</p>

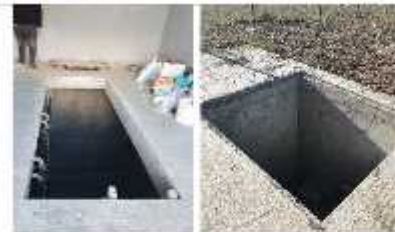
Photos of Bolnisi WW Network and Pumping Stations, PS#2 and PS#3

1. Proper Warning and information signs should installed on entrance gate (Photo N1);
2. Un-fenced/unsecured pipeline cross river near resident areas, where children may use it as a playground make threats to local population and should be adequately fenced and protected (Photo No. 2);
3. Clearly visible sign/safety tapes, trench side fences or proper cover should be installed around deep open pits/reservoirs (3-7m) to avoid accidents with working personal (Photo No. 3) (should be replaced immediately)

All these conditions have to be remedied immediately

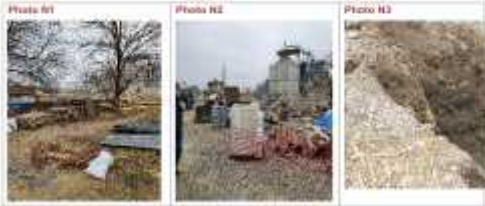
Photos of Marhejul WWTP Construction Site

- Deep and unprotected trenches poses a threat to workers and visitors to the construction site (Photo N3)

All these conditions must be addressed by both the contractor and the supervisor within 6 working days, by end of 27 December 2024	
Date of site visit: 20 December 2024	
Kate Chenukhites, Environmental Consultant UWSCG/USRP

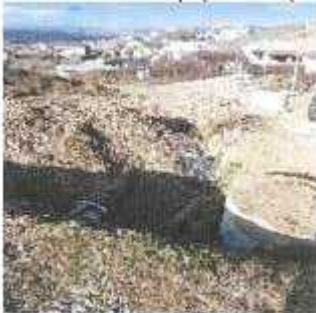
3. High visible safety signs/tapes and trench side barriers around of deep open excavation should be installed from all sides to avoid accidents of local population (Photo No.3);

3. The construction site is completely covered with a layer of gravel. (Photo No. 2);

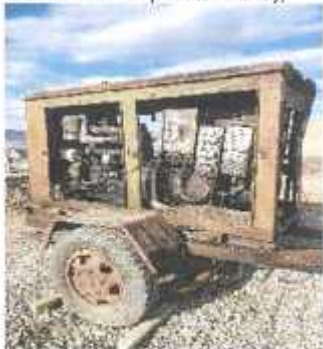
5. A power generator without a drip tray and/or concrete floor causes oil leaks and soil contamination (Photo No. 5);

5. A power generator is no longer needed, it has finished its job and was sent to the workshop for repairs;

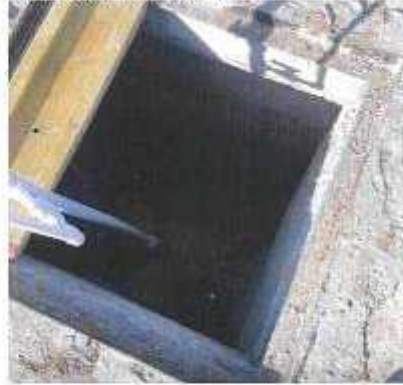
9. Safety ladder should be installed on construction site to avoid workers damage (PhotoNo. 9).

9. The work was completed and the ladder were removed (PhotoNo. 7).
