Semi-annual Environmental Monitoring Report

#14 Semiannual Report

(Reporting Period: July-December 2022)

**GEORGIA: URBAN SERVICES IMPROVEMENT INVESTMENT PROGRAM
(TRANCHE 4)**

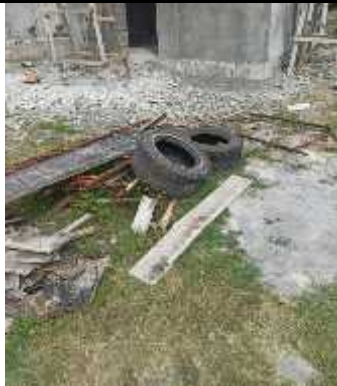
Date of Visit	Name of Company	Auditors Name	Purpose of audit	Summary of any Significant Findings	Cross Reference to Audit Report	Status of implementation

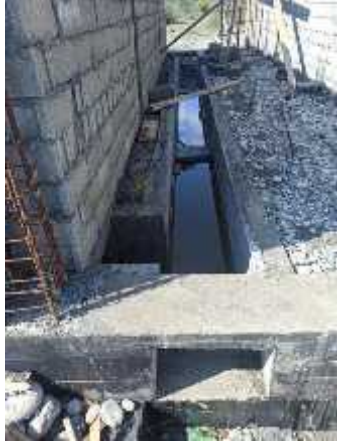
<p>No hard barrier/no warning tape/no warning sign, Please see Photo N2 below</p>

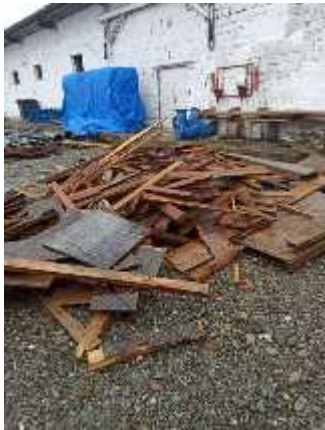
Date of Visit	Name of Company	Auditors Name	Purpose of audit	Summary of any Significant Findings	Cross Reference to Audit Report	Status of implementation
20 October 2022		<p>Environmental Specialist of SC Mr. Shalva Bosikashvili</p> <p>USIIP/ES Ms. Kate Chomakhidze</p>	Regular Monitoring of Sites	<p>Unacceptable housekeeping, Please see Photo N1 below</p>

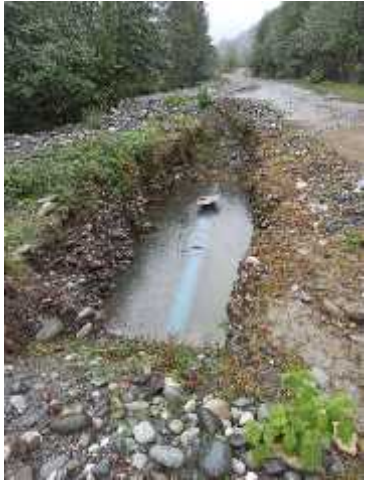
<p>No hard barrier, no warning tape/sign around the open pits, Please see Photo N2 below</p>

<p>Non-compliance notice were issued to contractor and corrective actions were required to immediately improve the situation on sites under JVA-01sub-project (Please see Annex C)</p>	<p>Completed, end of October 2022</p> <p>Completed, end of October 2022</p>

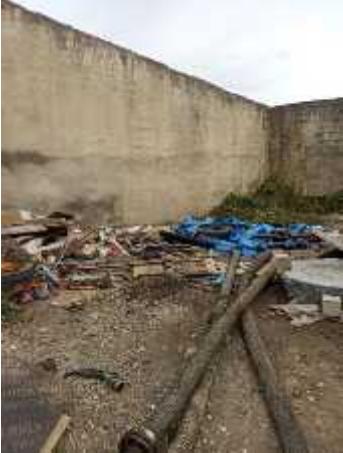
Date of Visit	Name of Company	Auditors Name	Purpose of audit	Summary of any Significant Findings	Cross Reference to Audit Report	Status of implementation
8 November 2022		<p>Environmental Specialist of SC Mr. Shalva Bosikashvili</p> <p>USIIP/ES Ms. Kate Chomakhidze</p>	Regular Monitoring of Sites	<p>Unacceptable housekeeping, please see Photo N1 below</p>

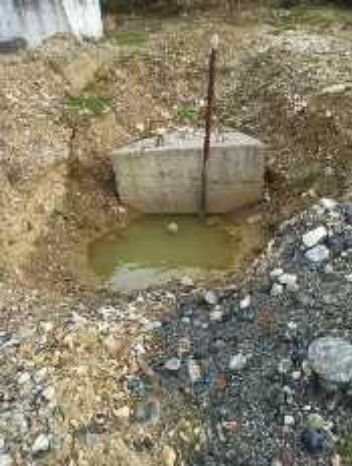
<p>No hard barrier, no warning tape/sign around the open pits, please see Photo N2 below</p>	<p>Non-compliance notice were issued to contractor and corrective actions were required to immediately improve the situation on sites under JVA-01 sub-project (Please see Annex C)</p>	<p>Completed end of November 2022</p> <p>Partially completed, all open trenches and excavated pits should be backfilled immediately after excavation is completed.</p>

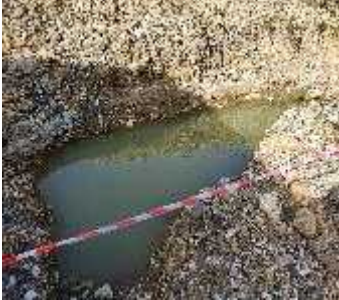
<p>No hard barrier, no warning tape/sign around the open pits, please see Photo N2 below</p>	Verbal instruction was given to contractor to immediately improve the situation.	<p>Completed by the end of November 2022</p> <p>Not completed, will be completed by the end of January 2023 and reflected in</p>

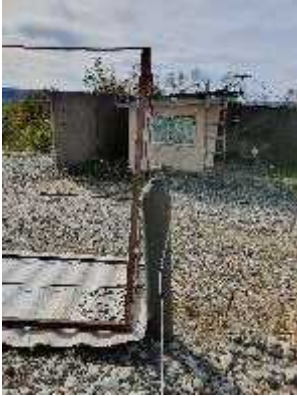
<p>Rusted gas cylinder on the ground without proper protection, please see Photo N3 below</p>

<p>Temporary fencing of the Reservoir construction site should be provided, while after completion of construction hard fencing of steel on strong column supports should be provided</p>		<p>the next SAEMR, January – June 2023</p> <p>Not completed, will be completed by the end of January 2023 and reflected in the next SAEMR, January – June 2023</p> <p>Not completed, will be completed by the end of January 2023 and reflected in the next SAEMR, January – June 2023</p>

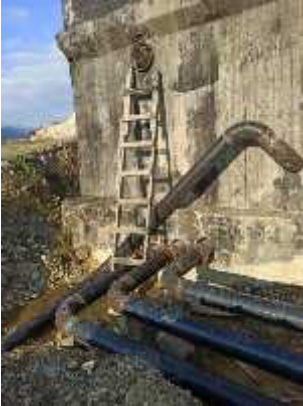
Date of Visit	Name of Company	Auditors Name	Purpose of audit	Summary of any Significant Findings	Cross Reference to Audit Report	Status of implementation
				Appropriate information banners to be installed at the entrance gates of the Jvari reservoir		Not completed, will be completed by the end of January 2023 and reflected in the next SAEMR, January – June 2023
6 December 2022		Environmental Specialist of SC Mr.Shalva Bosikashvili	Regular Monitoring of Sites	<p>Unsafe ladders makes threat to the H&S for workers, please see Photo N1 below</p>

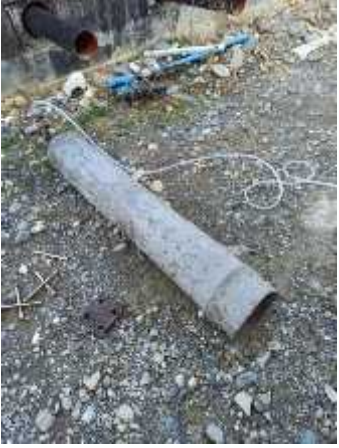
<p>Rusted gas cylinder without cage on the ground in horizontal position, please see Photo N2 below</p>	Non-compliance notice were issued to contractor and corrective actions were required to immediately improve the situation on sites under JVA-01sub-project (Please see Annex C)	<p>Not completed, will be completed by the end of January 2023 and reflected in the next SAEMR, January – June 2023</p> <p>Not completed, will be completed by the end of January 2023 and reflected in the next SAEMR, January – June</p>

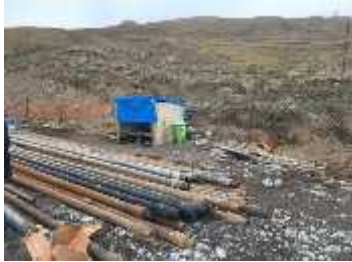
Date of Visit	Name of Company	Auditors Name	Purpose of audit	Summary of any Significant Findings	Cross Reference to Audit Report	Status of implementation
10 November 2022		<p>ADB's Environmental Safeguard mission headed by Ms. Nino Nadashvili, Associate Safeguards Officer Georgia Resident Mission Asian Development Bank;</p> <p>Ms. Kate Chomakhidze UWSCG/USIIP/ Environmental consultants</p>	Quarterly environmental Safeguard Mission	<p>Unacceptable housekeeping (Boring Well 3), Site internally should be arranged properly and cleaned regularly. All construction materials and wastes should be properly segregated and stored adequately, Please see Photo N1 below</p>

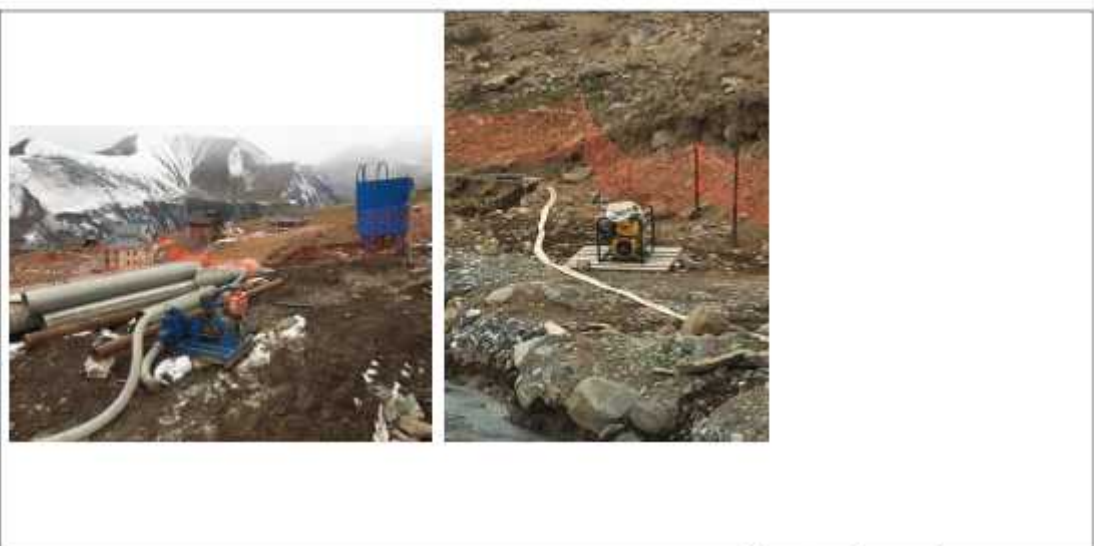
NON-COMPLIANCE IN Gudauri	
Construction of Sewage Collection and Water Supply Systems in Gudauri	
<ul style="list-style-type: none">- Unacceptable housekeeping (Boring Well 3)- Water pump and Generator without drip tray	
Unacceptable housekeeping

All these conditions have to be remedied within 10 days by the prime Contractor China Nuclear Industry 23 Construction Co., Ltd	
Date of site visit: 10.11.2022	
ShalvaBosikashvili - Environmental specialist - "SAFEGE"	
KetevanChomakhidze - Environmental specialist "UWSCG"

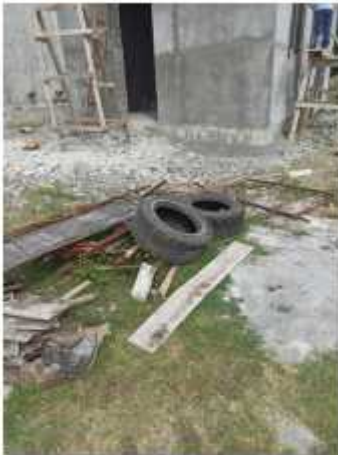
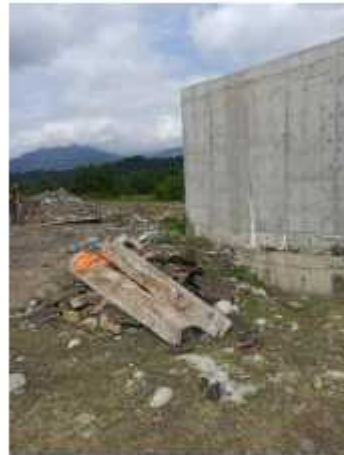
- Unacceptable housekeeping
- Unsafe wiring

Site internally should be arranged properly and cleaned regularly. All construction materials and wastes should be properly segregated and stored adequately, Oil spill response kits should be placed at the appropriate locations. Refuelling station should be equipped with the spill kit and fire relevant fighting equipment; drip tray should be used for fuel spillage prevention. Relevant traffic signs and flagmen should control traffic movement properly. PPE wearing is obligatory at the construction site.

All these conditions have to be remedied within 14 days by the prime Contractor AZ-Inshaat-N

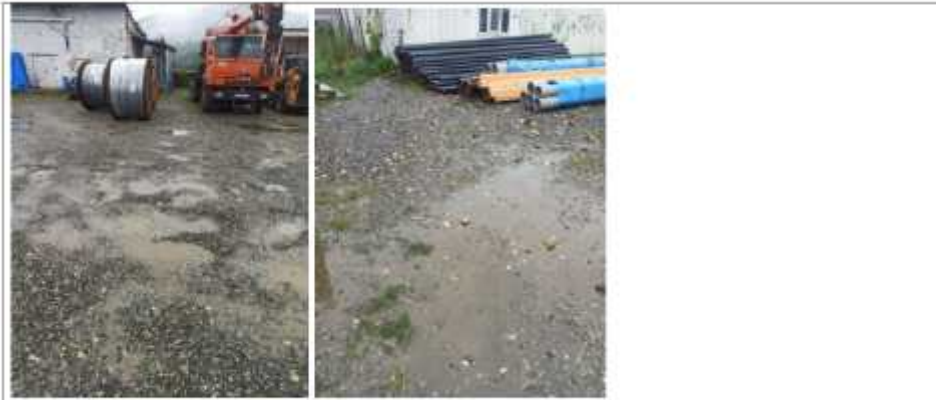
NON-COMPLIANCE IN JVARI	
<ul style="list-style-type: none">▪ Unacceptable housekeeping; waste container without label▪ Construction materials scattered everywhere (material storage should be defined and marked)	
Unacceptable housekeeping; waste container without label

All these conditions have to be remedied within 14 days by the prime Contractor AZ-Inshaat-N.

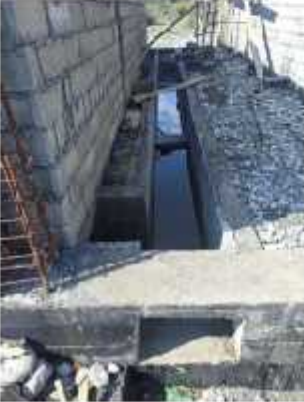
Project: Construction Supervision [under USIP, Tranche 4 Projects]. UWSCG/USIP/QCBS/02-2014	non-compliance Notice JVARI-01
Contract No: P13105-DC-JVA-01	
Contractor: AZ-Inshaat-N	
Reference:	
<p>This notice is to advise the prime Contractor, on the referenced Contract, of the following notice on health, safety and environmental measures to be implemented urgently.</p> <p>GENERAL COMMENT FOR ALL SITES: Site internally should be arranged properly and cleaned regularly. All construction materials and wastes should be properly segregated and stored adequately. Oil spill response kits should be placed at the appropriate locations. Refuelling station should be equipped with the spill kit and fire relevant fighting equipment; drip tray should be used for fuel spillage prevention. Relevant traffic signs and flagmen should control traffic movement properly. PPE wearing is obligatory at the construction site.</p> <p>NON-COMPLIANCE IN JVARI</p> <ul style="list-style-type: none"> • Unacceptable housekeeping & falling hazard (no guard barrier) • No hard barrier/no warning tape/no warning sign • Worker without PPE/falling hazard <p><i>Unacceptable housekeeping & falling hazard (no guard barrier)</i></p>

All these conditions have to be remedied within 14 days by the prime Contractor AZ-Inshaaf-N

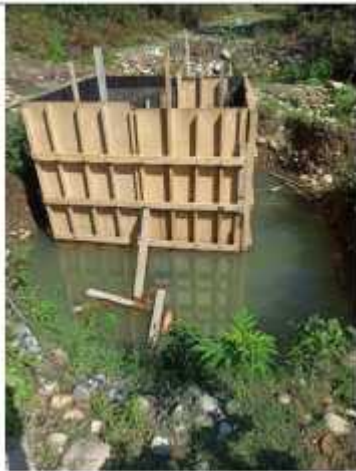
<p><i>No hard barrier/no warning tape/no warning sign</i></p>

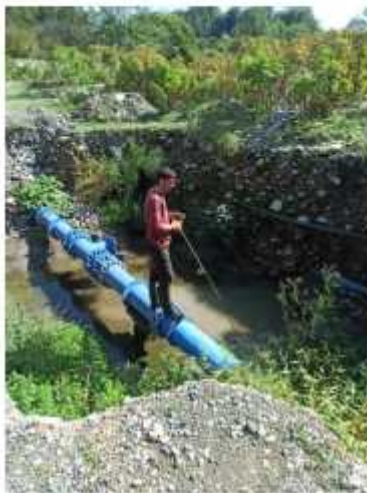
Worker without PPE/falling hazard

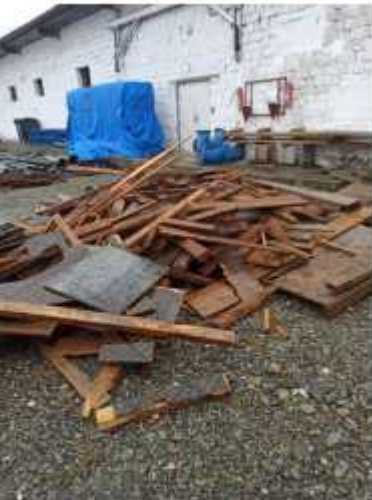
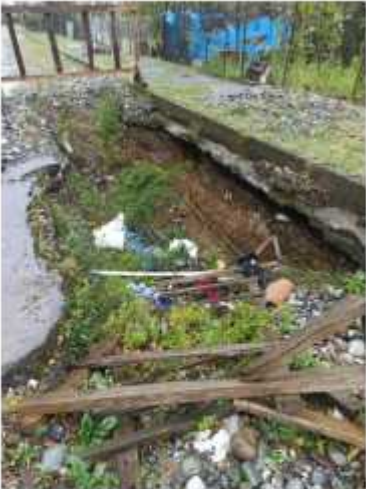
NON-COMPLIANCE IN JVARI	
<ul style="list-style-type: none">• Unacceptable housekeeping• No hard barrier, no warning tape/sign around the open pits	
Unacceptable housekeeping

All these conditions have to be remedied within 14 days by the prime Contractor AZ-Inshaat-N

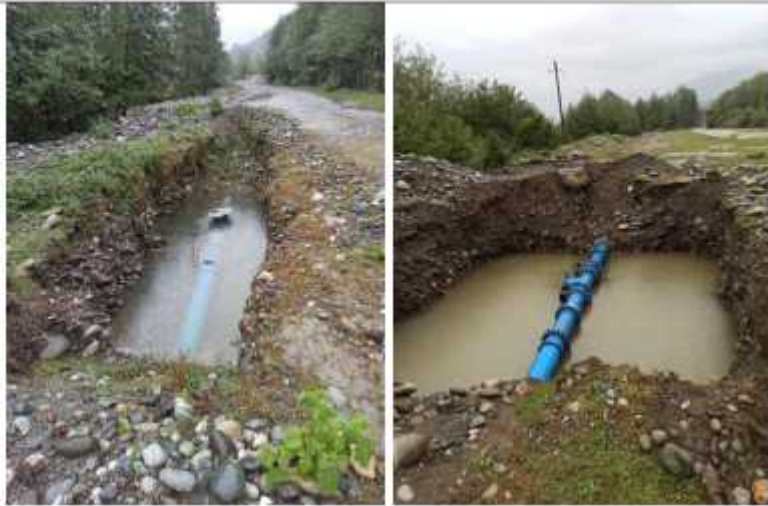
No hard barrier/no warning tape/no warning sign

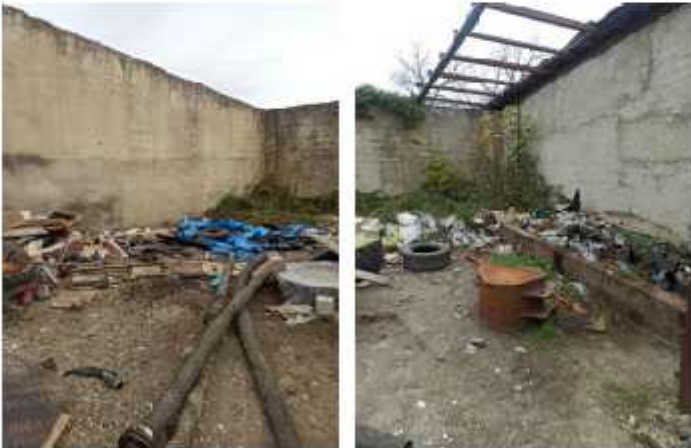
NON COMPLIANCE IN JVARI	
<ul style="list-style-type: none">• Unacceptable housekeeping• No hard barrier, no warning tape/sign around the open pits	
Unacceptable housekeeping

All these conditions have to be remedied within 14 days by the prime Contractor AZ-Inshaat-N

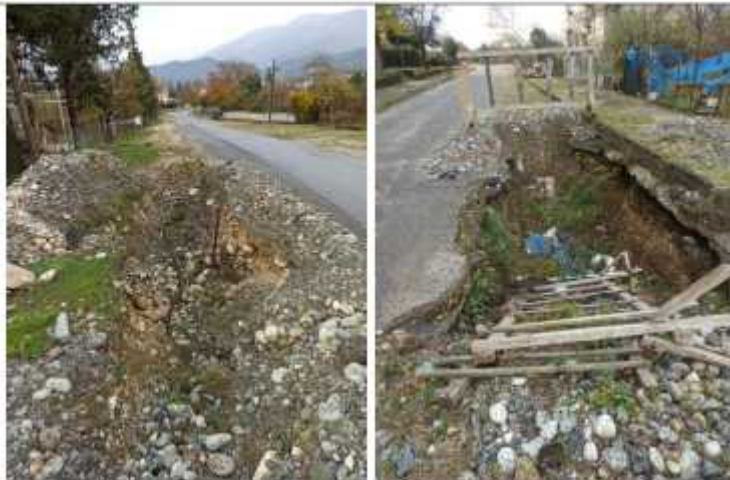
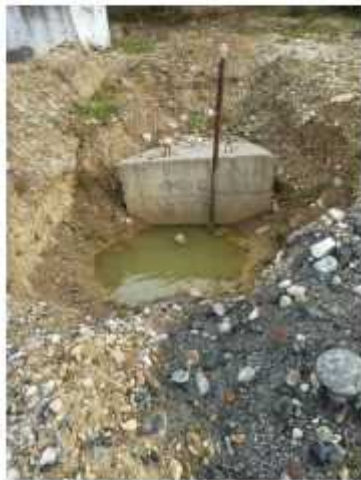
No hard barrier/no warning tape/no warning sign

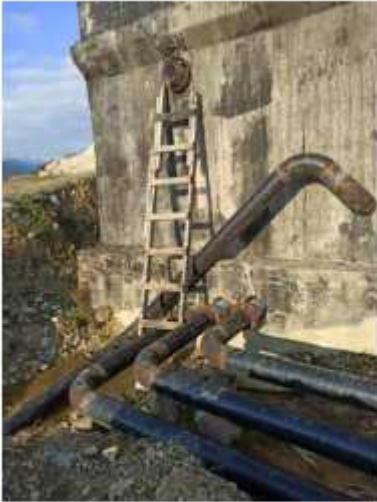
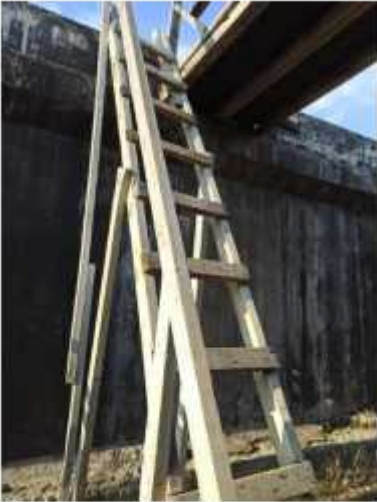
NON-COMPLIANCE IN JVARI	
<ul style="list-style-type: none">▪ Unsafe ladders▪ Rusted gas cylinder without cage on the ground in horizontal position	
Unsafe ladders

All these conditions have to be remedied within 14 days by the prime Contractor AZ-Inshaat-N

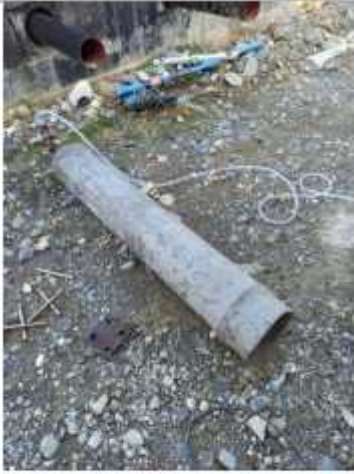
Gas cylinder without cage on the ground in horizontal position
